**APPENDIX B – UCFL2**

**Site UCFL2 Site 1** (Removed from 2021 monitoring by UCML)

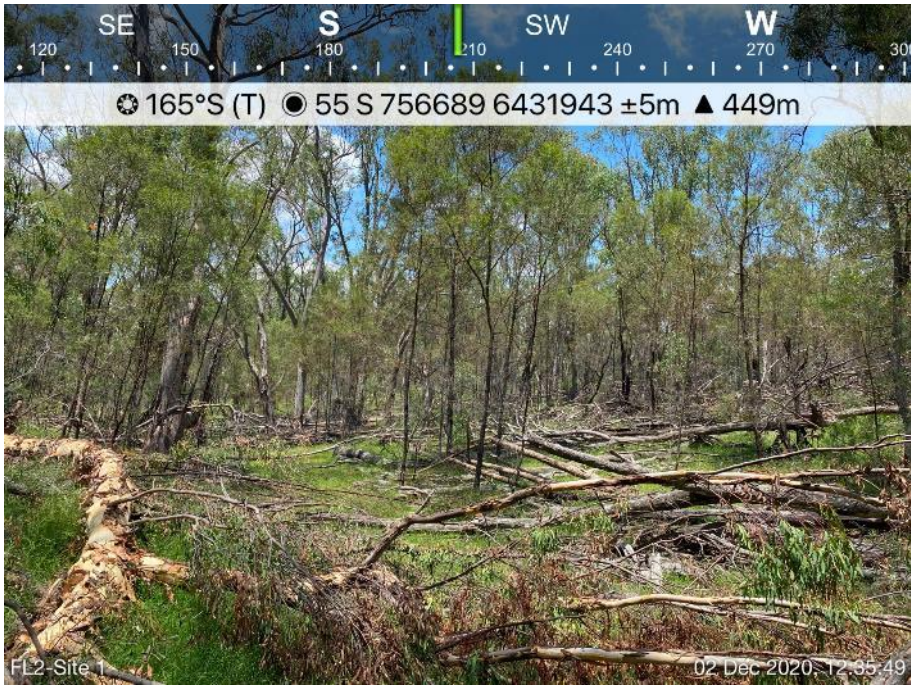
<b>Year</b>	December 2015	December 2016	October 2017	February 2019	December 2020
<b>Result</b>	No perceptible change	No perceptible change	No perceptible change	No perceptible change	No perceptible change
<b>Comments / Interpretation</b>					
<ul style="list-style-type: none"> <li>- UCFL2 Site 1 is approximately located on eastern edge just outside of LW1. To date no perceptible change has been identified as a result of longwall mining at this monitoring site.</li> <li>- During the 2020 inspection no evidence of subsidence related impacts were identified. Increased flood debris was noted.</li> <li>- This site could be considered for removal from the post mining monitoring program of Ulan Creek tributaries due to no perceptible change since the completion of LW1 in May 2015.</li> </ul>

<b>Recommendations</b>					
<ul style="list-style-type: none"> <li>- If unchanged and past two year recommend remove from annual monitoring program (<b>yes/no</b>)</li> <li>- Recommend recording cross sections at locations identified with channel and/or channel bank cracking as a result of subsidence, to monitor for erosion and/or changes to the channel width (<b>yes/no</b>)</li> </ul>					
<b>Photographic Recording (see below)</b>

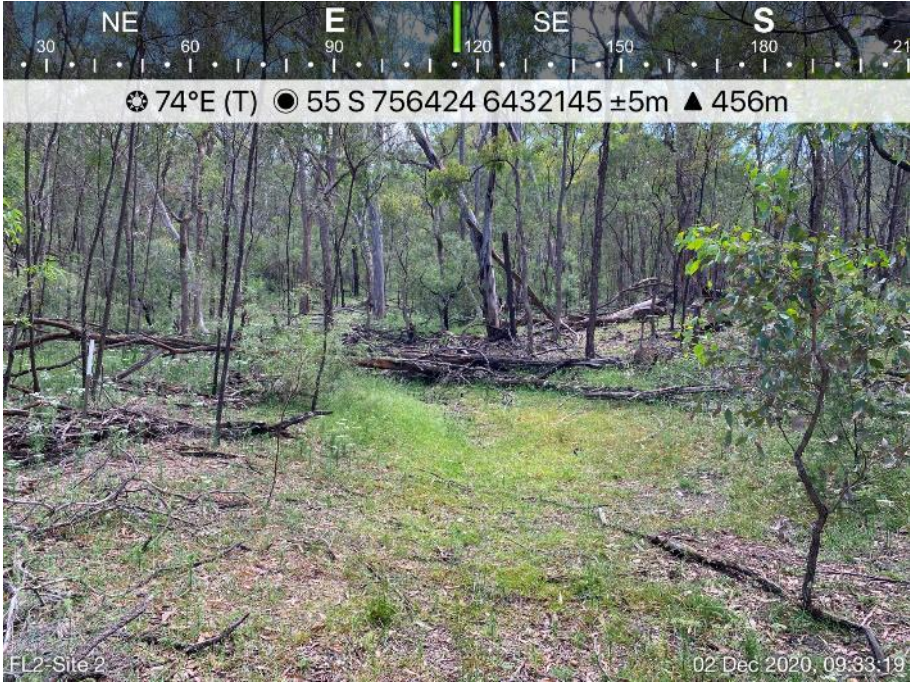
**Site UCFL2 Site 2 (Removed from 2021 monitoring by UCMLP)**

<b>Year</b>	<b>December 2015</b>	<b>December 2016</b>	<b>October 2017</b>	<b>February 2019</b>	<b>December 2020</b>
<b>Results</b>	No perceptible change	No perceptible change	No perceptible change	No perceptible change	No perceptible change
<b>Comments / Interpretation</b>					
<ul style="list-style-type: none"> <li>- UCFL2 Site 2 is approximately located towards the western edge of LW1. To date no perceptible change has been identified as a result of longwall mining at this monitoring site.</li> <li>- During the 2020 inspection there was no evidence of subsidence related impacts identified. There was an increase in ground vegetation, additional flood debris within and along the banks of the flow line were observed.</li> <li>- This site should be considered for removal from the post mining monitoring program of Ulan Creek tributaries due to no perceptible change since the completion of LW1 in May 2015.</li> </ul>

<b>Recommendations</b>					
<ul style="list-style-type: none"> <li>- If unchanged and past two year recommend remove from annual monitoring program (<b>yes/no</b>)</li> <li>- Recommend recording cross sections at locations identified with channel and/or channel bank cracking as a result of subsidence, to monitor for erosion and/or changes to the channel width (<b>yes/no</b>)</li> </ul>					
<b>Photographic Recording (see below)</b>

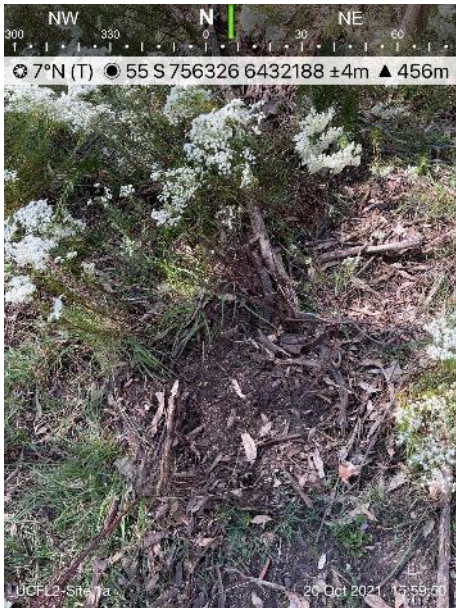
**Site UCFL2 Site 1A (Removed from 2022 monitoring by UCMLP)**

<b>Year</b>	<b>October 2017</b>	<b>February 2019</b>	<b>December 2020</b>	<b>October 2021</b>
<b>Result</b>	Perceptible impacts	Perceptible impacts (no change)	Perceptible impacts (no change)	Perceptible impacts (no change)
<b>Comments / Interpretation</b>				
<ul style="list-style-type: none"> <li>- UCFL2 Site 1A (near site 2A) is above LW2 and was identified during the 2017 monitoring program. Perceptible impacts in the form of a potential ponding site and minor surface cracking were observed.</li> <li>- During the 2020 inspection there was no perceptible change to historical cracking in the channel bed as previously recorded. There was observed infilling of the crack. There was an increase in ground vegetation, additional flood debris within and along the banks of the flow line observed.</li> <li>- Continue to monitor infilling of crack with the channel bed.</li> <li>- During the 2021 the crack could not be located, the site had not deteriorated since previous monitoring</li> <li>- Remove from monitoring.</li> </ul>

<b>Recommendations</b>				
<ul style="list-style-type: none"> <li>- If unchanged and past two year recommend remove from annual monitoring program (<b>yes/no</b>)</li> <li>- Recommend recording cross sections at locations identified with channel and/or channel bank cracking as a result of subsidence, to monitor for erosion and/or changes to the channel width (<b>yes/no</b>)</li> </ul>				
<b>Photographic Recording (see below)</b>

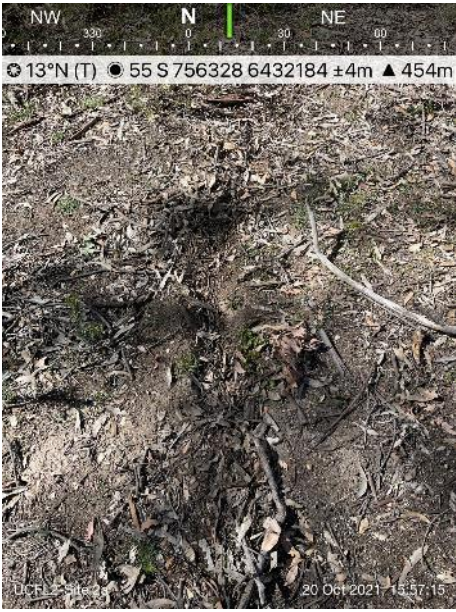
**Site UCFL2 Site 2A (Removed from 2022 monitoring by UCMLP)**

<b>Year</b>	<b>October 2017</b>	<b>February 2019</b>	<b>December 2020</b>	<b>October 2021</b>
<b>Result</b>	Perceptible impacts	Perceptible impacts (no change)	Perceptible impacts (no change)	Perceptible impacts (no change)
<b>Comments / Interpretation</b>				
<ul style="list-style-type: none"> <li>- UCFL2 Site 2A (near site 1A) is above LW2 and was identified during the 2017 monitoring program. Perceptible impacts in the form of a potential ponding site and minor surface cracking were observed.</li> <li>- During the 2020 inspection no perceptible change to historical cracking, partial infilling of cracking, an increase in ground vegetation, additional flood debris within and along the banks of the flow line were observed.</li> <li>- Continue to monitor infilling of crack with the channel bed noted 2020.</li> <li>- Partial infilling of cracks noted in 2021 – had not deteriorated since 2020.</li> <li>- Remove from monitoring</li> </ul>

<b>Recommendations</b>				
<ul style="list-style-type: none"> <li>- If unchanged and past two year recommend remove from annual monitoring program (<b>yes/no</b>)</li> <li>- Recommend recording cross sections at locations identified with channel and/or channel bank cracking as a result of subsidence, to monitor for erosion and/or changes to the channel width (<b>yes/no</b>)</li> </ul>				
<b>Photographic Recording (see below)</b>

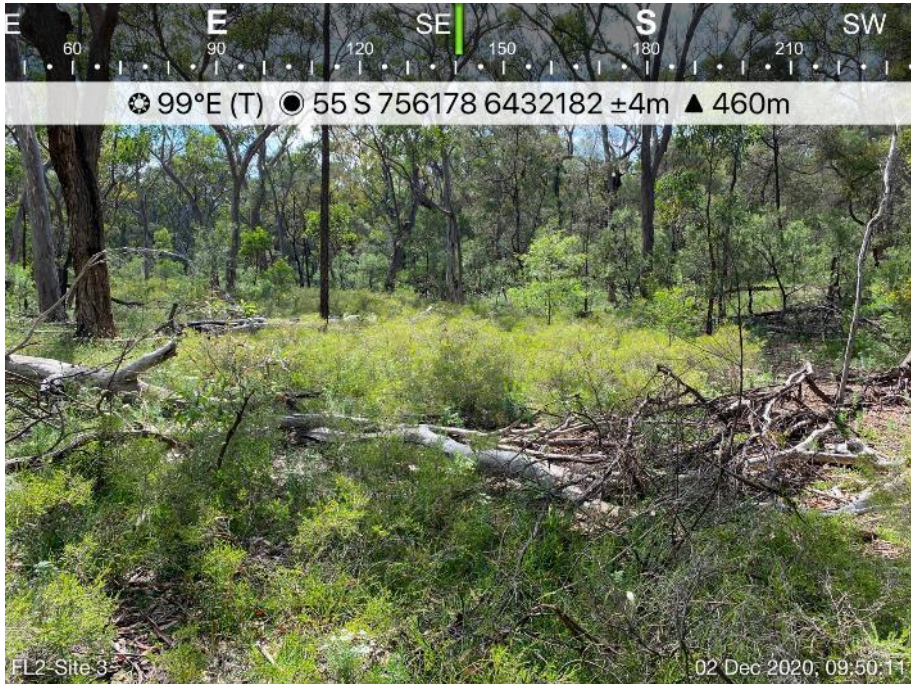
**Site UCFL2 Site 3 (Removed from 2021 monitoring by UCMPL)**

<b>Year</b>	<b>December 2015</b>	<b>December 2016</b>	<b>October 2017</b>	<b>February 2019</b>	<b>December 2020</b>
<b>Results</b>	No perceptible change	No perceptible change	No perceptible change	No perceptible change	No perceptible change
<b>Comments / Interpretation</b>					
<ul style="list-style-type: none"> <li>- UCFL2 Site 3 is centrally located above LW2. To date no perceptible change has been identified as a result of longwall mining at this monitoring site.</li> <li>- During the 2020 inspection there was no evidence of subsidence related impacts identified. There was an increase in ground vegetation, additional flood debris within and along the banks of the flow line observed.</li> <li>- This site could be considered for removal from the post mining monitoring program of Ulan Creek tributaries due to no perceptible change since the completion of LW2 in May 2016.</li> </ul>

<b>Recommendations</b>					
<ul style="list-style-type: none"> <li>- If unchanged and past two year recommend remove from annual monitoring program (<b>yes/no</b>)</li> <li>- Recommend recording cross sections at locations identified with channel and/or channel bank cracking as a result of subsidence, to monitor for erosion and/or changes to the channel width (<b>yes/no</b>)</li> </ul>					
<b>Photographic Recording (see below)</b>

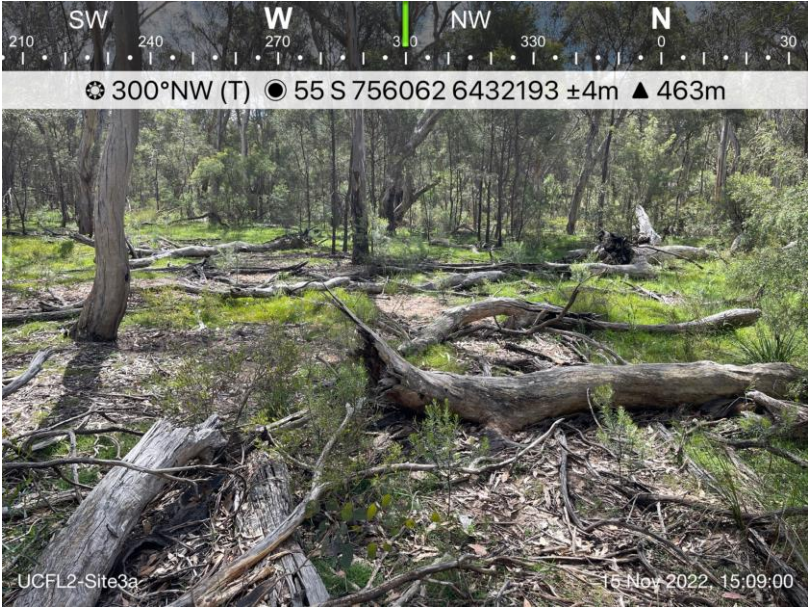
**Site UCFL2 Site 3A (Removed from 2023 monitoring by UCMLP)**

<b>Year</b>	<b>October 2017</b>	<b>February 2019</b>	<b>December 2020</b>	<b>October 2021</b>	<b>November 2022</b>
<b>Result</b>	Perceptible impacts	Perceptible impacts	Perceptible impacts	Perceptible impacts (no change)*	Perceptible impacts (no change)*
<b>Comments / Interpretation</b>					
<ul style="list-style-type: none"> <li>- UCFL2 Site 3A is above LW2 towards the western edge of the longwall panel and was identified during the 2017 monitoring program. Perceptible impacts in the form of channel cracking were observed.</li> <li>- During the 2019 inspection there were signs of potential tunnel erosion noted.</li> <li>- During the 2020 inspection there were signs of increased tunnel erosion, although partial infilling was also observed.</li> <li>- Partial infilling of cracks noted in 2021 – had not deteriorated since 2020.</li> <li>- In 2022 the exact location of the erosion site was difficult to relocate due to increased ground vegetation and timber. The site in general appeared stable and past evidence of subsidence related impacts were not perceptible on the day of the inspection.</li> </ul>

<b>Recommendations</b>					
<ul style="list-style-type: none"> <li>- If unchanged and past two year recommend remove from annual monitoring program (<b>yes/no</b>)</li> <li>- Recommend recording cross sections at locations identified with channel and/or channel bank cracking as a result of subsidence, to monitor for erosion and/or changes to the channel width (<b>yes/no</b>)</li> </ul>					
<b>Photographic Recording (see below)</b>

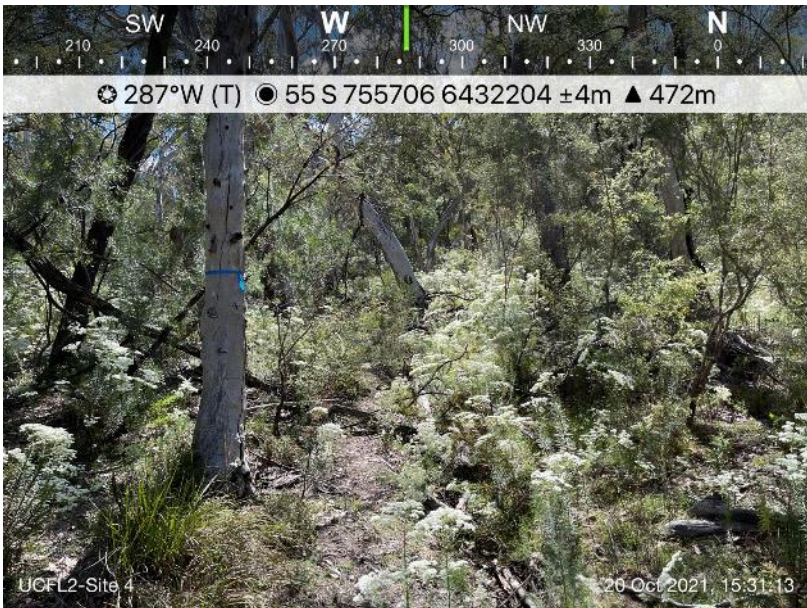
**Site UCFL2 Site 4 (Removed from 2022 Monitoring by UCMPL)**

<b>Year</b>	<b>December 2015</b>	<b>December 2016</b>	<b>October 2017</b>	<b>February 2019</b>	<b>December 2020</b>	<b>October 2021</b>
<b>Results</b>	No perceptible change	No perceptible change	No perceptible change	No perceptible change	No perceptible change	No perceptible change
<b>Comments / Interpretation</b>

<ul style="list-style-type: none"> <li>- UCFL2 Site 4 is approximately located towards the western edge of LW3. To date no perceptible change has been identified as a result of longwall mining at this monitoring site.</li> <li>- During the 2020 inspection there was no evidence of subsidence related impacts identified. There was an increase in ground vegetation, additional flood debris within and along the banks of the flow line observed.</li> <li>- This site could be considered for removal from the post mining monitoring program of Ulan Creek tributaries due to no perceptible change since the completion of LW3 in October 2017.</li> <li>- During the 2021 there was no perceptible change to previous monitoring.</li> <li>- Remove from monitoring</li> </ul>						
<b>Recommendations</b>						
<ul style="list-style-type: none"> <li>- If unchanged and past two year recommend remove from annual monitoring program (<b>yes/no</b>)</li> <li>- Recommend recording cross sections at locations identified with channel and/or channel bank cracking as a result of subsidence, to monitor for erosion and/or changes to the channel width (<b>yes/no</b>)</li> </ul>

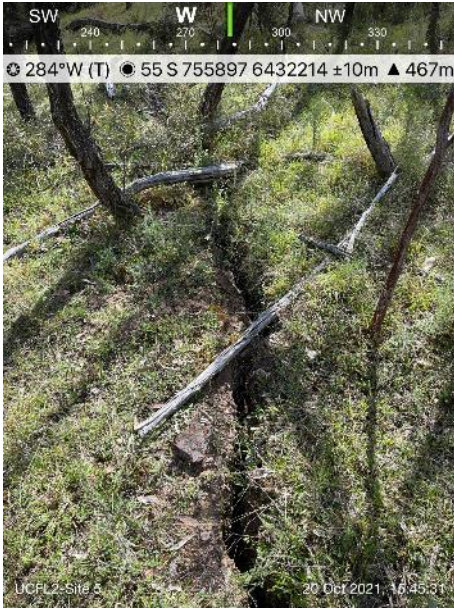
**Site UCFL2 Site 5 (Removed from 2022 monitoring by UCMPL)**

<b>Year</b>	<b>February 2019</b>	<b>December 2020</b>	<b>October 2021</b>	
<b>Result</b>	Perceptible Impacts	Perceptible impacts (no change)	Perceptible impacts (no change)	
<b>Comments / Interpretation</b>				
<ul style="list-style-type: none"> <li>- UCFL2 Site 5 is located above LW4 near the eastern edge of the panel and was added to the monitoring program in 2019. This site is located well above the flow line.</li> <li>- During the 2019 inspection, there was evidence of subsidence related impacts including a small step feature and cracking of approximately 200mm – 250mm in height along the LHB (approx. 70-80m in length)</li> <li>- During the 2020 inspection there was no perceptible change to historical cracking previously recorded. There was no observed infilling.</li> <li>- During the 2021 there was no perceptible change to previously noted impacts.</li> <li>- Remove from monitoring</li> </ul>

<b>Recommendations</b>				
<ul style="list-style-type: none"> <li>- If unchanged and past two year recommend remove from annual monitoring program (<b>yes/no</b>)</li> <li>- Recommend recording cross sections at locations identified with channel and/or channel bank cracking as a result of subsidence, to monitor for erosion and/or changes to the channel width (<b>yes/no</b>)</li> </ul>				
<b>Photographic Recording (see below)</b>

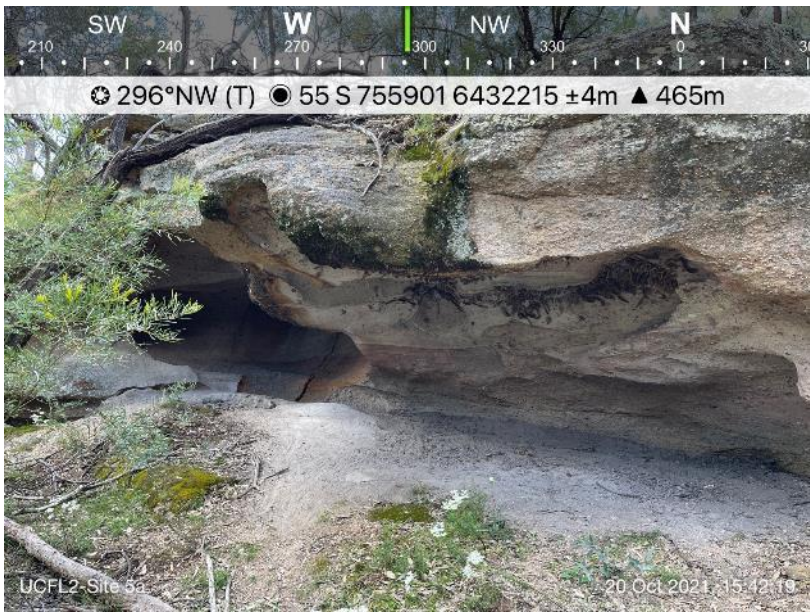
**Site UCFL2 Site 5A (Removed from 2022 monitoring by UCMLP)**

<b>Year</b>	<b>October 2017</b>	<b>February 2019</b>	<b>December 2020</b>	<b>October 2021</b>
<b>Result</b>	Perceptible impacts	Perceptible impacts (no change)	Perceptible impacts (no change)	Perceptible impacts (no change)
<b>Comments / Interpretation</b>				
<ul style="list-style-type: none"> <li>- UCFL2 Site 5A is above LW3 towards the middle of the longwall panel and was identified during the 2017 monitoring program. Perceptible impacts in the form of bedrock cracking with a small overhang above the flow line was observed.</li> <li>- During the 2019 inspection cracking appeared noticeable in the bedrock, with no evidence of further instabilities or cracking.</li> <li>- During the 2020 inspection there was no perceptible change to historical cracking previously recorded.</li> <li>- This site could be considered for removal from the post mining monitoring program of Ulan Creek tributaries due to no perceptible change to historical impacts since the completion of LW3 in October 2017.</li> <li>- During the 2021 there was no perceptible change to previously noted impacts.</li> <li>- Remove from monitoring.</li> </ul>

<b>Recommendations</b>				
<ul style="list-style-type: none"> <li>- If unchanged and past two year recommend remove from annual monitoring program (<b>yes/no</b>)</li> <li>- Recommend recording cross sections at locations identified with channel and/or channel bank cracking as a result of subsidence, to monitor for erosion and/or changes to the channel width (<b>yes/no</b>)</li> </ul>				
<b>Photographic Recording (see below)</b>

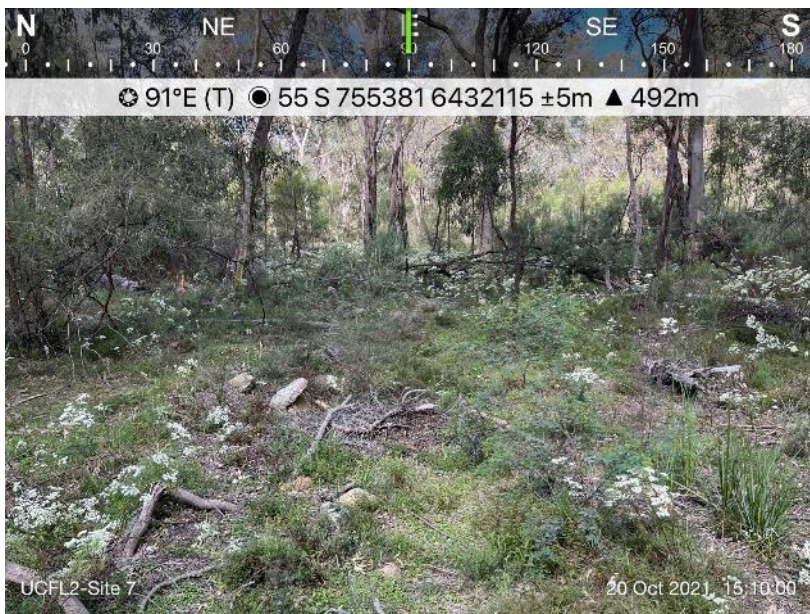
**Site UCFL2 Site 7 (Removed from 2022 monitoring by UCMPL)**

<b>Year</b>	<b>February 2019</b>	<b>December 2020</b>	<b>October 2021</b>	
<b>Result</b>	Perceptible Impacts	Perceptible impacts (no change)	Perceptible impacts (no change)	
<b>Comments / Interpretation</b>				
<ul style="list-style-type: none"> <li>- UCFL2 Site 7 is located above LW4 near the center of the panel and was added to the monitoring program in 2019.</li> <li>- During the 2019 inspection, there was evidence of subsidence related impacts including minor uplifting noted in the channel bed including tree roots uplifted within the channel bed. A mature eucalypt tree had also recently fallen across the flow line at this location.</li> <li>- During the 2020 inspection there was no perceptible change to historical impacts previously recorded. There was increased ground vegetation and flood debris noted.</li> <li>- During the 2021 there was no perceptible change to previously noted impacts.</li> <li>- Remove from monitoring.</li> </ul>

<b>Recommendations</b>				
<ul style="list-style-type: none"> <li>- If unchanged and past two year recommend remove from annual monitoring program (<b>yes/no</b>)</li> <li>- Recommend recording cross sections at locations identified with channel and/or channel bank cracking as a result of subsidence, to monitor for erosion and/or changes to the channel width (<b>yes/no</b>)</li> </ul>				
<b>Photographic Recording (see below)</b>

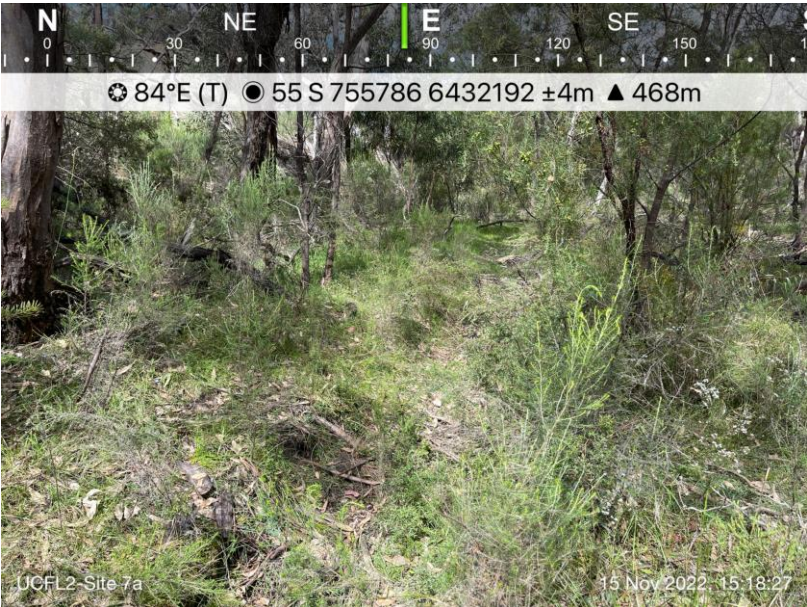
<b>Year</b>	<b>October 2017</b>	<b>February 2019</b>	<b>December 2020</b>	<b>October 2021</b>	<b>November 2022</b>
<b>Result</b>	Perceptible impacts	Monitor perceptible impacts	Perceptible impacts (no change)	Perceptible impacts (no change)	Perceptible impacts (no change)
<b>Comments / Interpretation</b>					
<ul style="list-style-type: none"> <li>- UCFL2 Site 7A is above LW3 towards the middle of the longwall panel and was identified during the 2017 monitoring program. Perceptible impacts in the form of channel cracking and cracking along the banks were observed.</li> <li>- During the 2019 inspection, there were signs of active slumping and movement occurring since the 2017 monitoring.</li> <li>- During the 2020 inspection there was no perceptible change to historical impacts previously recorded in 2019. There was increased ground vegetation and flood debris noted.</li> <li>- During the 2022 there was no perceptible change to previously noted impacts, although the vegetation had increased which hindered observations.</li> <li>- Remove from monitoring</li> </ul>

<b>Recommendations</b>					
<ul style="list-style-type: none"> <li>- If unchanged and past two year recommend remove from annual monitoring program (<b>yes/no</b>)</li> <li>- Recommend recording cross sections at locations identified with channel and/or channel bank cracking as a result of subsidence, to monitor for erosion and/or changes to the channel width (<b>yes/no</b>)</li> </ul>					
<b>Photographic Recording (see below)</b>

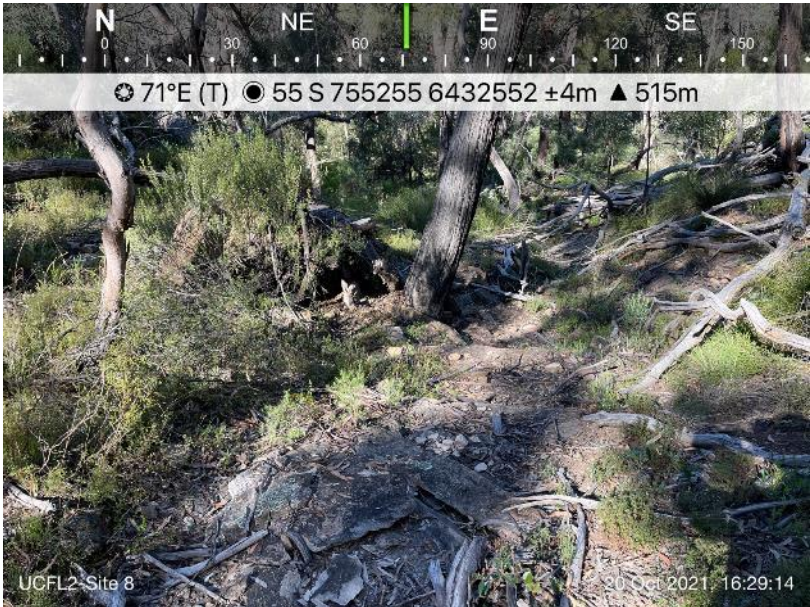
<b>Year</b>	<b>February 2019</b>	<b>December 2020</b>	<b>October 2021</b>	
<b>Result</b>	Perceptible Impacts	Perceptible impacts (no change)	Perceptible impacts (no change)	
<b>Comments / Interpretation</b>				
<ul style="list-style-type: none"> <li>- UCFL2 Site 8 is located above LW4 near the western edge of the panel and was added to the monitoring program in 2019.</li> <li>- During the 2019 inspection, there was evidence of subsidence related impacts including cracking of the bedrock material within the channel bed.</li> <li>- During the 2020 inspection there was no perceptible change to historical impacts previously recorded.</li> <li>- During the 2021 inspection there was no perceptible change to historical impacts previously recorded.</li> <li>- Remove from monitoring</li> </ul>

<b>Recommendations</b>				
<ul style="list-style-type: none"> <li>- If unchanged and past two year recommend remove from annual monitoring program (<b>yes/no</b>)</li> <li>- Recommend recording cross sections at locations identified with channel and/or channel bank cracking as a result of subsidence, to monitor for erosion and/or changes to the channel width (<b>yes/no</b>)</li> </ul>				
<b>Photographic Recording (see below)</b>

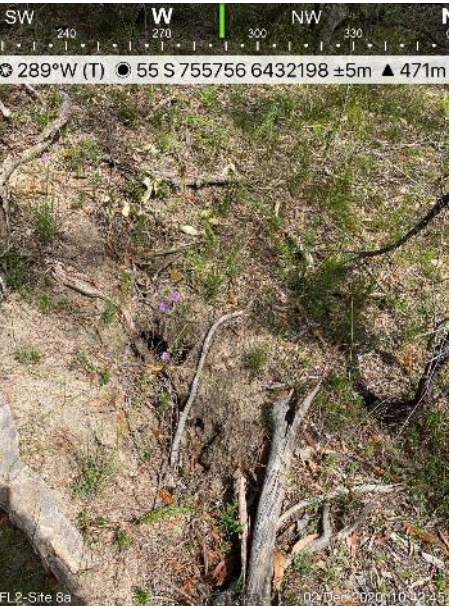
Year			
2020	  <p data-bbox="277 778 719 802">Recently identified cracking within flowline</p>

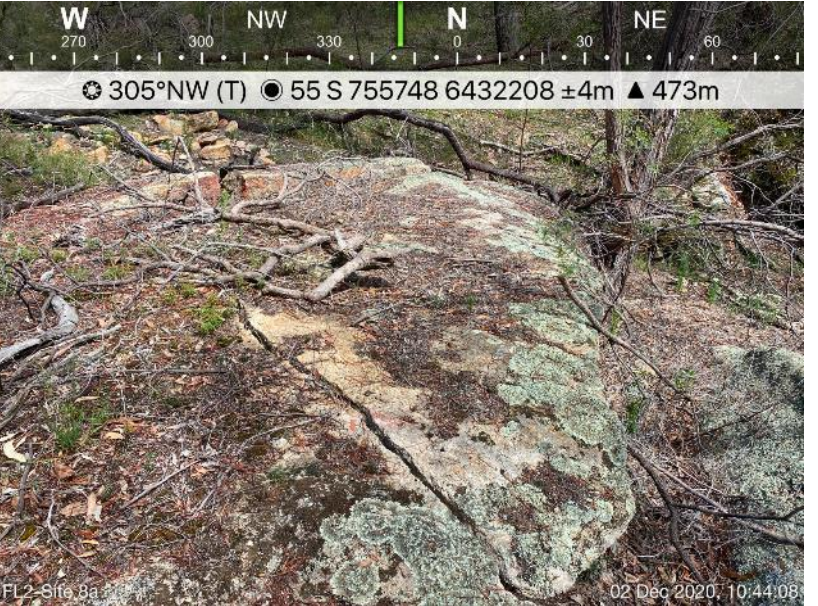
<p data-bbox="1464 778 1760 802">Cracking associated with 8A</p>
2021

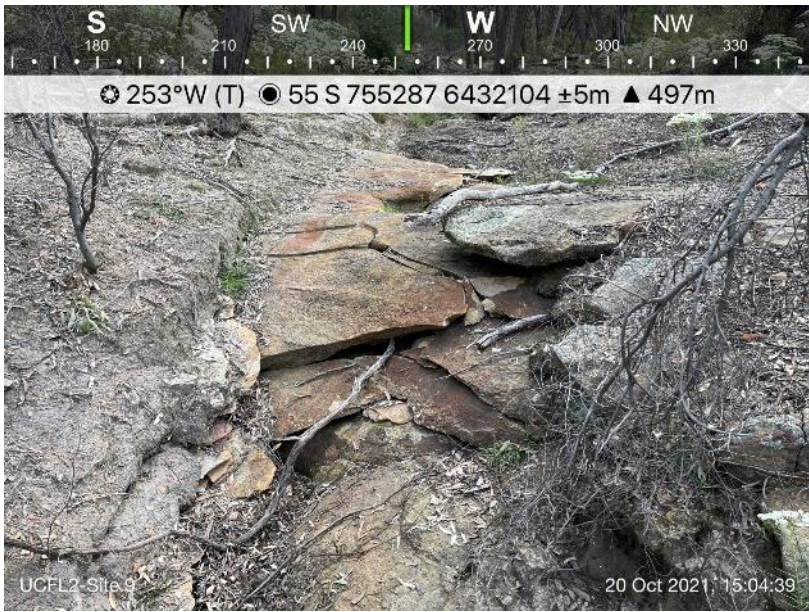
<b>Year</b>	<b>February 2019</b>	<b>December 2020</b>	<b>October 2021</b>	
<b>Result</b>	Perceptible impacts	Perceptible impacts (no change)	Perceptible impacts (no change)	
<b>Comments / Interpretation</b>				
<ul style="list-style-type: none"> <li>- UCFL2 Site 9 is located above LW4 towards the western edge of the panel and was added to the monitoring program in 2019.</li> <li>- During the 2019 inspection, there was evidence of subsidence related impacts including cracking of the bedrock material within the channel bed.</li> <li>- During the 2020 inspection there was no perceptible change to historical impacts previously recorded, with no evidence of infilling. Dislodged rock material had been transported downstream approximately 10m. Additional flood debris noted downstream.</li> <li>- During the 2021 there was no perceptible change to previously noted impacts.</li> <li>- Remove from monitoring.</li> </ul>

<b>Recommendations</b>				
<ul style="list-style-type: none"> <li>- If unchanged and past two year recommend remove from annual monitoring program (<b>yes/no</b>)</li> <li>- Recommend recording cross sections at locations identified with channel and/or channel bank cracking as a result of subsidence, to monitor for erosion and/or changes to the channel width (<b>yes/no</b>)</li> </ul>				
<b>Photographic Recording (see below)</b>

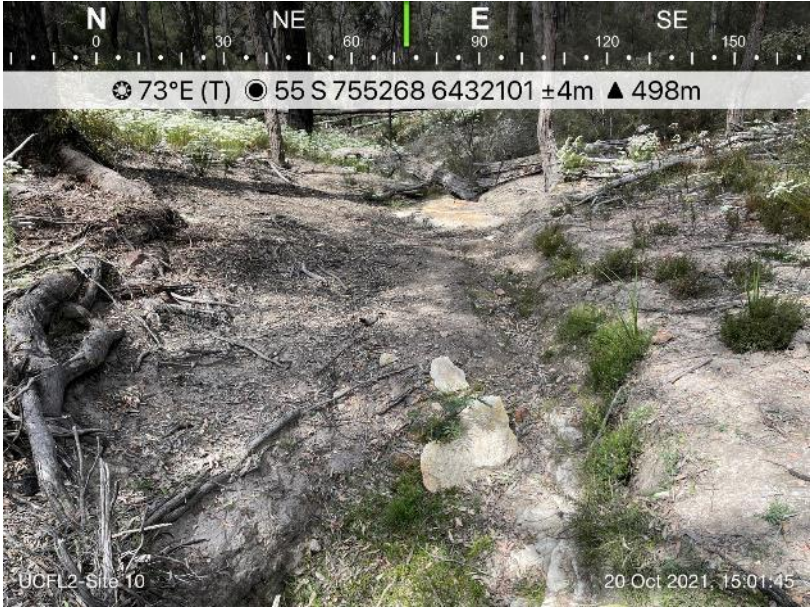
<b>Year</b>	<b>February 2019</b>	<b>December 2020</b>	<b>October 2021</b>	
<b>Result</b>	Perceptible Impacts	Perceptible impacts (no change)	Perceptible impacts (no change)	
<b>Comments / Interpretation</b>				
<ul style="list-style-type: none"> <li>- UCFL2 Site 10 is located above LW4 towards the western edge of the panel and was added to the monitoring program in 2019.</li> <li>- During the 2019 inspection, there was evidence of subsidence related impacts including minor uplifting noted in the channel bed, cracking along the RHB/LHB and uplifting of tree roots within the channel bed.</li> <li>- During the 2020 inspection there was no perceptible change to historical impacts previously recorded, although the cracking along the edges appeared to be infilling. Also dislodged sandstone rock material also noted in the flowline.</li> <li>- During the 2021 there was no perceptible change to previously noted impacts.</li> <li>- Remove from monitoring.</li> </ul>

<b>Recommendations</b>				
<ul style="list-style-type: none"> <li>- If unchanged and past two year recommend remove from annual monitoring program (<b>yes/no</b>)</li> <li>- Recommend recording cross sections at locations identified with channel and/or channel bank cracking as a result of subsidence, to monitor for erosion and/or changes to the channel width (<b>yes/no</b>)</li> </ul>				
<b>Photographic Recording (see below)</b>

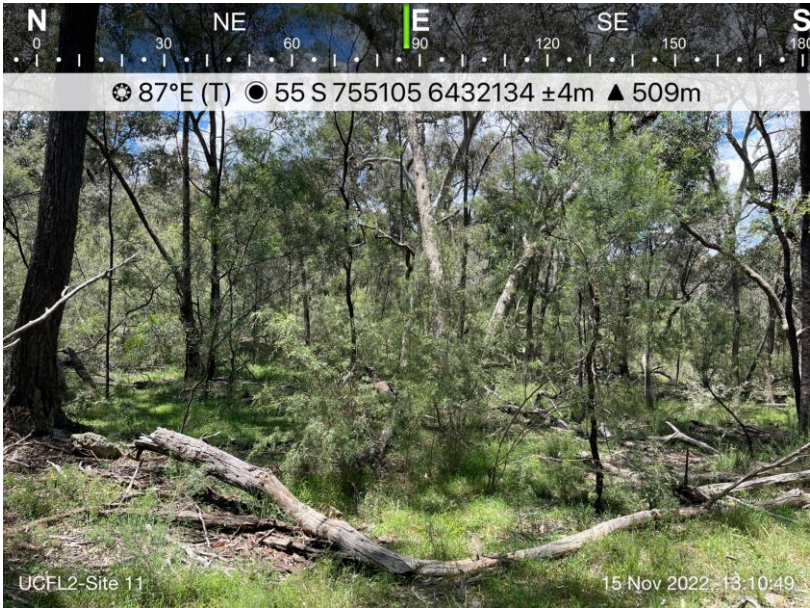
<b>Year</b>	<b>December 2020</b>	<b>October 2021</b>	<b>November 2022</b>	
<b>Result</b>	Perceptible impacts*	Perceptible impacts* (no change)	Perceptible impacts* (no change)	
<b>Comments / Interpretation</b>				
<ul style="list-style-type: none"> <li>- UCFL2 Site 11 is located above LW5 towards the eastern edge of the panel and was added to the monitoring program in 2020.</li> <li>- During the 2020 inspection there was no evidence of subsidence related impacts, with no perceptible change to the flow line identified as a result of longwall mining at this monitoring site. Flood debris was also noted at this site.</li> <li>- *In 2020 small, isolated cracking of the bedrock within the flowline between monitoring sites 11 and 12 was noted.</li> <li>- During the 2022 there was no perceptible change when compared to 2021. * Minor cracking in bedrock downstream (between Site 12 and 11) noted in 2020 remained unchanged in 2021 and 2022. Increased vegetation in 2022 hindered observations along the flow line outside of exposed bedrock.</li> <li>- Remove from monitoring.</li> </ul>

<b>Recommendations</b>				
<ul style="list-style-type: none"> <li>- If unchanged and past two year recommend remove from annual monitoring program (<b>yes/no</b>)</li> <li>- Recommend recording cross sections at locations identified with channel and/or channel bank cracking as a result of subsidence, to monitor for erosion and/or changes to the channel width (<b>yes/no</b>)</li> </ul>				
<b>Photographic Recording (see below)</b>

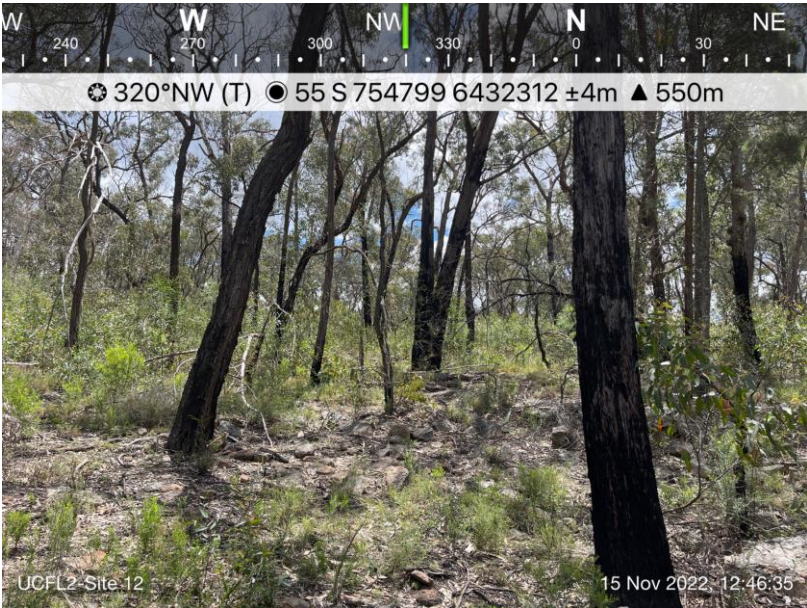
<b>Year</b>	<b>December 2020</b>	<b>October 2021</b>	<b>November 2022</b>	
<b>Result</b>	Perceptible impacts*	Perceptible impacts* (no change)	Perceptible impacts* (no change)	
<b>Comments / Interpretation</b>				
<ul style="list-style-type: none"> <li>- UCFL2 Site 12 is located above LW5 towards the western edge of the panel and was added to the monitoring program in 2020 at the head of this flow line.</li> <li>- During the 2020 inspection there was no evidence of subsidence related impacts, with no perceptible change to the flow line identified as a result of longwall mining at this monitoring site*.</li> <li>- *In 2020 small, isolated cracking of the bedrock within the flowline between monitoring sites 11 and 12 was noted.</li> <li>- During the 2022 there was no perceptible change when compared to 2021. * Minor cracking in bedrock downstream (between Site 12 and 11) noted in 2020 remained unchanged in 2021 and 2022. Increased vegetation in 2022 hindered observations along the flow line outside of exposed bedrock.</li> <li>- Remove from monitoring.</li> </ul>

<b>Recommendations</b>				
<ul style="list-style-type: none"> <li>- If unchanged and past two year recommend remove from annual monitoring program (yes/no)</li> <li>- Recommend recording cross sections at locations identified with channel and/or channel bank cracking as a result of subsidence, to monitor for erosion and/or changes to the channel width (yes/no)</li> </ul>				
<b>Photographic Recording (see below)</b>
