APPENDIX D – Brokenback Creek

Site BBC-Site 1

Site Attributes				
Date Sampled	27 November 2024			
Approximate Easting	755093			
Approximate Northing	6435473			
Monitoring Requirement	Monitoring to distinguish between natural erosion and erosion from mine subsidence instability, surface cracking, surface ponding and out of channel flows. Monitoring before longwall retreats and annually for a period of two years. Notes: Longwall (LW5) at Ulan West completed in June 2020			
2024 Monitoring Photo

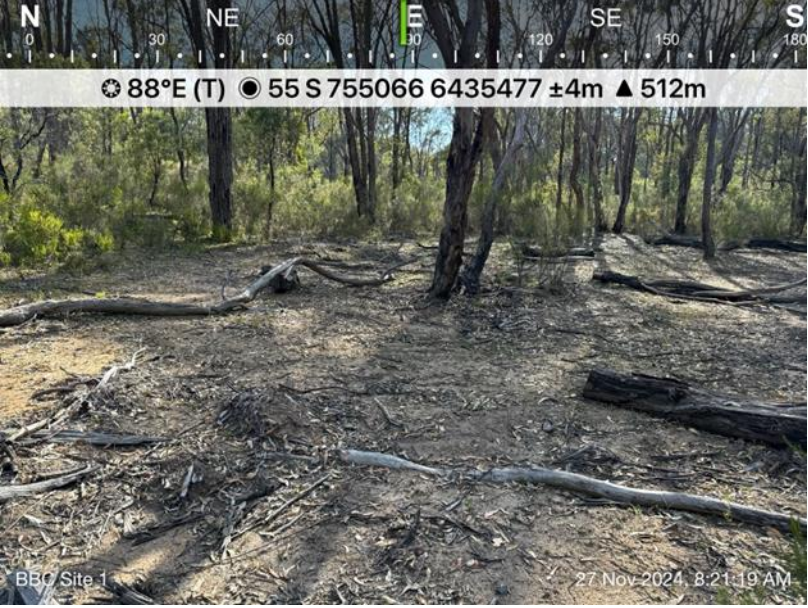
Year	October 2021	October 2022	November 2023	November 2024
Result	Perceptible Impacts	Perceptible Impacts*	Remediation of Impacts	Remediation Completed
Comments / Interpretation				
<ul style="list-style-type: none"> - BBC-Site 1 (Brokenback Creek) is located above LW5 towards the eastern edge of the panel and was added to the monitoring program in 2021. - At the time of the 2021 inspection, extensive erosion of the creek line was observed. The erosion impacts may be due to high flow creek event/s in 2020/2021 coinciding with a change in the longitudinal gradients from subsidence (an example of nick point erosion)¹. The site appeared very unstable in 2021. - *Observations in 2022 and 2023 were comparable although increased ground vegetation made it difficult to determine if the impacts had deteriorated since 2021 for example further tunnel erosion. - In 2023 UCML commenced remediation works (see photos below). Remediation of BBC1 had not been completed at the time of the inspection. - Remediation works completed as observed in 2024.

Recommendations				
<ul style="list-style-type: none"> - If unchanged and past two year recommend remove from annual monitoring program (yes/no) - Recommend recording cross sections at locations identified with channel and/or channel bank cracking as a result of subsidence, to monitor for erosion and/or changes to the channel width (yes/no) 				
Photographic Recording (see below)

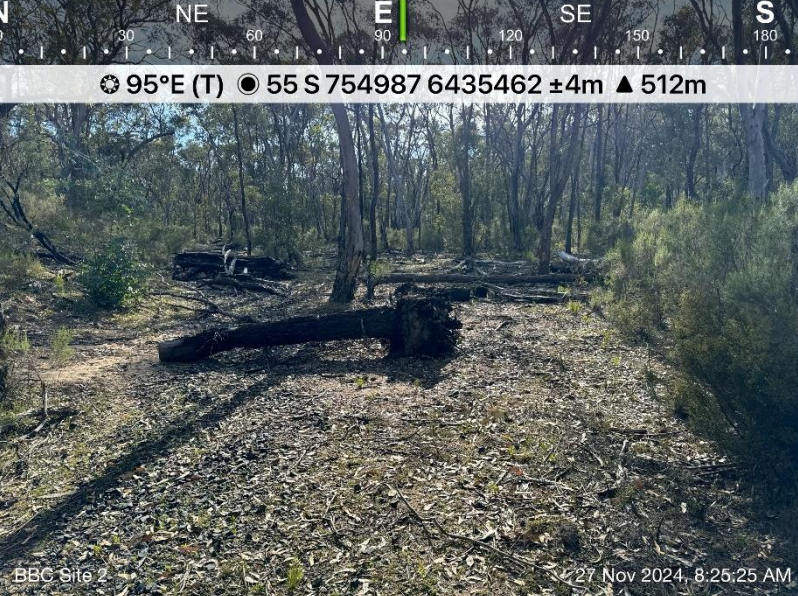
<p>95°E (T) ● 55 S 754987 6435462 ±4m ▲ 512m</p> <p>BBC Site 2 27 Nov 2024, 8:25:25 AM</p>

Site Attributes				
Date Sampled	27 November 2024			
Approximate Easting	754994			
Approximate Northing	6435465			
Monitoring Requirement	Monitoring to distinguish between natural erosion and erosion from mine subsidence instability, surface cracking, surface ponding and out of channel flows. Monitoring before longwall retreats and annually for a period of two years. Notes: Longwall (LW5) at Ulan West completed in June 2020			
2024 Monitoring Photo				
Year	October 2021	October 2022	November 2023	November 2024
Result	Perceptible Impacts	Perceptible Impacts*	Remediation of Impacts	Remediation Completed
Comments / Interpretation				
<ul style="list-style-type: none"> - BBC-Site 2 (Brokenback Creek) is located above LW5 towards the center of the panel and was added to the monitoring program in 2021. - At the time of the 2021 inspection, extensive erosion of the creek line was observed. The erosion impacts may be due to high flow creek event/s in 2020/2021 coinciding with a change in the longitudinal gradients from subsidence (an example of nick point erosion)². The site appeared very unstable. - *Observations in 2022 and 2023 were comparable although increased ground vegetation made it difficult to determine if the impacts had deteriorated since 2021 for example further tunnel erosion. - In 2023 UCMPL commenced remediation works (see photos below). Remediation of BBC2 had commenced at the time of the inspection. - Remediation works completed as observed in 2024.

Recommendations				
<ul style="list-style-type: none"> - If unchanged and past two year recommend remove from annual monitoring program (yes/no) - Recommend recording cross sections at locations identified with channel and/or channel bank cracking as a result of subsidence, to monitor for erosion and/or changes to the channel width (yes/no) 				
Photographic Recording (see below)

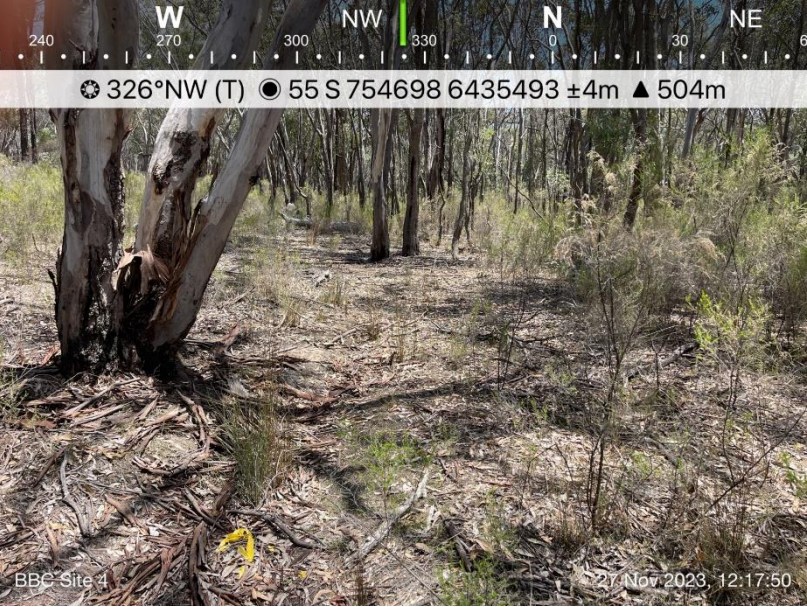
Site BBC-Site 4 (Removed from 2024 monitoring by UCMLP)

Year	October 2021	October 2022	November 2023	
Result	No Perceptible Impacts	No Perceptible Impacts	No Perceptible Impacts	
Comments / Interpretation				
<ul style="list-style-type: none"> - BBC-Site 4 (Brokenback Creek) is located above LW6 towards the eastern edge of the panel and was added to the monitoring program in 2021. - At the time of the 2021 inspection there was no perceptible impacts. Flow channel becomes less defined at this location. Upstream is a small scour. - Observations in 2022 and 2023 were comparable with 2021. Water was flowing and pooling at this location at the time of the 2022 inspection. No water was observed in 2023. - UCMLP to consider removing this site from the monitoring program in 2024.

Recommendations				
<ul style="list-style-type: none"> - If unchanged and past two year recommend remove from annual monitoring program (yes/no) - Recommend recording cross sections at locations identified with channel and/or channel bank cracking as a result of subsidence, to monitor for erosion and/or changes to the channel width (yes/no) 				
Photographic Recording (see below)

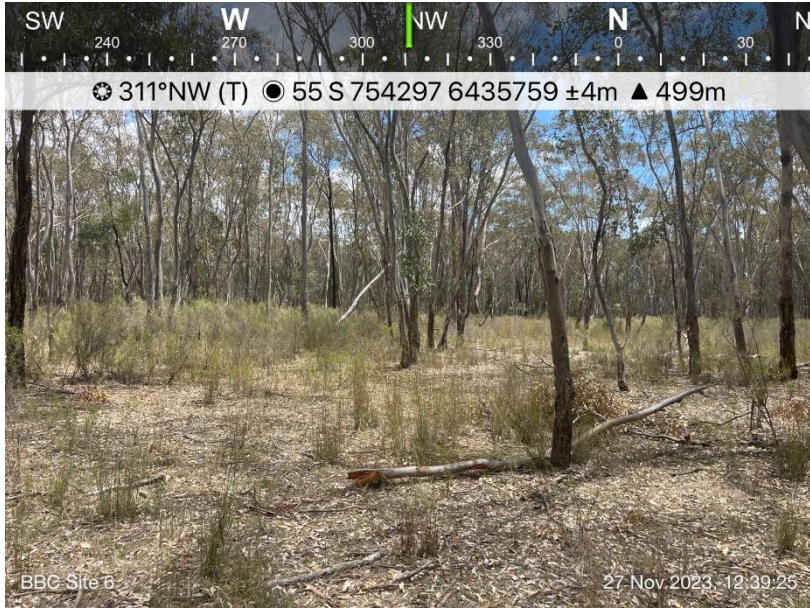
Site BBC-Site 6

<p>BBC Site 6 27 Nov. 2023, 12:39:25</p>			
Year	October 2021	October 2022	November 2023	November 2024
Result	Pre Mining	Pre Mining	No Perceptible Impacts	No Perceptible Impacts
Comments / Interpretation				
<ul style="list-style-type: none"> - BBC-Site 6 (Brokenback Creek) is located above LW7 towards the eastern edge of the panel and was added to the monitoring program in 2021. - At the time of the 2021 inspection there was no perceptible impacts. Flow channel becomes less defined at this location into a broad flood plain. - Observations in 2022 were comparable with 2021. The ground was saturated and well vegetated. At the time of the inspection this site is still considered pre-mining. - In 2023 the ground was dry and decreasing ground vegetation noted. Leaf litter was extensive. No perceptible impacts were noted. - Observations during 2024 were comparable with 2023.

Recommendations				
<ul style="list-style-type: none"> - If unchanged and past two year recommend remove from annual monitoring program (yes/no) - Recommend recording cross sections at locations identified with channel and/or channel bank cracking as a result of subsidence, to monitor for erosion and/or changes to the channel width (yes/no) 				
Photographic Recording (see below)

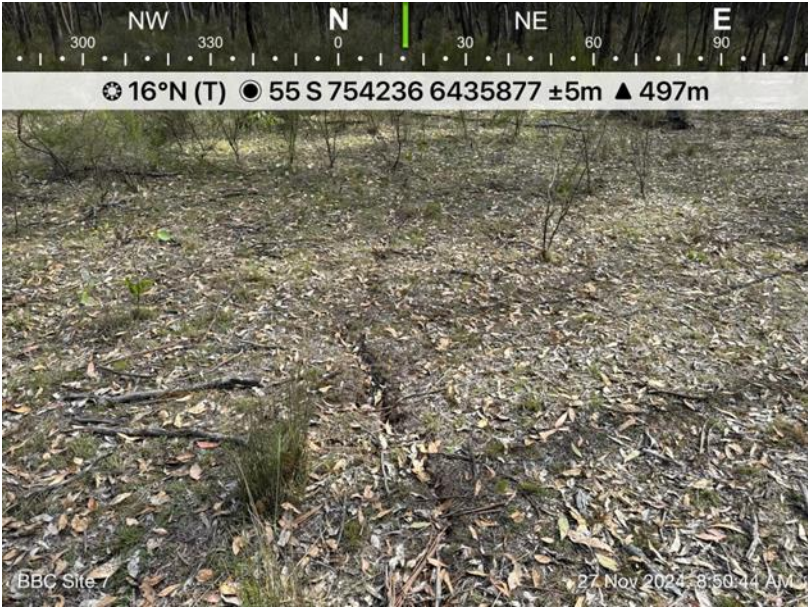
Site BBC-Site 7

Year	October 2022	November 2023	November 2024	
Result	Pre-Mining	Perceptible Impacts	Perceptible Impacts (no change)	
Comments / Interpretation				
<ul style="list-style-type: none"> - BBC-Site 7 (Brokenback Creek) is located above LW7 towards the eastern edge of the panel and was added to the monitoring program in 2022. - At the time of the 2022 inspection there was no perceptible impacts. Flow channel becomes less defined at this location into a broad flood plain. The ground was saturated and well vegetated. At the time of the inspection. - In 2023 the ground was dry and decreasing ground vegetation noted. Leaf litter was extensive. Cracking was observed. - Observations during 2024 were comparable with 2023. Cracking was still visible although natural infilling had reduced its overall visibility.

Recommendations				
<ul style="list-style-type: none"> - If unchanged and past two year recommend remove from annual monitoring program (yes/no) - Recommend recording cross sections at locations identified with channel and/or channel bank cracking as a result of subsidence, to monitor for erosion and/or changes to the channel width (yes/no) 				
Photographic Recording (see below)

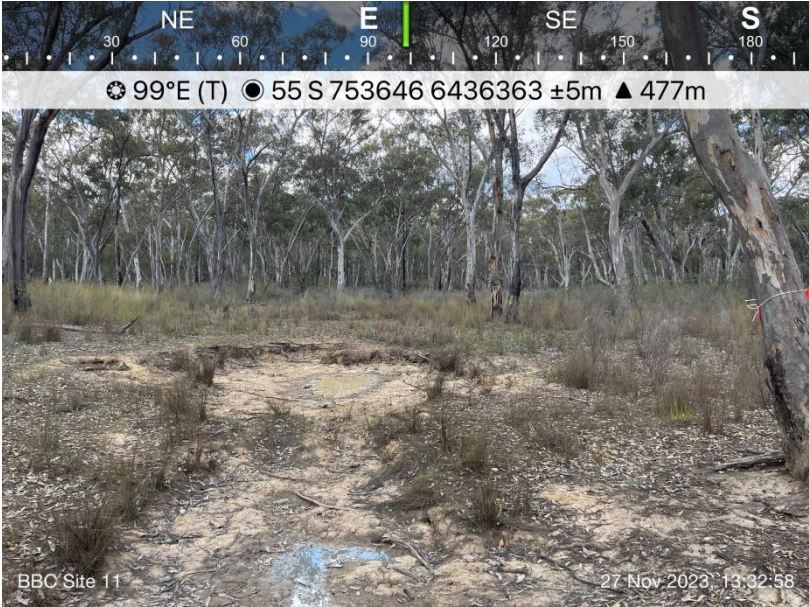
Site BBC-Site 11

Year	November 2023			
Result	Pre-Mining			
Comments / Interpretation				
<ul style="list-style-type: none"> - BBC-Site 11 (Brokenback Creek) is located centrally above LW8B and was added to the monitoring program in 2023. - At the time of the 2023 inspection there were no perceptible impacts. The flow channel is defined at this location with a bare, shallow scour feature. In 2023 the ground was mostly dry; however a small volume of pooled water was observed. Decreasing ground vegetation noted. Leaf litter was extensive. At the time of the 2023 inspection this site is still considered pre-mining. - Continue to monitor.

Recommendations				
<ul style="list-style-type: none"> - If unchanged and past two year recommend remove from annual monitoring program (yes/no) - Recommend recording cross sections at locations identified with channel and/or channel bank cracking as a result of subsidence, to monitor for erosion and/or changes to the channel width (yes/no) 				
Photographic Recording (see below)

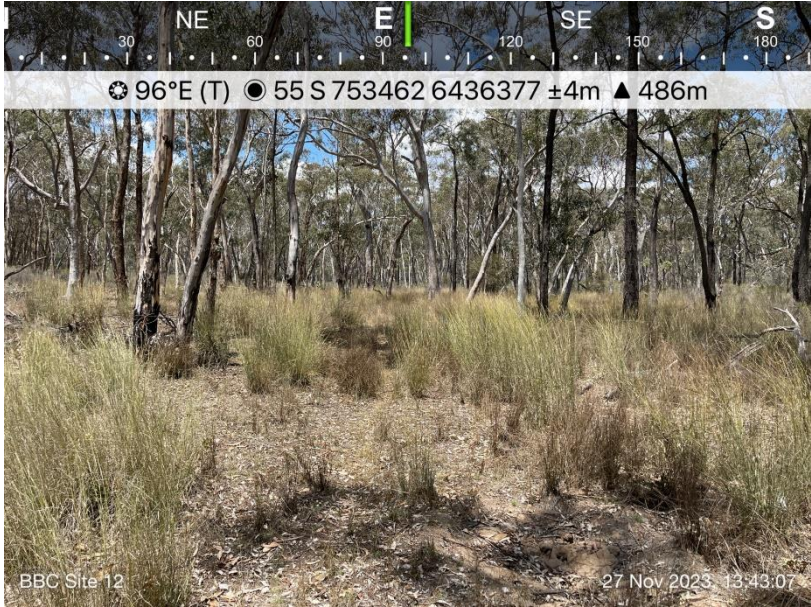
Site BBC-Site 12

Year	November 2023			
Result	Pre-Mining			
Comments / Interpretation				
<ul style="list-style-type: none"> - BBC-Site 12 (Brokenback Creek) is located above LW7 towards the western edge of the panel and was added to the monitoring program in 2022. - At the time of the 2023 inspection there were no perceptible impacts. Flow channel becomes less defined at this location into a broad flood plain. In 2023 the ground was dry and decreasing ground vegetation noted. Leaf litter was extensive. At the time of the 2023 inspection this site is still considered pre-mining. - Continue to monitor.

Recommendations				
<ul style="list-style-type: none"> - If unchanged and past two year recommend remove from annual monitoring program (yes/no) - Recommend recording cross sections at locations identified with channel and/or channel bank cracking as a result of subsidence, to monitor for erosion and/or changes to the channel width (yes/no) 				
Photographic Recording (see below)

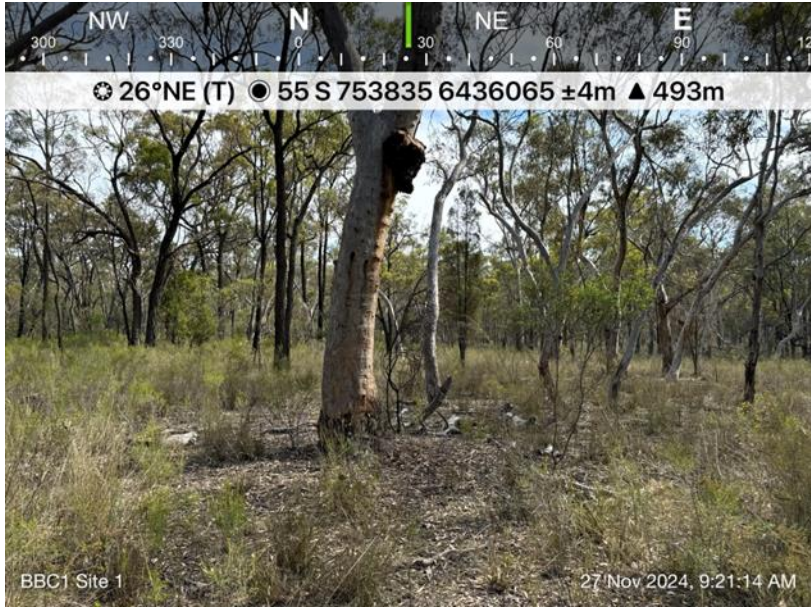
Site BBC1-Site 1

Year	November 2024			
Result	Pre-Mining			
Comments / Interpretation				
<ul style="list-style-type: none"> - BBC1-Site 1 (a lower order flowline of Brokenback Creek) is located above LW8B towards the eastern edge of the panel and was added to the monitoring program in 2024. - The flow line channel is less defined at this location. In 2024 the ground was dry and decreasing ground vegetation noted. Leaf litter was extensive. At the time of the 2024 inspection this site is still considered pre-mining. - Continue to monitor.

Recommendations				
<ul style="list-style-type: none"> - If unchanged and past two year recommend remove from annual monitoring program (yes/no) - Recommend recording cross sections at locations identified with channel and/or channel bank cracking as a result of subsidence, to monitor for erosion and/or changes to the channel width (yes/no) 				
Photographic Recording (see below)

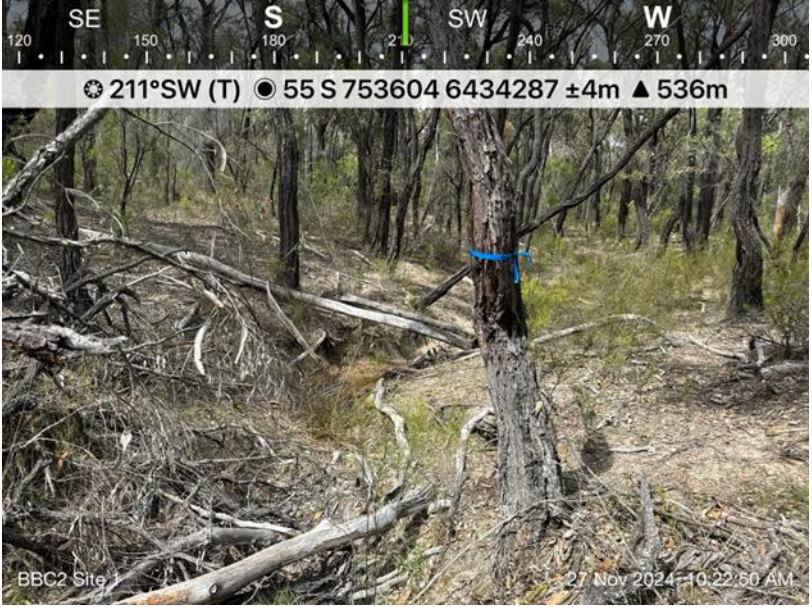
Site BBC2-Site 1

Year	November 2024			
Result	Pre-Mining			
Comments / Interpretation				
<ul style="list-style-type: none"> - BBC2-Site 1 (a lower order flowline of Brokenback Creek) is located above LW8B towards the centre of the panel and was added to the monitoring program in 2024. - The flow line channel is well defined at this location. In 2024 the ground was dry and decreasing ground vegetation noted. Leaf litter and fallen timber was extensive. At the time of the 2024 inspection this site is still considered pre-mining. - Continue to monitor.

Recommendations				
<ul style="list-style-type: none"> - If unchanged and past two year recommend remove from annual monitoring program (yes/no) - Recommend recording cross sections at locations identified with channel and/or channel bank cracking as a result of subsidence, to monitor for erosion and/or changes to the channel width (yes/no) 				
Photographic Recording (see below)

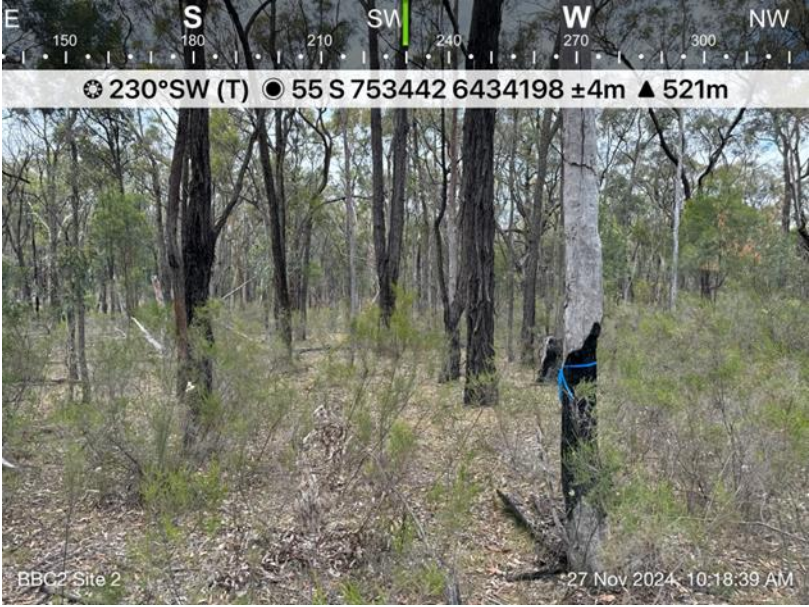
Site BBC2-Site 2

Year	November 2024			
Result	Pre-Mining			
Comments / Interpretation				
<ul style="list-style-type: none"> - BBC2-Site 2 (a lower order flowline of Brokenback Creek) is located above LW8B towards the western edge of the panel and was added to the monitoring program in 2024. - The flow line channel is less defined at this location. In 2024 the ground was dry and decreasing ground vegetation noted. Leaf litter was extensive. At the time of the 2024 inspection this site is still considered pre-mining. - Continue to monitor.

Recommendations				
<ul style="list-style-type: none"> - If unchanged and past two year recommend remove from annual monitoring program (yes/no) - Recommend recording cross sections at locations identified with channel and/or channel bank cracking as a result of subsidence, to monitor for erosion and/or changes to the channel width (yes/no) 				
Photographic Recording (see below)

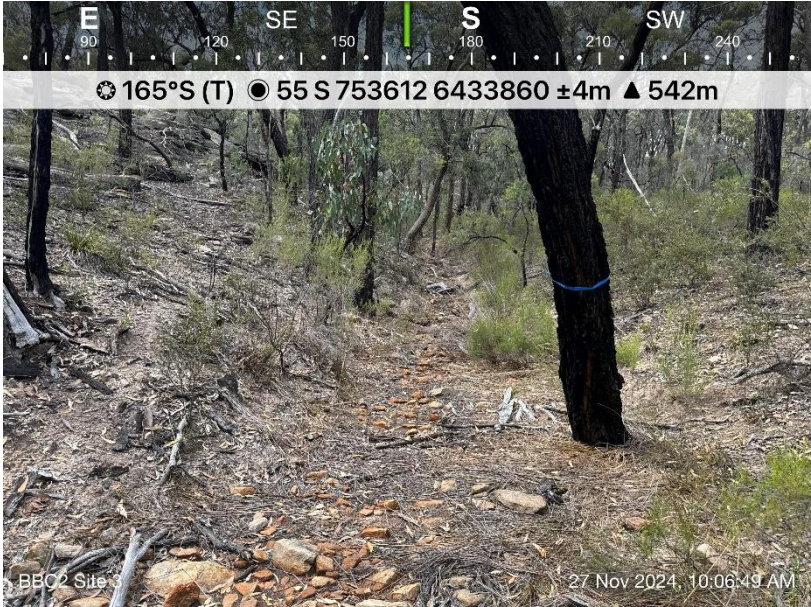
Site BBC2-Site 3

Year	November 2024			
Result	Pre-Mining			
Comments / Interpretation				
<ul style="list-style-type: none"> - BBC2-Site 3 (a lower order flowline of Brokenback Creek) is located above LW8B towards the centre of the panel and was added to the monitoring program in 2024. - The flow line channel is well defined at this location. In 2024 the ground was dry and decreasing to little ground vegetation noted. Rock material lined the flow line. Leaf litter was less extensive when compared to the surrounds. At the time of the 2024 inspection this site is still considered pre-mining. - Continue to monitor.

Recommendations				
<ul style="list-style-type: none"> - If unchanged and past two year recommend remove from annual monitoring program (yes/no) - Recommend recording cross sections at locations identified with channel and/or channel bank cracking as a result of subsidence, to monitor for erosion and/or changes to the channel width (yes/no) 				
Photographic Recording (see below)
