# APPENDIX C – UCLF3

## Site UCFL3-Site 1

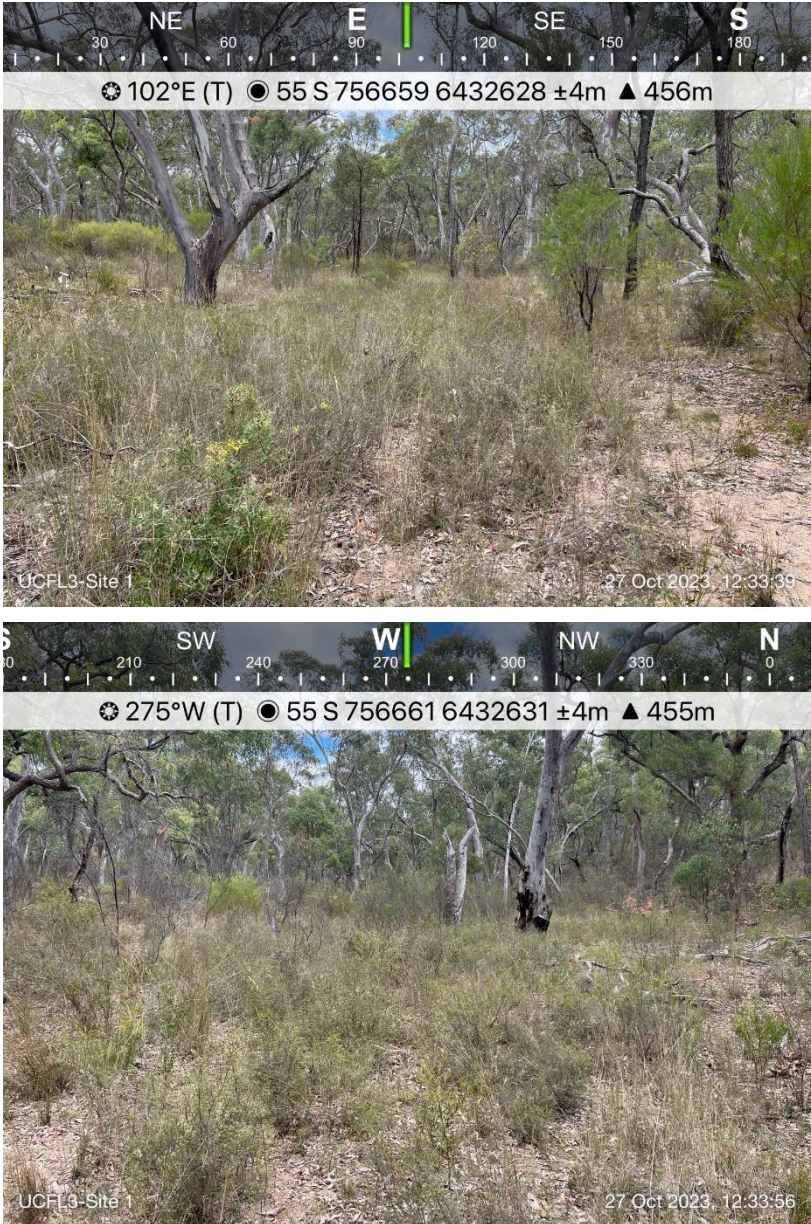
| Site Attributes | |
|---|---|
| <ul style="list-style-type: none"> <li>- UCFL3-Site 1 is located above LW1 towards the eastern edge of the panel. The flow line is not well defined, the bed is made up of a coarse/fine sand material, sparsely vegetated within a well-established woodland.</li> <li>- No perceptible impacts as a result of subsidence were observed during the inspection.</li> </ul> | |

| Site Attributes | |
|---|---|
| <ul style="list-style-type: none"> <li>- If unchanged and past two year recommend remove from annual monitoring program (yes/no)</li> <li>- Recommend recording cross sections at locations identified with channel and/or channel bank cracking as a result of subsidence, to monitor for erosion and/or changes to the channel width (yes/no)</li> </ul> | |

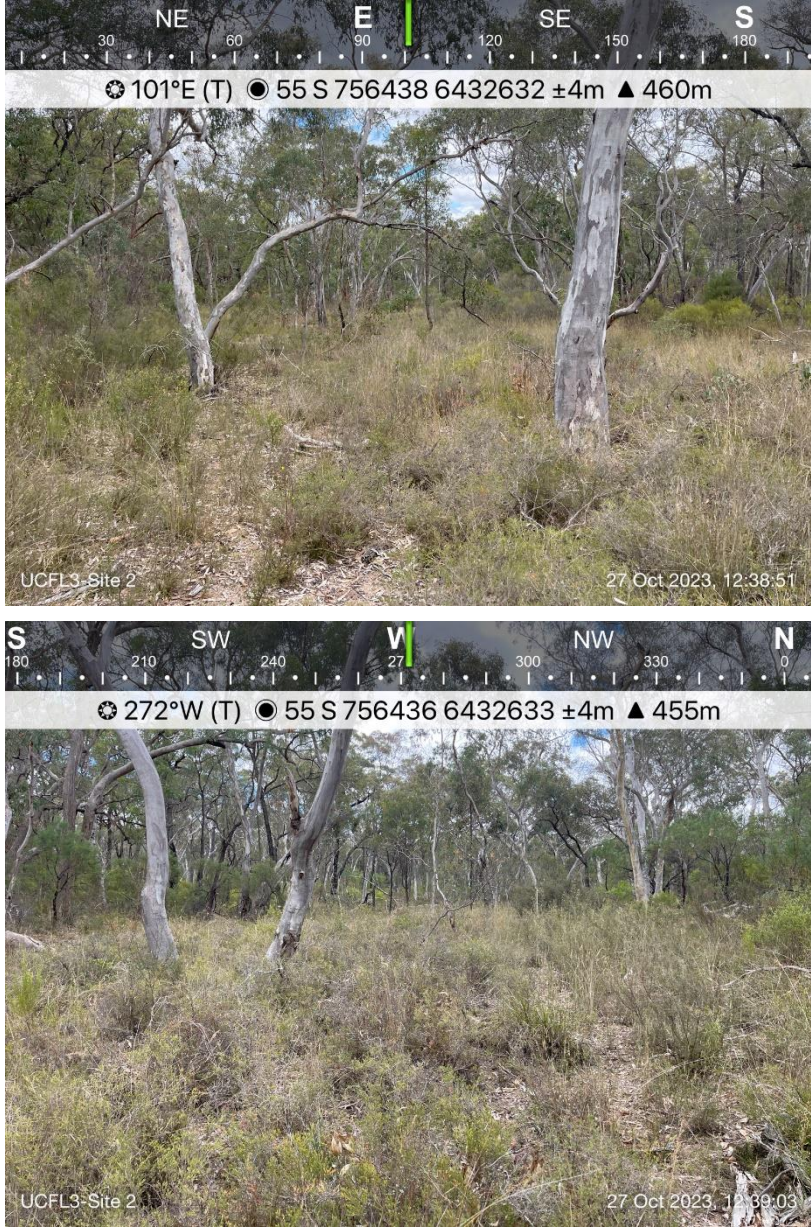
## Site UCFL3-Site 2

| Site Attributes | |
|---|---|
| <ul style="list-style-type: none"> <li>- UCFL3-Site 2 is located above LW1 towards the western edge of the panel. The flow line is not well defined, the bed is made up of a coarse/fine sand material, sparsely vegetated within a well-established woodland.</li> <li>- No perceptible impacts as a result of subsidence were observed during the inspection.</li> </ul> | |

| Site Attributes | |
|---|---|
| <ul style="list-style-type: none"> <li>- If unchanged and past two year recommend remove from annual monitoring program (<b>yes/no</b>)</li> <li>- Recommend recording cross sections at locations identified with channel and/or channel bank cracking as a result of subsidence, to monitor for erosion and/or changes to the channel width (<b>yes/no</b>)</li> </ul> | |

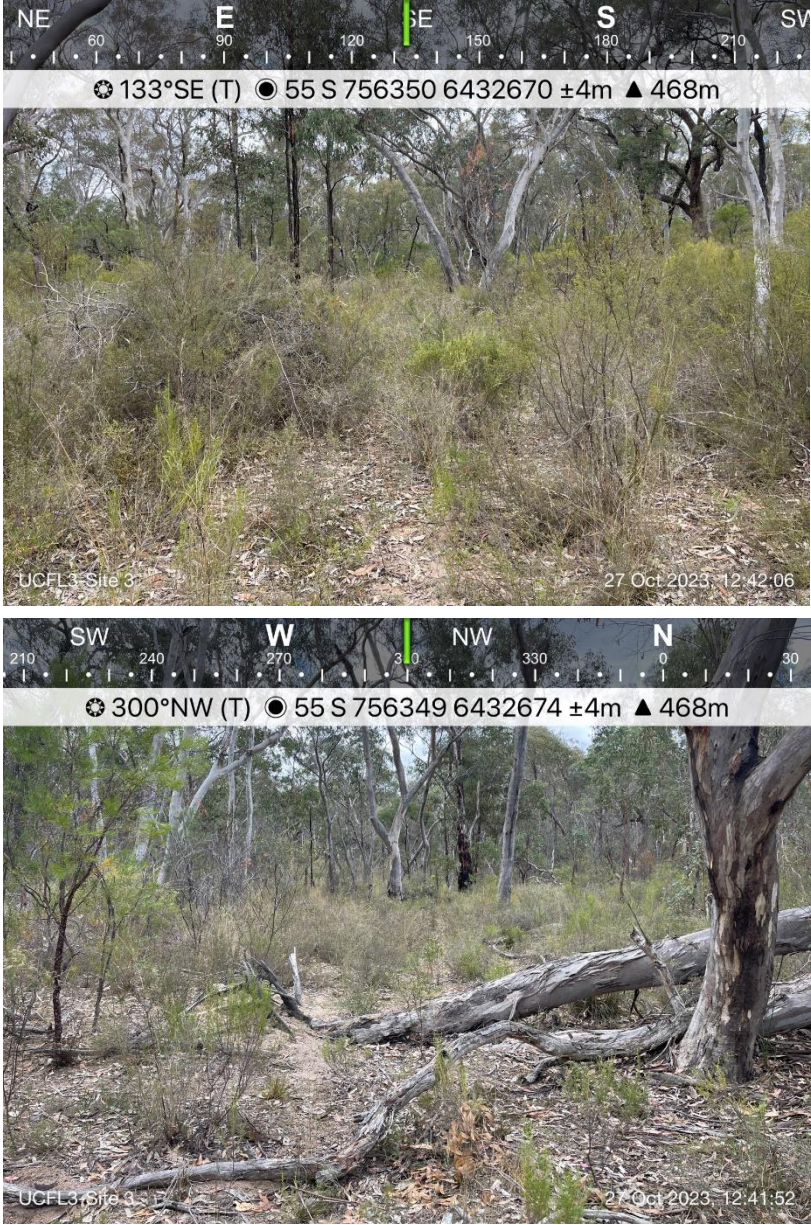
## Site UCFL3-Site 3

| Site Attributes | |
|---|---|
| <ul style="list-style-type: none"> <li>UCFL3-Site 3 is located above LW2 towards the eastern edge of the panel. The flow line is not well defined, the bed is made up of a coarse/fine sand material, sparsely vegetated within a well-established woodland.</li> <li>No perceptible impacts as a result of subsidence were observed during the inspection.</li> </ul> | |

| Site Attributes | |
|---|---|
| <ul style="list-style-type: none"> <li>If unchanged and past two year recommend remove from annual monitoring program (yes/no)</li> <li>Recommend recording cross sections at locations identified with channel and/or channel bank cracking as a result of subsidence, to monitor for erosion and/or changes to the channel width (yes/no)</li> </ul> | |

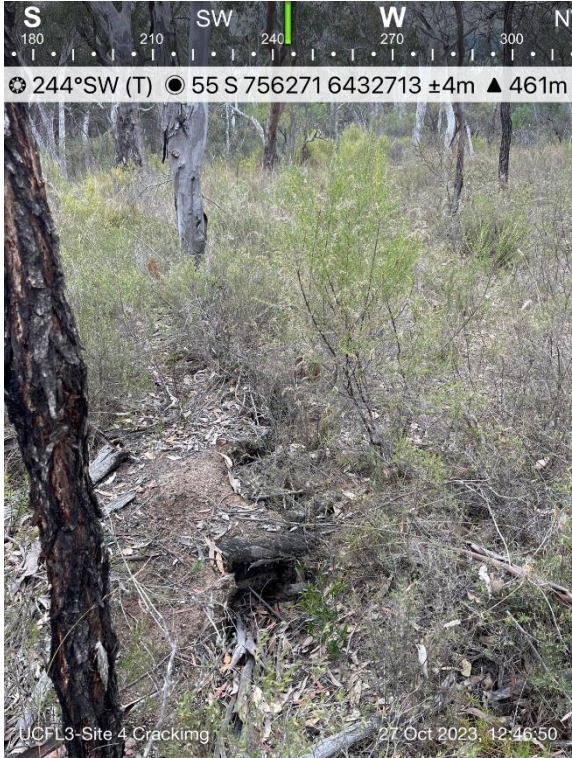
## Site UCFL3-Site 4

| Site Attributes | |
|---|---|
| <ul style="list-style-type: none"> <li>- UCFL3-Site 4 is located above LW2 towards the center of the panel. The flow line is not well defined, the bed is made up of a coarse/fine sand material, sparsely vegetated within a well-established woodland.</li> <li>- Subsidence related impacts in the form of cracking along the bed were observed during the inspection.</li> </ul> | |

| Site Attributes | |
|---|---|
| <ul style="list-style-type: none"> <li>- If unchanged and past two year recommend remove from annual monitoring program (yes/no)</li> <li>- Recommend recording cross sections at locations identified with channel and/or channel bank cracking as a result of subsidence, to monitor for erosion and/or changes to the channel width (yes/<b>no</b>)</li> </ul> | |

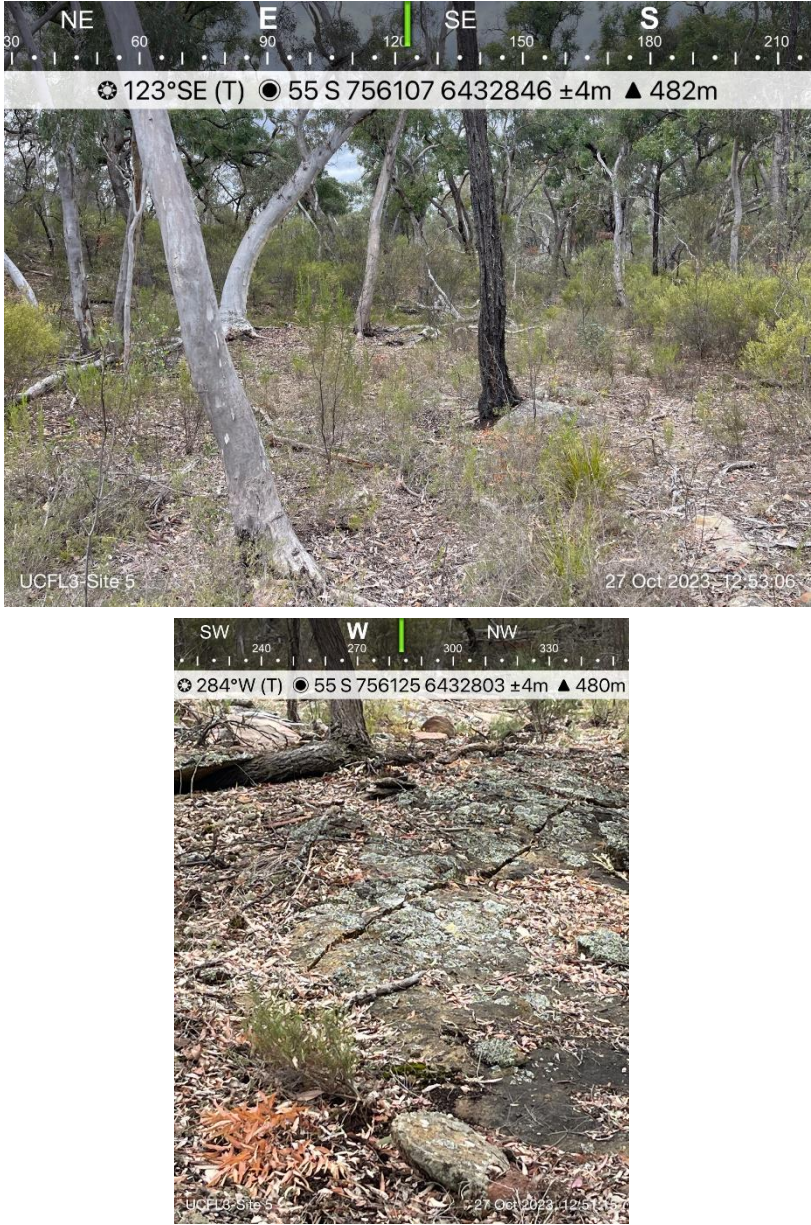
## Site UCFL3-Site 5

| Site Attributes | |
|---|---|
| <ul style="list-style-type: none"> <li>- UCFL3-Site 5 is located above LW2 towards the western edge of the panel. The flow line is better defined, the bed and surrounds are exposed bedrock/larger rock and coarse/fine sand material, sparsely vegetated within a well-established woodland.</li> <li>- Perceptible impacts in the form of cracking above the main channel were observed during the inspection.</li> </ul> | |

| Site Attributes | |
|---|---|
| <ul style="list-style-type: none"> <li>- If unchanged and past two year recommend remove from annual monitoring program (<b>yes/no</b>)</li> <li>- Recommend recording cross sections at locations identified with channel and/or channel bank cracking as a result of subsidence, to monitor for erosion and/or changes to the channel width (<b>yes/no</b>)</li> </ul> | |

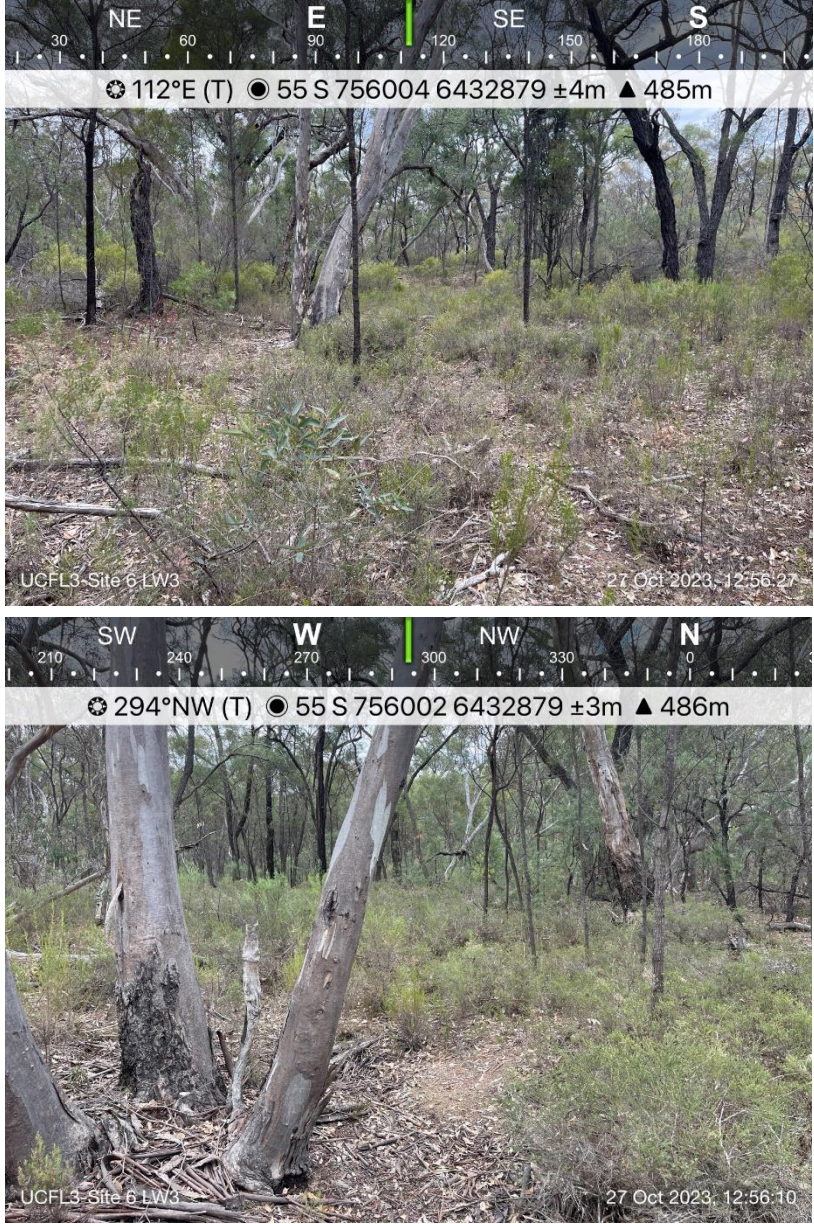
## Site UCFL3-Site 6

| Site Attributes | |
|---|---|
| <ul style="list-style-type: none"> <li>- UCFL3-Site 6 is located above LW3 towards the eastern edge of the panel. The flow line becomes more defined, the bed and surrounds are exposed bedrock (less evident) and coarse/fine sand material, sparsely vegetated within a well-established woodland.</li> <li>- No perceptible impacts as a result of subsidence were observed during the inspection.</li> </ul> | |

| Site Attributes | |
|---|---|
| <ul style="list-style-type: none"> <li>- If unchanged and past two year recommend remove from annual monitoring program (<b>yes/no</b>)</li> <li>- Recommend recording cross sections at locations identified with channel and/or channel bank cracking as a result of subsidence, to monitor for erosion and/or changes to the channel width (<b>yes/no</b>)</li> </ul> | |

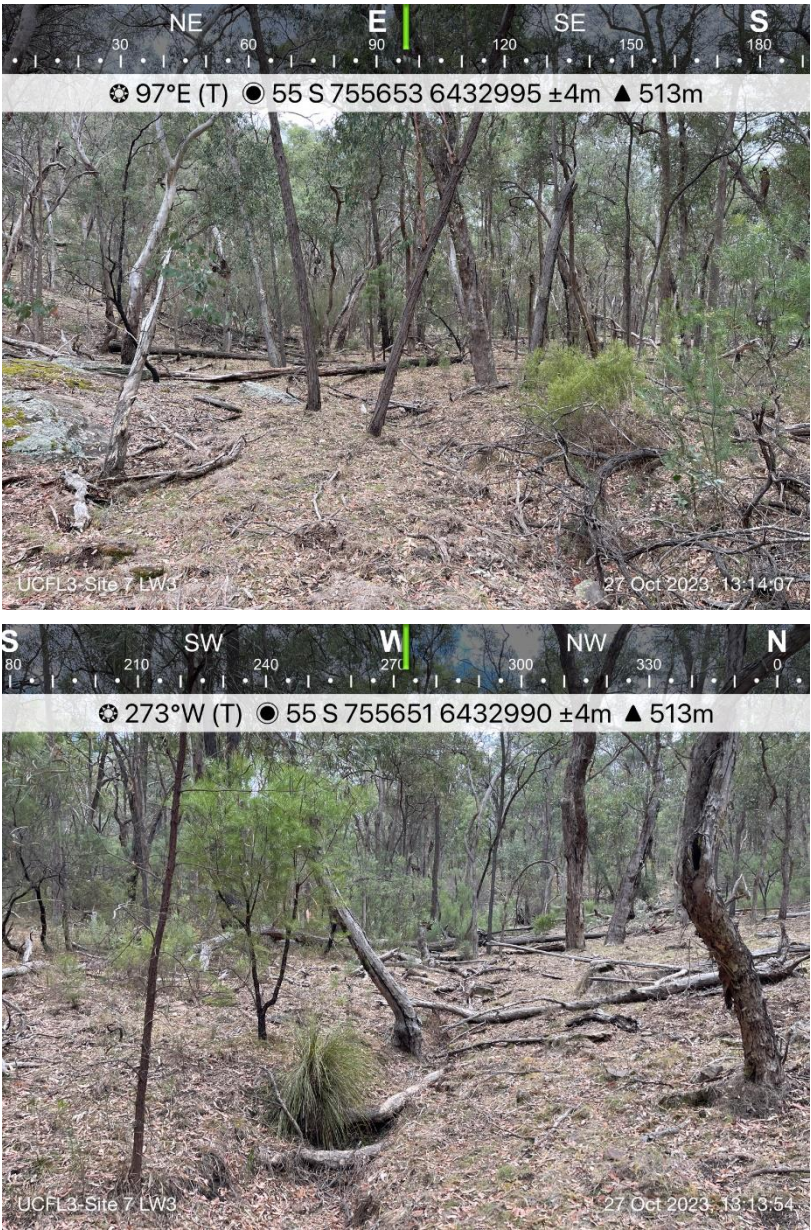
## Site UCFL3-Site 7

| Site Attributes | |
|---|---|
| <ul style="list-style-type: none"> <li>- UCFL3-Site 7 is located above LW3 towards the western edge of the panel. The flow line is well defined, the bank/bed and surrounds are exposed bedrock, small and larger rock and soil-like material, sparsely vegetated within a well-established woodland.</li> <li>- No perceptible impacts as a result of subsidence were observed during the inspection.</li> </ul> | |

| Site Attributes | |
|---|---|
| <ul style="list-style-type: none"> <li>- If unchanged and past two year recommend remove from annual monitoring program (<b>yes/no</b>)</li> <li>- Recommend recording cross sections at locations identified with channel and/or channel bank cracking as a result of subsidence, to monitor for erosion and/or changes to the channel width (<b>yes/no</b>)</li> </ul> | |

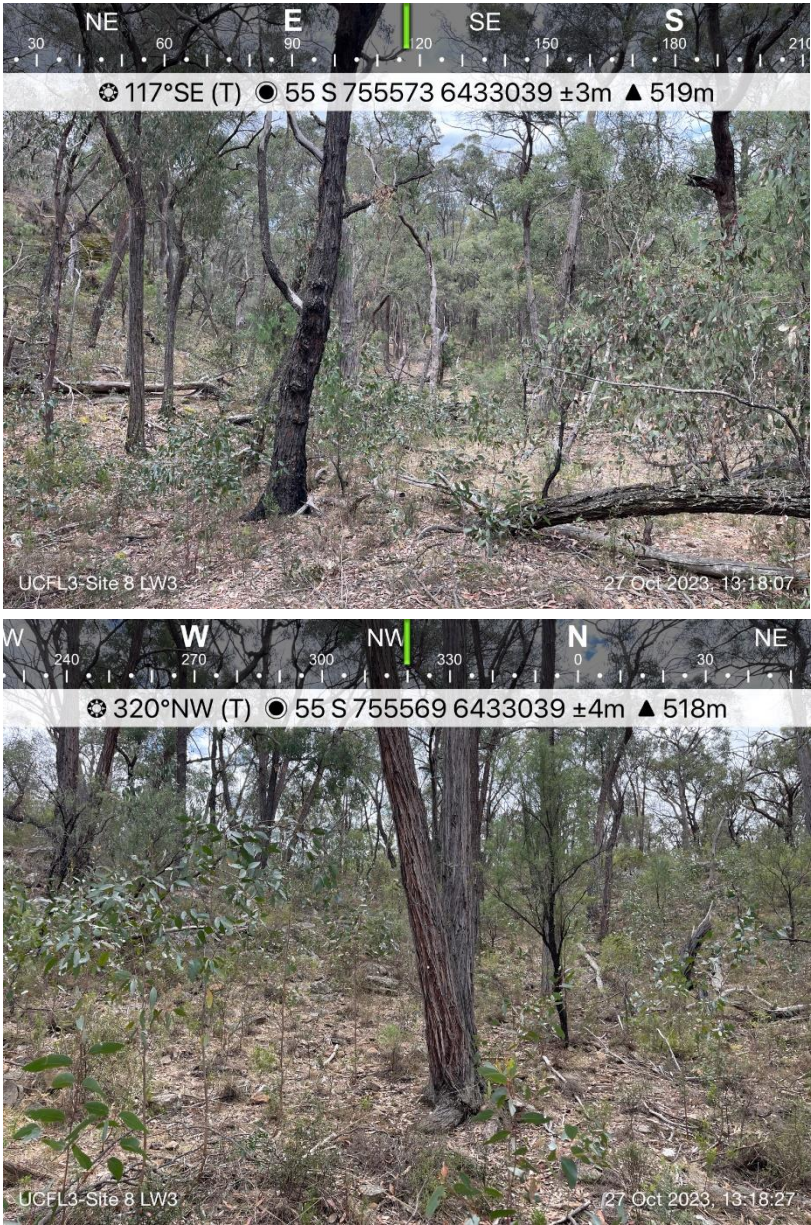
## Site UCFL3-Site 8

| Site Attributes | |
|---|---|
| <ul style="list-style-type: none"> <li>- UCFL3-Site 8 is located above LW4 towards the eastern edge of the panel. The flow line is defined along a moderate slope, the bank/bed and surrounds are exposed bedrock, small and larger rock and soil-like material, sparsely vegetated within a well-established woodland.</li> <li>- No perceptible impacts as a result of subsidence were observed during the inspection.</li> </ul> | |

| Site Attributes | |
|---|---|
| <ul style="list-style-type: none"> <li>- If unchanged and past two year recommend remove from annual monitoring program (<b>yes/no</b>)</li> <li>- Recommend recording cross sections at locations identified with channel and/or channel bank cracking as a result of subsidence, to monitor for erosion and/or changes to the channel width (<b>yes/no</b>)</li> </ul> | |

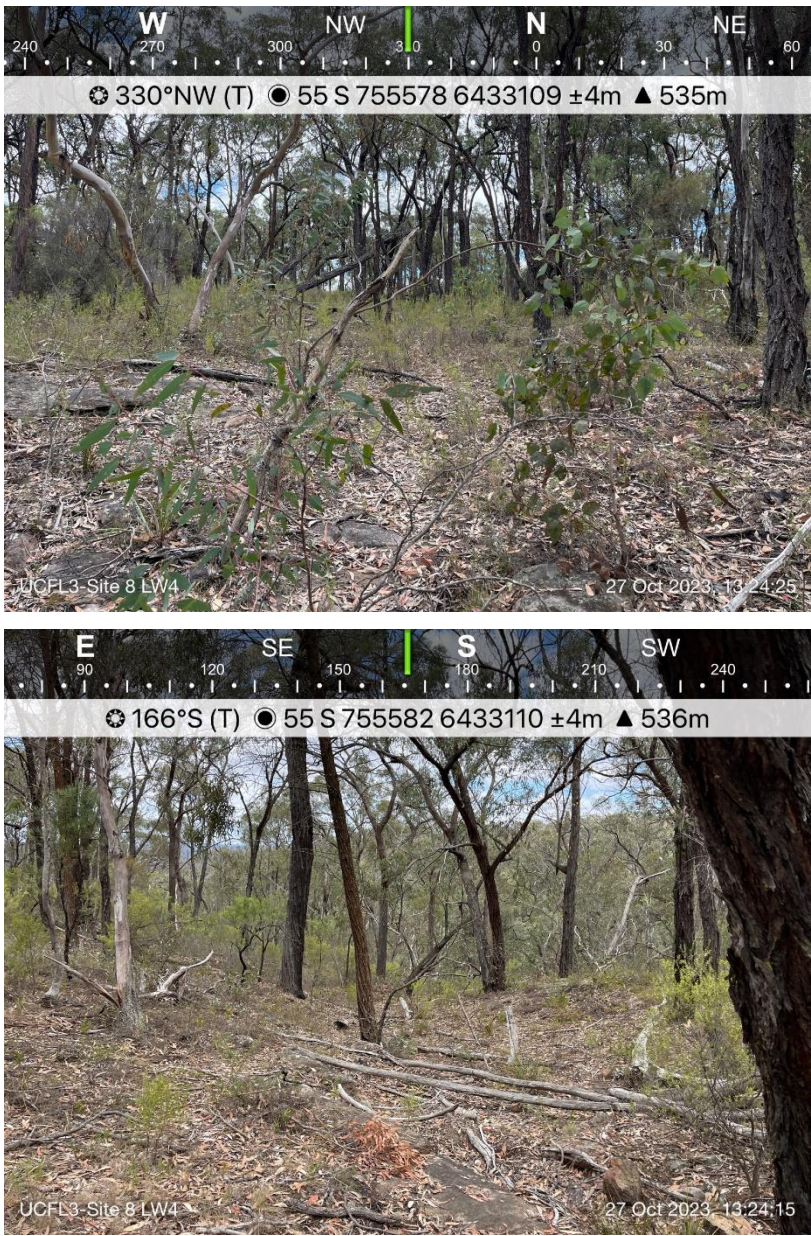
## Site UCFL3-Site 8a

| Site Attributes | |
|---|---|
| <ul style="list-style-type: none"> <li>- UCFL3-Site 8a is located above LW4 towards the eastern edge of the panel. The flow line is defined along a moderate slope, the bank/bed and surrounds are exposed bedrock, small and larger rock and soil-like material, sparsely vegetated within a well-established woodland.</li> <li>- No perceptible impacts as a result of subsidence were observed during the inspection.</li> </ul> | |

| Site Attributes | |
|---|---|
| <ul style="list-style-type: none"> <li>- If unchanged and past two year recommend remove from annual monitoring program (<b>yes/no</b>)</li> <li>- Recommend recording cross sections at locations identified with channel and/or channel bank cracking as a result of subsidence, to monitor for erosion and/or changes to the channel width (<b>yes/no</b>)</li> </ul> | |

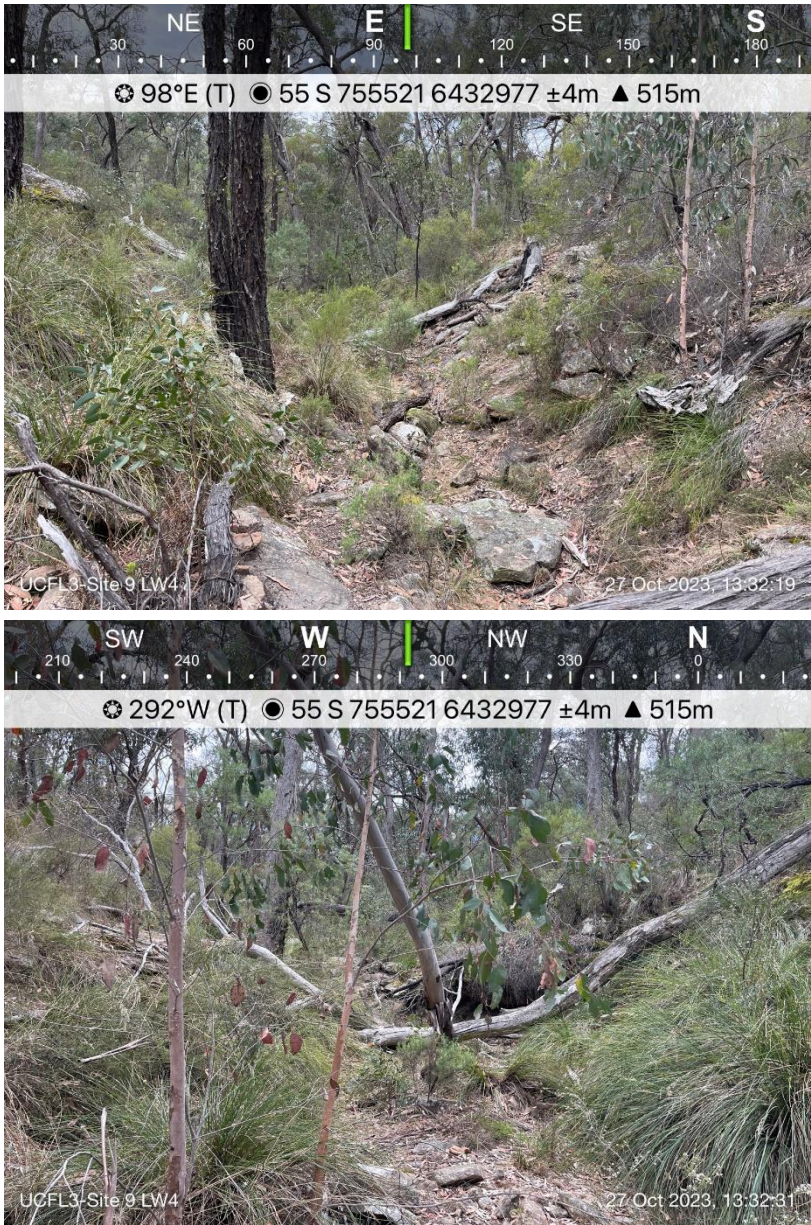
## Site UCFL3-Site 9

| Site Attributes | |
|---|---|
| <ul style="list-style-type: none"> <li>- UCFL3-Site 9 is located above LW4 towards the eastern edge of the panel. The flow line is well defined along a moderate slope, the bank/bed and surrounds are exposed bedrock, small and larger rock, sparsely vegetated within a well-established woodland.</li> <li>- No perceptible impacts as a result of subsidence were observed during the inspection.</li> </ul> | |

| Site Attributes | |
|---|---|
| <ul style="list-style-type: none"> <li>- If unchanged and past two year recommend remove from annual monitoring program (<b>yes/no</b>)</li> <li>- Recommend recording cross sections at locations identified with channel and/or channel bank cracking as a result of subsidence, to monitor for erosion and/or changes to the channel width (<b>yes/no</b>)</li> </ul> | |

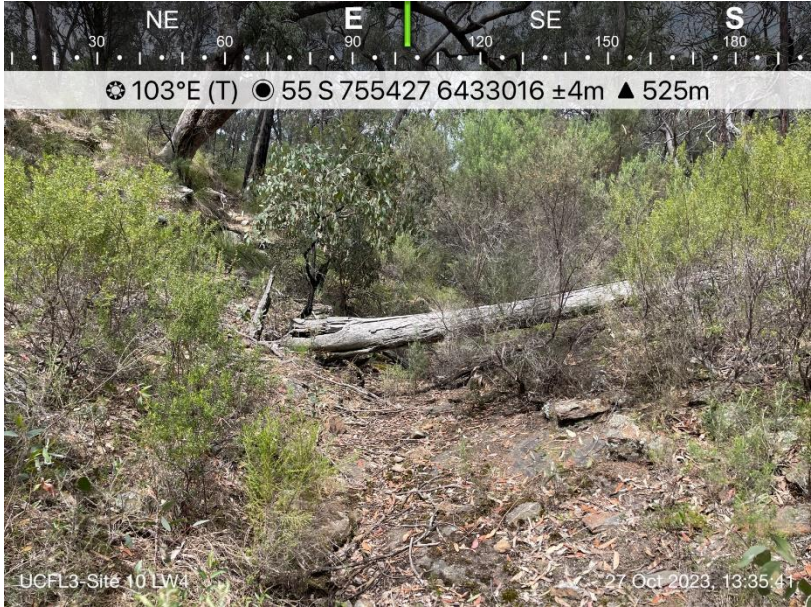
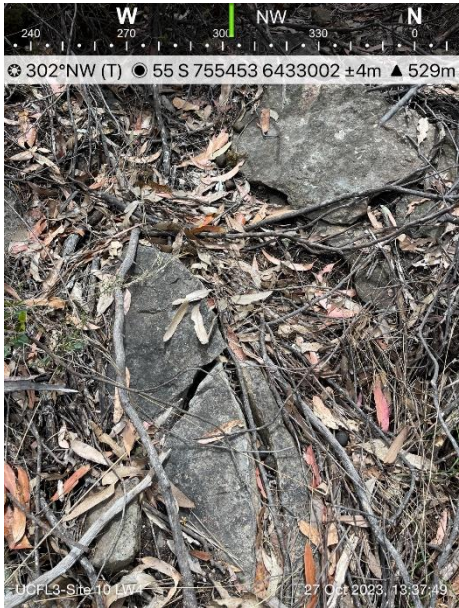
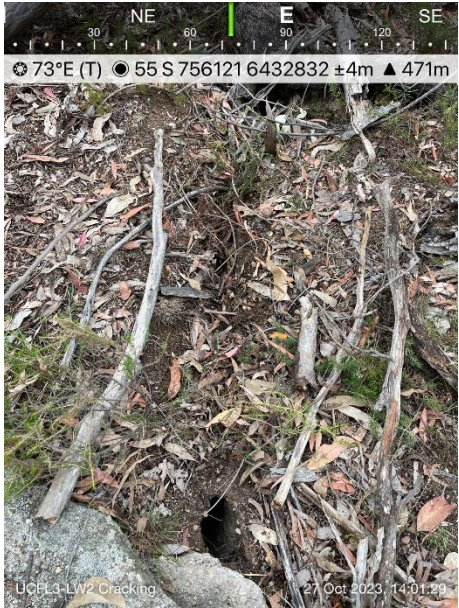
## Site UCFL3-Site 10

| Site Attributes | |
|---|---|
| <ul style="list-style-type: none"> <li>- UCFL3-Site 10 is located above LW4 towards the center of the panel almost at the top of the flow line. The flow line is well defined along a moderate to steep slope, the bank/bed and surrounds are exposed bedrock, small and larger rock, sparsely vegetated within a well-established woodland.</li> <li>- Perceptible related impacts in the form of minor cracking in the channel were observed during the inspection.</li> </ul> | |

| Site Attributes | |
|---|---|
| <ul style="list-style-type: none"> <li>- If unchanged and past two year recommend remove from annual monitoring program (<b>yes/no</b>)</li> <li>- Recommend recording cross sections at locations identified with channel and/or channel bank cracking as a result of subsidence, to monitor for erosion and/or changes to the channel width (<b>yes/no</b>)</li> </ul> | |
