## APPENDIX E – Mona Creek

### Site MC-1

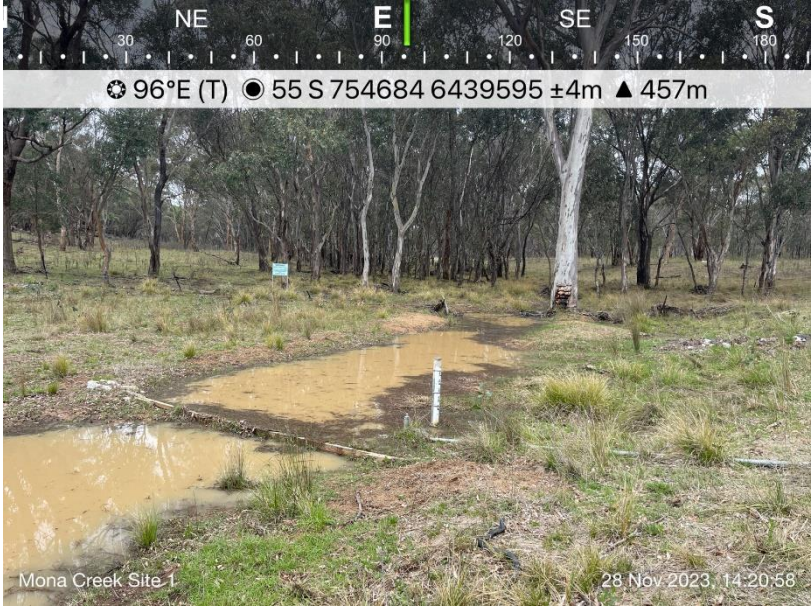
| <ul style="list-style-type: none"> <li>- MC1 is within open pasture area west of LWW8.</li> <li>- In 2023 LHB is a mild slope and well vegetated. RHB is a flat broad flood plain and is also well vegetated. Channel bed at this location is within a slight depression and is well vegetated. A small amount of flood debris was noted across the gauging control. A wombat hole in the channel bed was noted upstream. Water had pooled at this location.</li> <li>- Continue to monitor.</li> </ul> | | | | |

| <ul style="list-style-type: none"> <li>- If unchanged and past two year recommend remove from annual monitoring program (yes/no)</li> <li>- Recommend recording cross sections at locations identified with channel and/or channel bank cracking as a result of subsidence, to monitor for erosion and/or changes to the channel width (yes/no)</li> </ul> | | | | |

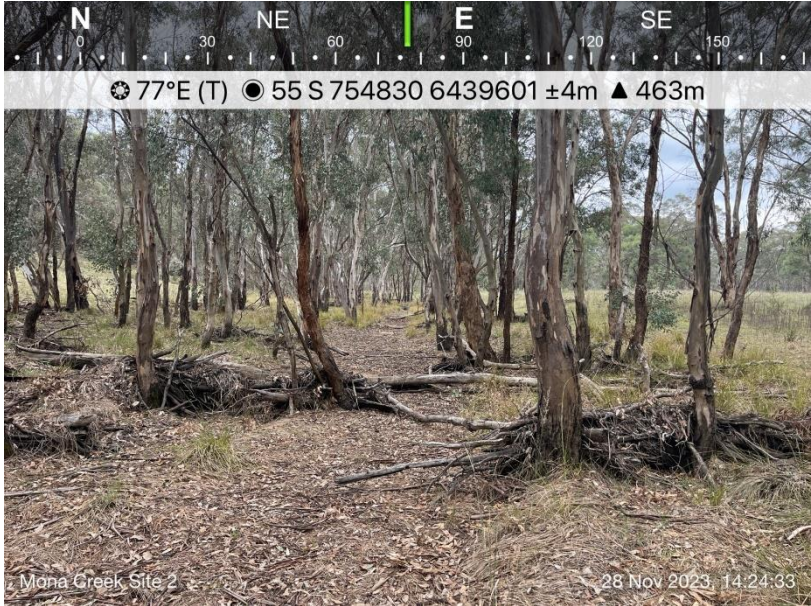
### Site MC-2

| <ul style="list-style-type: none"> <li>- MC2 is within an established open woodland area, west of LWW8.</li> <li>- In 2023 this location has mature trees either side of the channel. LHB and RHB have flat to gentle slopes with good groundcover vegetation and dense leaf litter. Accumulation of flood debris was noted in the low flow section of the channel. The creek bed is a mix of fine and coarse sand. A minor tributary flows into MC2 at the location in 2023.</li> <li>- Continue to monitor.</li> </ul> | | | | |

| <ul style="list-style-type: none"> <li>- If unchanged and past two year recommend remove from annual monitoring program (yes/no)</li> <li>- Recommend recording cross sections at locations identified with channel and/or channel bank cracking as a result of subsidence, to monitor for erosion and/or changes to the channel width (yes/no)</li> </ul> | | | | |

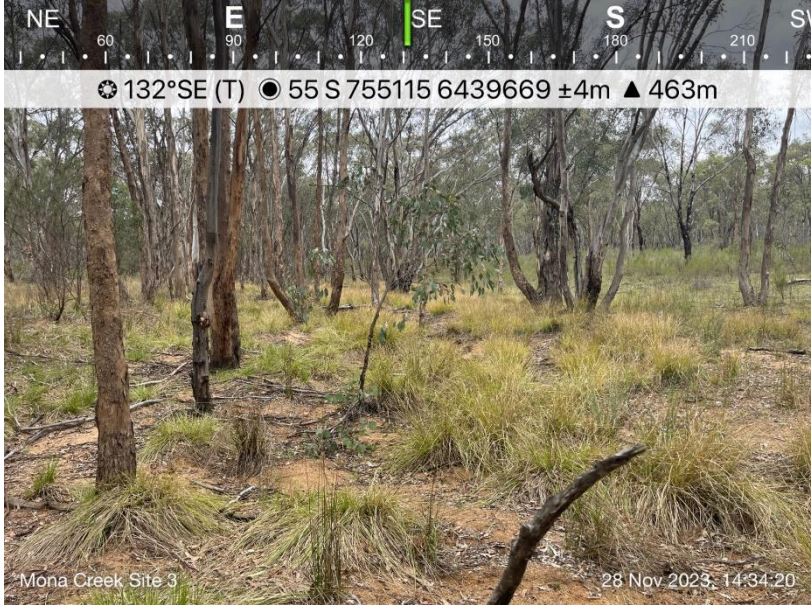
### Site MC-3

| <ul style="list-style-type: none"> <li>- MC3 is within an established open woodland area, immediately west of LWW8 commencement end.</li> <li>- In 2023 this location has mature trees either side of the channel. LHB and RHB have gentle slopes with good groundcover vegetation and leaf litter. The creek bed is a mix of fine and coarse sand with increasing bare areas. A small scour has developed at this location.</li> <li>- Continue to monitor.</li> </ul> | | | | |

| <ul style="list-style-type: none"> <li>- If unchanged and past two year recommend remove from annual monitoring program (yes/no)</li> <li>- Recommend recording cross sections at locations identified with channel and/or channel bank cracking as a result of subsidence, to monitor for erosion and/or changes to the channel width (yes/no)</li> </ul> | | | | |

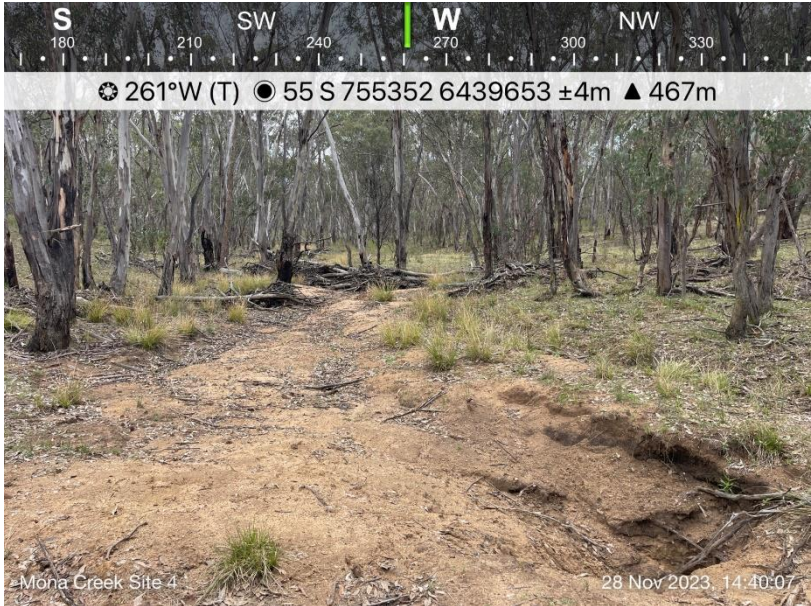
### Site MC-4

| <ul style="list-style-type: none"> <li>- MC4 is within an established open woodland area, above LWW8.</li> <li>- In 2023 this location has mature trees either side of the channel. LHB and RHB have gentle slopes with good groundcover vegetation and leaf litter. The creek bed is a mix of fine and coarse sand and soil like material, mostly bare areas. An active wombat burrow was within an existing scour.</li> <li>- Continue to monitor.</li> </ul> | | | | |

| <ul style="list-style-type: none"> <li>- If unchanged and past two year recommend remove from annual monitoring program (yes/no)</li> <li>- Recommend recording cross sections at locations identified with channel and/or channel bank cracking as a result of subsidence, to monitor for erosion and/or changes to the channel width (yes/no)</li> </ul> | | | | |

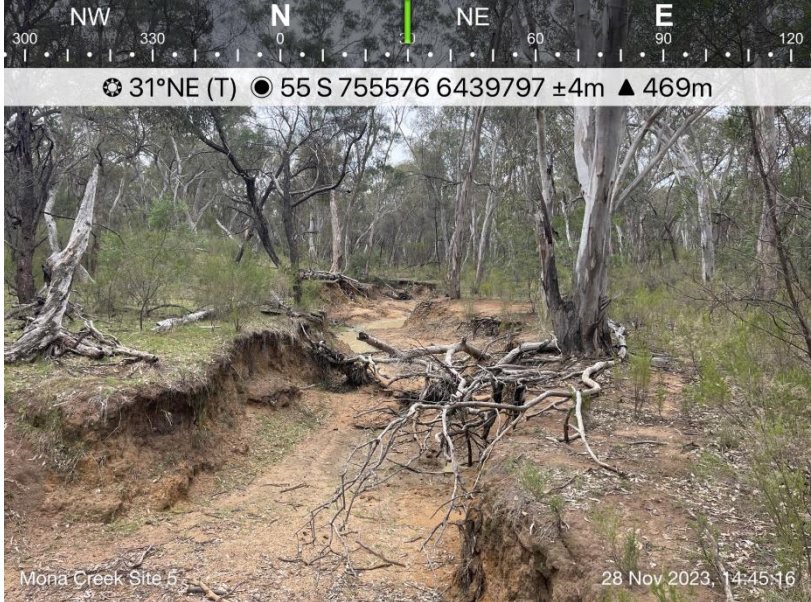
### Site MC-5

| <ul style="list-style-type: none"> <li>- MC5 is within an established open woodland area, approximately 200m within LWW8.</li> <li>- In 2023 this location has mature trees either side of the channel. RHB has near vertical bare walls &gt;1m, exposed tree roots with recent signs of erosion. The LHB is very similar to the RHB, with undercutting noted along the LHB. Channel bed is well defined at this location with signs of recent erosion and movement. There is no groundcover vegetation within the channel at this location which has formed an active scour. The bed The creek bed is a mix of fine and coarse sand and small gravel material. A large accumulation of flood debris was noted.</li> <li>- Continue to monitor.</li> </ul> | | | | |

| <ul style="list-style-type: none"> <li>- If unchanged and past two year recommend remove from annual monitoring program (yes/no)</li> <li>- Recommend recording cross sections at locations identified with channel and/or channel bank cracking as a result of subsidence, to monitor for erosion and/or changes to the channel width (yes/no)</li> </ul> | | | | |

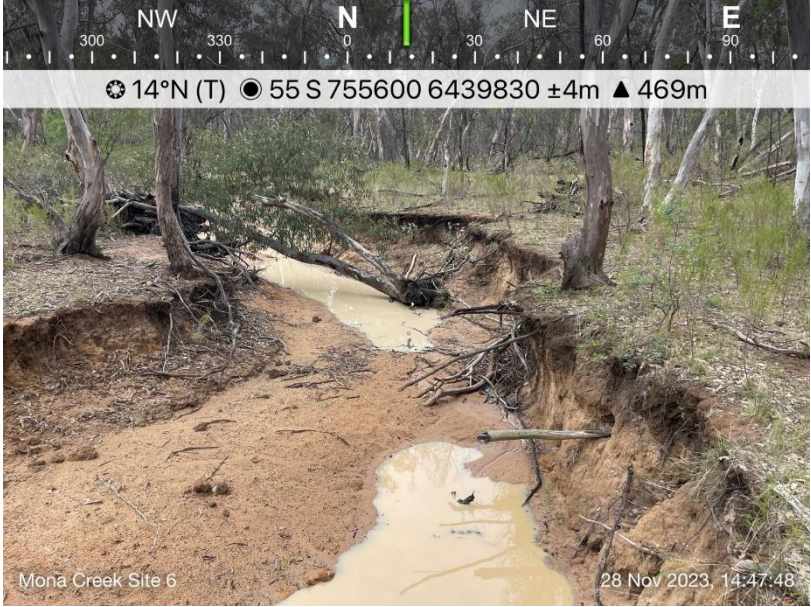
### Site MC-6

| <ul style="list-style-type: none"> <li>- MC6 is within an established open woodland area, within LWW8.</li> <li>- In 2023 this location has mature trees either side of the channel. RHB has almost near vertical bare walls &gt;1m, exposed tree roots with recent signs of erosion. The LHB is vertical and very similar to the RHB, with undercutting noted along the LHB and RHB. Channel bed is well defined at this location with signs of recent erosion and movement. There is no groundcover vegetation within the channel at this location which has formed an active scour. Water was pooling with the scour hole at this location. There was a fallen tree from the LHB into the channel. A tributary of Mona Creek flows into the creek system at this location causing further erosion and instabilities. The bed is a mix of fine and coarse sand and small gravel material.</li> <li>- Continue to monitor.</li> </ul> | | | | |

| <ul style="list-style-type: none"> <li>- If unchanged and past two year recommend remove from annual monitoring program (yes/no)</li> <li>- Recommend recording cross sections at locations identified with channel and/or channel bank cracking as a result of subsidence, to monitor for erosion and/or changes to the channel width (yes/no)</li> </ul> | | | | |

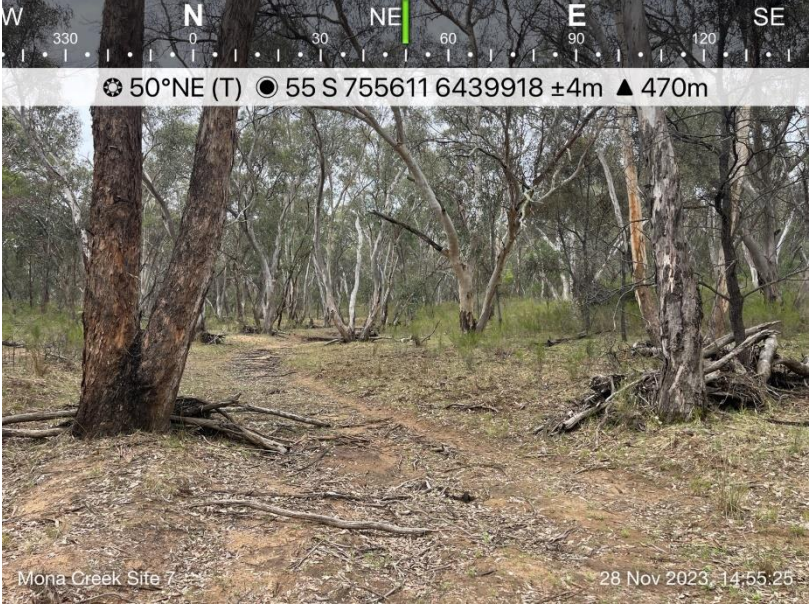
### Site MC-7

| <ul style="list-style-type: none"> <li>- MC7 is within an established open woodland area, on the Chain Pillar of LWW8.</li> <li>- In 2023 this location has mature trees either side of the channel. RHB is a mild to gentle slope with good groundcover vegetation. The LHB is a gentle slope with good groundcover vegetation. Flood debris, leaf litter, fallen trees and tree limbs were noted. The channel bed is less defined at this location. Very little groundcover vegetation within the channel at this location. The creek bed is a mix of fine and coarse sand and soil like material.</li> <li>- Continue to monitor.</li> </ul> | | | | |

| <ul style="list-style-type: none"> <li>- If unchanged and past two year recommend remove from annual monitoring program (yes/no)</li> <li>- Recommend recording cross sections at locations identified with channel and/or channel bank cracking as a result of subsidence, to monitor for erosion and/or changes to the channel width (yes/no)</li> </ul> | | | | |

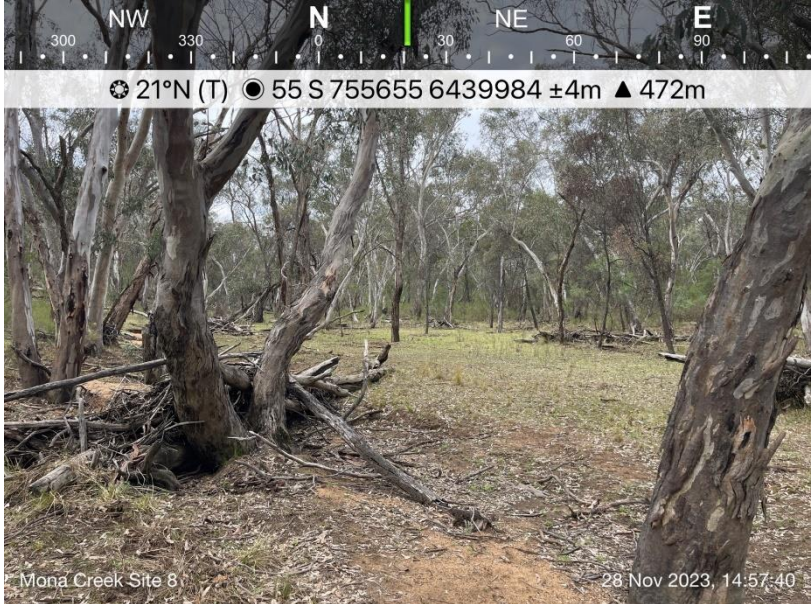
### Site MC-8

| <ul style="list-style-type: none"> <li>- MC8 is within an established open woodland area, approximately 80m to the north of LWW8.</li> <li>- In 2023 this location has mature trees either side of the channel. RHB is a mild to gentle slope with good groundcover vegetation. The LHB is a gentle slope with good groundcover vegetation. Flood debris, leaf litter, fallen trees and tree limbs were noted. The channel bed is less defined at this location. Very little groundcover vegetation within the channel at this location. The creek bed is a mix of fine and coarse sand and soil like material.</li> <li>- Continue to monitor.</li> </ul> | | | | |

| <ul style="list-style-type: none"> <li>- If unchanged and past two year recommend remove from annual monitoring program (yes/no)</li> <li>- Recommend recording cross sections at locations identified with channel and/or channel bank cracking as a result of subsidence, to monitor for erosion and/or changes to the channel width (yes/no)</li> </ul> | | | | |
