**ULAN COAL MINES PTY LIMITED  
2025 CLIFF LINE MONITORING REPORT**

| <b>Document Title:</b> | 2025 Cliff Line Monitoring Report |
| <b>General Description:</b> | Pre & post mining inspections of cliff lines associated with LW8 in 2025 above Ulan West, Brokenback Conservation Area and incorporating previous cliff line monitoring results from Ulan Underground LWW4 and LWW7. |
| <b>Date:</b> | 4 March 2026 |

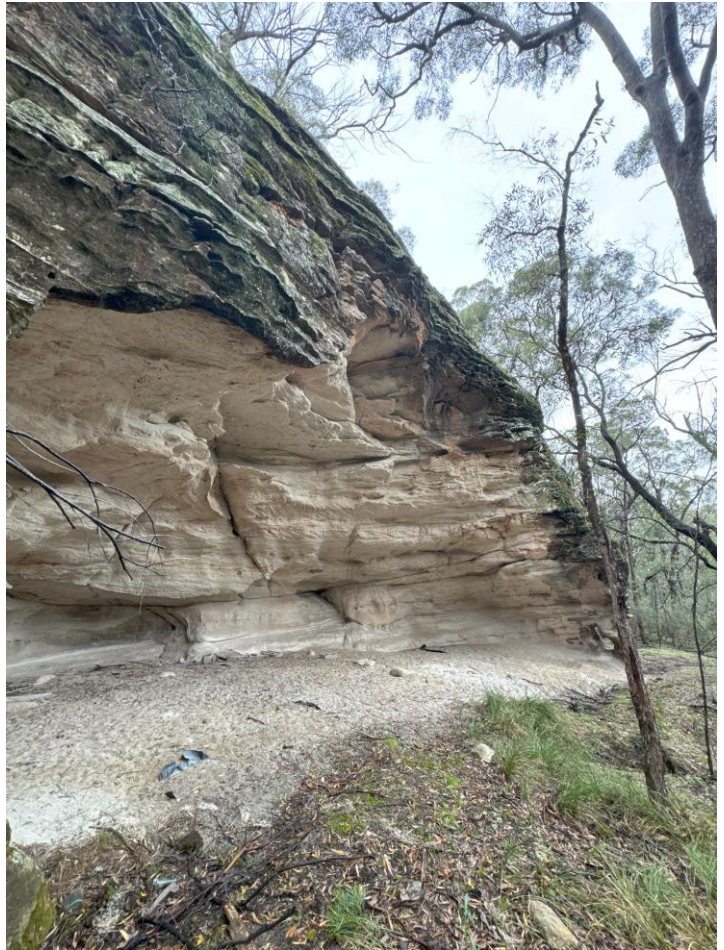
**Cover Photo:** Cliff line C6-2 & Ulan ID#191

| LW | Easting | Northing | Cliff Line Reference | Rock Fall Length (m) | Notes |
|---|---|---|---|---|---|
| LW8B | 753820 | 6436481 | C6-2 <sup>^</sup> | 0.0 | No perceptible cracking. No rock falls. |
