## APPENDIX B: Ulan Creek

## 2025 Channel Stability Monitoring - Site Inspection Details

**Creek Name:** Ulan Creek

**Date:** 18 September 2025

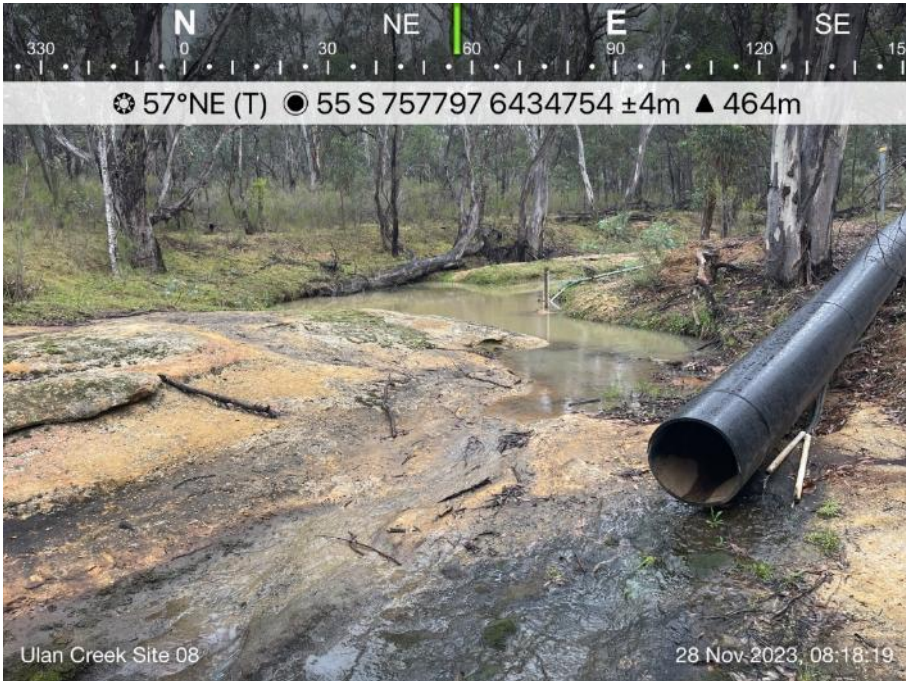
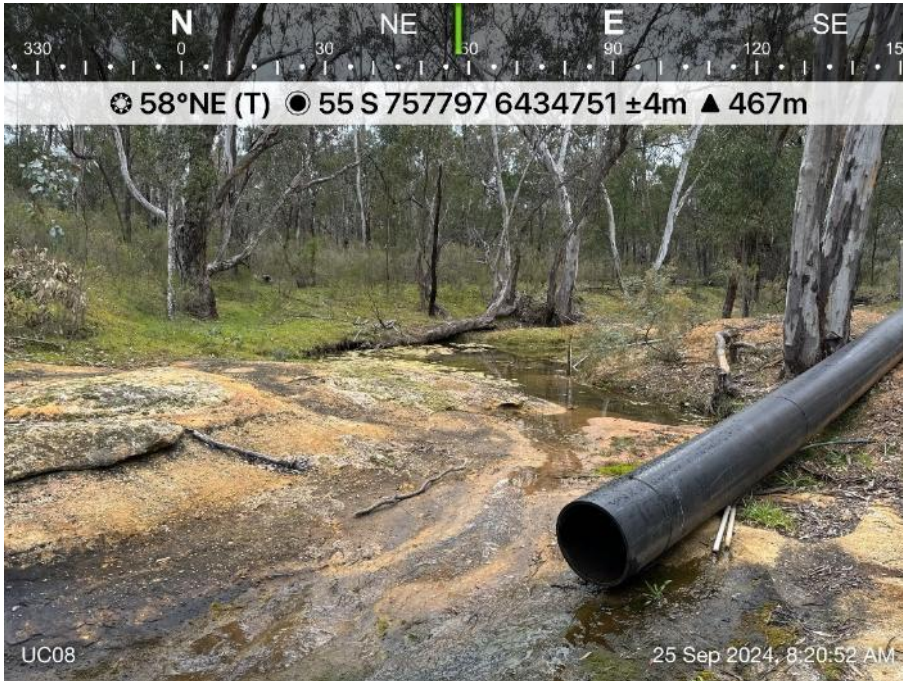
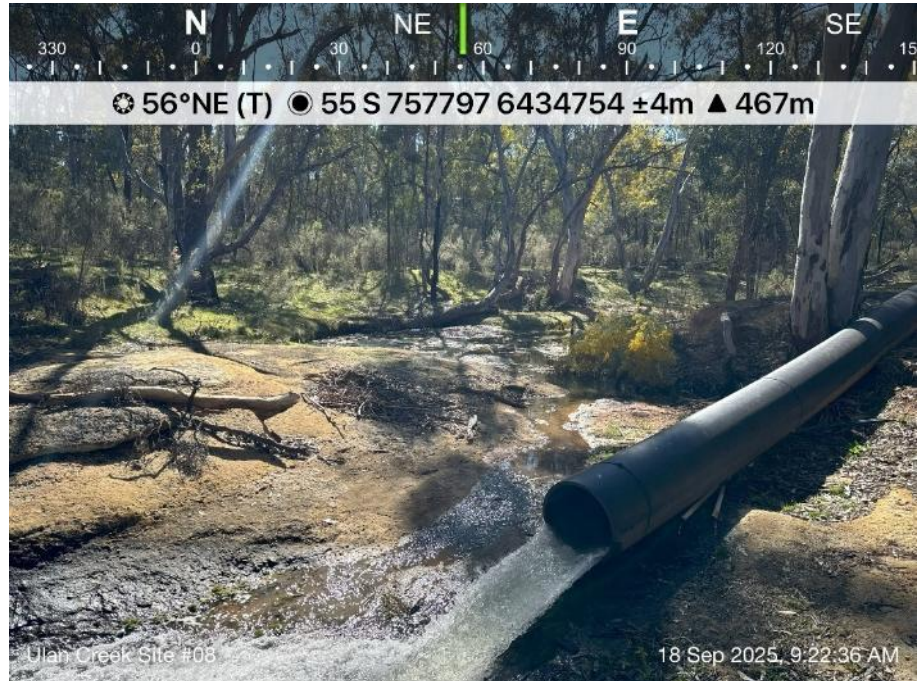
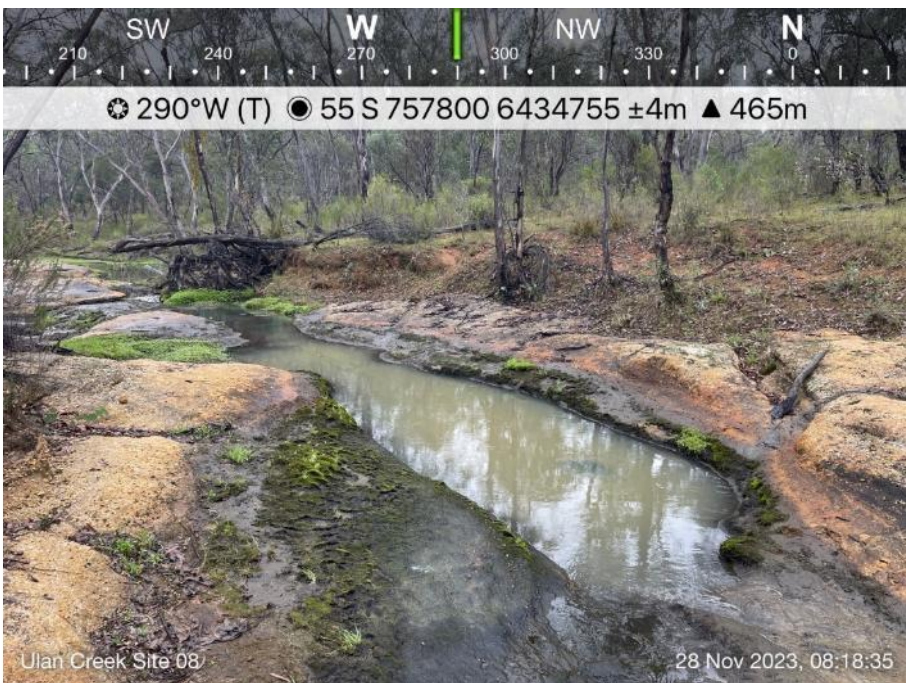
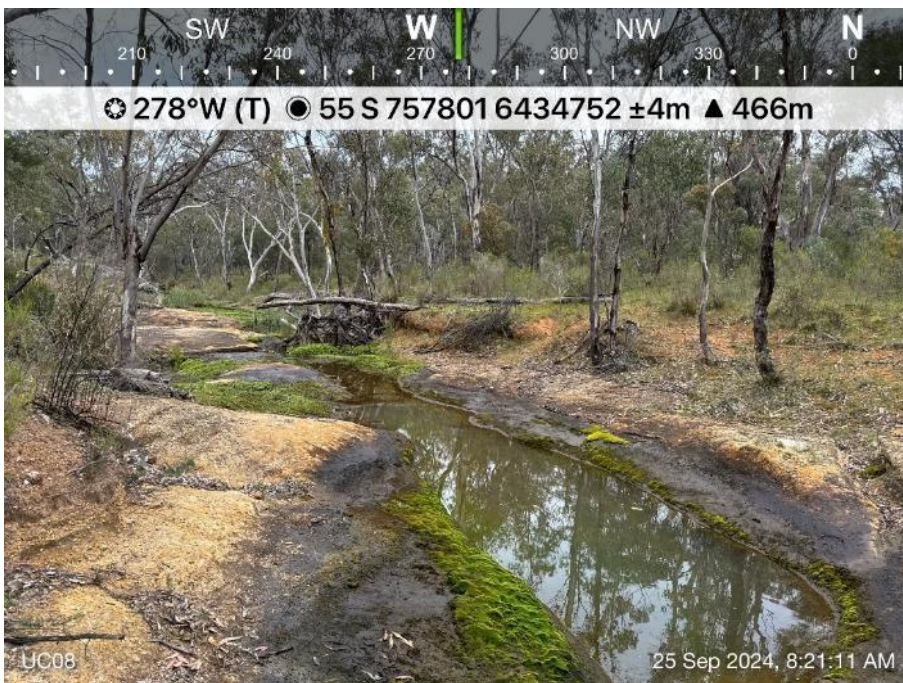
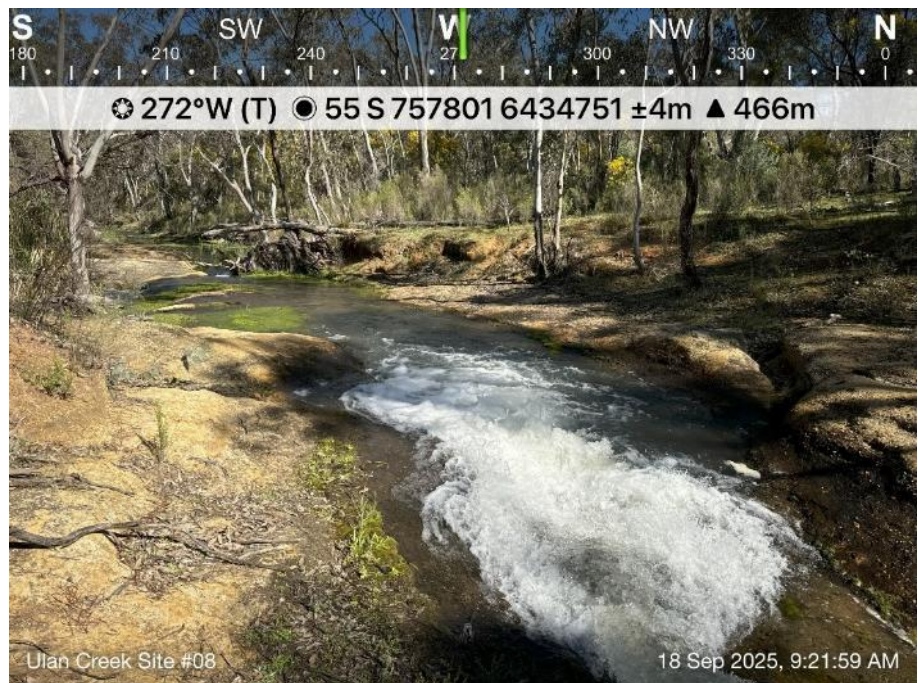
**Monitoring Site: UC08**

**General Observations:** Ulan Creek had water pooling and flowing at this location above LDP6 in 2024. LDP6 discharging into Ulan Creek at the time of the inspection. In 2020, flood debris was recorded above flow line on both the LHB and RHB. The channel bed at the discharge point is formed from bedrock and provides stability at this location. Several meters upstream of LDP6 (the assessment site), the RHB has a moderate slope above, established trees with comparable ground vegetation coverage in 2025 to that observed in 2023 and 2024. The LHB has a gentle slope above with areas of exposed bare ground and is also tree lined. The LHB wall has steep sections (when not covered by water) which are bare and exposed with signs of instability. As in previous years the channel bed assessment in 2025 could not be completed due to water in the creek. Accumulation of flood debris on the bedrock above LDP6 indicating at least one natural flow event has occurred during the monitoring period. Observations in 2025 are comparable to previous monitoring. The CSIRO *Ephemeral Stream Assessment* classification at this location as 'active'.

**Notes:** In 2025 observations were limited to the LHB and water flowing. The creek bed could not be assessed in 2024. The site appeared potentially stabilising above the water line upstream of LDP6. As a general comment algal discolouration of the bedrock at LPD6 was comparable to 2022, 2023 and 2024.

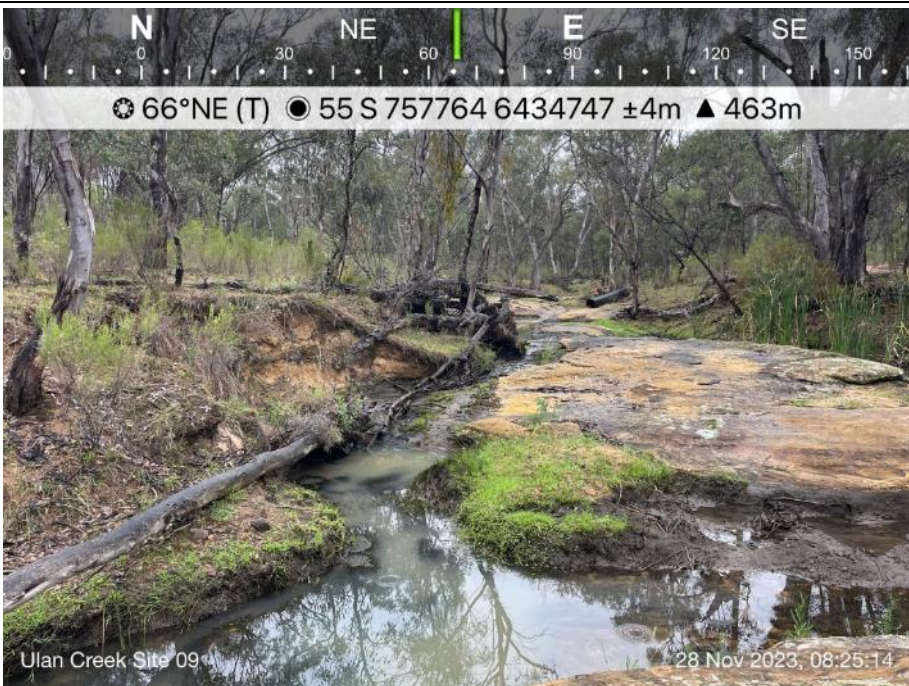
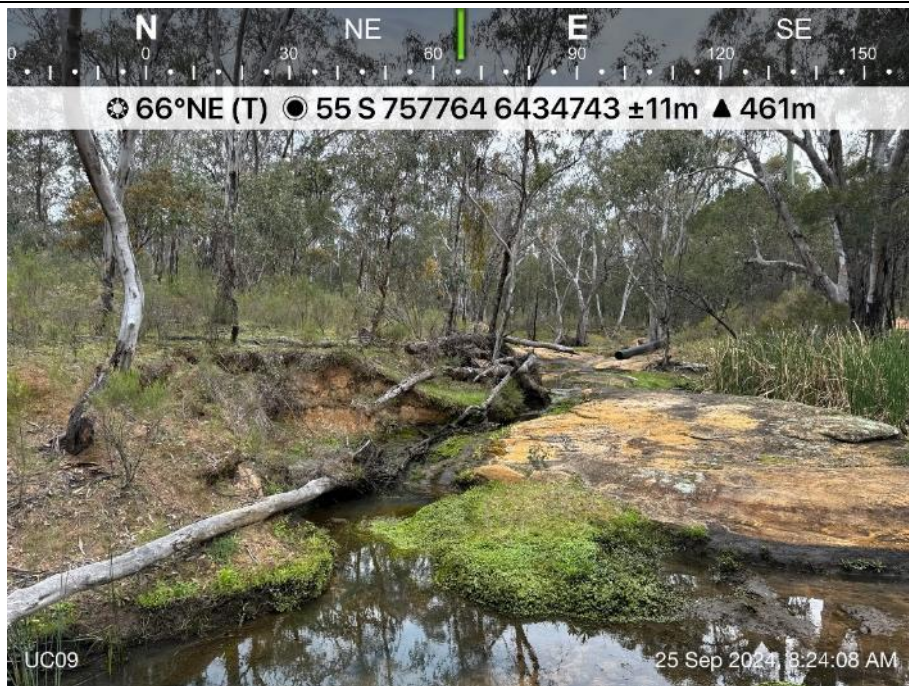
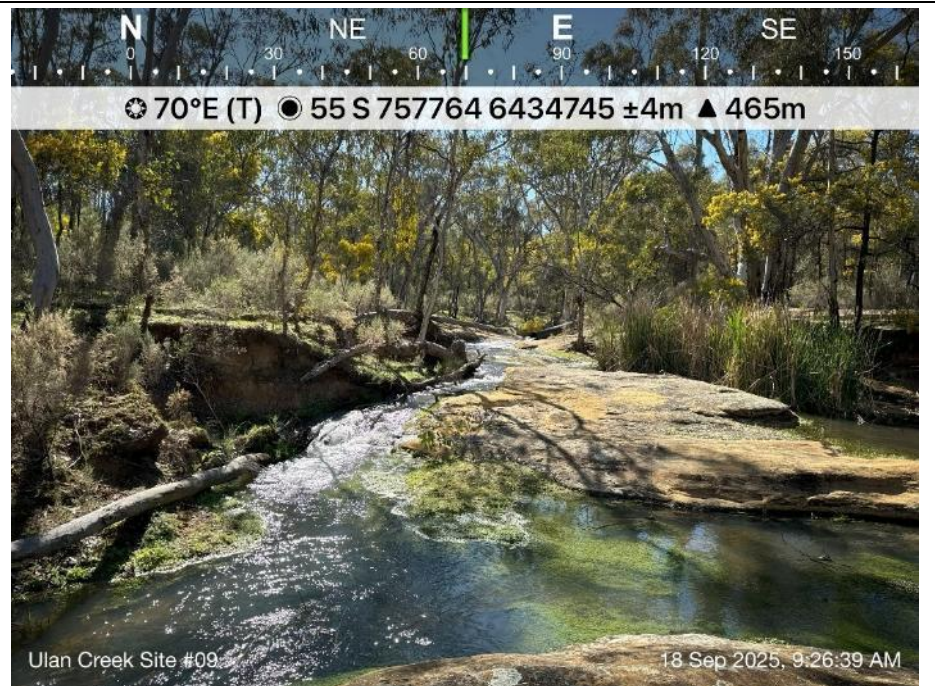
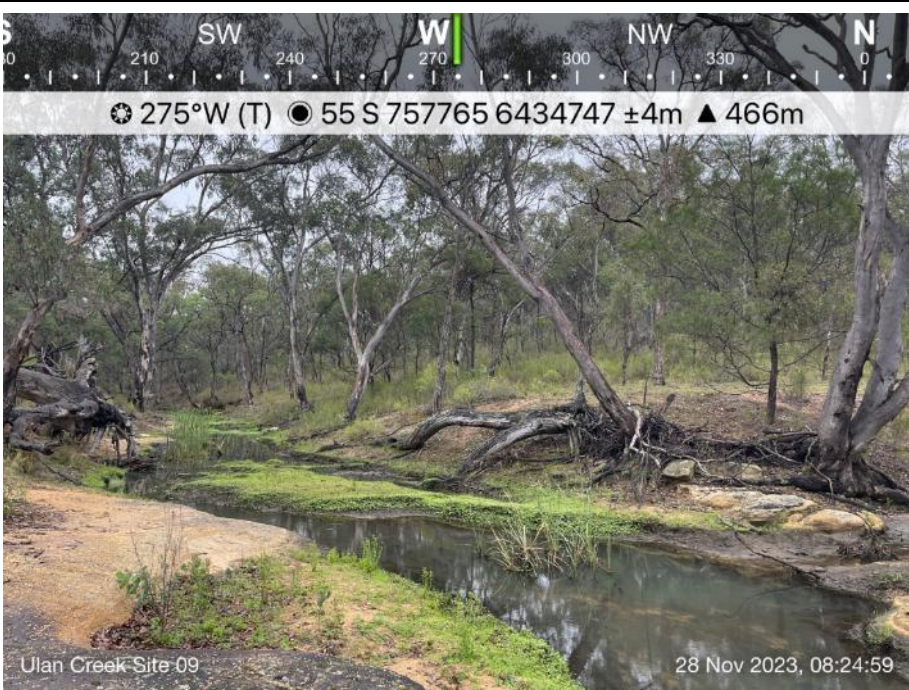
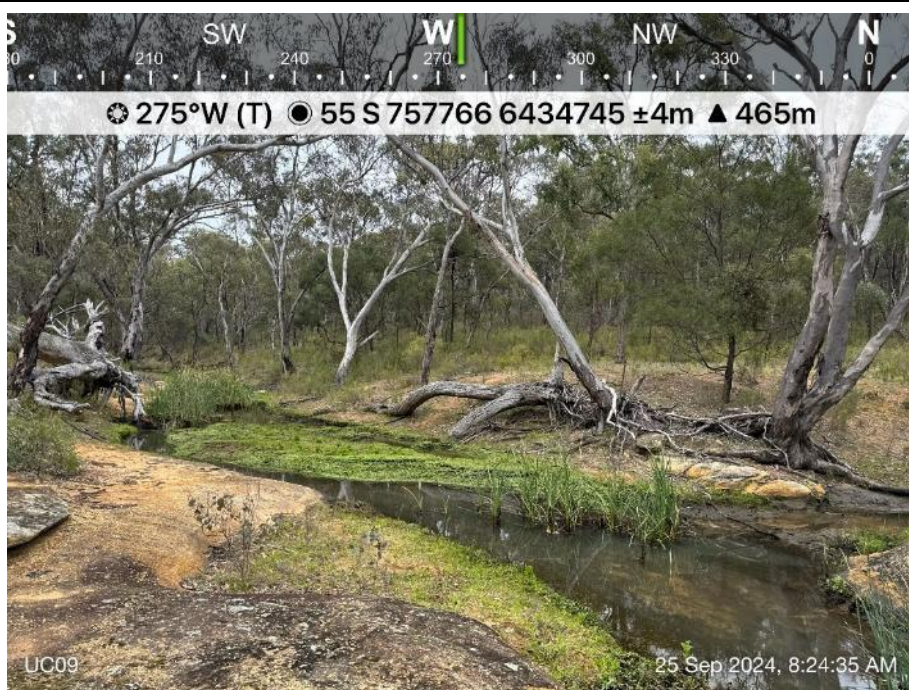
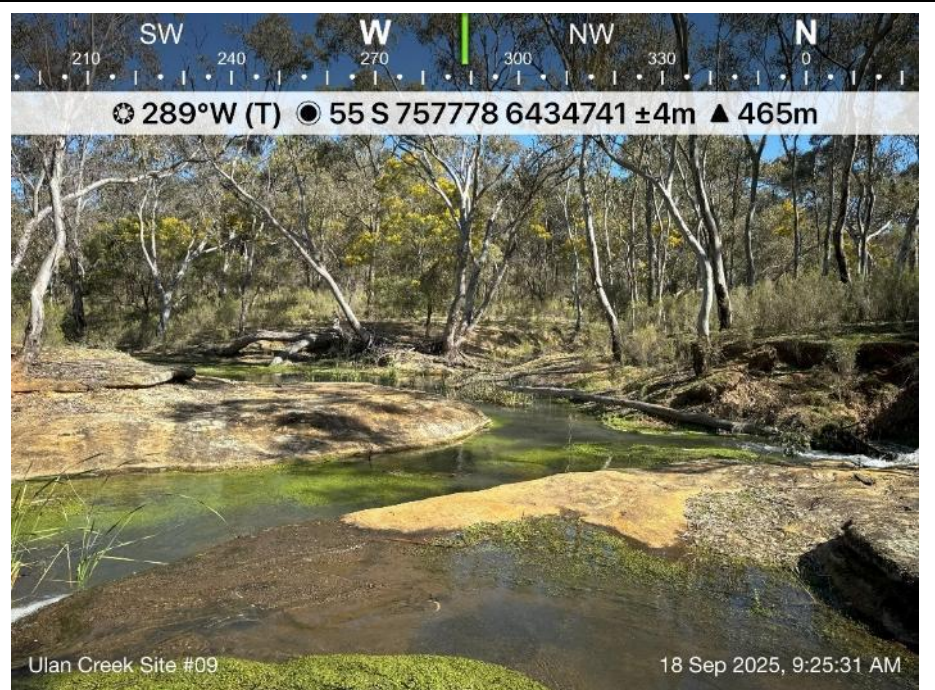
**Monitoring Site: UC09**

**General Observations:** Ulan Creek had water flowing at this location in 2025. Exposed bedrock is within the floor of the channel, although channel bed assessment in 2025 could not be completed due to water in the creek. A high flow event in the 2020 monitoring period moved the log that was across the channel. In 2020, flood debris was recorded above the banks. In 2022 signs of additional sand and silts deposits were noted just above the water line on the LHB. Signs of instabilities along both banks was observed in 2021 and 2022. The LHB walls are near vertical, exposed with signs of recent erosion. The RHB wall is a more moderate slope and mostly vegetated. Both banks are tree lined with fewer trees along the LHB. The tunnel erosion deep into the RHB, is comparable to previous observations since 2020 and appears to have partially stabilised. An increase of ground vegetation was noted in 2025. The observations in 2025 are comparable with recent years. The CSIRO *Ephemeral Stream Assessment* classification at this location as 'very active'.

**Notes:** In 2025 observations were limited to the LHB and water flowing. The creek bed could not be assessed. Due to water flows in the creek, slight changes to the location of taking photographs in 2025 were required.

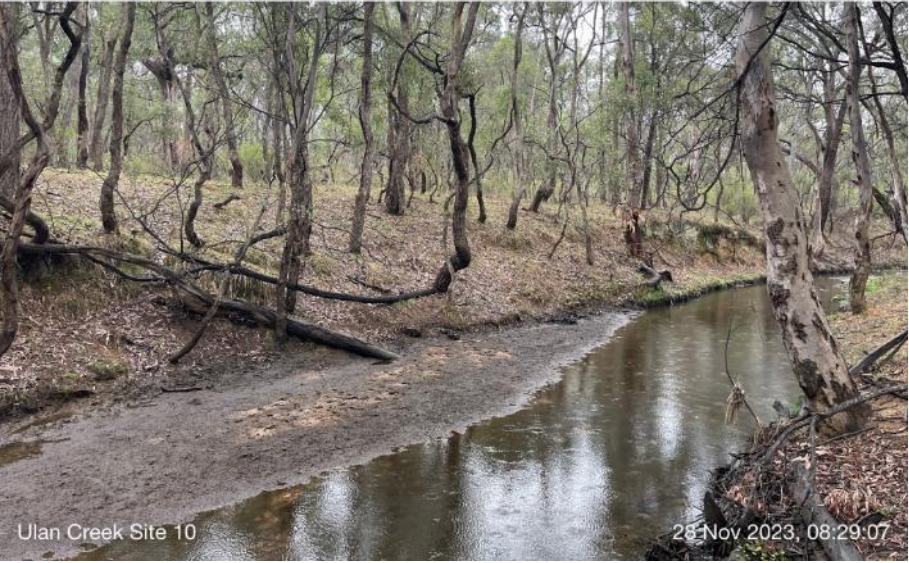
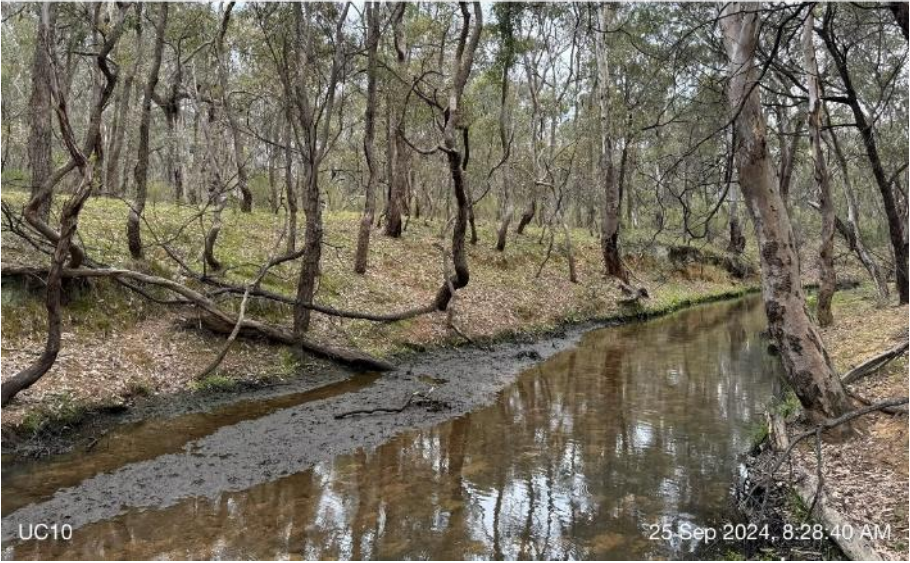
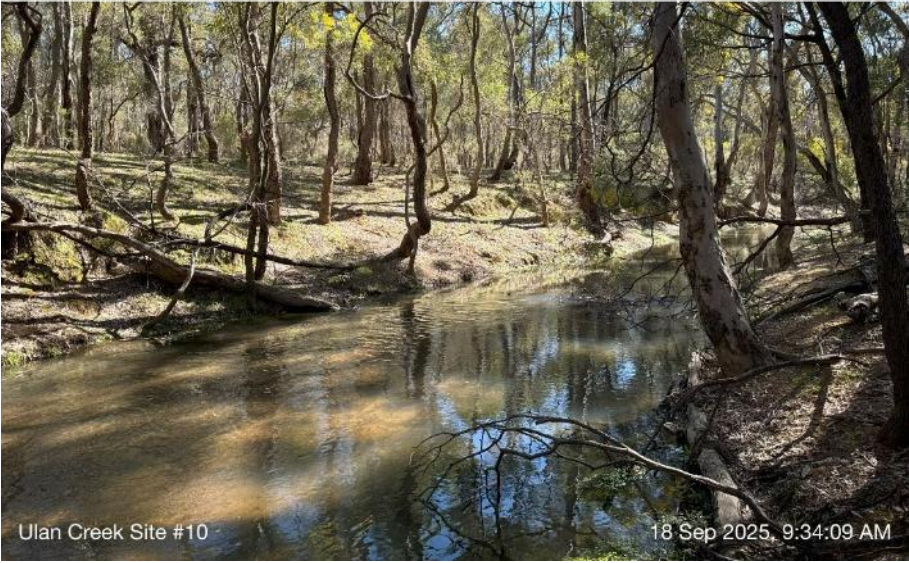
Monitoring Site: UC10

**General Observations:** Ulan Creek had water flowing at this location in 2025. The channel bed assessment in 2025 could not be completed due to water in the creek. From previous monitoring, the creek bed is a mix of silt, sand and small gravel. In 2020, flood debris was located above the LHB with fine sand deposits. Comparable groundcover above the LHB and RHB on previous year. The RHB walls are near vertical, mostly exposed with signs of recent erosion. Tree roots are exposed along the RHB with signs of minor bank undercutting. The LHB is a more moderate slope and was vegetated. Both banks are tree lined. Tree of Heaven was noted along the LHB at this location. Observations in 2025 are comparable to previous monitoring. The CSIRO *Ephemeral Stream Assessment* classification at this location as 'active'.

**Notes:** In 2025 observations were limited to water flowing and the LHB. The creek bed could not be assessed. This site appeared potentially stabilising above the water line.

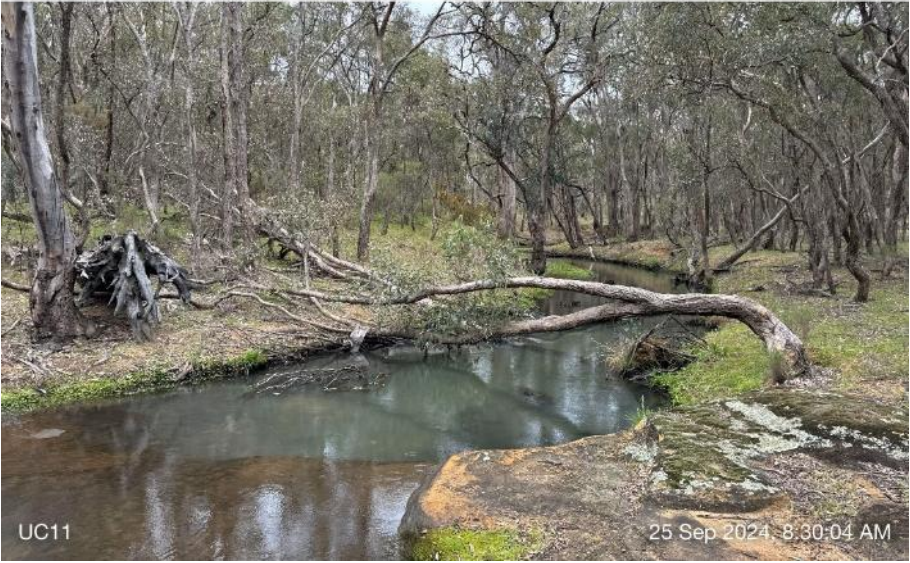
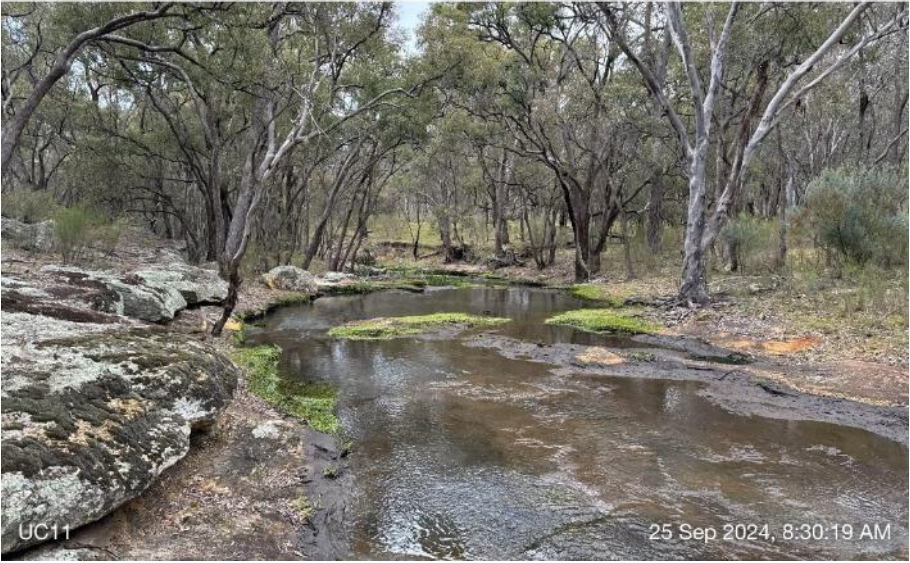
Monitoring Site: UC11

**General Observations:** Ulan Creek had water flowing at this location in 2025. Exposed bedrock is within the floor of the channel providing stability, although the channel bed assessment (immediately upstream) in 2025 could not be completed due to water in the creek. Flood debris was located above the LHB in 2020. Comparable groundcover above the LHB and RHB on previous year. The LHB is formed from bedrock with a moderate slope. The RHB has a gentler slope partially vegetated in 2025 with some signs of minor undercutting. Both banks are tree lined. A tree had fallen into the creek from the LHB prior to monitoring in 2021. Observations in 2025 are comparable to previous monitoring. The CSIRO *Ephemeral Stream Assessment* classification at this location as 'stable'.

**Notes:** In 2025 observations were limited to the LHB and water flowing. This site appeared stable above the water line upstream of the bedrock.

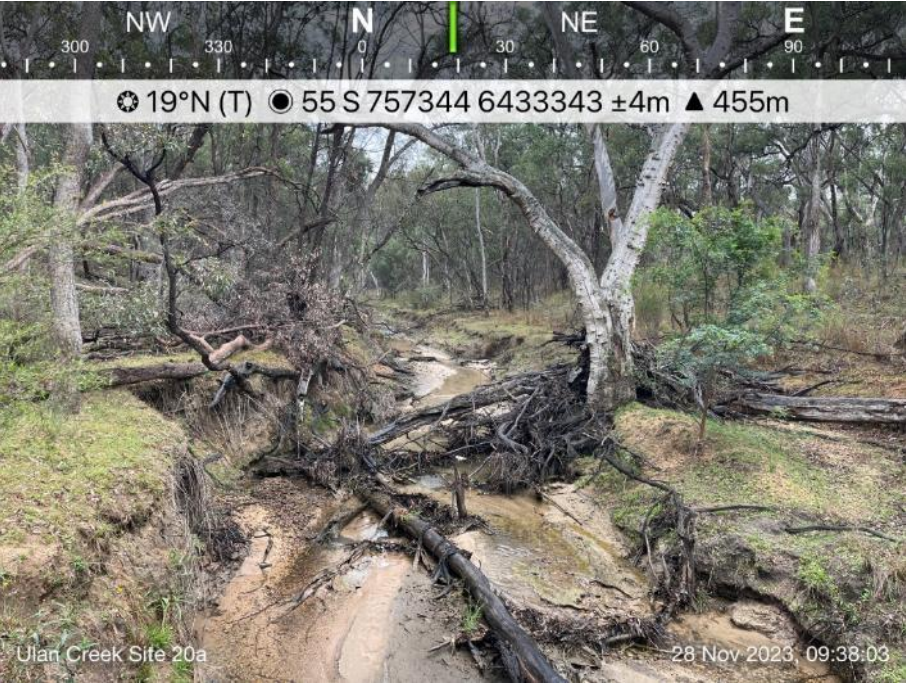
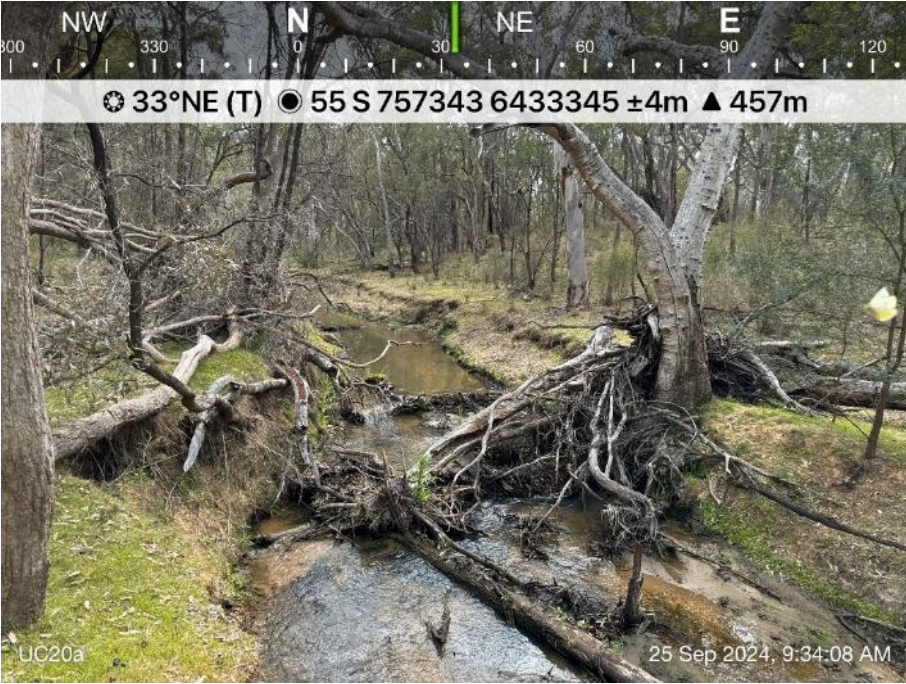
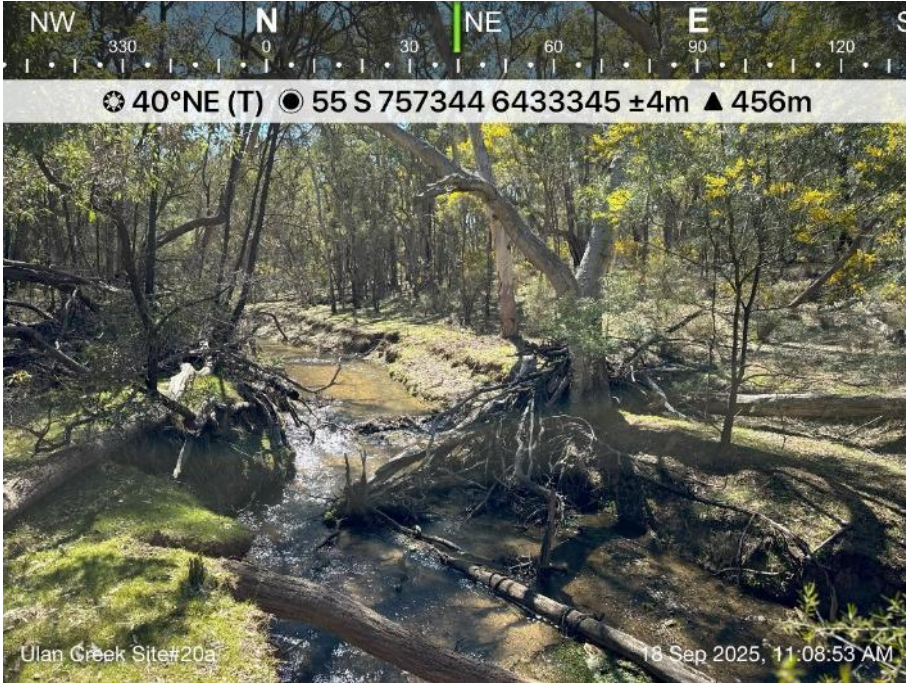
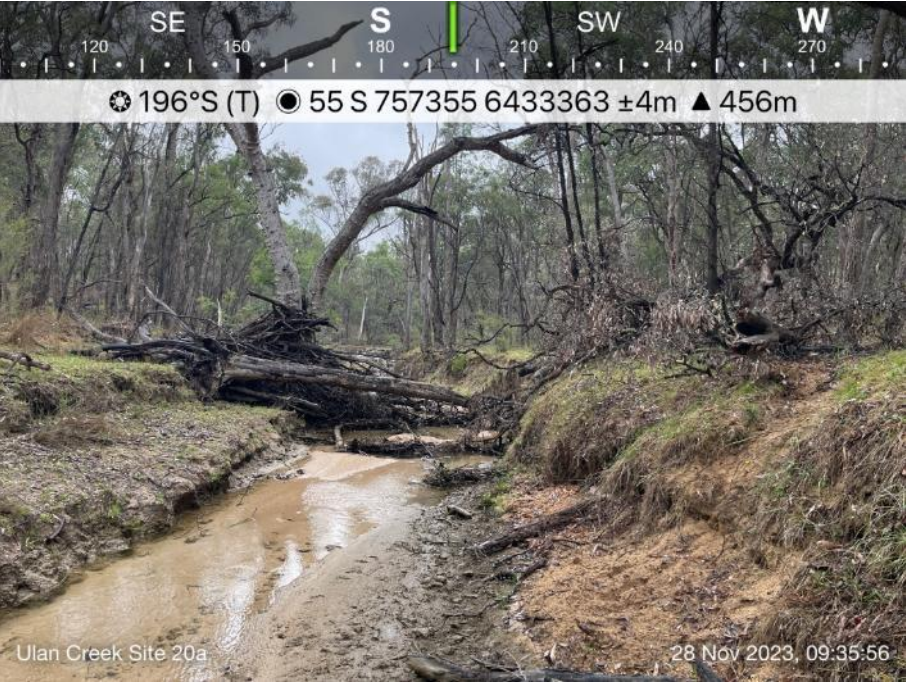
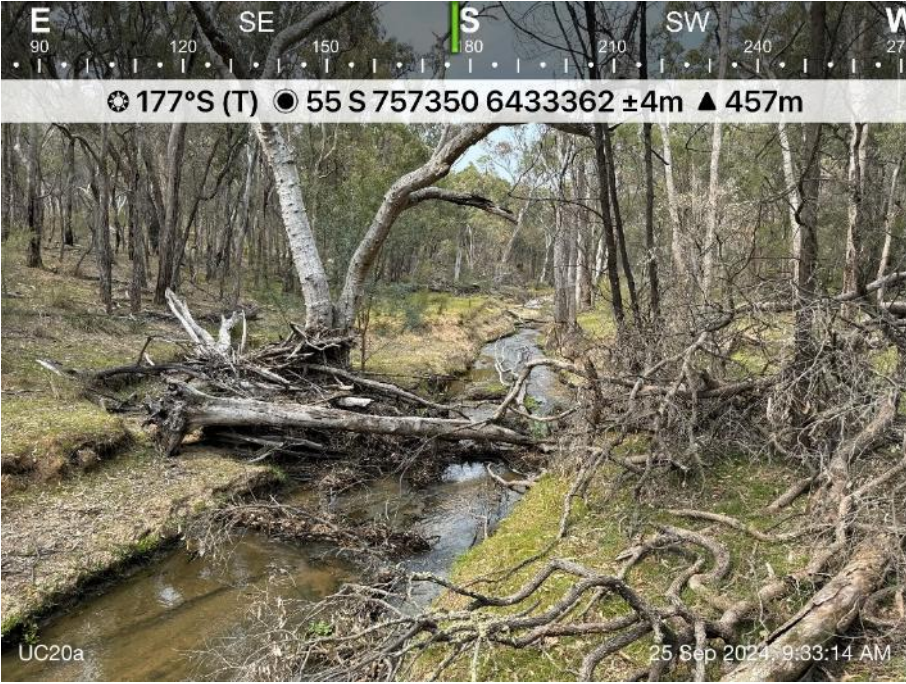
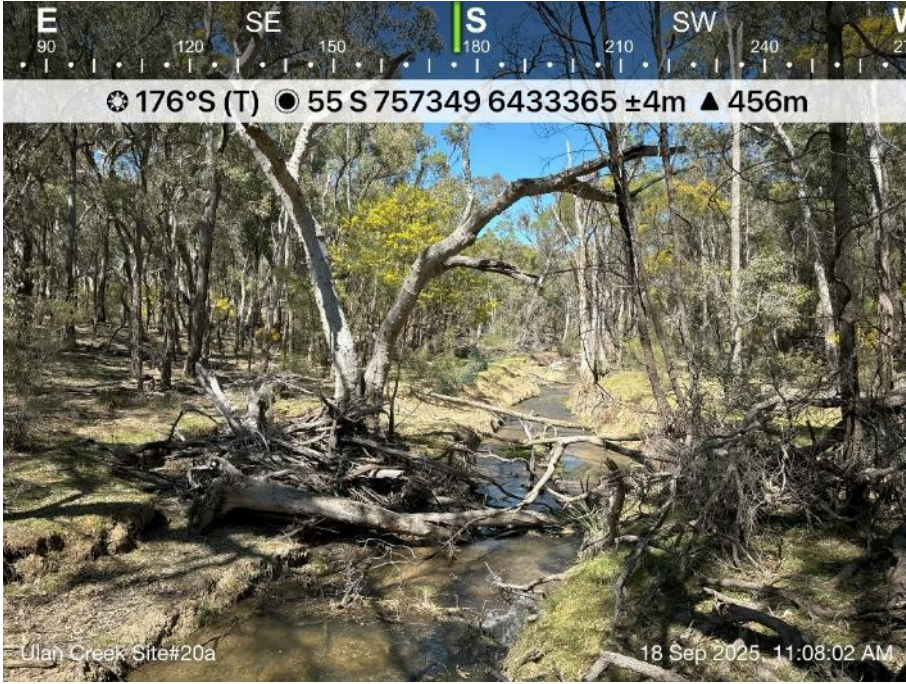
**General Observations:** Ulan Creek had water flowing at this location in 2024. Active erosion along both banks was again observed. Accumulation of flood debris was observed in 2020 caught up around the dead tree located in the middle of the flow line. The flow channel bed had little to no vegetation and is a mix of silt, sand and small gravel material. In 2022 additional build up of sand, silt and small gravel deposits were noted. Both the LHB and RHB have a moderate slope above the channel and were well vegetated. Both banks display recent signs slumping and bank undercutting, in particular the RHB has significant active erosion. A tree has fallen along the edge of the RHB in 2022. Since 2015 the channel width at this location has increased. Comparable groundcover above the LHB and RHB as previous year. Both sides of the creek are tree lined. Observations in 2025 are comparable to previous monitoring\*. The CSIRO *Ephemeral Stream Assessment* classification at this location as 'very active'.

**Notes:** In 2025 observations were limited to the LHB and water flowing. \*The increased erosion on the RHB exposing >1m of wall height decreased the 2022 score. Additional flood debris build up noted in 2023.

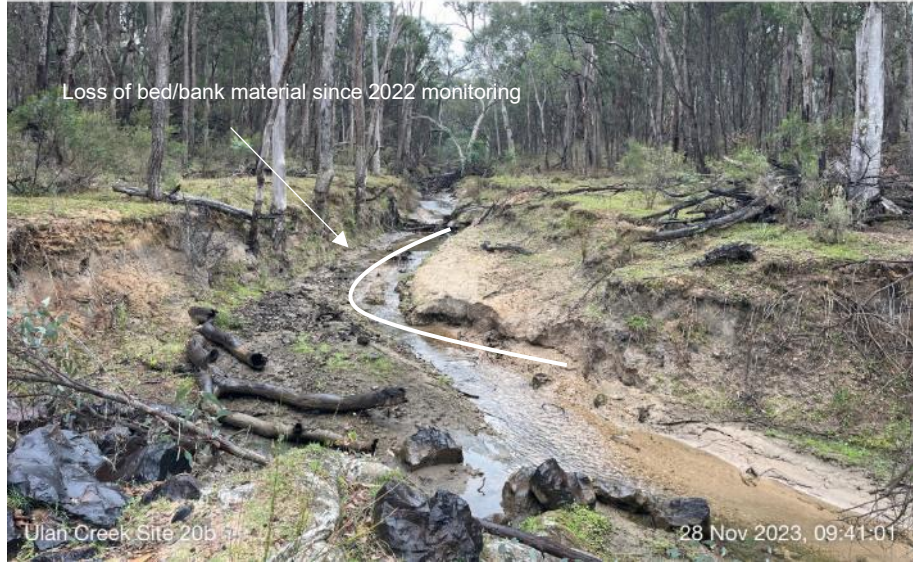
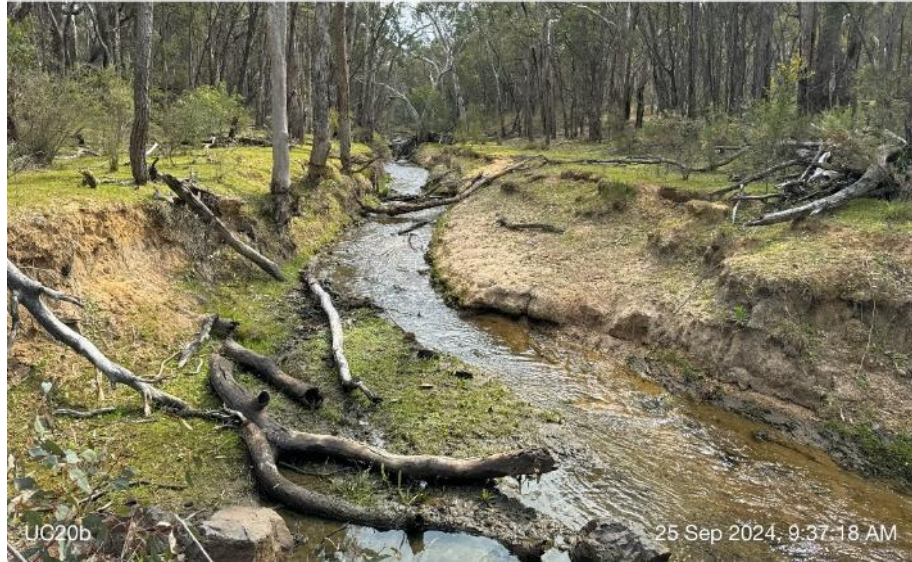
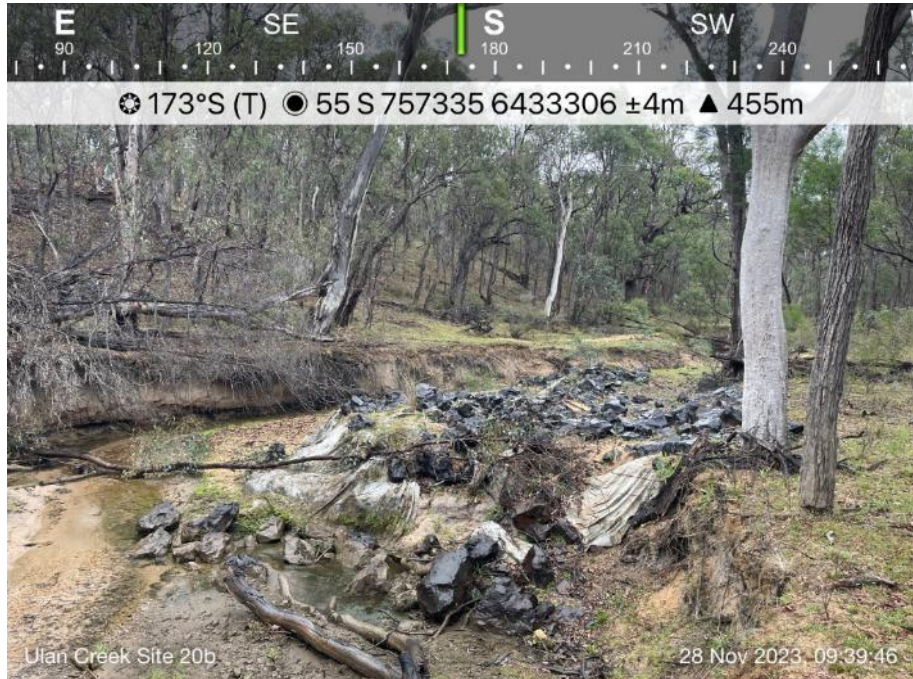
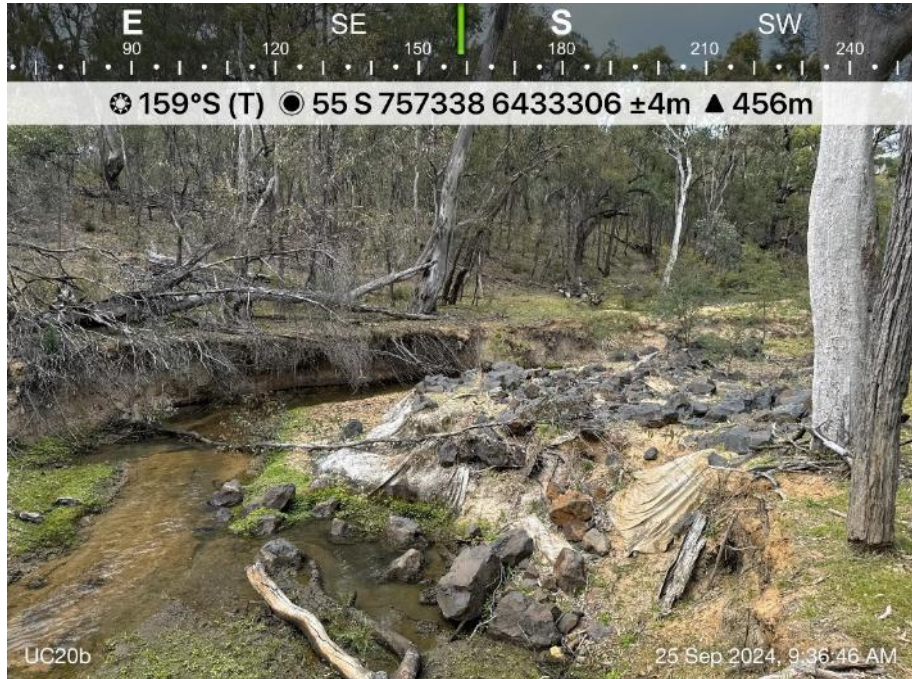
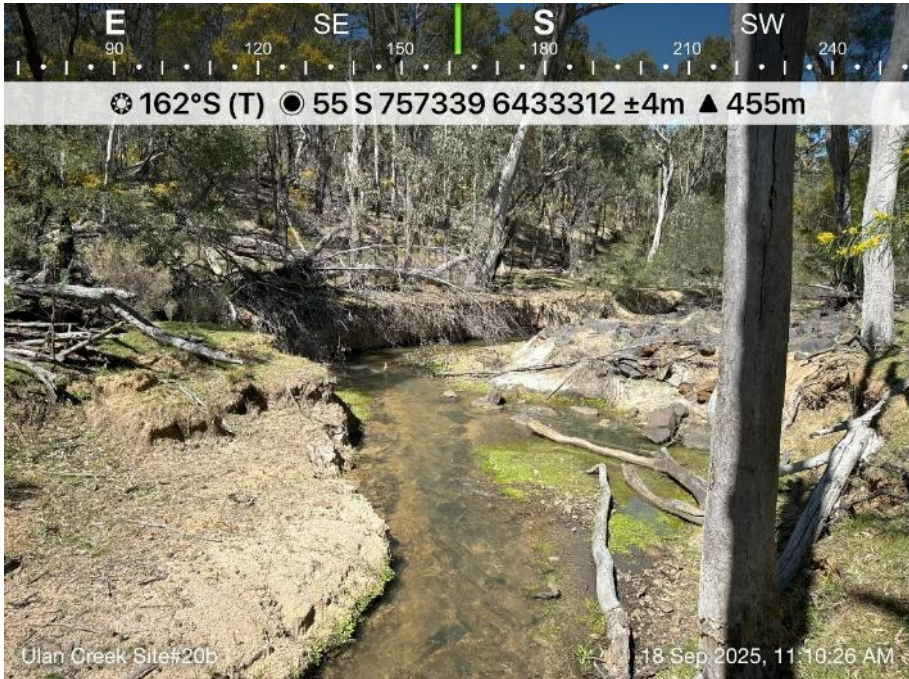
**General Observations:** Ulan Creek had flowing at this location in 2025. Active erosion along both banks was again observed. The flow channel bed had little to no vegetation. Silt, sand and small gravel size rock material was noted in the channel bed. Significant loss of a bank material and widening of the flow channel observed in 2020. Sand deposits above the flow line along the RHB noted in 2020. In 2022 additional build up of sand, silt and small gravel deposits were noted. The channel bed contains much larger foreign rock placed in the creek at some point, to possibly stabilise the creek (a portion of the RHB displays stability due to the rock armouring), however it appears to be having a more destabilising impact. Both the LHB and RHB have a moderate slope above the bank. The banks walls are sparsely vegetated, display recent signs of slumping, bank undercutting and causing a widening of the creek (particularly along the LHB). Comparable groundcover above the LHB and RHB as previous year. Both sides are tree lined. Observations in 2025 noted a similar deteriorating trend when compared to previous monitoring\*. The CSIRO *Ephemeral Stream Assessment* classification at this location as 'very active'.

**Notes:** In 2025 observations were limited to the LHB and water flowing. \*The increased erosion on the LHB exposing >1m of wall height decreased the 2022 score.Loss of bed/bank material since 2022 monitoring.

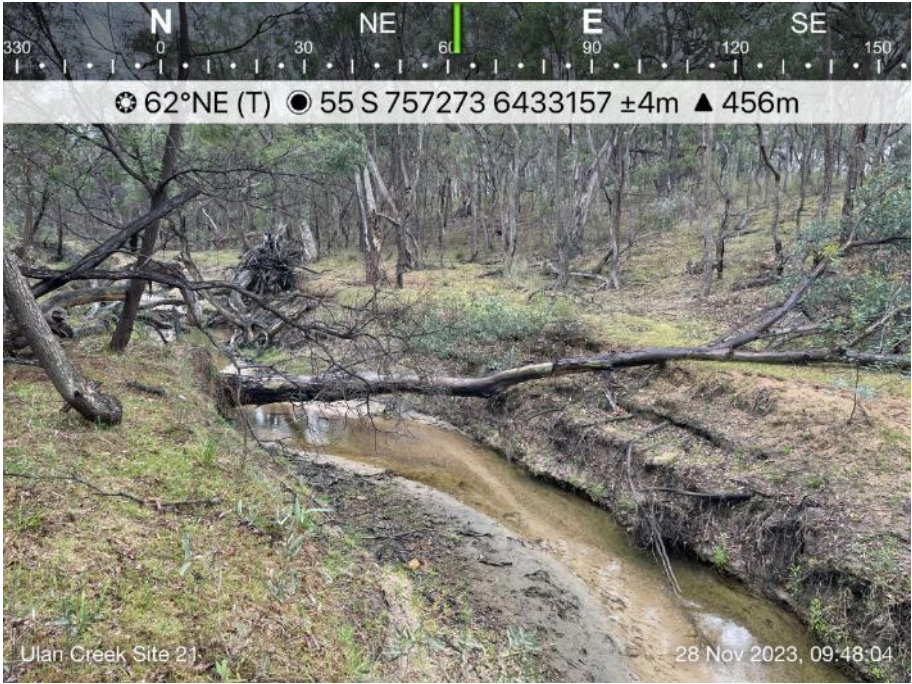
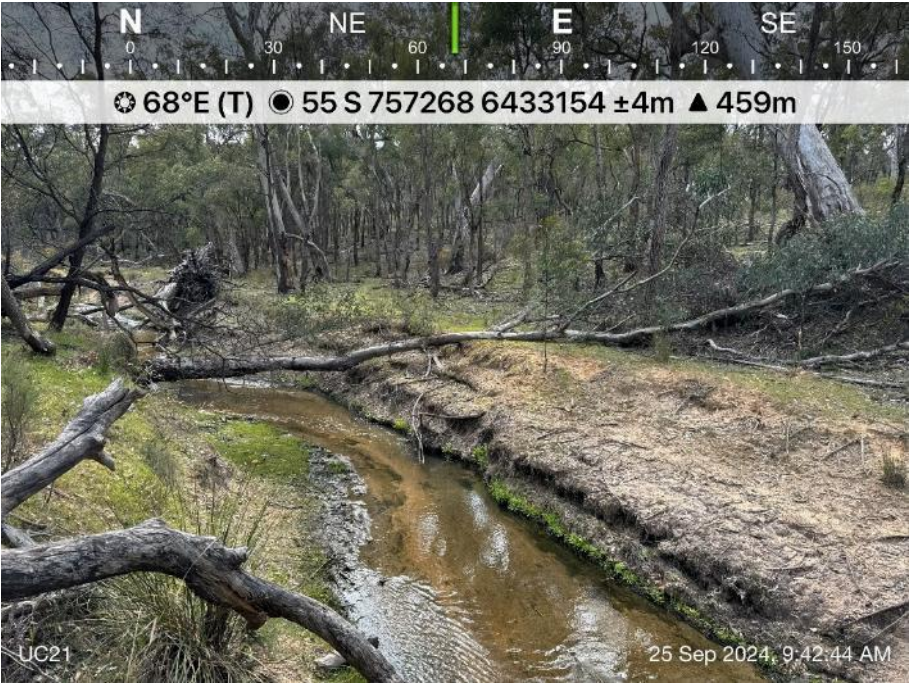
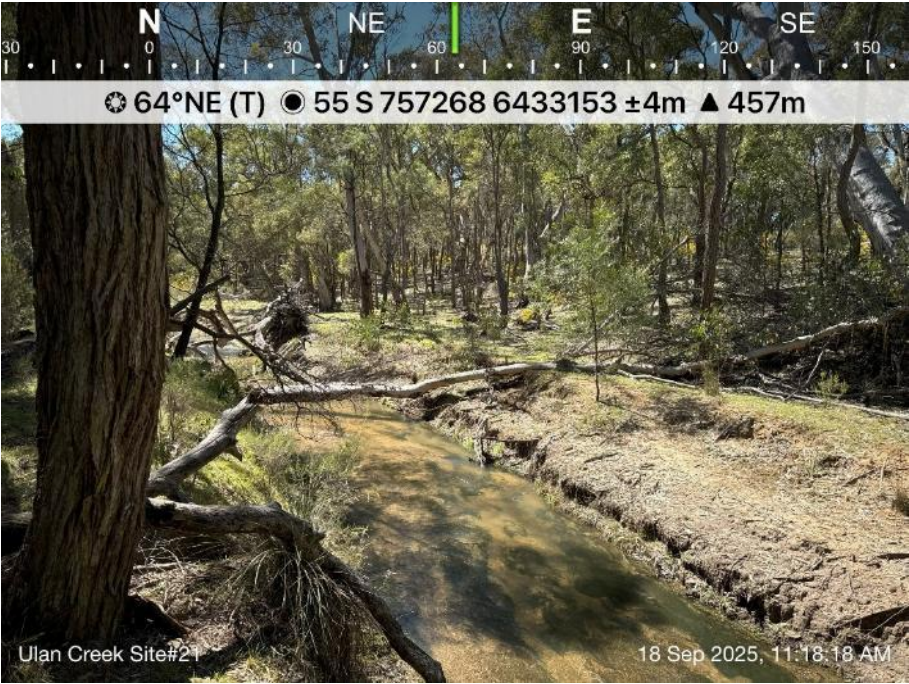
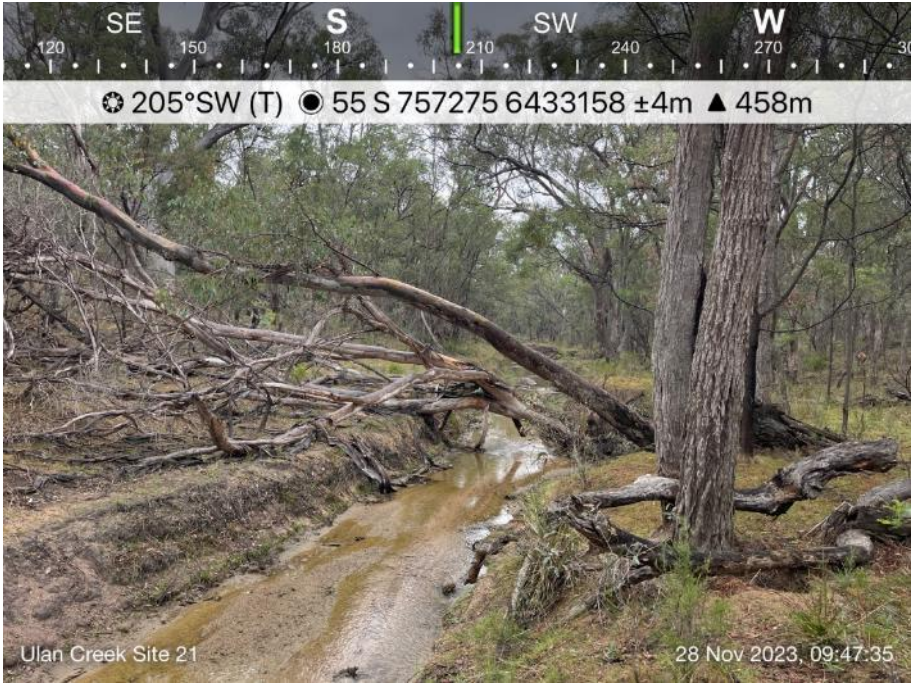
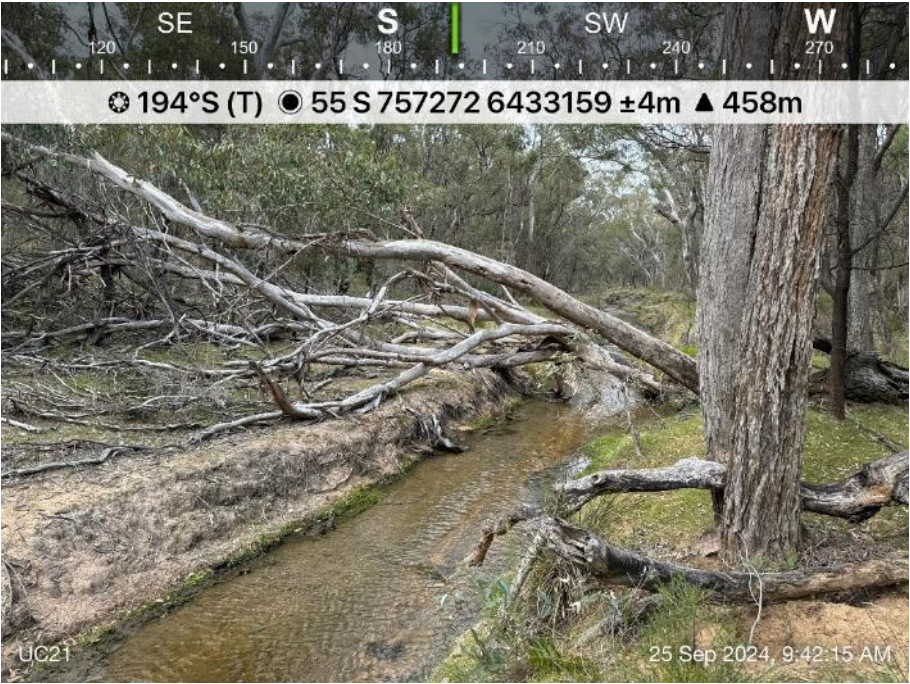
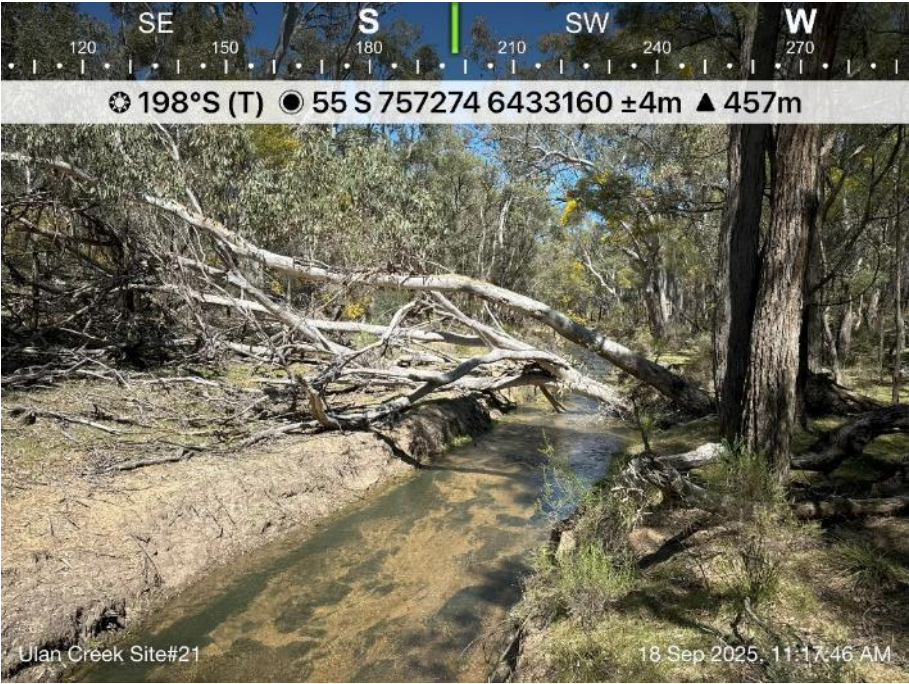
**General Observations:** Ulan Creek had water flowing at this location in 2025. Water was seeping from the LHB into the channel in 2022. Active erosion along both banks was again observed. The flow channel bed had little to no vegetation and is a mix of sand, small size gravel and rock material. Decrease of vegetation above the banks. Both the LHB and RHB have a moderate slope. Both banks have exposed bare areas and display recent signs of erosion. The RHB has near vertical sections with bank undercutting. The LHB displayed bank undercutting in 2021 although in 2022 additional build up of sand, silt and small gravel deposits had infilled. The formation of small scour holes in 2019 appeared to have been infilled since 2020. Comparable groundcover above the LHB and RHB as previous year. Both sides of the creek are tree lined. Observations in 2025 are comparable to previous monitoring. The CSIRO *Ephemeral Stream Assessment* classification at this location as 'active'.

**Notes:** In 2025 observations were limited to the RHB and water flowing. One tree upstream and another tree downstream had fallen across the creek from the RHB since 2022 monitoring.
