## APPENDIX B: Ulan Creek

## 2025 Channel Stability Monitoring - Site Inspection Details

**Creek Name:** Ulan Creek

**Date:** 18 September 2025

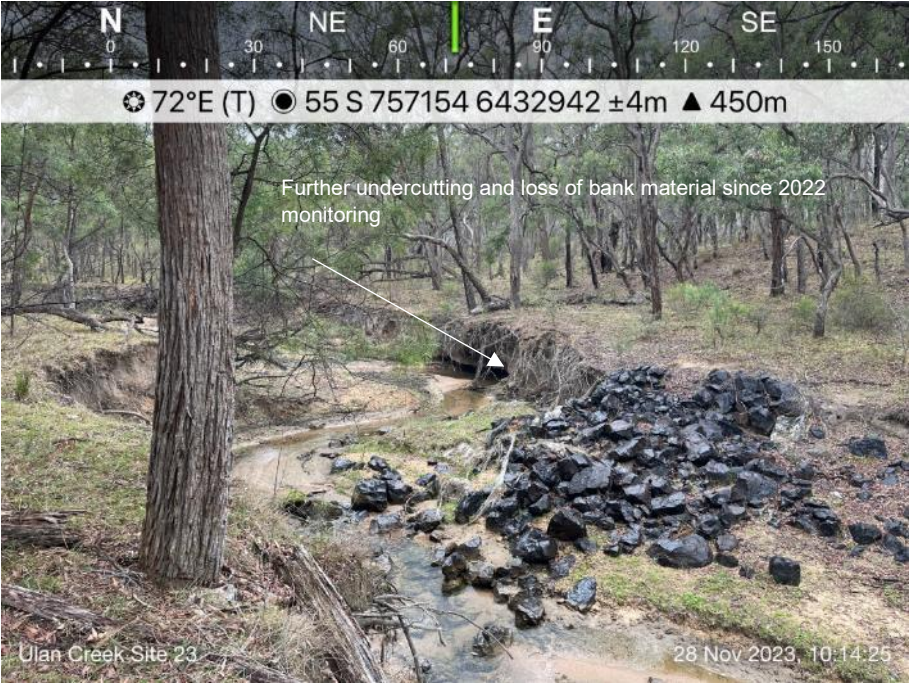
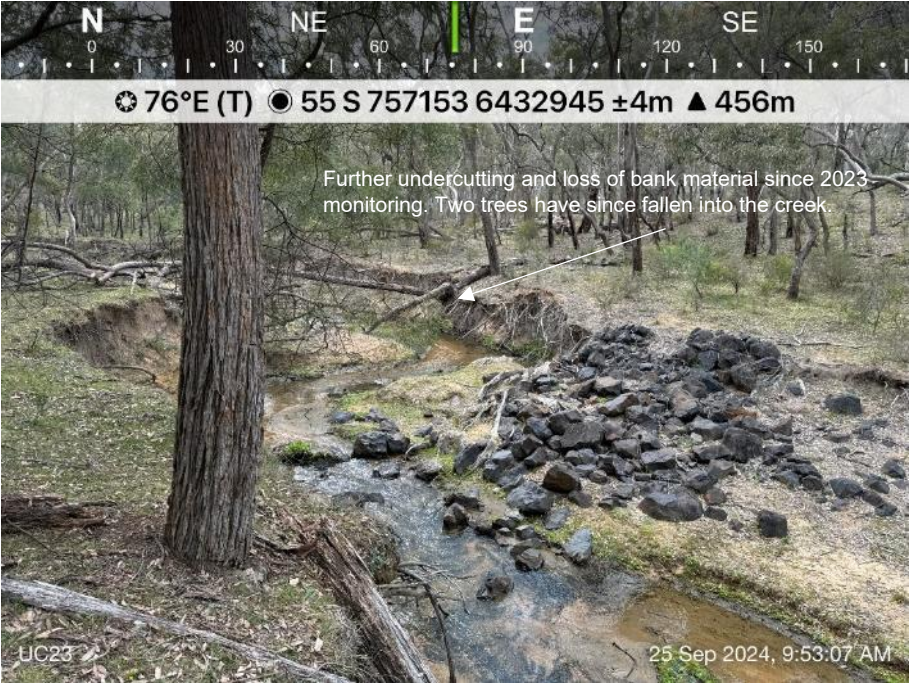
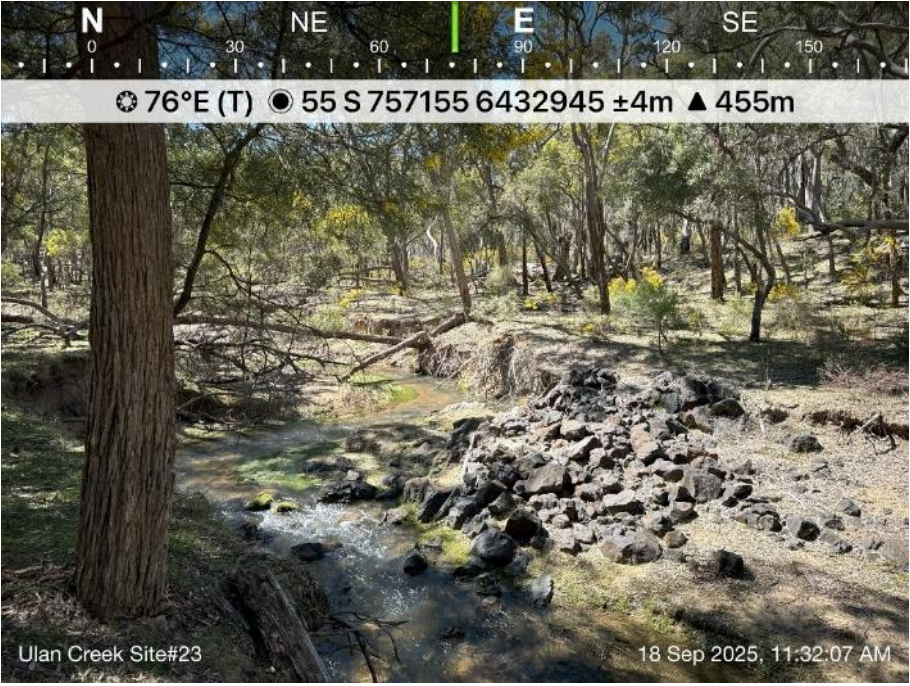
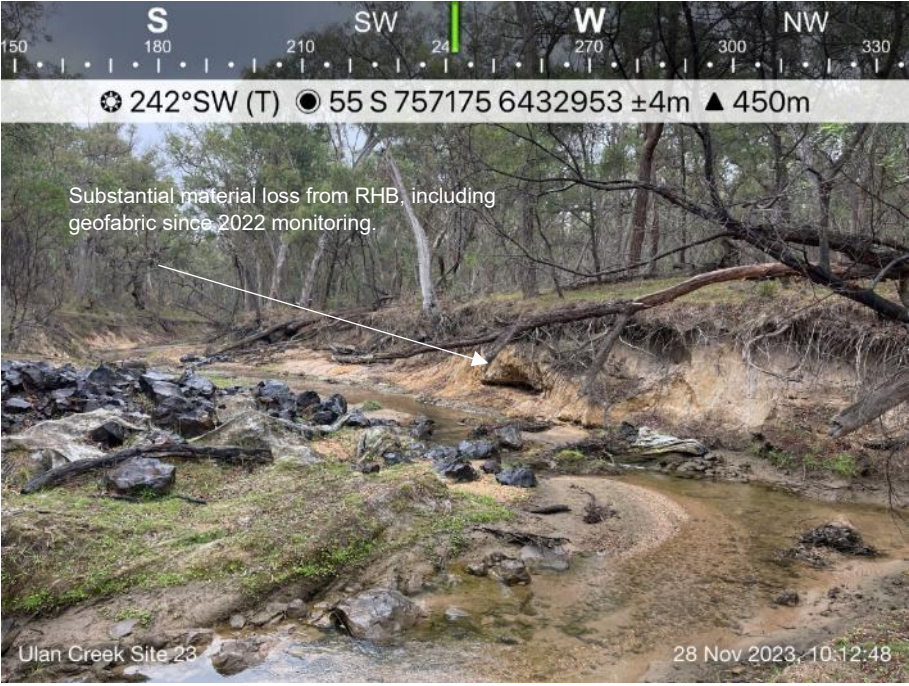
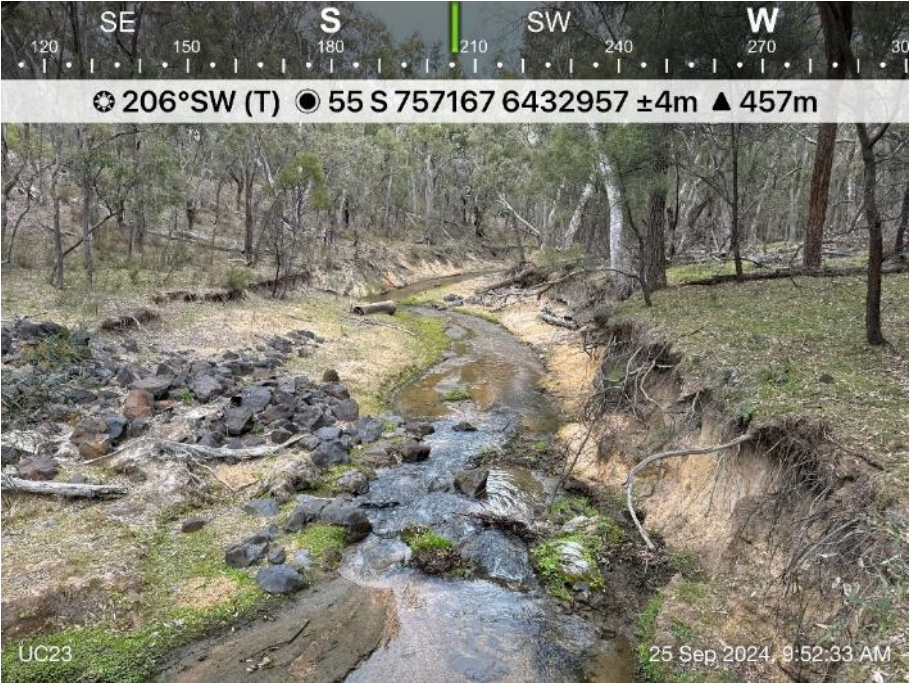
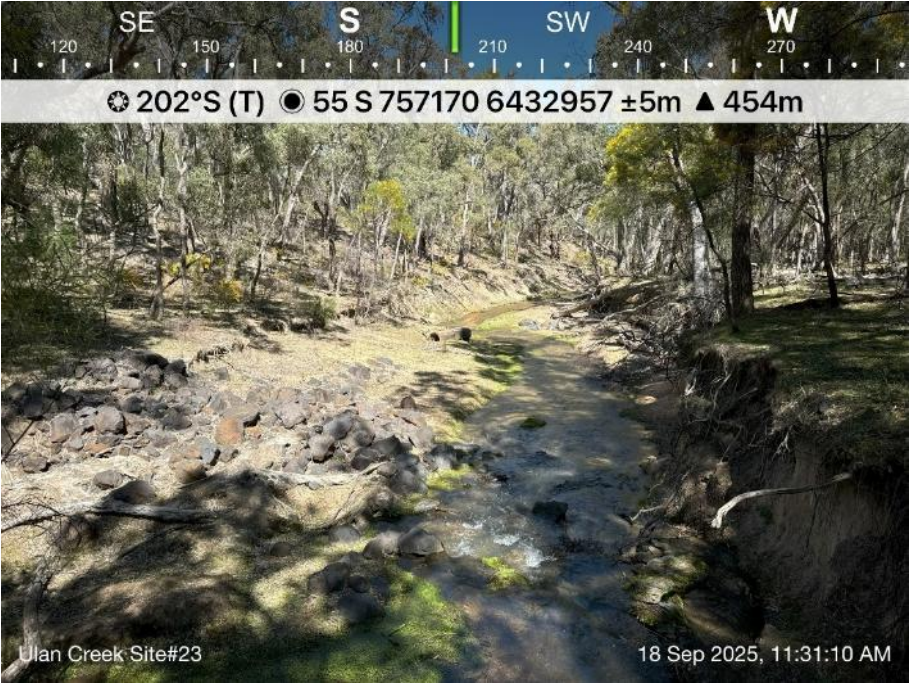
**General Observations:** Ulan Creek had water flowing at this location in 2025. The channel bed had little to no vegetation and is a mix of sand and small to medium size gravel. In 2022 additional build up of sand, silt and small gravel deposits were noted. The channel also has larger foreign rock and geofabric material to possibly stabilise the creek, however it appears to be having a more destabilising impact. Very active erosion along both banks was observed, particularly along the RHB causing a widening of the creek at this location. The RHB has a gentle slope above the bank. The bank wall is bare and exposed, near vertical walls and displays recent signs of erosion and undercutting. The LHB has a steeper slope above the bank and is partially stabilised by the foreign rock material. An old concrete pipe also sits downstream from this location and has been moved further downstream since 2019. Comparable groundcover above the LHB and RHB as previous year. Both sides of the creek are tree lined. Observations in 2025 noted a similar deteriorating trend when compared to previous monitoring\*. The CSIRO *Ephemeral Stream Assessment* classification at this location as 'very active'.

**Notes:** In 2025 observations were limited to the RHB and water flowing. Very active undercutting and bank instabilities noted in 2024 and 2025, two small tress has fallen on the creek along the LHB in 2024.

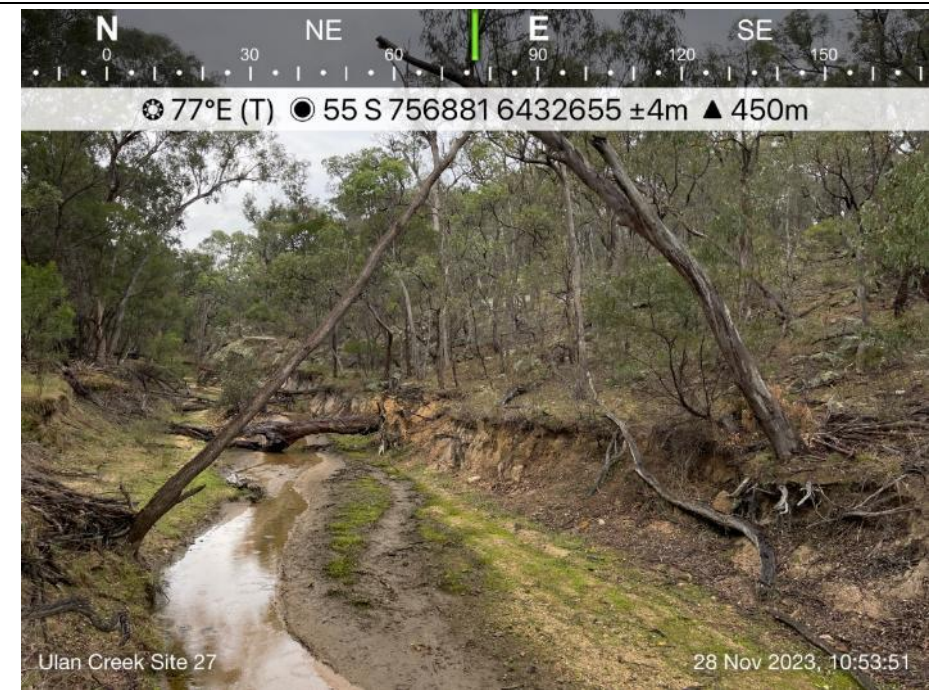
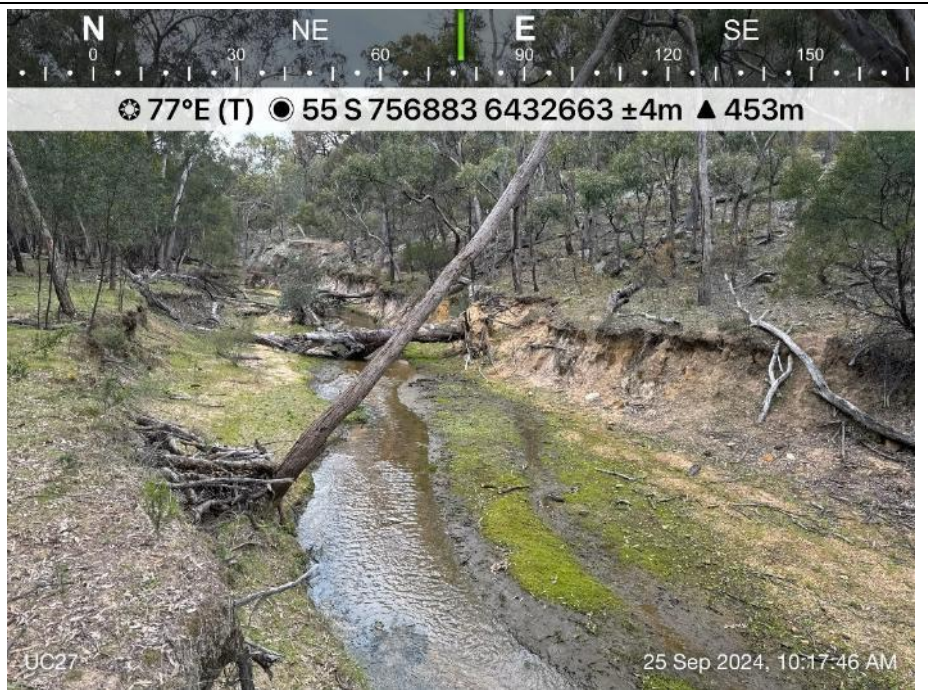
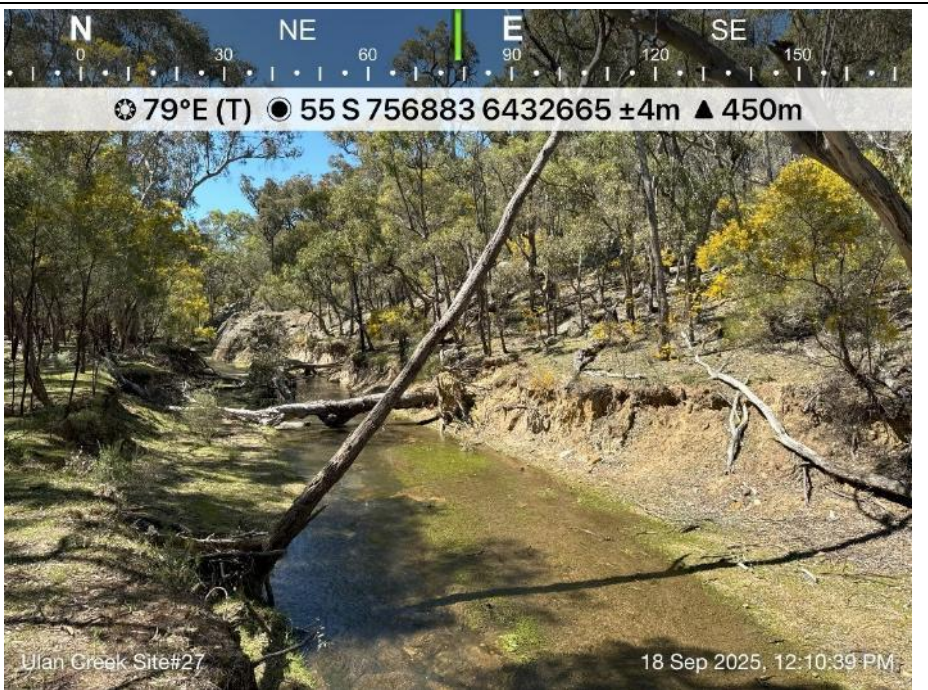
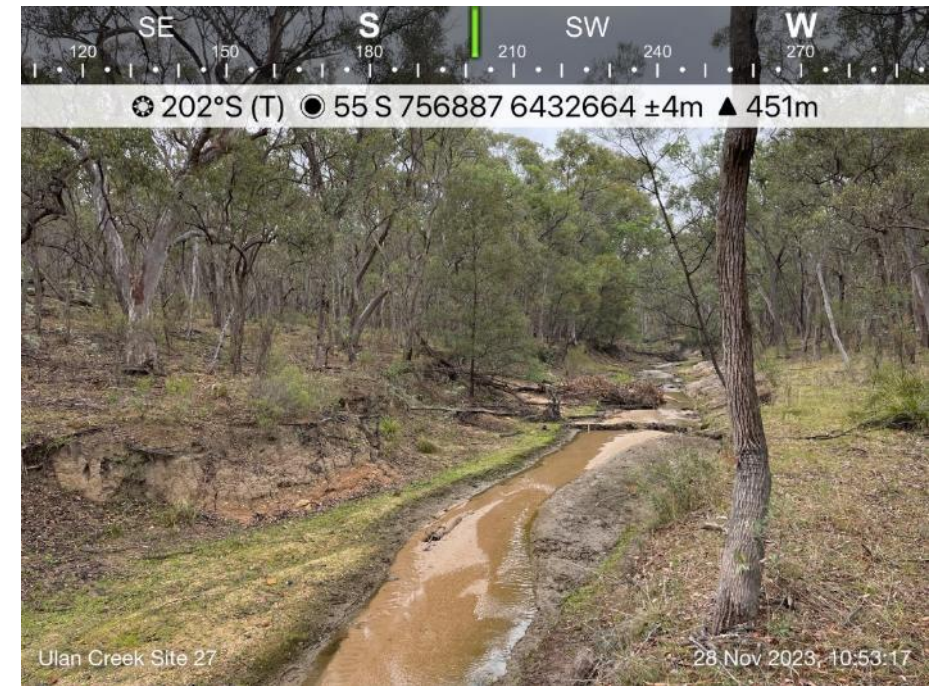
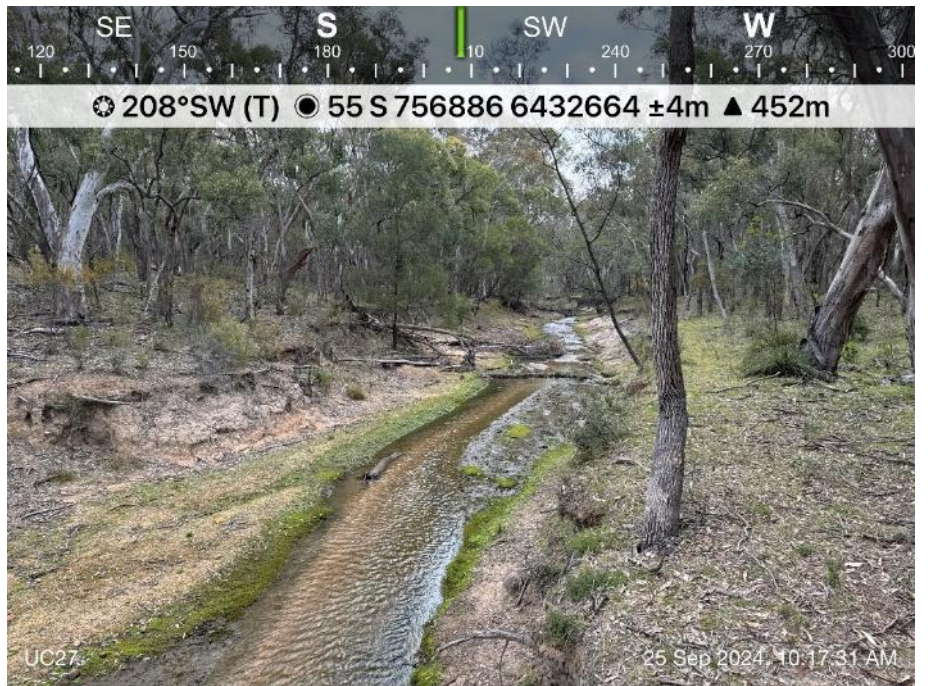
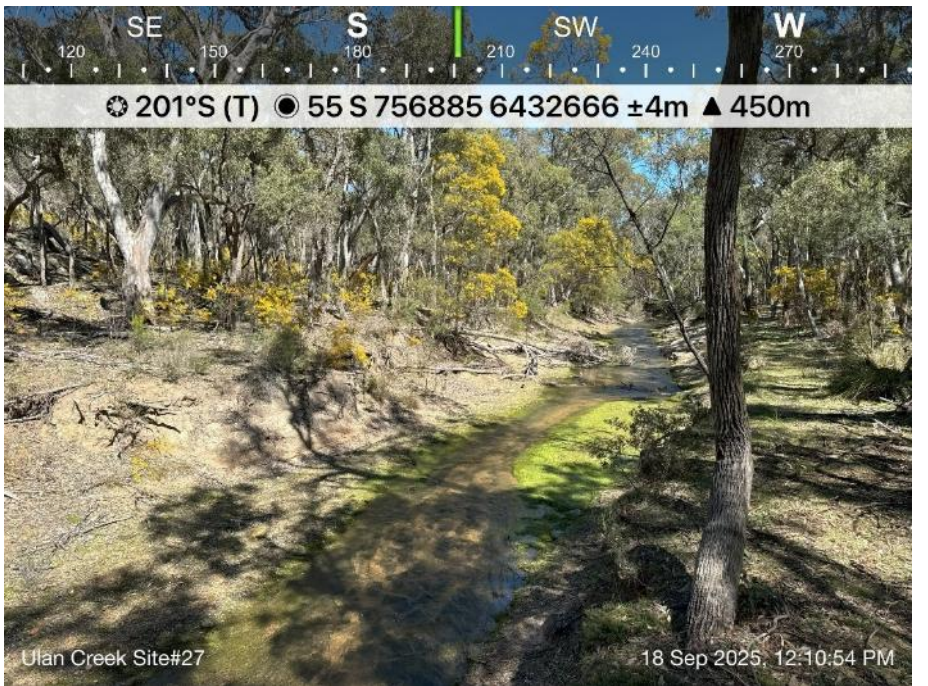
**General Observations:** Ulan Creek had water flowing at this location in 2025. The channel bed had little to no vegetation and is a mix of silt, sand and small gravel material. Active erosion was again noted along both banks in 2022, particularly on the RHB. In 2022 additional build up of sand, silt and small gravel deposits were noted. Sand deposits above the RHB were recorded in 2020. Both the LHB and RHB have a gentle slope above the bank. The RHB wall is near vertical, bare and exposed with signs of erosion. The LHB wall also has near vertical sections and is also bare and exposed. Tree roots are exposed on both bank walls. There is slight bank undercutting along the LHB. Comparable groundcover above the LHB and RHB as previous year. Both sides of the creek are tree lined. Observations in 2024 noted a similar deteriorating trend when compared to previous monitoring. The *CSIRO Ephemeral Stream Assessment* classification at this location as 'active'.

**Notes:** In 2025 observations were limited to the RHB and water flowing. Upstream a tree had fallen from the LHB across the creek since 2022 monitoring.

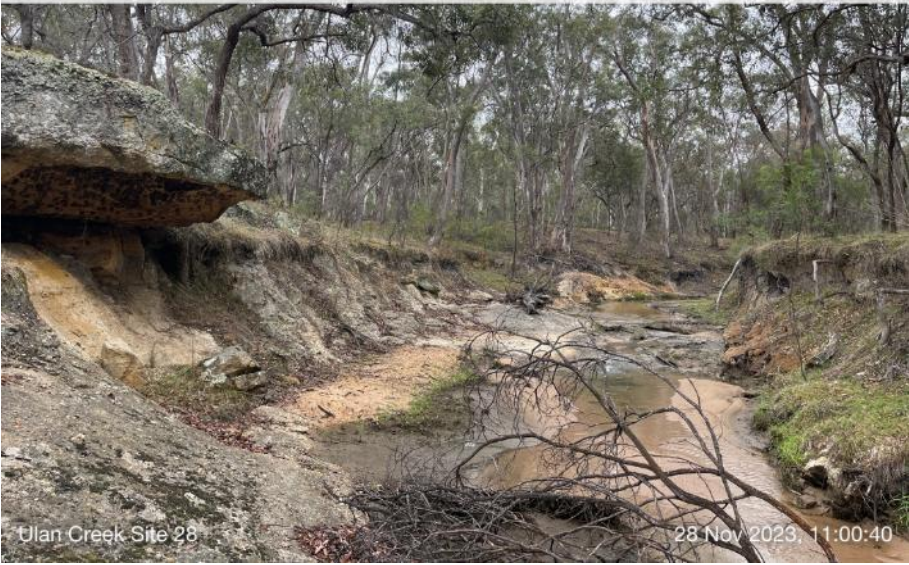
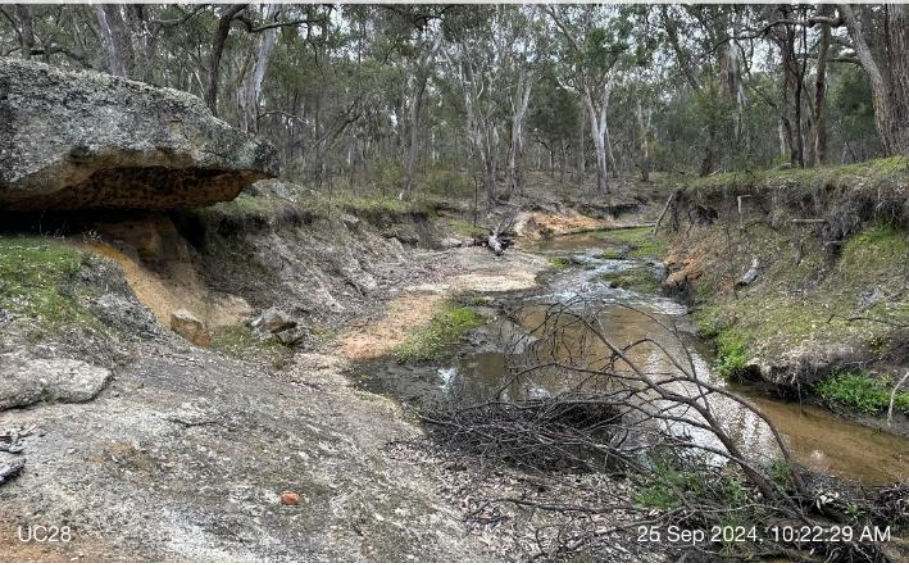
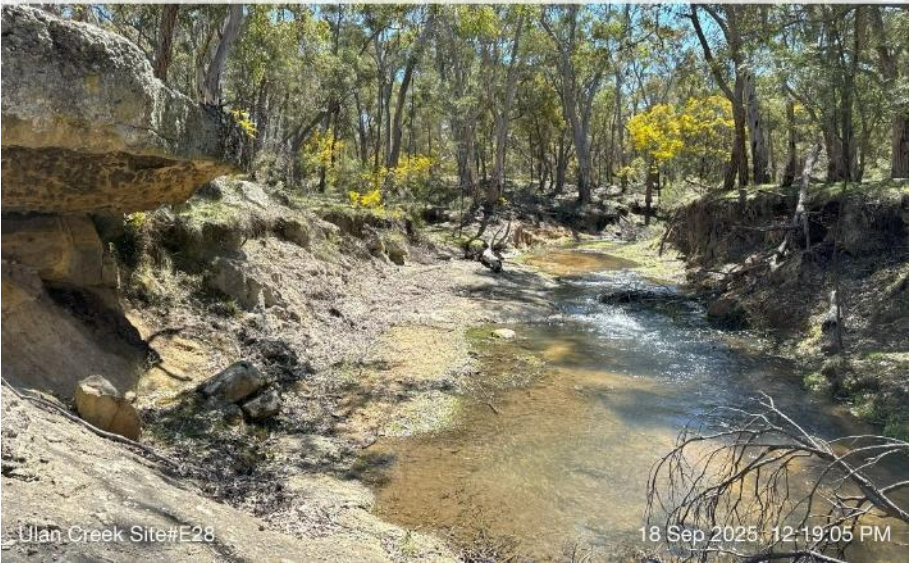
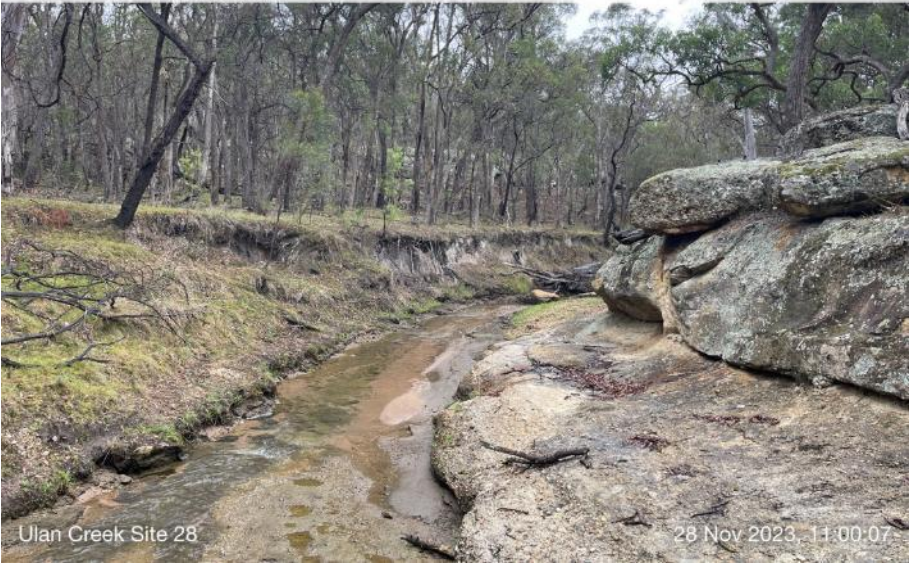
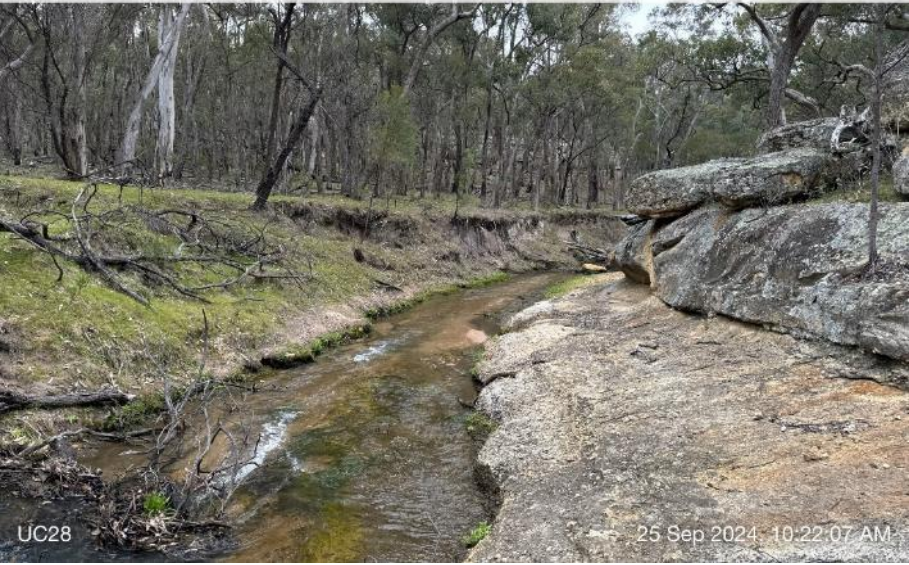
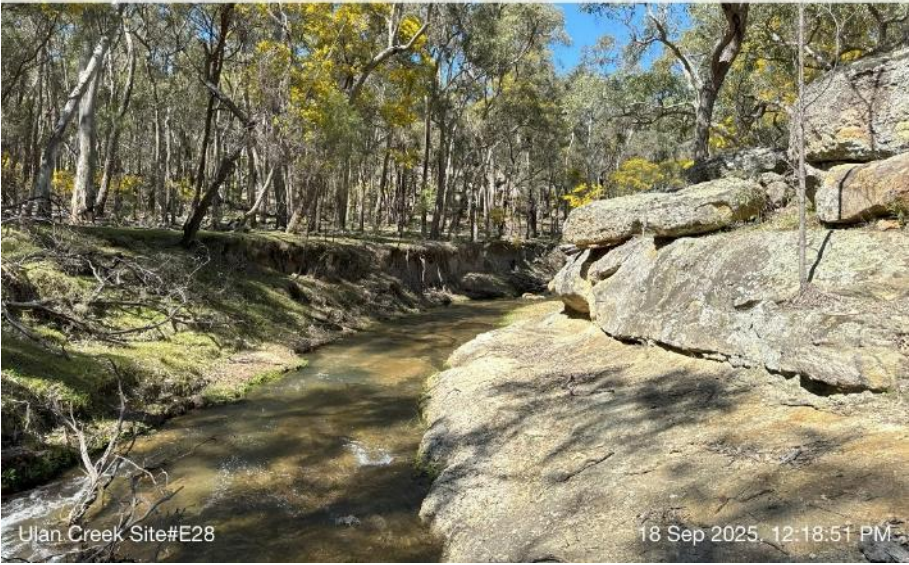
**Creek Name:** Ulan Creek  
**Date:** 18 September 2025  
**Monitoring Site:** UC28  
**Coordinates (MGA/Zone 55):** 756824 (E) 6432508 (N)  
**CISRO Ephemeral Stream Assessment:** Potentially Stabilising

**General Observations:** Ulan Creek had water flowing at this location in 2025. The flow channel bed had little to no vegetation and is a mix of silt, sand, small size gravel and rock material. Deposited sediment was noted in the channel bed in 2020. Both the LHB and RHB have a gentle slope above the bank. The RHB wall is formed from bedrock and is stable. The LHB has near vertical lower sections, partially vegetated with signs of erosion and bank undercutting. Comparable groundcover above the LHB and RHB as previous year. Both sides of the creek are tree lined. Observations in 2025 are comparable to previous monitoring. The CSIRO *Ephemeral Stream Assessment* classification at this location as 'potentially stabilising'.

**Notes:** In 2025 observations were limited to the RHB and water flowing.

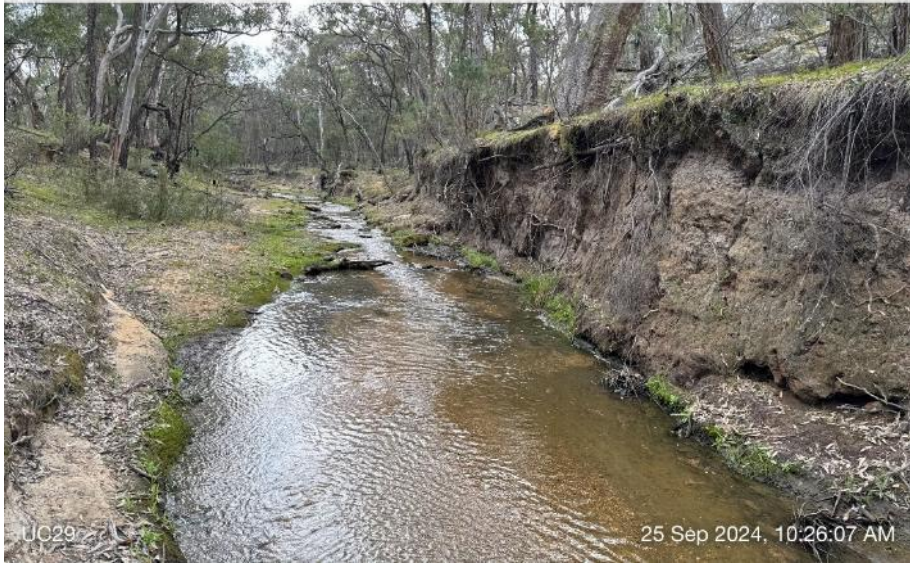
**Creek Name:** Ulan Creek  
**Date:** 18 September 2025  
**Monitoring Site:** UC29  
**Coordinates (MGA/Zone 55):** 756821 (E) 6432374 (N)  
**CISRO Ephemeral Stream Assessment:** Active

**General Observations:** Ulan Creek had water flowing at this location in 2025. The low flow channel bed had little to no vegetation and was a mix of sand and small to medium gravel size rock material. Deposited sediment was noted in the channel bed in 2020. Both the LHB and RHB have a steep rock/boulder slope above the bank. The RHB is near vertical formed from bedrock and is stable. The LHB wall has near vertical mid sections, sparsely vegetated with signs of active erosion in 2022. Comparable groundcover above the LHB and RHB as previous year. Both sides of the creek are tree lined. A piece of jute mesh that was most likely from Site UC25 was caught up on the RHB. Observations in 2024 are comparable to previous monitoring. The CSIRO *Ephemeral Stream Assessment* classification at this location as 'active'.

**Notes:** In 2025 observations were limited to the LHB and water flowing. Jute mesh material from RHB transported downstream since 2022 monitoring.

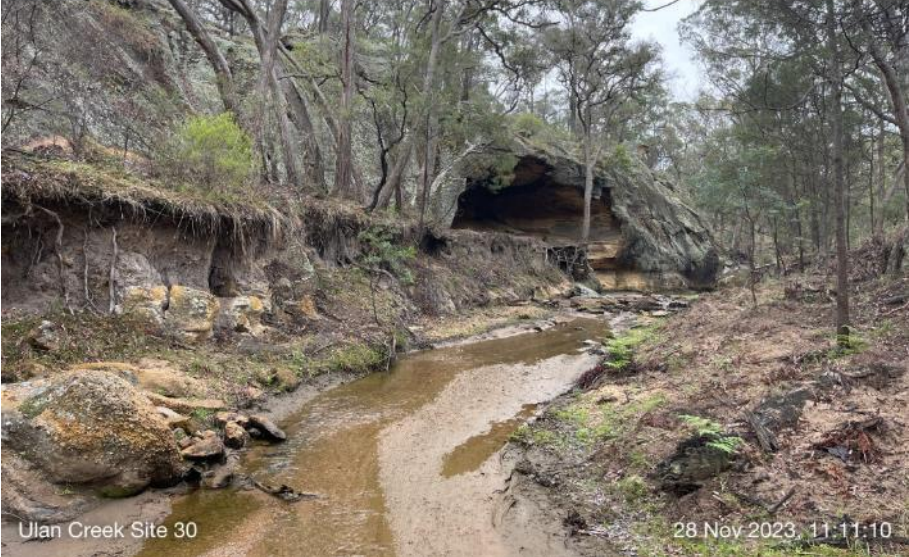
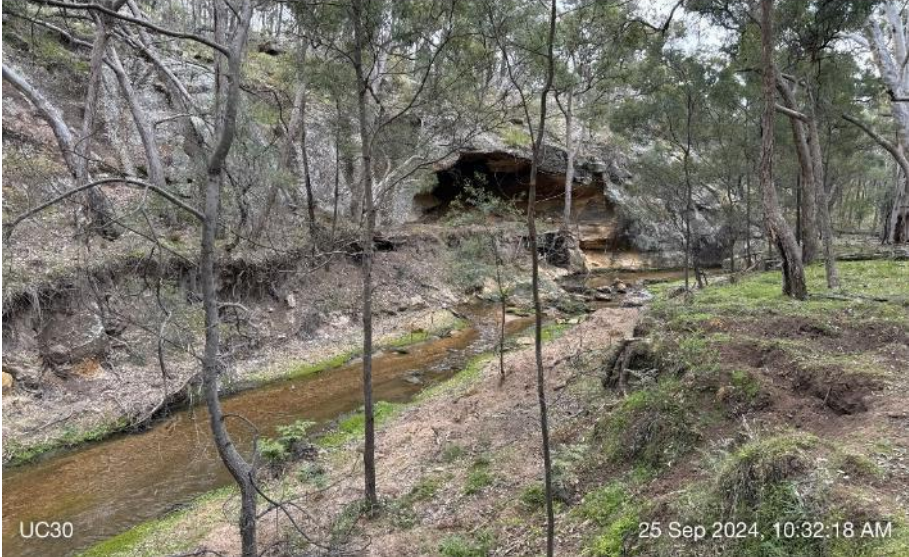
**General Observations:** Ulan Creek had water pooling at this location in 2024. The channel bed had little to no vegetation and is a mix of silt, sand and small gravel size rock material with several large boulders. In 2022 additional build up of sand, silt and small gravel deposits were noted. The RHB has a steep rock and boulder slope above the bank. The RHB wall is near vertical, bare and exposed, displays undercutting erosion with exposed tree roots. The LHB wall has near vertical sections from the top of the bank, a moderate to steep slope above the bank, increased vegetation in 2022 with signs of erosion. Both sides of the creek are tree lined. A large tree had fallen across the channel downstream since 2021. Observations in 2023 are comparable to previous monitoring. The CSIRO *Ephemeral Stream Assessment* classification at this location as 'active'.

**Notes:** In 2024 observations were limited to the LHB and water flowing. Decreasing vegetative ground cover noted in 2023. Silt deposits along the edges of the channel bed noted in 2023.

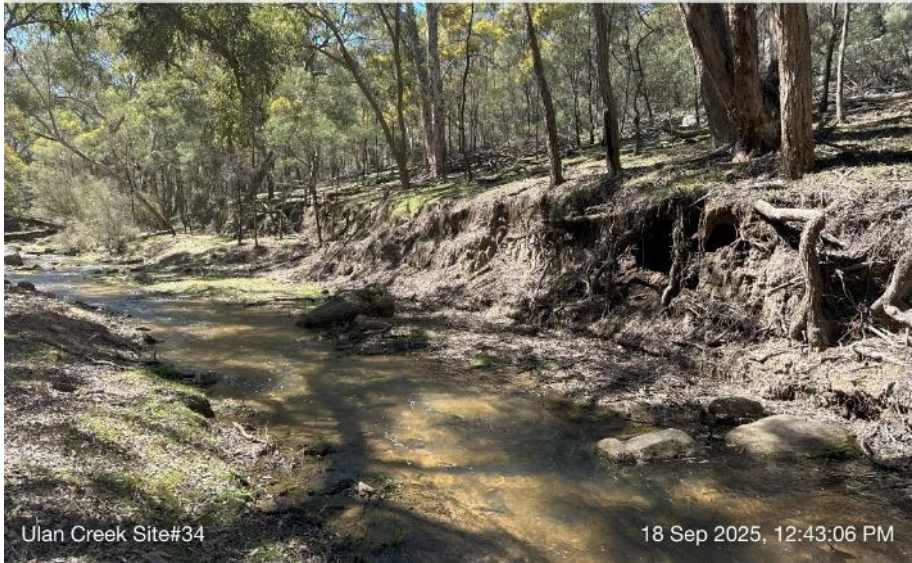
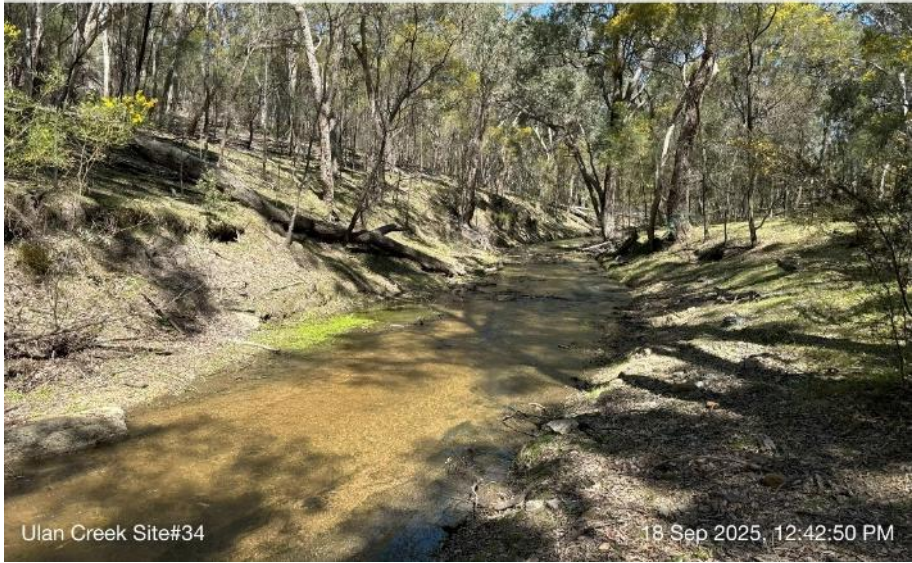
**General Observations:** Ulan Creek had water flowing at this location in 2025. Small to medium size rock material and deposited sediments noted in the channel bed. In 2022 additional build up of sand, silt and small gravel deposits were noted. The RHB is a moderate slope with increasing vegetation up slope, with little to no vegetation along the lower section. The LHB wall has near vertical sections from the top of the bank, mostly bare and exposed, with a moderate to steep slope above the bank. Signs of erosion was noted along both the LHB and RHB in 2022. Comparable groundcover above the LHB and RHB as previous year. Both sides of the creek are tree lined. Observations in 2025 are comparable to previous monitoring. The CSIRO *Ephemeral Stream Assessment* classification at this location as 'active'.

**Notes:** In 2025 observations were limited by water flowing.

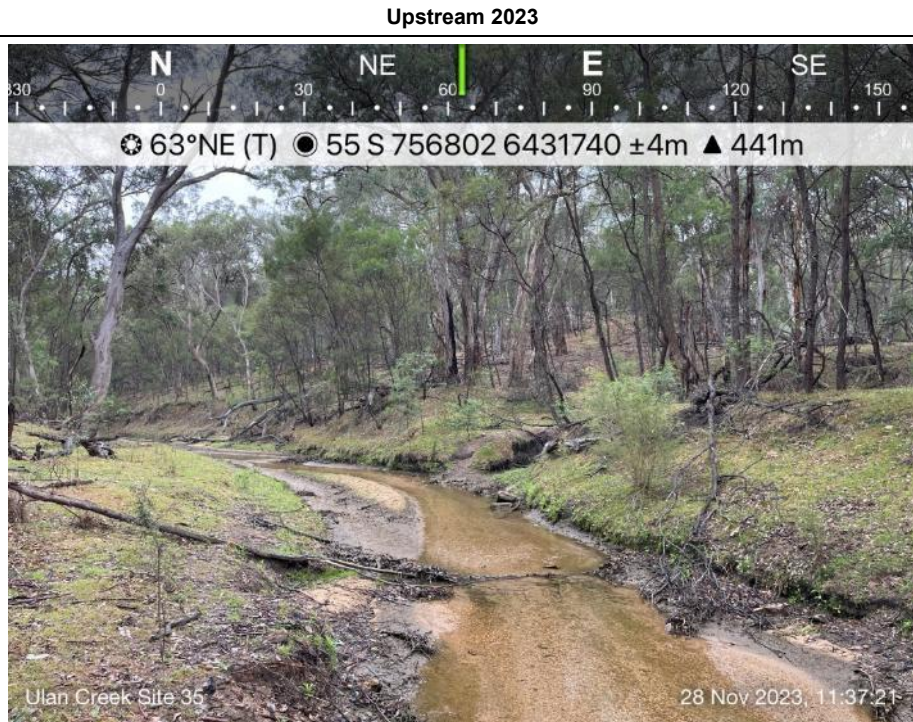
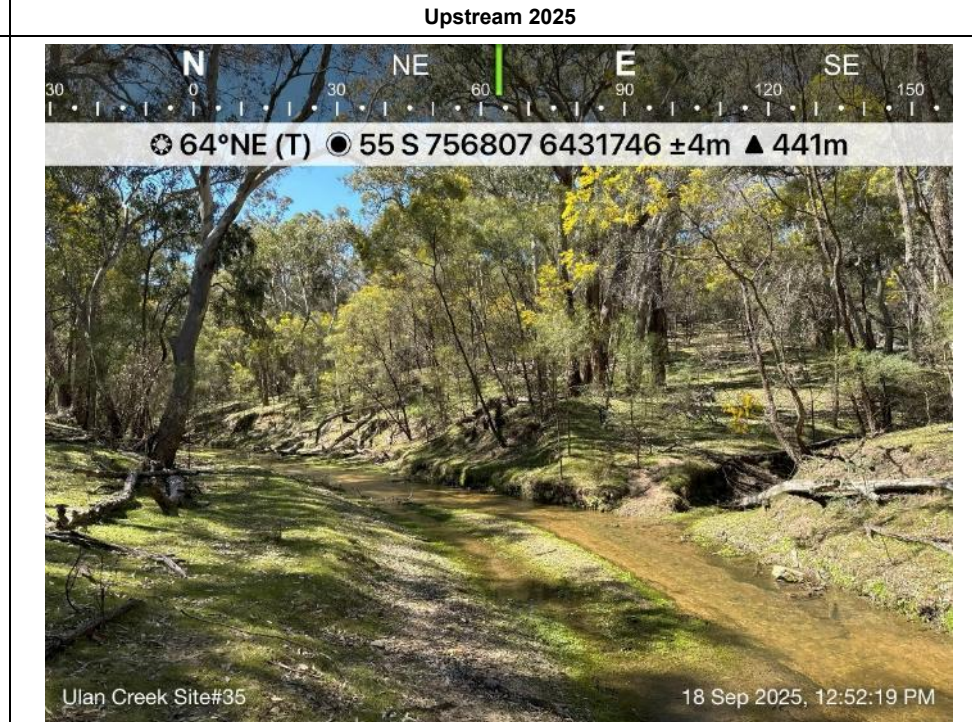
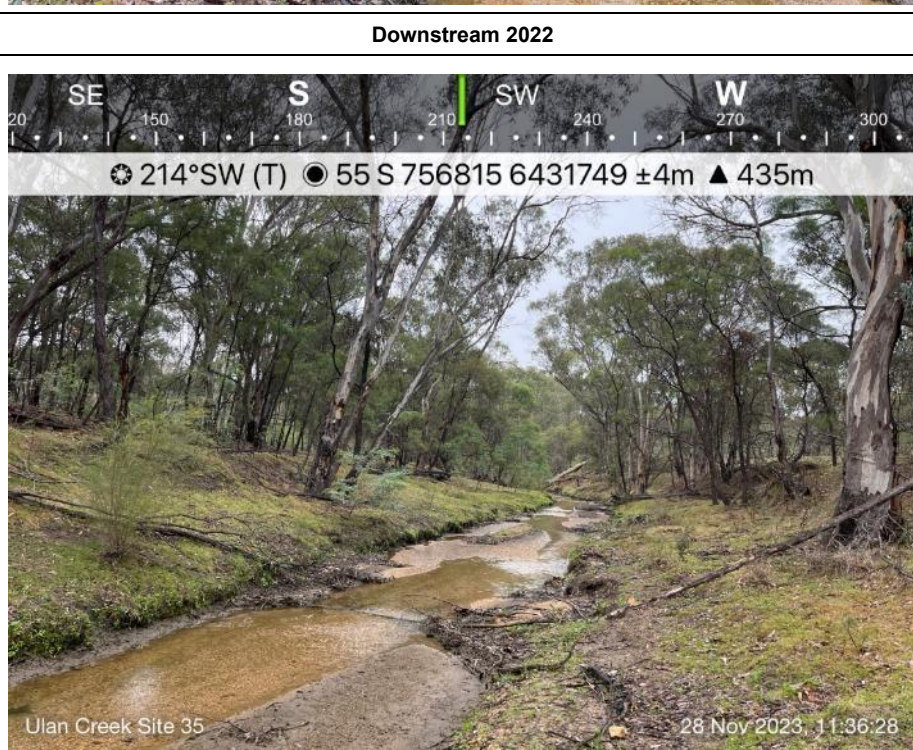
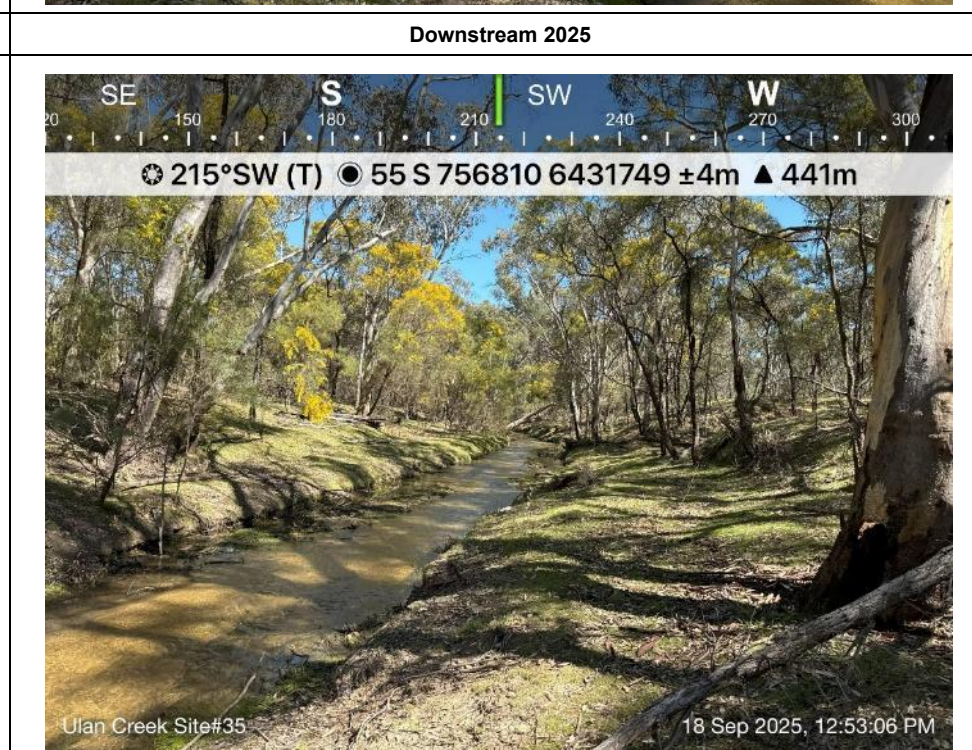
**General Observations:** Ulan Creek had water flowing at this location in 2022. The low flow channel bed had little to no vegetation and is a mix of silt, sand and small to medium size gravel. In 2022 additional build up of sand, silt and small gravel deposits were noted. Minor bank instabilities were noted in 2022 along the LHB. A flow line enters Ulan Creek at this point. The LHB has a moderate slope and is well vegetated. The RHB is similar to the LHB. An increase of groundcover above the LHB and RHB when compared to 2023. Both sides of the creek are tree lined. Observations in 2025 are comparable to previous monitoring. The CSIRO *Ephemeral Stream Assessment* classification at this location as 'potentially stabilising'.

**Notes:** In 2025 observations were limited to the RHB by water flowing.
