Annual Review 2020

Number: ULNCX-1862890609-23

Name of operation	Ulan Coal Mine
Name of operator	Ulan Coal Mines Propriety Limited
Development consent / project approval #	PA 08_0184
Name of holder of development consent / project approval	Ulan Coal Mines Propriety Limited
Mining lease #	CCL 741, MPL 315, ML 1341, ML1365, ML 1366, ML 1467, ML 1468, ML 1511, ML 1554, ML 1656, ML1754, ML1796, EL 5573, EL 7542, & EL 8687
Name of holder of mining lease	Ulan Coal Mines Propriety Limited
Water licence #	WAL41492, WAL19047, WAL37192, WAL37192, WAL41906, WAL42900 & WAL34921 (only allocation Licences listed).
Name of holder of water licence	Ulan Coal Mines Propriety Limited
MOP/RMP start date	01/12/2017
MOP/RMP end date	01/12/2024
Annual Review start date	01/01/2020
Annual Review end date	31/12/2020
<p>I, Robyn Stoney, certify that this audit report is a true and accurate record of the compliance status of Ulan Coal Mines Limited for the period 2020 and that I am authorised to make this statement on behalf of Ulan Coal Mines Pty Limited.</p> <p>Note.</p> <p>a) The Annual Review is an 'environmental audit' for the purposes of section 122B (2) of the Environmental Planning and Assessment Ac

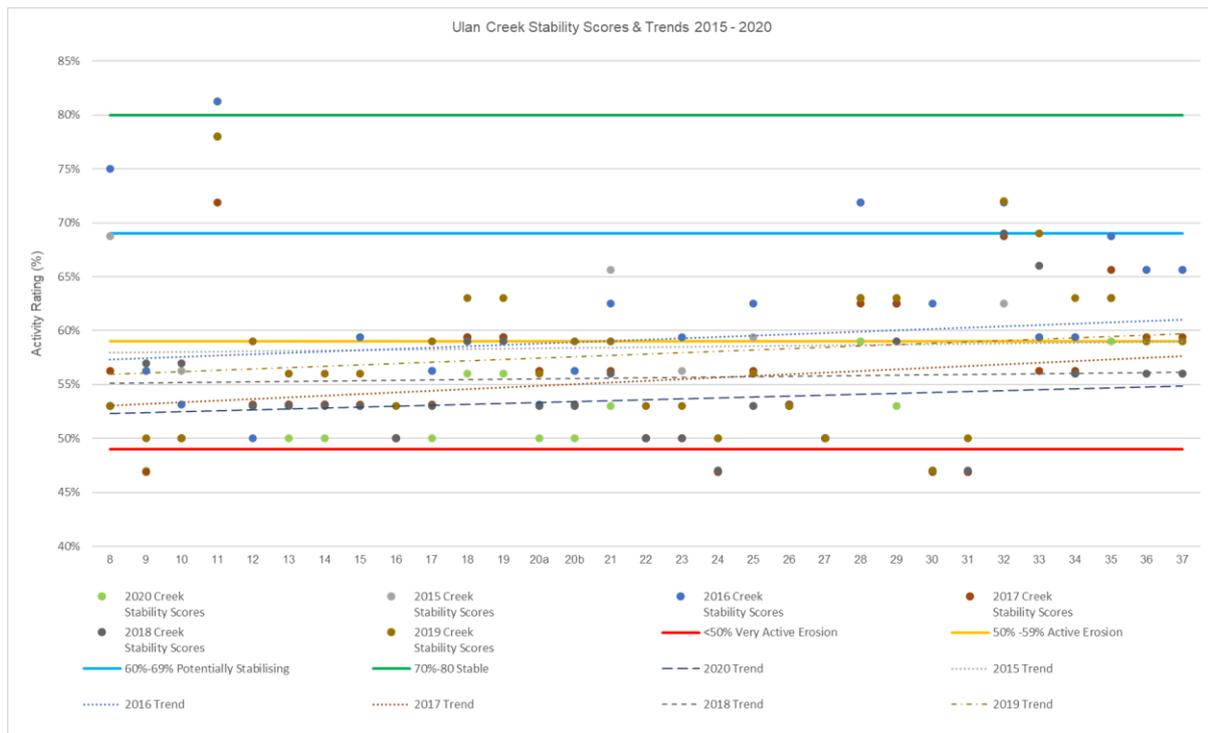
Figure 7-13 Ulan Creek Stability Monitoring Assessment Scores

was observed, one or more high flow events in 2020 has caused significant instabilities and further exacerbated the existing erosion along the creek inspected.

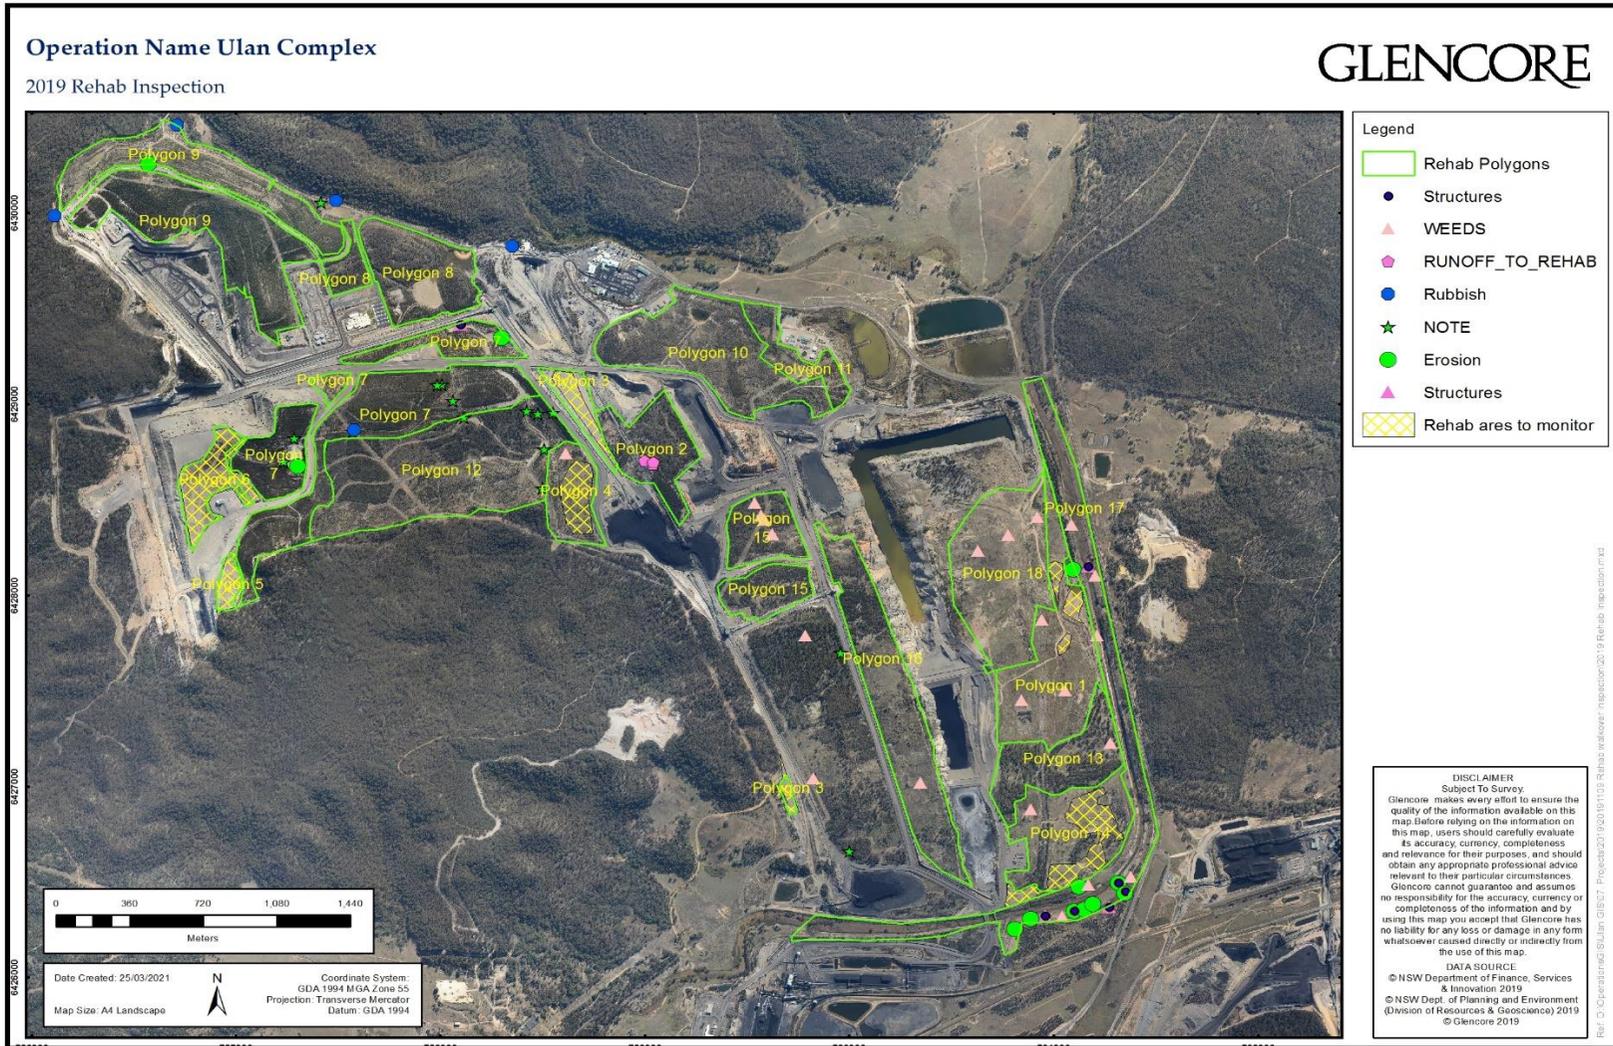
Figure 8-3 2020 Rehabilitation Inspection - Issues Identified

15	Monitor	4-5	Poor species diversity predominately acacia species with little tree establishment - low presence of eucalypts in large areas	Monitor and planting of eucalypts trees may be required	Walk over inspection weed spraying
16	Monitor	4-5	Poor diversity (This area is proposed for capping and potential tailings facility Weed spraying	Continue with weed spraying No other work proposed	Weed control Area will be used for tailings capping
17	Monitor	4	Weeds small areas of erosion	Continue monitoring for bank and revetment stability and repair erosion issues weed spraying	GRD stable weed spraying Walk over inspection Lidar survey of revetment completed after flood event
18	Rework	3	Failed rehab area from 1990-2000 (Final Land form in this area is subject to change)	Area to be replanted within the current MOP period once final landform is confirmed.
