impact of development on trees - moore theological college, newtown

prepared by
Melanie Howden - Ass. Dip. Hort. (HaC), SoA Arb. (TAFE) , MAIH. MNAAA, MIACA

9th October 2009

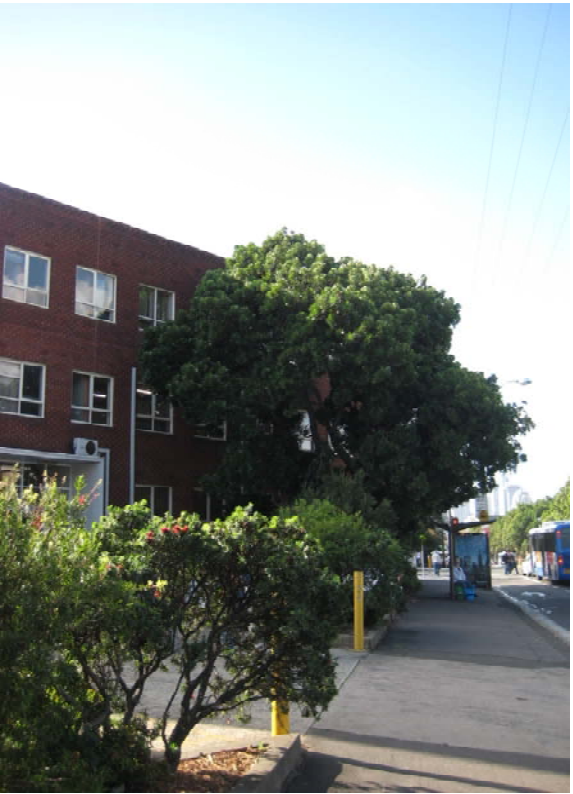
figure 8.2 - tree no. 1, Kaffir Plum on the site fronting King Street

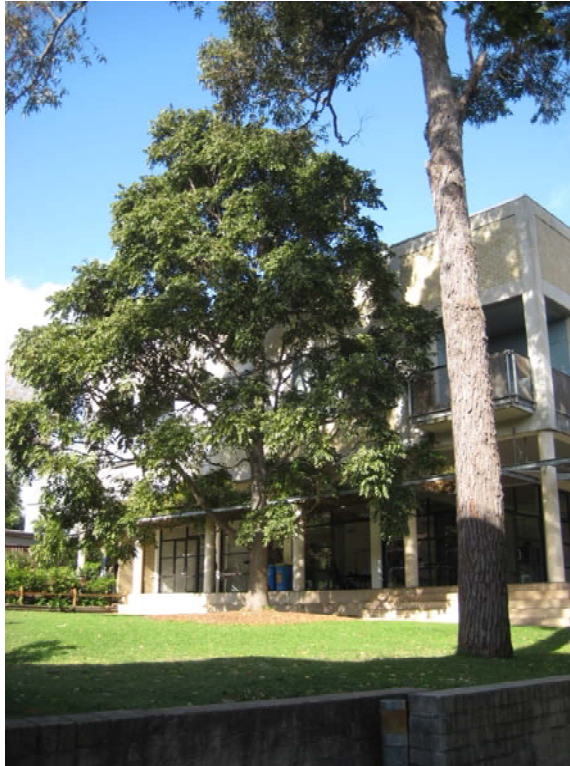
figure 8.3 - tree no. 53 (front) with tree no. 54 (rear) viewed from Campbell Street
