**Orange City Council**

**EUCHAREENA ROAD RESOURCE  
RECOVERY CENTRE**

Road User Safety & Operational Assessment

November 2009

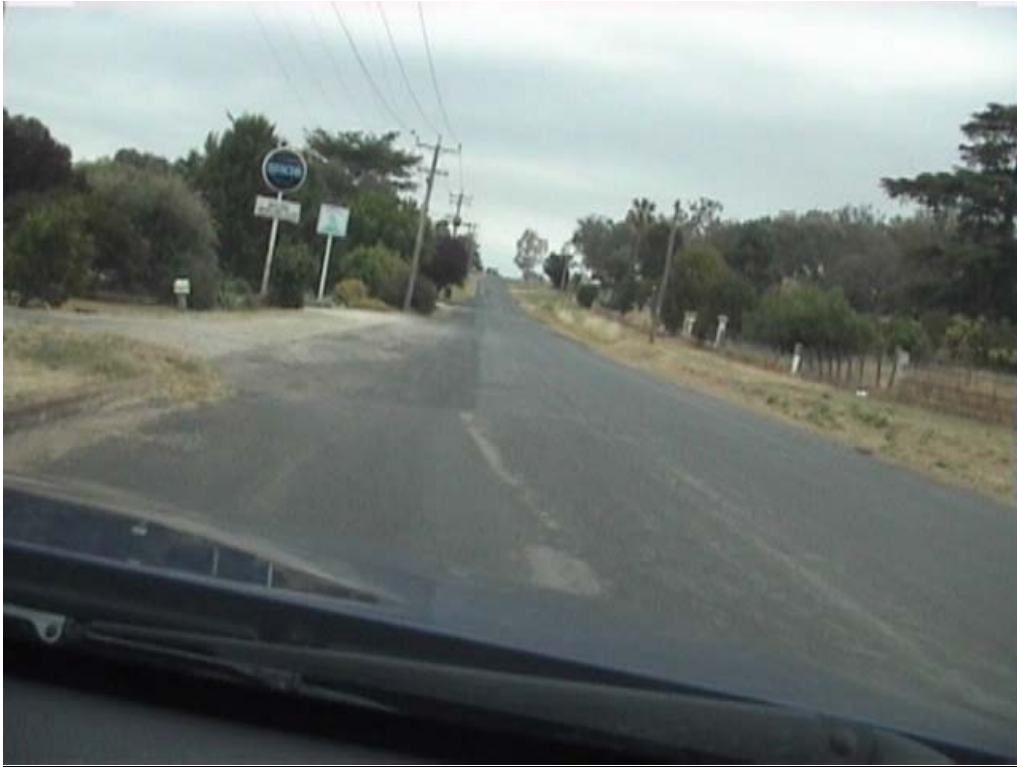
| Item No. | Location | Description of deficiency | Risk Rating | Priority (High, medium, low) | Photo Reference (Appendix. 1) |
|---|---|---|---|---|---|
| 1 | General | Generally there is a lack of delineation within the whole of the assessed road network. In most areas pavement markings especially centreline markings are worn and barely visible at night, there is a lack of roadside guidepost delineation and most signs are weathered and require replacement. | Intolerable | HIGH | 1,2,3,4 |

**1 – Deficiency Log Item 1** Generally there is a lack of delineation within the whole of the assessed road network. In most areas pavement markings especially centreline markings are worn and barely visible at night, there is a lack of roadside guidepost delineation and most signs are weathered and require replacement.

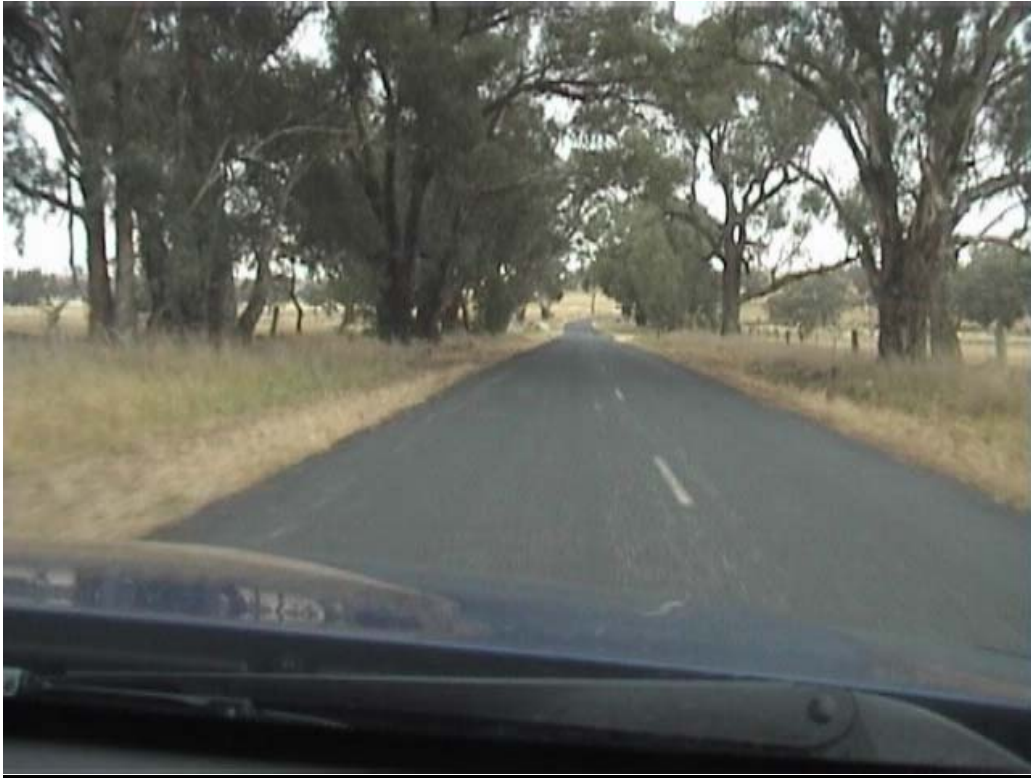
| Item No. | Location | Description of deficiency | Risk Rating | Priority (High, medium, low) | Photo Reference (Appendix. 1) |
|---|---|---|---|---|---|
| 2 | General | Within the 100 km/hr regulatory speed zone there are a number of substantial trees that encroach into "clear zone" of the road (6m – refer RTA Road Design Guide –Section 6) and possibly Heavy Vehicle (HV) vertical envelope. In addition a number of saplings (that grow to be a potential hazard) are also located within this zone. | Intolerable | HIGH | 5,6 |

**5 - Deficiency Log Item 2** Within the 100 km/hr regulatory speed zone there are a number substantial trees that encroach into "clear zone" of the road (6m – refer RTA Road Design Guide – Section 6) and possibly Heavy Vehicle (HV) vertical envelope. In addition a number of saplings (that grow to be a potential hazard) are also located within this zone.

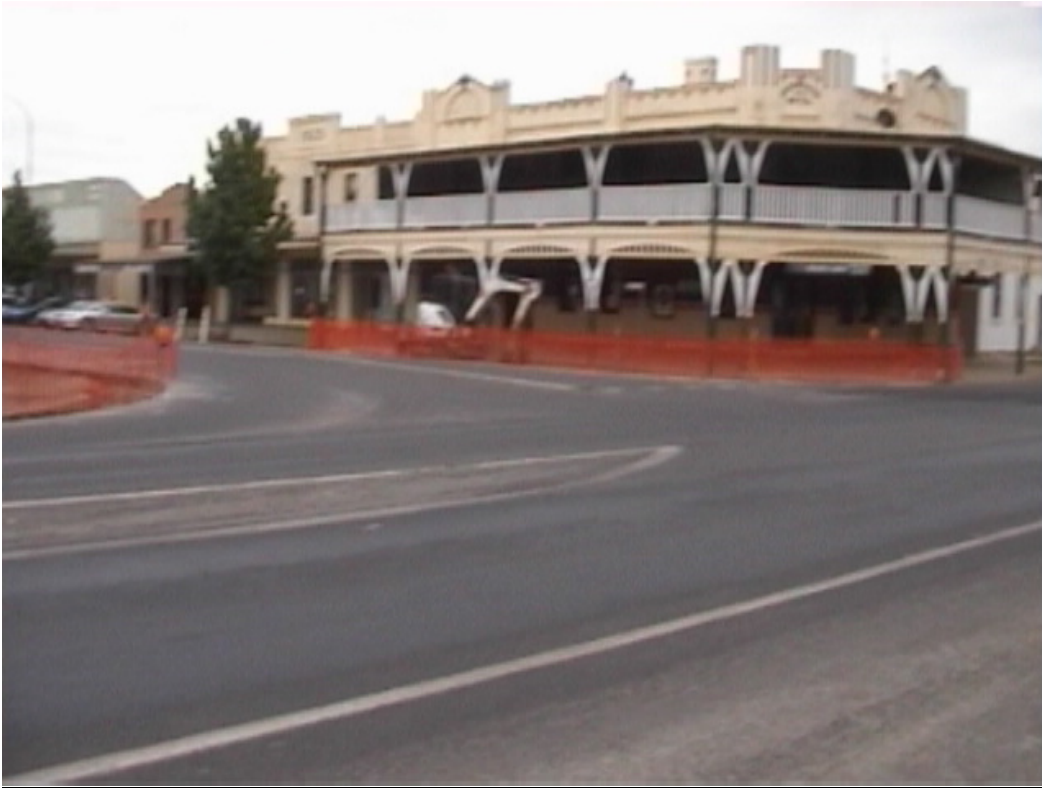
| Item No. | Location | Description of deficiency | Risk Rating | Priority (High, medium, low) | Photo Reference (Appendix. 1) |
|---|---|---|---|---|---|
| 4 | At the junction of Bank Street & Watson Street (Mitchell Highway) & | Bank Street is controlled by "Give Way" traffic management. There is no regulatory signposting supporting "Give Way" operation. It is noted that currently the kerb alignment in Bank Street at Watson Street is under construction providing kerb blisters in Bank Street. This new configuration will need to be included in any future designs. | Medium | MEDIUM | 7,8 |

**7 - Deficiency Log Item 4** Bank Street is controlled by "Give Way" traffic management. There is no regulatory signposting supporting "Give Way" operation. It is noted that currently the kerb alignment in Bank Street at Watson Street is under construction providing kerb blisters in Bank Street. This new configuration will need to be included in any future designs.

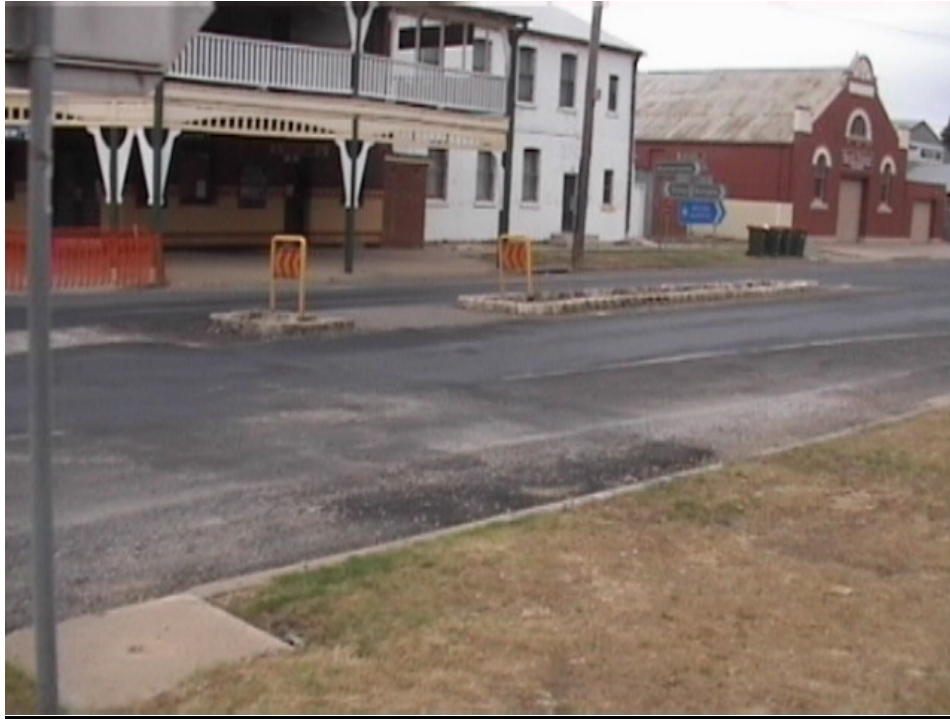
| Item No. | Location | Description of deficiency | Risk Rating | Priority (High, medium, low) | Photo Reference (Appendix. 1) |
|---|---|---|---|---|---|
| 6 contd. | | access. It was observed wheelchair access is north of Euchareena Rd to cross Watson Street to driveways on the western kerb. It appears the temporary construction has been impacted and knocked out of alignment.<br>Given the impact of turning vehicles and heavy vehicle (HV) content within the traffic stream the location of this pedestrian refuge is considered inappropriate. | | | |

**9 – Deficiency Log Item 6** Temporary construction (clip lock) of a pedestrian refuge within Watson Street is located within a high vehicle conflict area. Driver appreciation of pedestrian activity is competing with vehicles entering and leaving both Bank St. and Euchareena Road. There is no provision in the western kerb for disabled access. It was observed wheelchair access is north of Euchareena Rd to cross Watson Street to driveways on the western kerb. It appears the temporary construction has been impacted and knocked out of alignment. Given the impact of turning vehicles and heavy vehicle (HV) content within the traffic stream the location of this pedestrian refuge is considered inappropriate.

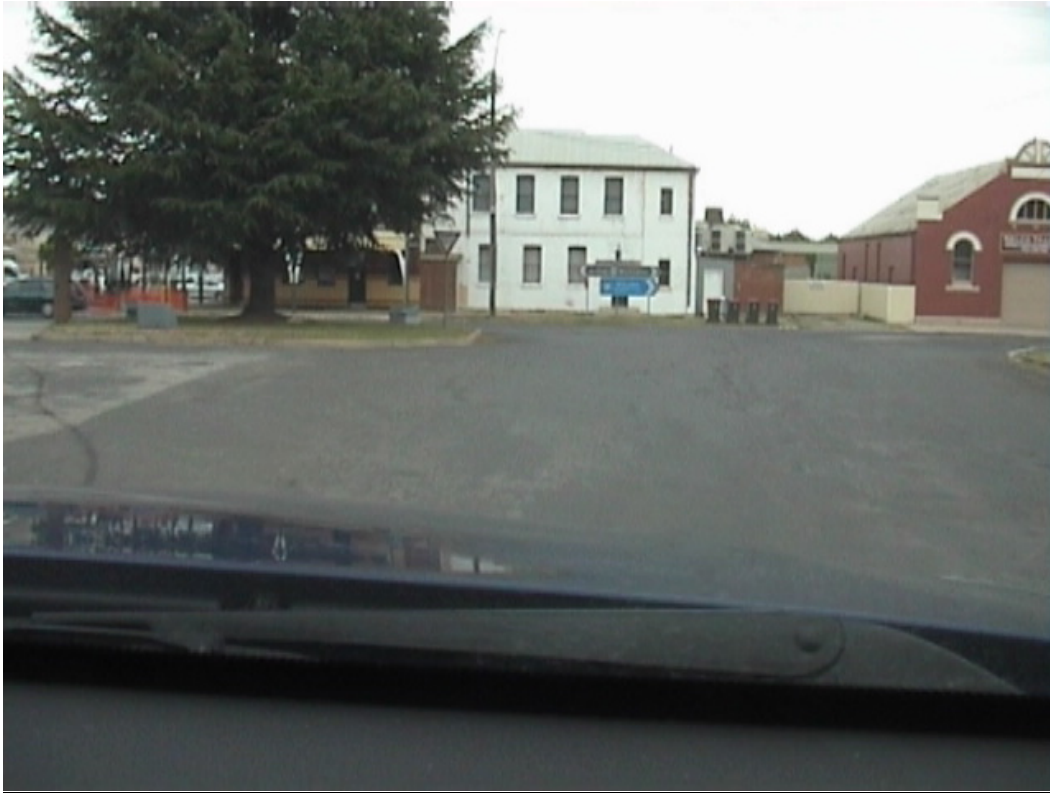
| Item No. | Location | Description of deficiency | Risk Rating | Priority (High, medium, low) | Photo Reference (Appendix. 1) |
|---|---|---|---|---|---|
| 8 | In Euchareenna Road | Located approx. 30m to the east of Watson Road (Mitchell Highway) is a vehicle access to the car park servicing the Railway Station Library and Bus Stop. At this point there is an expansive area of uncontrolled pavement and it was observed eastbound vehicles (including Buses) travelled in the opposing traffic flow lane to access the site. The road configuration of this access is considered hazardous. | High | MEDIUM | 11,12 |

**11 – Deficiency Log Item 8** Located approx. 30m to the east of Watson Road (Mitchell Highway) is a vehicle access to the car park servicing the Railway Station Library and Bus Stop. At this point there is an expansive area of uncontrolled pavement and it was observed eastbound vehicles (including Buses) travelled in the opposing traffic flow lane to access the site. The road configuration of this access is considered hazardous.

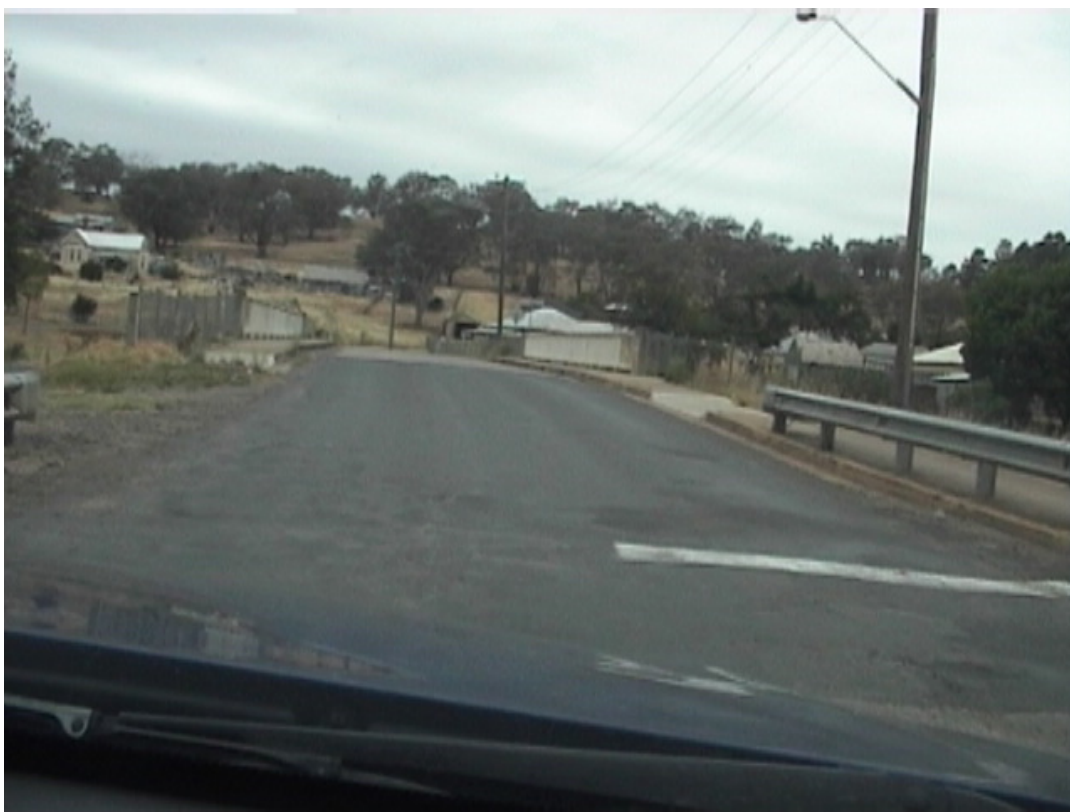
- 9 There are no double unbroken lines (BB markings) in the lead up to the railway level crossing. As the boom gates control only half of the carriageway, this is in contravention of *AS 1742.11 Railway Level Crossings*;

**13 – Deficiency Log Item 9** In advance of the Railway Level Crossing centreline BB markings are non-existent. As the boom gates control only half of the road carriageway it is considered essential BB centreline markings be installed in accordance with AS 1742.11 Railway Level Crossings.

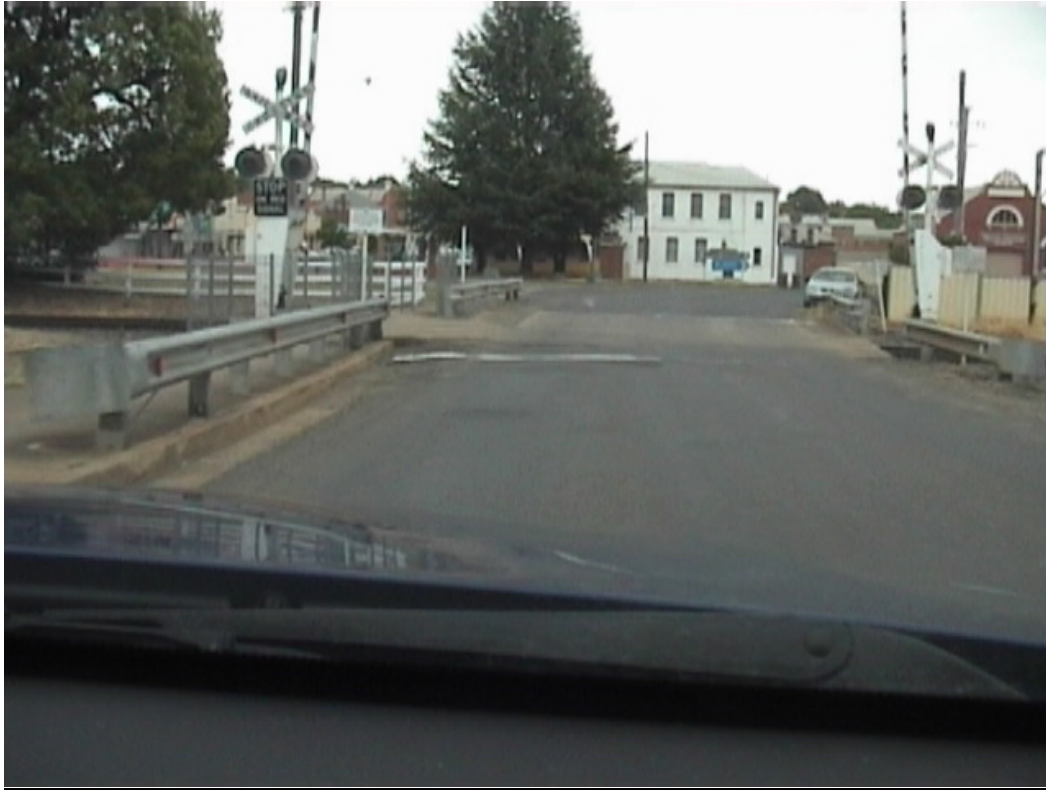
| Item No. | Location | Description of deficiency | Risk Rating | Priority (High, medium, low) | Photo Reference (Appendix. 1) |
|---|---|---|---|---|---|
| 10 | In Euchareenna Road | At the Railway Level Crossing the guardrail accommodates redundant Breakaway Cable Terminal (BCT) end treatments. In addition the timber posts supporting the guardrail terminals are rotted and require replacement. The guardrail in the south eastern corner is damaged and requires replacement. | Low | LOW | 15,16 |

**15 – Deficiency Log Item 10** At the Railway Level Crossing the guardrail accommodates redundant Breakaway Cable Terminal (BCT) end treatments. In addition the timber posts supporting the guardrail terminals are rotted and require replacement. The guardrail in the south eastern corner is damaged and requires replacement.

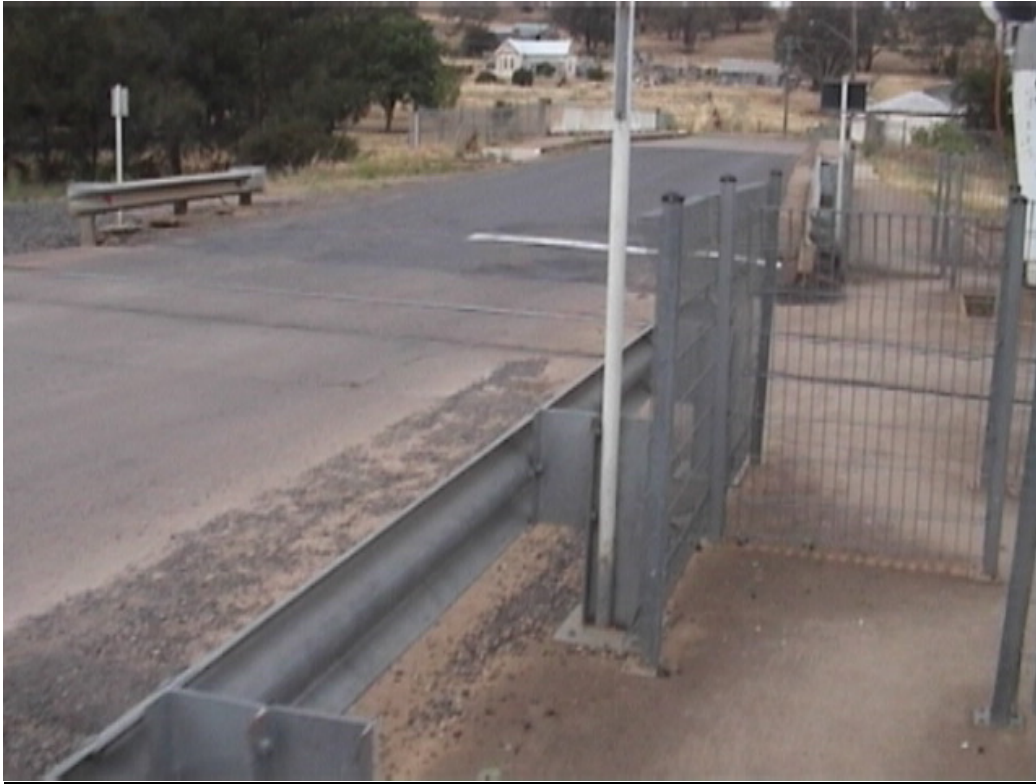
- 11 There is no wheelchair access at the railway level crossing nor are there any pedestrian controls other than warning bells;
- 13 The 'give way' sign in the south bound direction on Euchareena Road has been damaged and is not facing oncoming traffic;

**17 – Deficiency Log Item 11** At the Railway Level Crossing there is no provision for disabled wheelchair access. In addition there are no pedestrian controls other than audio (bells) to warn pedestrians of an approaching train.

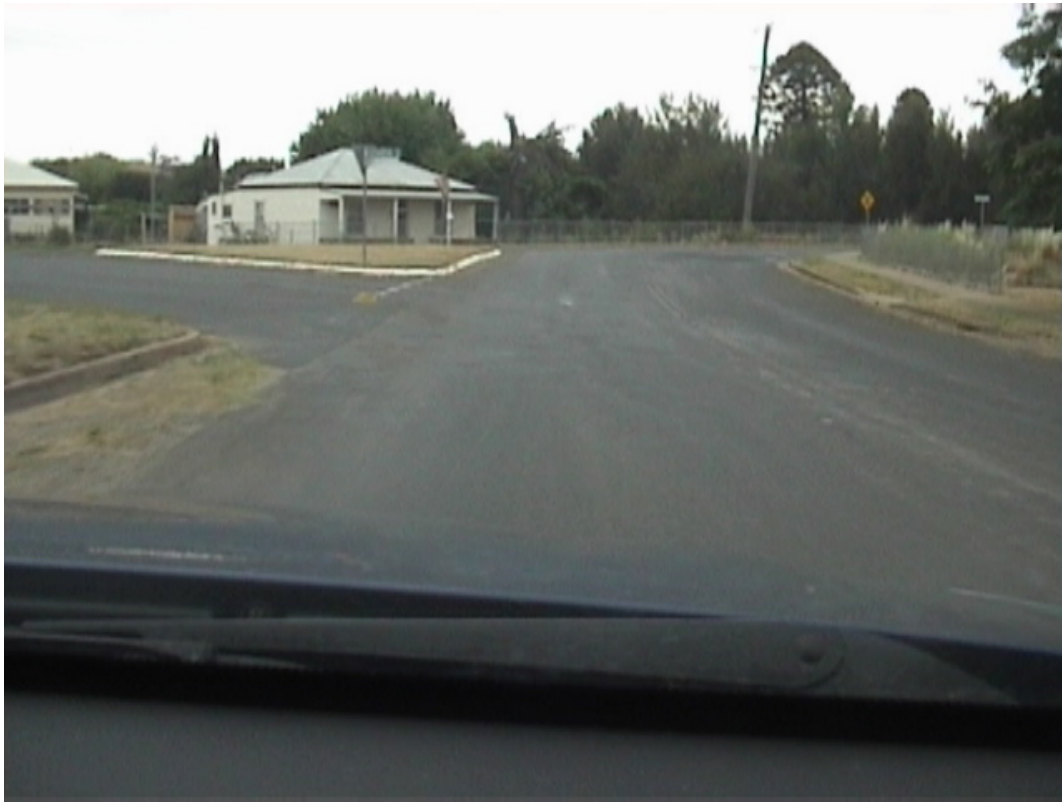
**19 – Deficiency Log Item 12** Linemarking at this junction is extremely poor. Given the unusual configuration of the junction, centreline markings are considered imperative for driver appreciation/expectation and operational safety of the junction

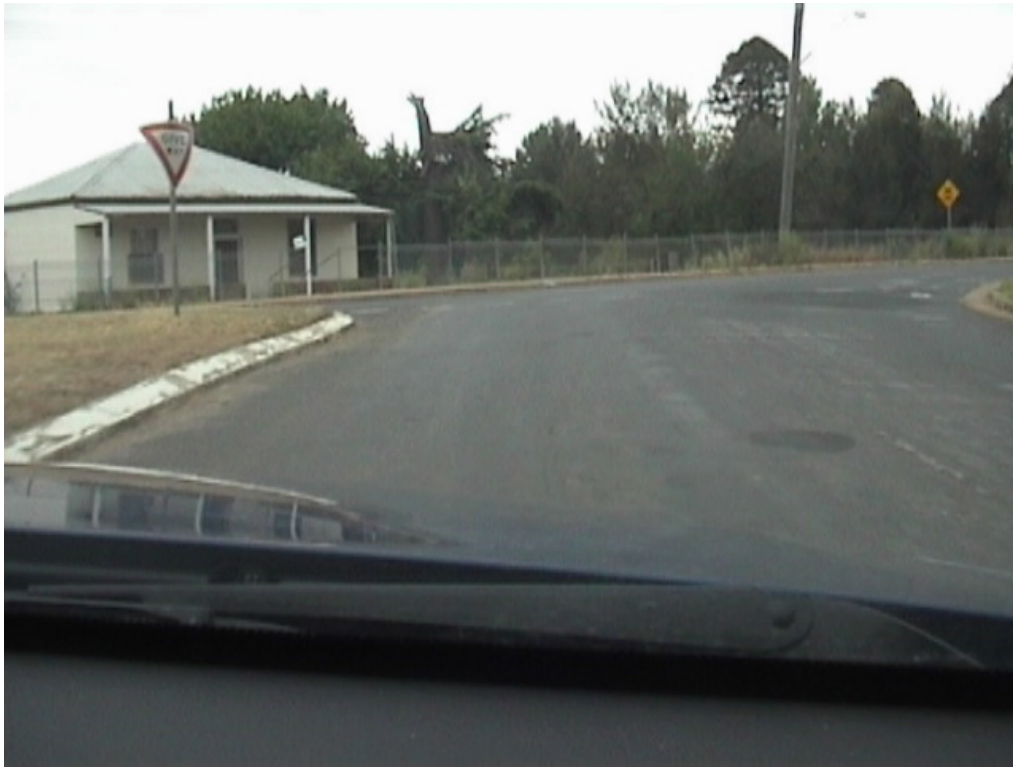
| Item No. | Location | Description of deficiency | Risk Rating | Priority (High, medium, low) | Photo Reference (Appendix. 1) |
|---|---|---|---|---|---|
| 13 | At Betts Road | In the south bound direction in Euchareena Road the "Give Way" sign has been damaged and is not perpendicular to oncoming traffic. | <b>Intolerable</b> | <b>HIGH</b> | 21,22 |

**21 – Deficiency Log Item 13** In the south bound direction in Euchareena Road the “Give Way” sign has been damaged and is not perpendicular to oncoming traffic.

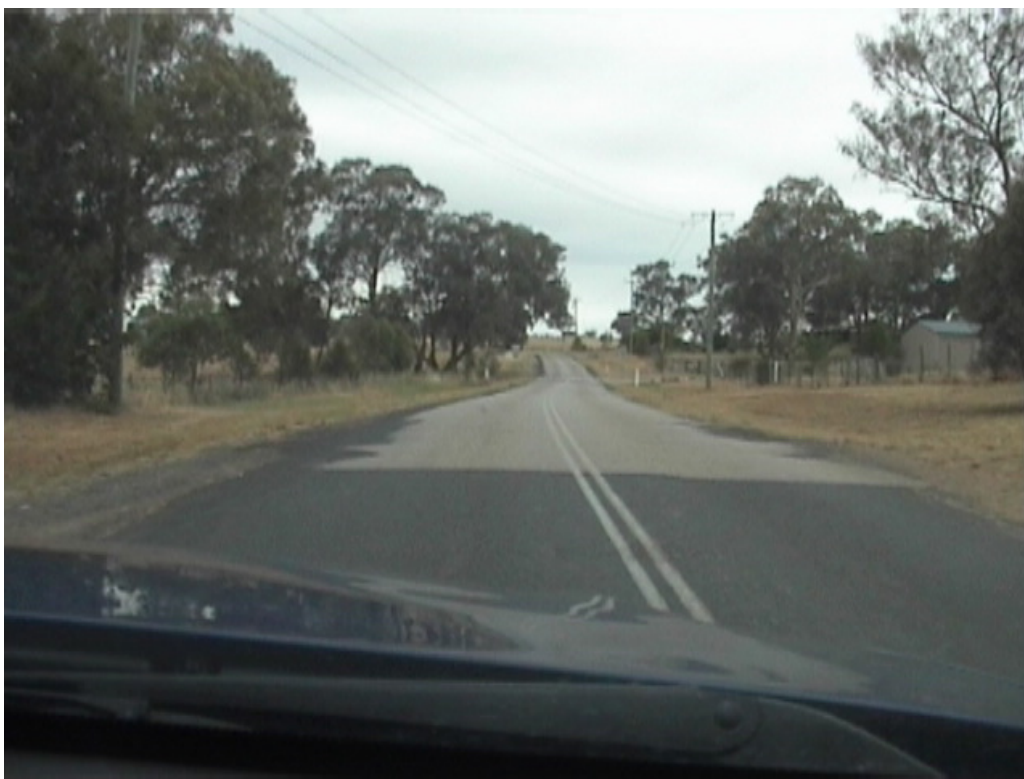
**23 – Deficiency Log Item 16** Approx. 100m south of the 50/100 speed zone change the pavement narrows and is extenuated by different pavement colour and textures. Advance warning “Road Narrows” signs (W4-3) may be appropriate under these circumstances.

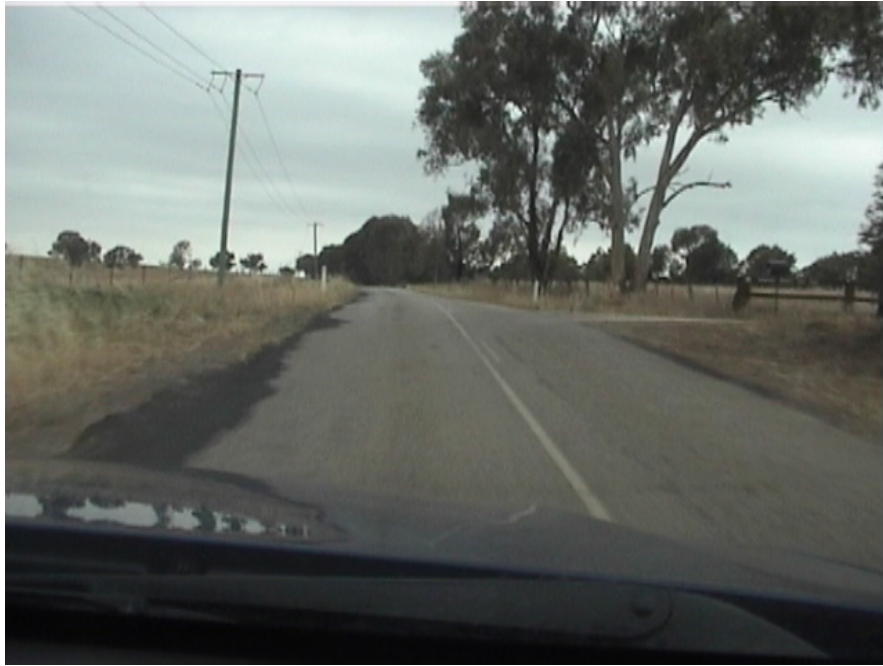
| Item No. | Location | Description of deficiency | Risk Rating | Priority (High, medium, low) | Photo Reference (Appendix. 1) |
|---|---|---|---|---|---|
| 17 | Between 50/100 Speed Zone Change & Back Saleyard Road | It is understood that an upgrade of Euchareena Road between Beets Road and Back Saleyard Road has been approved by Cabonne Council but no timeframe was indicated except within the Euchareena Road proposed upgrade works plan (2007) prepared by Geolyse.<br><br>Pavement condition along this length of road is poor. The road width was measured between 5.5m and 6.0m. Pavement patching and edge repairs provide a contrasting pavement colour and texture which results in the vehicle occupying the centre of the carriageway especially at night and wet weather. Along this section of road there are substantial trees growing within the clear zone. Given the narrow carriageway and content of HV within the traffic stream, especially during summer holiday season, a vehicle correcting to avoid an on- | High | <b>HIGH</b> | 25,26 |

| Item No. | Location | Description of deficiency | Risk Rating | Priority (High, medium, low) | Photo Reference (Appendix. 1) |
|---|---|---|---|---|---|
| 17 contd. | | coming vehicle has potential to enter the shoulder area and impact a tree.<br>This length of road is considered hazardous and contains a high probability that should an incident occur the likely outcome would be severe. | | | |

**25 – Deficiency Log Item 17** It is understood that an upgrade of Euchareena Road between Beets Road and Back Saleyard Road has been approved by Cabonne Council but no timeframe was indicated except within the Euchareena Road proposed upgrade works plan (2007) prepared by Geolyse.

Pavement condition along this length of road is poor. The road width was measured between 5.5m and 6.0m. Pavement patching and edge repairs provide a contrasting pavement colour and texture which results in the vehicle occupying the centre of the carriageway especially at night and wet weather. Along this section of road there are substantial trees growing within the clear zone. Given the narrow carriageway and content of HV within the traffic stream, especially during summer holiday season, a vehicle correcting to avoid an on-coming vehicle has potential to enter the shoulder area and impact a tree.

This length of road is considered hazardous and contains a high probability that should an incident occur the likely outcome would be severe.

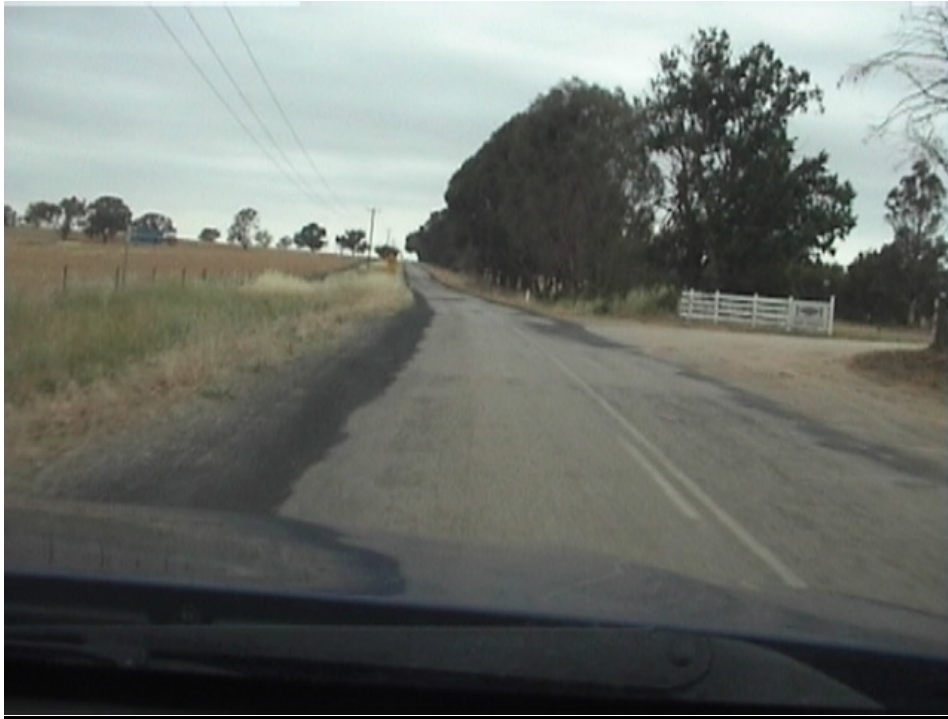
| Item No. | Location | Description of deficiency | Risk Rating | Priority (High, medium, low) | Photo Reference (Appendix. 1) |
|---|---|---|---|---|---|
| 18 | At the entrance to Golf Club and Showground | The access roadway to these facilities is gravel. The road pavement in Euchareena Road at this access narrows to 5.8m, is of different colour/texture, there is evidence that vehicles use the road shoulder (possibly to pass a turning vehicle that would expedite edge of pavement deterioration) and gravel stones have been tracked onto the bitumen pavement from the access road. It is considered the combination of these issues render the operation of this access mildly hazardous. | High | MEDIUM | 27,28 |

**27 – Deficiency Log Item 18** The access roadway to these facilities is gravel. The road pavement in Euchareena Road at this access narrows to 5.8m, is of different colour/texture, there is evidence that vehicles use the road shoulder (possibly to pass a turning vehicle that would expedite edge of pavement deterioration) and gravel stones have been tracked onto the bitumen pavement from the access road. It is considered the combination of these issues render the operation of this access mildly hazardous.

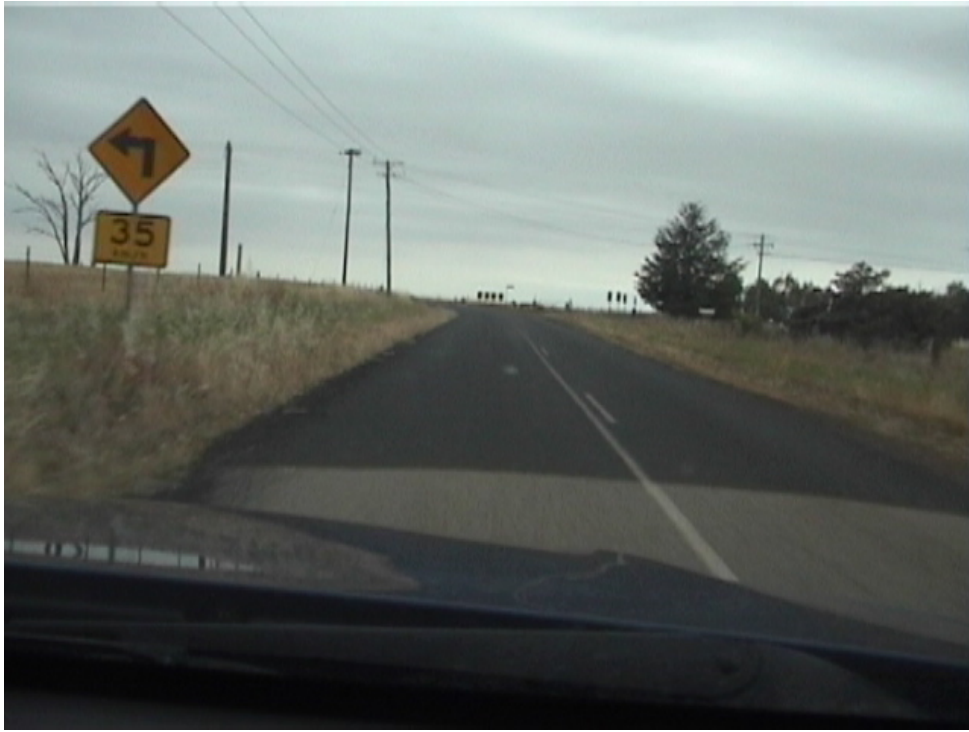
change in road alignment. Sight through the intersection along Euchareena Road in both directions is also poor due to roadside vegetation. These factors, and the pavement width at the centre of the curve of only 6.0m, makes operation of the road at this point extremely hazardous.

| Item No. | Location | Description of deficiency | Risk Rating | Priority (High, medium, low) | Photo Reference (Appendix. 1) |
|---|---|---|---|---|---|
| 19 | At Back Saleyard Road | At this junction Euchareena Road traverses a 90° bend and accommodates advance warning signs indicating 35 km/hr and chevron alignment markers (G9-243) within the curve. Advance warning of the severity in the change and speed of alignment is poor, mutual sight through the junction along Euchareenna Road (in both directions) is poor due to roadside vegetation and pavement width at the centre of the curve measured 6.0m.<br>It is considered the combination of these issues makes operation of the road at this point extremely hazardous. | Intolerable | HIGH | 29,30,31,32 |

**29 – Deficiency Log Item 19** At this junction Euchareena Road traverses a 90° bend and accommodates advance warning signs indicating 35 km/hr and chevron alignment markers (G9-243) within the curve. Advance warning of the severity in the change and speed of alignment is poor, mutual site through the junction along Euchareena Road (in both directions) is poor due to roadside vegetation, pavement width at the centre of the curve measured 6.0m. It is considered the combination of these issues makes operation of the road at this point extremely hazardous.

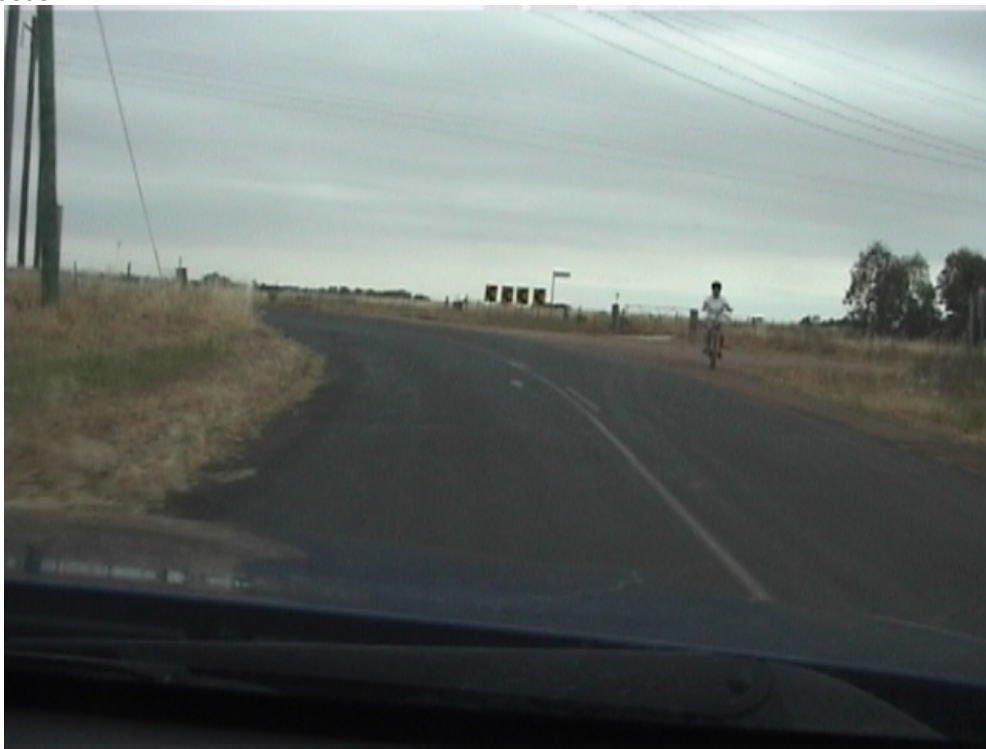
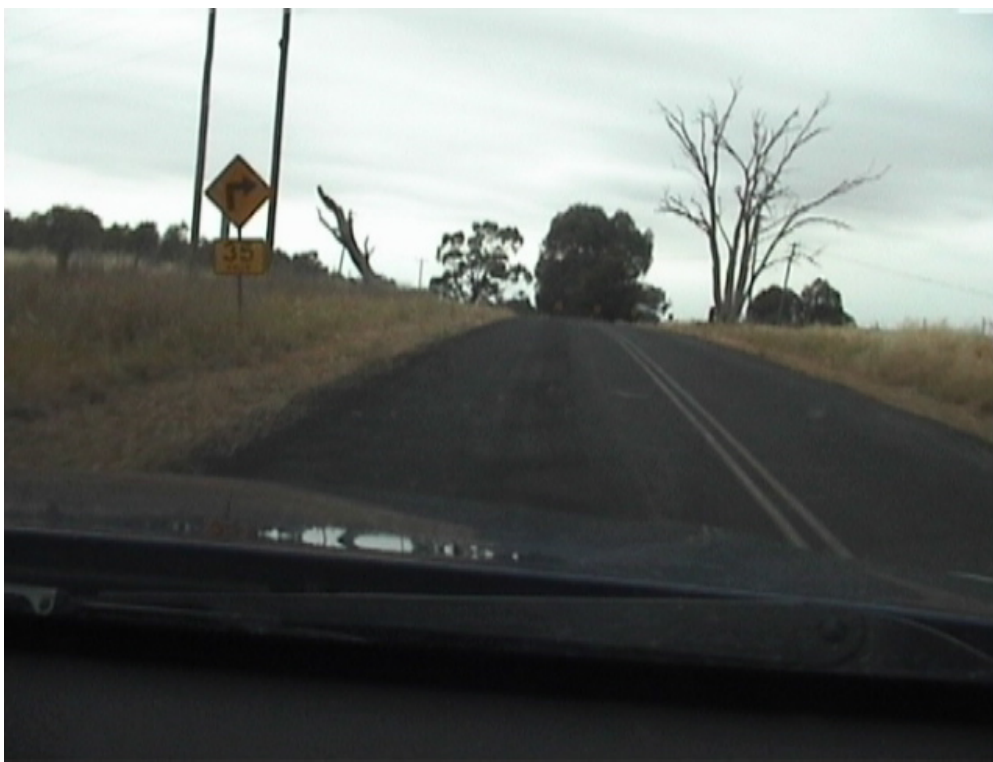
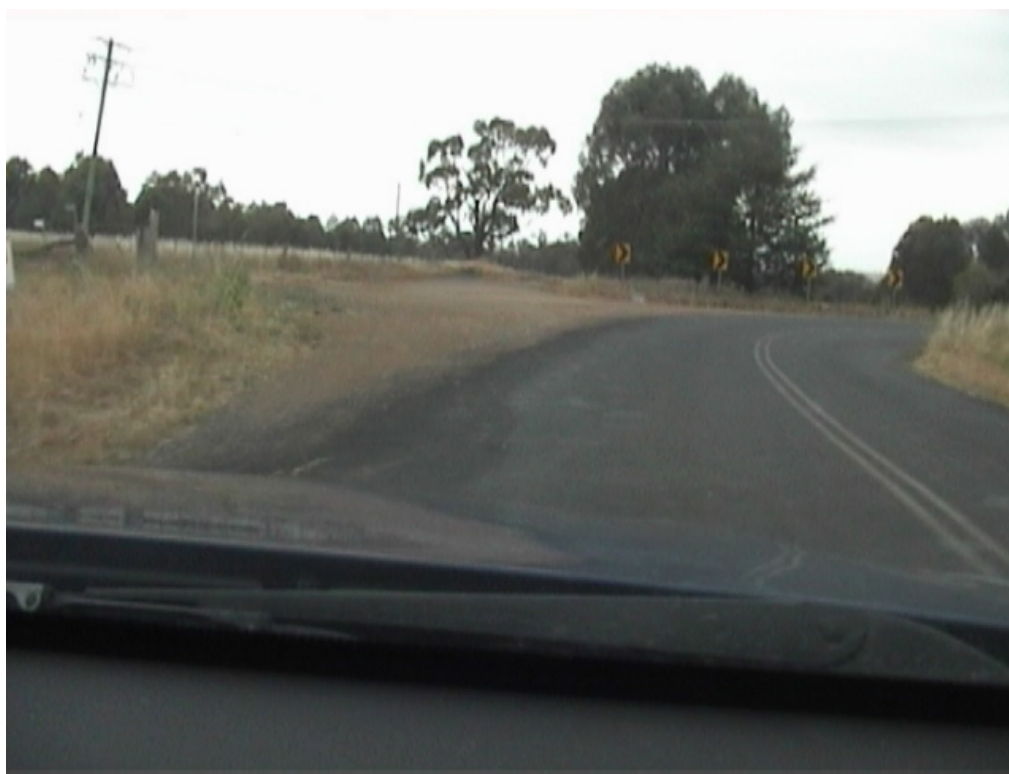
**30 – Deficiency Log Item 19**

31 – Deficiency Log Item 19

32 – Deficiency Log Item 19

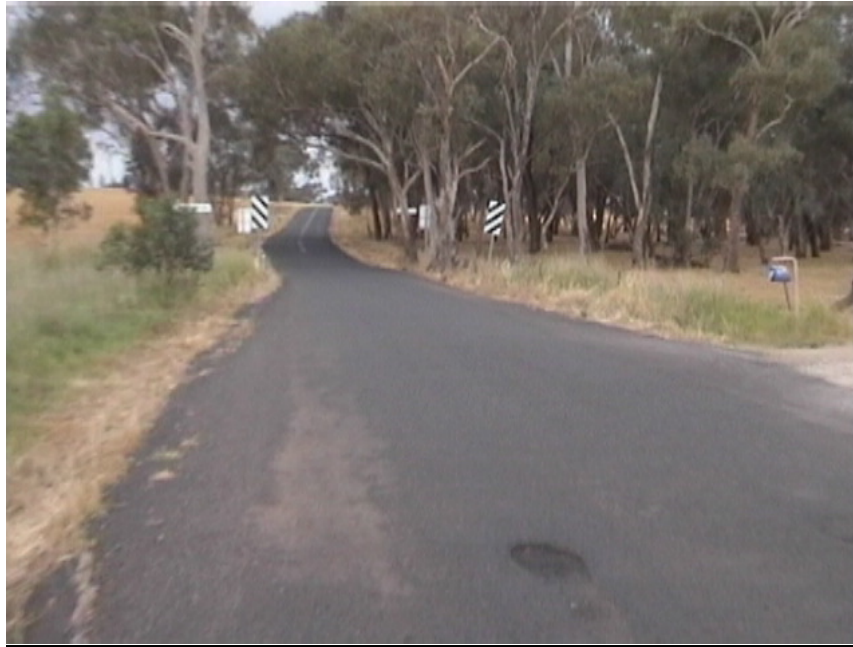
- 21 A number of deficiencies were noted where Euchareena Road crosses Back Creek in the 100 km/h speed zone. These were:

- The road pavement is narrow at just 5.4m wide;
- There are no advance warning 'road narrow' signs;
- The road alignment deviates/changes across the culvert;
- The existing bridge rail across the culvert is substandard, deteriorating and hazardous;
- There is no guardrail protection of the creek on the approaches to the culvert; and
- There are trees in the roadside clear zone.

The combination of these factors makes the operation of the road at this point extremely hazardous.

| Item No. | Location | Description of deficiency | Risk Rating | Priority (High, medium, low) | Photo Reference (Appendix. 1) |
|---|---|---|---|---|---|
| 21 contd. | | <p>the Euchareena Road proposed upgrade works plan (2007) prepared by Geolyse.</p> <p>The road crossing of Back Creek, within a 100 km/hr speed environment, has a number of deficiencies that have been recognised in documents reviewed.</p> <p>These deficiencies include:</p> <ul style="list-style-type: none"> <li>• The narrow pavement across the culvert measured at 5.4m.</li> <li>• There are no advance warning "Road Narrow" signs (W4-3) in advance of the culvert.</li> <li>• The road alignment deviates/changes across the culvert.</li> <li>• The existing bridge rail across the culvert is substandard deteriorating and hazardous.</li> <li>• In approaches to the culvert there is no guardrail protection of the Creek from errant vehicles.</li> <li>• Grown tree vegetation encroaches into the clear zone.</li> </ul> <p>It is considered the combination of these issues makes operation of the road at this point extremely hazardous.</p> | | | |

**33 – Deficiency Log Item 21** It is understood that the reconstruction of the culvert at Back Creek and its approaches has been approved by Cabonne Council but no timeframe was indicated except within the Eucharreena Road proposed upgrade works plan (2007) prepared by Geolyse. The road crossing of Back Creek, within a 100 km/hr speed environment, has a number of deficiencies that have been recognised in documents reviewed.

These deficiencies include:

- The narrow pavement across the culvert measured at 5.4m
- There are no advance warning “Road Narrow” signs (W4-3) in advance of the culvert
- The road alignment deviates/changes across the culvert
- The existing bridge rail across the culvert is substandard deteriorating and hazardous
- In approaches to the culvert there is no guardrail protection of the Creek from errant vehicles
- Grown tree vegetation encroaches into the clear zone

It is considered the combination of these issues makes operation of the road at this point extremely hazardous.

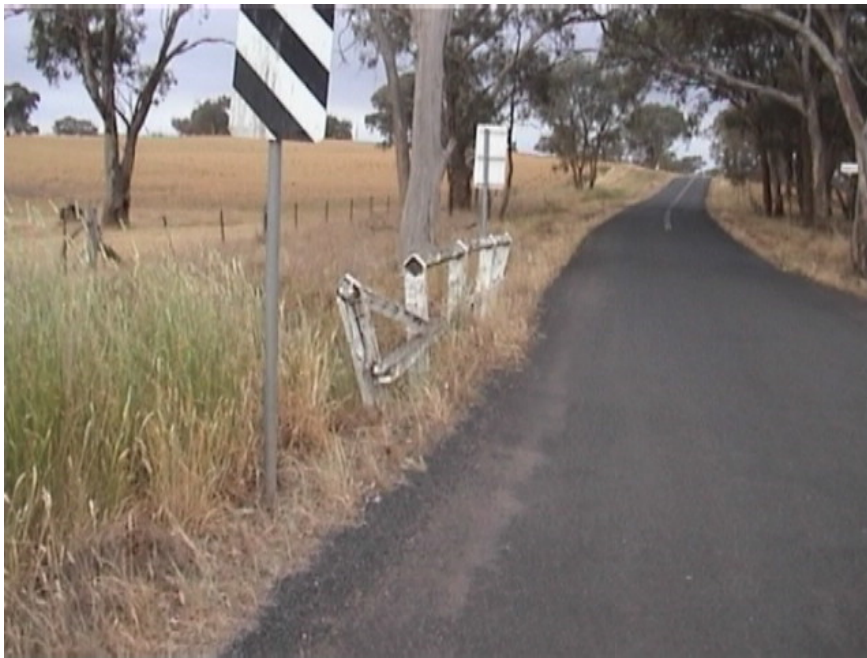
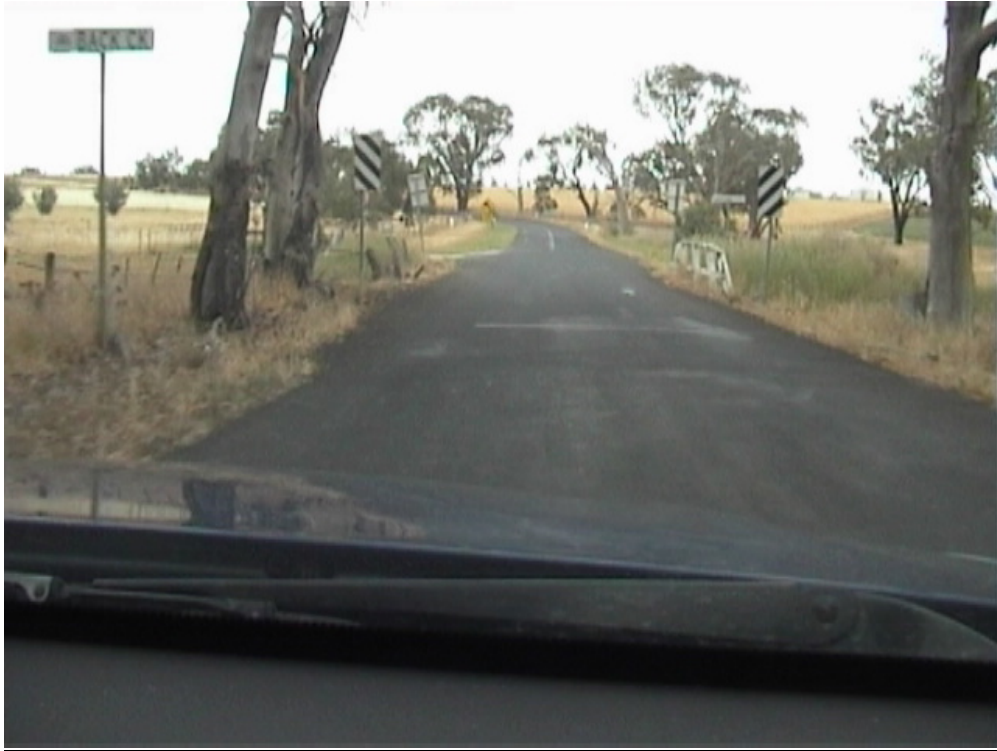
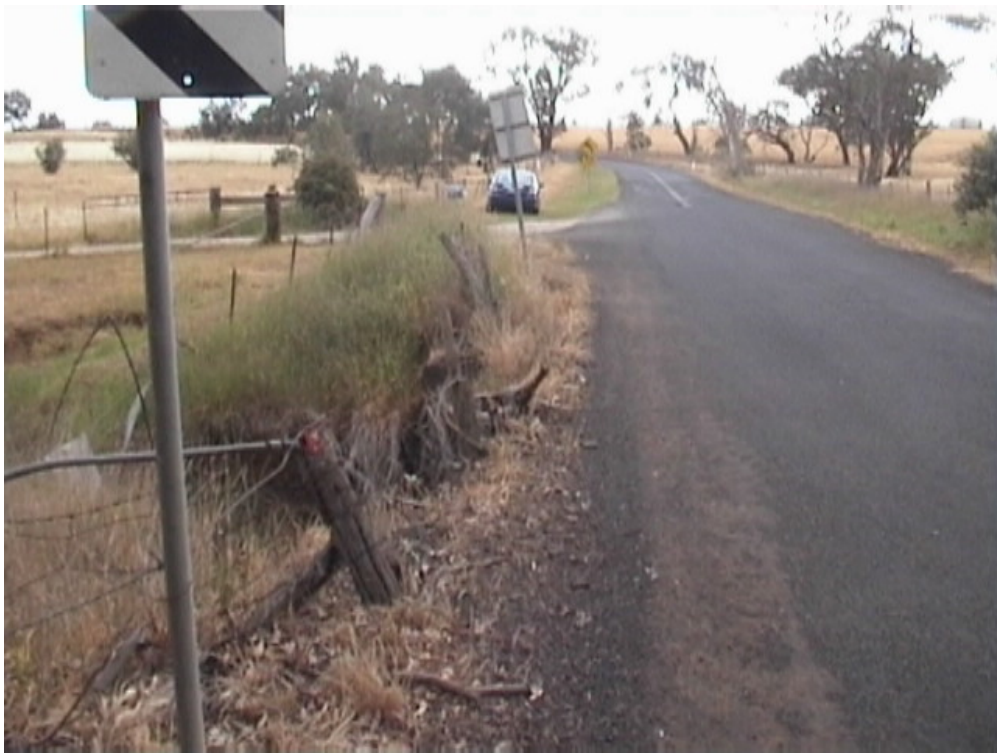
**34 – Deficiency Log Item 21**

**35 – Deficiency Log Item 21**

**36 – Deficiency Log Item 21**

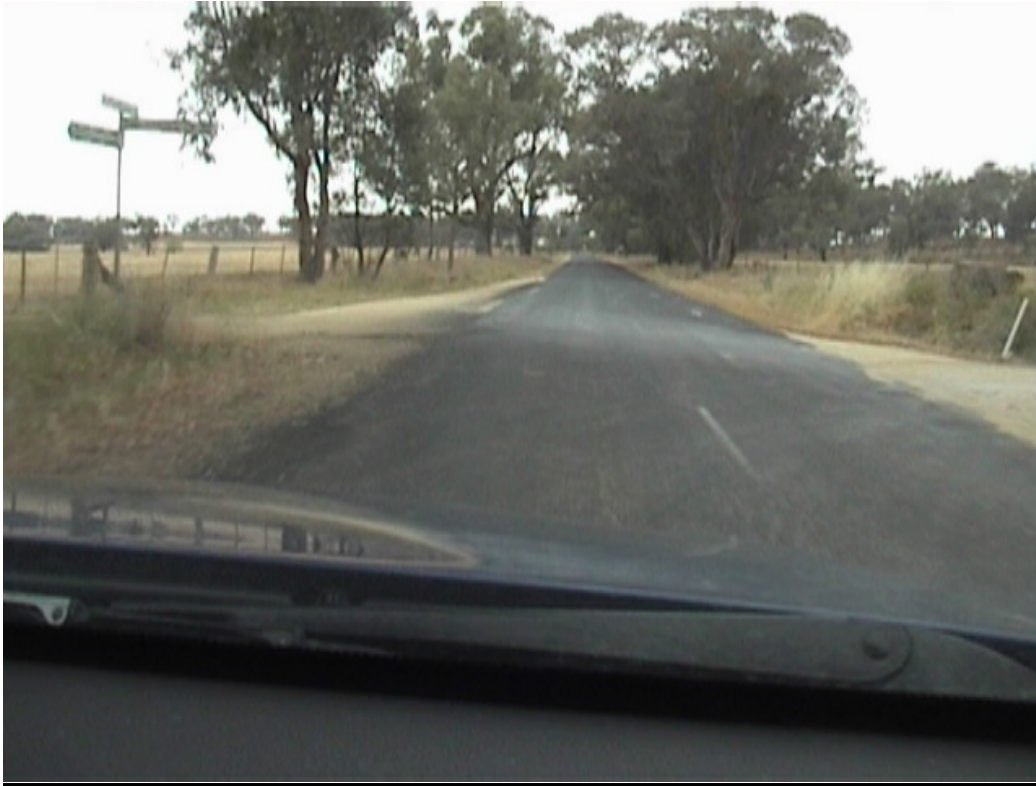
| Item No. | Location | Description of deficiency | Risk Rating | Priority (High, medium, low) | Photo Reference (Appendix. 1) |
|---|---|---|---|---|---|
| 23 | At Shades Creek Road | Shades Creek Road services a number of properties and connects through to the Mitchell Highway in the west. At this point the Euchareena Road pavement narrows and tracking of large stones occurs onto the bitumen pavement. It is considered there is a reasonable probability that windscreen damage to vehicles could occur at this location. | Medium | MEDIUM | 37,38 |

**37 – Deficiency Log Item 23** Shades Creek Road services a number of properties and connects through to the Mitchell Highway in the west. At this point the Euchareena Road pavement narrows and tracking of large stones occurs onto the bitumen pavement. It is considered there is a reasonable probability that windscreen damage to vehicles could occur at this location.

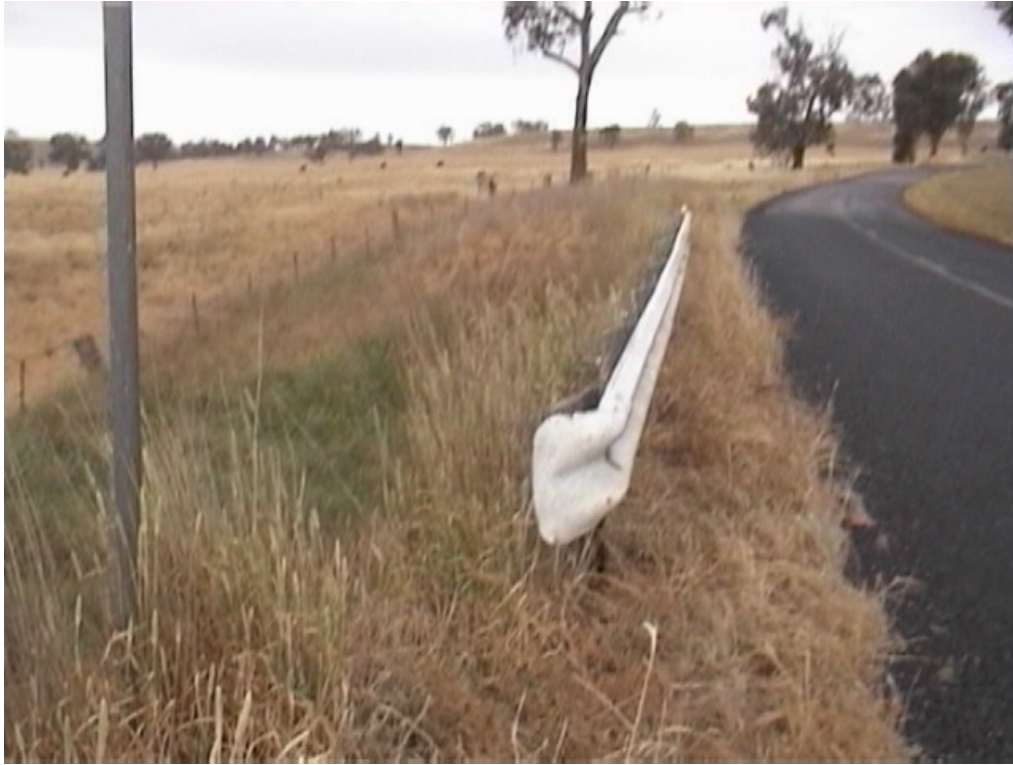
- 24 The guardrail at the Shades Creek culvert is redundant and deteriorated by white ant and rot. The 'fish tail' end treatment is also redundant.

| Item No. | Location | Description of deficiency | Risk Rating | Priority (High, medium, low) | Photo Reference (Appendix. 1) |
|---|---|---|---|---|---|
| 24 | At Shades Creek | The culvert at Shades Creek accommodates redundant guardrail treatment. The rail is supported by timber posts for its length (deteriorated by white ant and rot) and redundant "fish tail" end treatment. | <b>Intolerable</b> | <b>HIGH</b> | 39,40 |

**39 - Deficiency Log Item 24** The culvert at Shades Creek accommodates redundant guardrail treatment. The rail is supported by timber posts for its length (deteriorated by white ant and rot) and redundant “fish tail” end treatment.
