# The University of Sydney: University Ovals 1 & 2

prepared by

The Tree School  
in association with

TREE MANAGEMENT PLAN

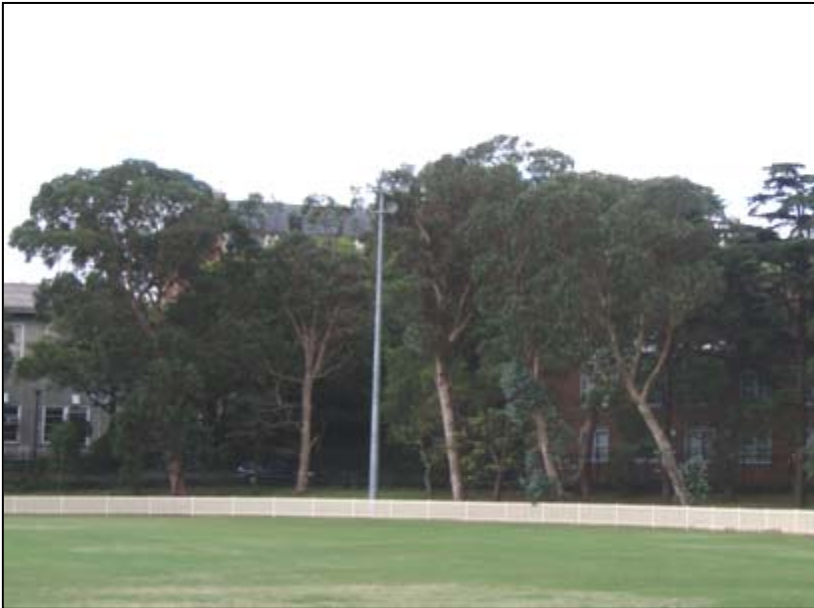
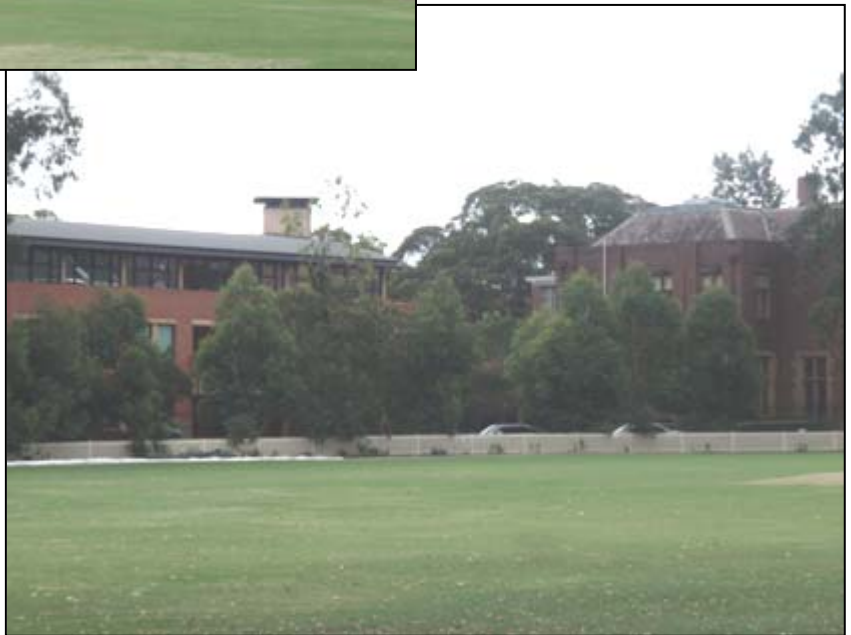
FIGURE 4: Group 1

This group of trees consists mainly of over-mature *Eucalyptus bicostata* (Southern Blue Gum). They are located to the south of the Ross St entrance and, as a group, they are a prominent feature of the Ovals' landscape. The majority of these trees contain defects such as large diameter deadwood, previous branch failures and storm damage. A fungal bracket was also noted on Tree 1121.

This group of trees also contains a number of newly planted *Eucalyptus microcorys* (Tallow-wood). These have been planted to replace several over-mature *Eucalyptus bicostata* (Southern Blue Gum) that have been removed. However, the use of poor quality plant material has resulted in these trees having a number of above- and below-ground defects, such as girdled roots and poor branch attachments. These defects cannot be remediated, and the trees are unlikely to reach their full potential.

| Trees | Action | Priority |
|---|---|---|
| 2590-2592, 1124-1128. | Stage 4 block removal | 2 (high-medium) |
| 1113 | Stage 5 block removal | 2 (high-medium) |

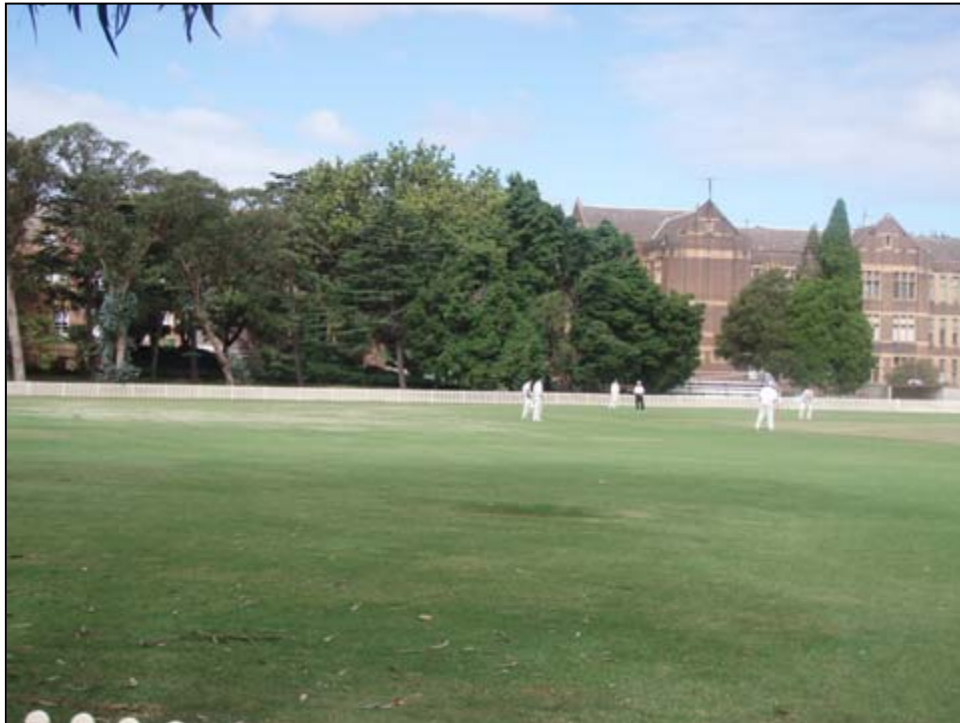
FIGURE 6: Group 2

This group consists of several conifer species, including *Cedrus deodara* (Himalayan Cedar), *Cupressus sempervirens* (Mediterranean Cypress), *Cupressus macrocarpa* (Monterey Cypress) and *Cupressus torulosa* (Bhutan Cypress). These trees are located to the west of the Wallace Theatre and John Woolley Building. Other than normal deadwood, no significant defects were noted on these trees.

Minor grass competition and soil compaction was noted.

| Trees | Action | Priority |
|---|---|---|
| Group 2 | Undertake coring | 4 (low) |
| N/A (Trees not numbered on plan) | Remove the smaller <i>Callistemon viminalis</i> (Weeping Bottle). | 4 (low) |

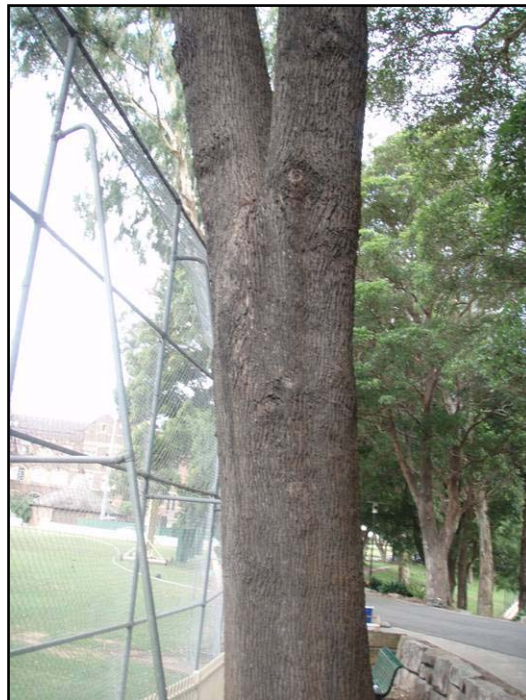
FIGURE 8: Tree 1044

A large wound was also noted on Tree 1048 *Lophostemon confertus* (Brush Box).

| Trees | Action | Priority |
|---|---|---|
| Group 4 | Undertake deadwood removal | 4 (low) |
| Group 4 | Undertake coring | 4 (low) |

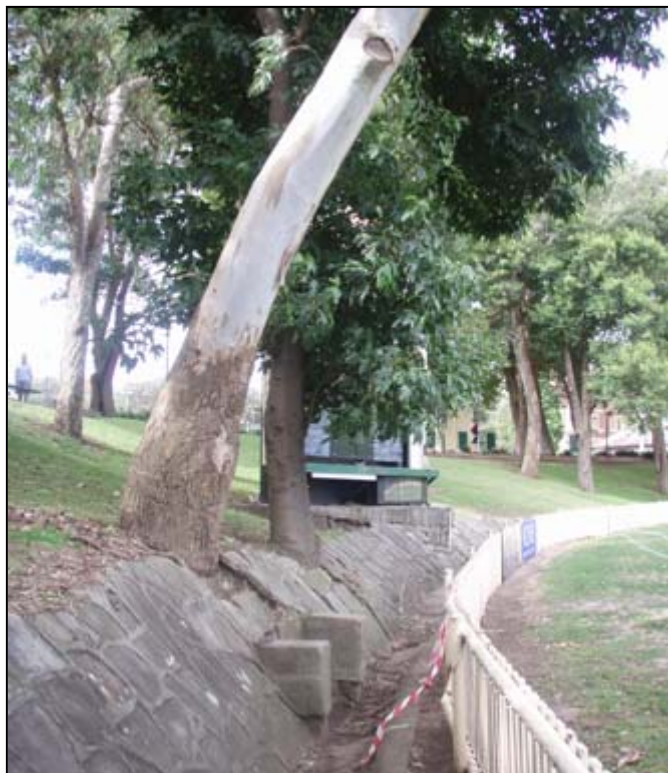
FIGURE 9: Tree 1054

Tree 1054 *Eucalyptus camaldulensis* (River red Gum) is located on top of a sandstone retaining wall and drain. This tree has a phototropic lean to the south-east due to suppression from the adjacent trees. Previous branch failures were also noted.

| Trees | Action | Priority |
|---|---|---|
| 1054 | Monitor | 3 (medium) |

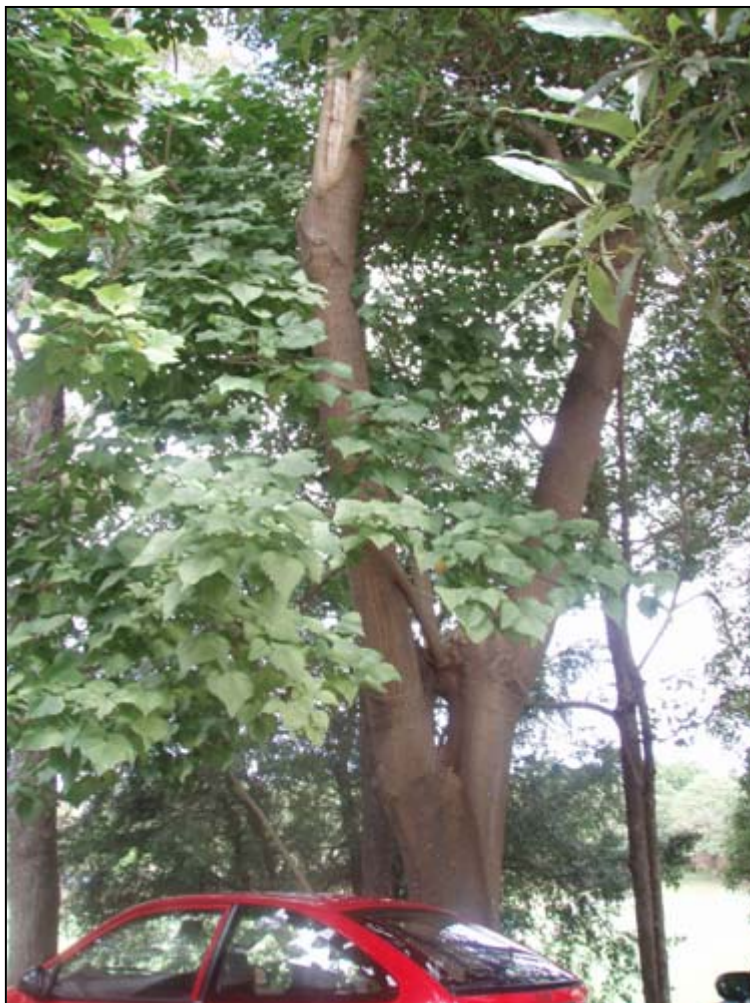
FIGURE 10: Tree 1066

It is understood that Tree 1066 has had a branch fail which resulted in damage to a vehicle.

| Trees | Action | Priority |
|---|---|---|
| Group 6 | Undertake deadwood removal | 4 (low) |
| Group 6 | Undertake coring | 4 (low) |

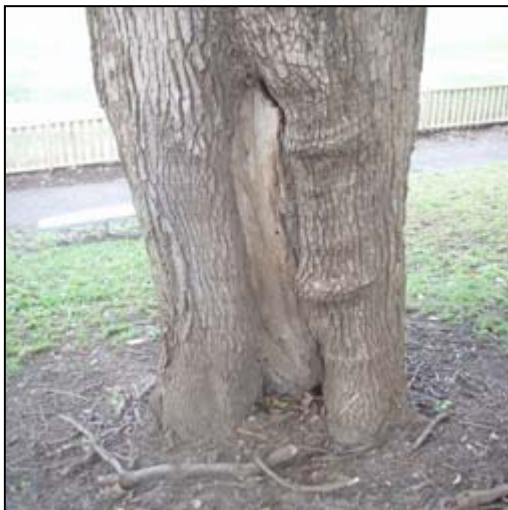
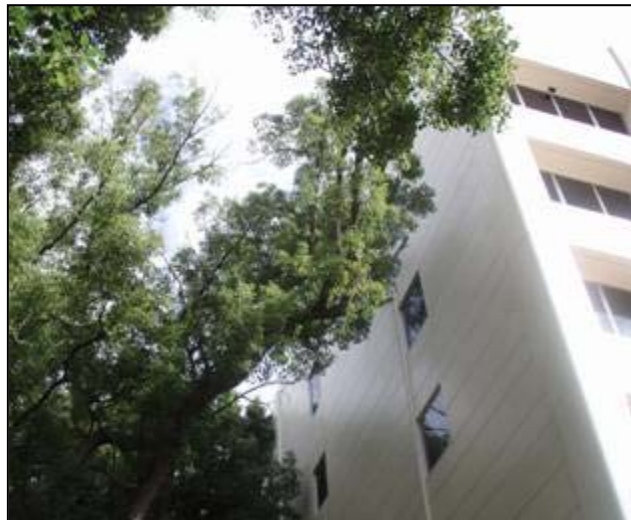
FIGURE 11: Tree 1073

The trees are approximately 15-20m in height and provide excellent canopy cover to the area. This group of trees is in the mature age class and could be retained for 15-40 years. However, wounding with possible decay was noted at the base of Trees 1070 and 1073. Tree 1070 also has a declining branch that extends west towards the adjacent building.

Ivy was also noted growing on several of the *Ficus microcarpa* var. 'Hilli' (Hills Weeping Fig).

| Trees | Action | Priority |
|---|---|---|
| Group 7 | Remove Ivy | 4 (low) |
| Group 7 | Undertake deadwood removal | 4 (low) |

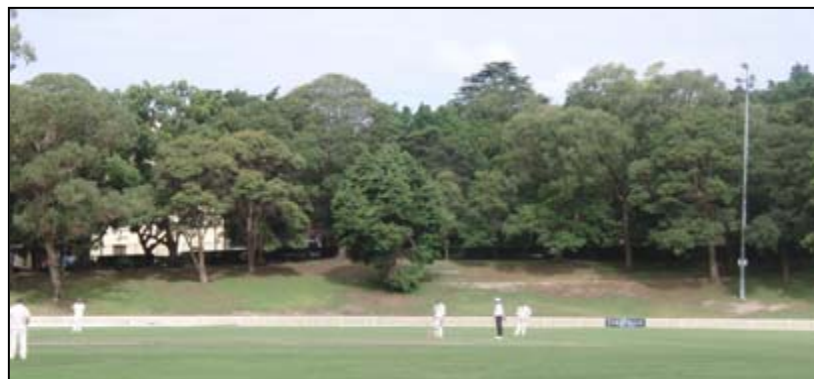
FIGURE 14: Group 9 & Area 10

Trees 951 and 953 are *Eucalyptus paniculata* (Grey Ironbark). These trees have been planted too close to the adjacent trees and, as a result, have become suppressed. Notable defects include large diameter deadwood and storm damage. A large wound was also noted on Tree 955 *Lophostemon confertus* (Brush Box).

This tree is located in an area that can easily accommodate (sustain) two (2) large canopy trees. The removal of this tree in the short term will provide the scope to install two replacement trees. These trees will have the opportunity to become established prior to the removal of the adjacent groups, which should minimize the visual impact of the removal of adjacent trees.

| Tree | Action | Priority |
|---|---|---|
| 956 | Remove tree | Low (4) |
| Area 10 | Undertake coring | 4 (low) |

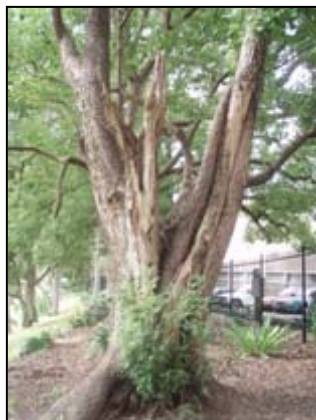
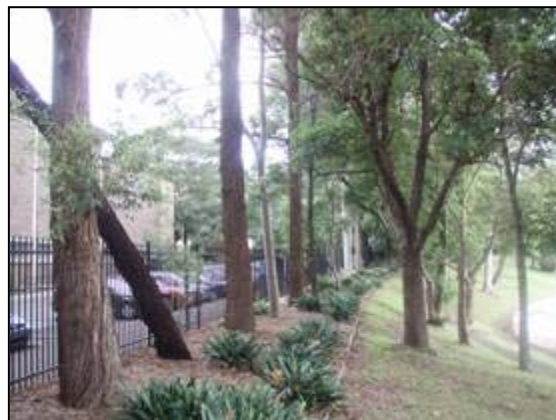
FIGURE 15: Tree 961

Trees 993, 997 (both *Populus deltoides*) and 964 (*Eucalyptus bicostata*, (Southern Blue Gum)) are mature specimens containing a number of defects such as large and small diameter deadwood, suspect branch attachments and storm damage.

| Trees | Action | Priority |
|---|---|---|
| Group 11 | Undertake deadwood removal | 4 (low) |

Due to the number of trees that have been recommended for removal and several other trees in this group which are suppressed, consideration should be given to block removal of this group.
