HAZARDOUS MATERIALS SURVEY AND REGISTER

**Former Pelican Beach Resort
740-742 Pacific Highway
Sapphire Beach NSW 2450**

DAVID LANE ASSOCIATES

June 2009

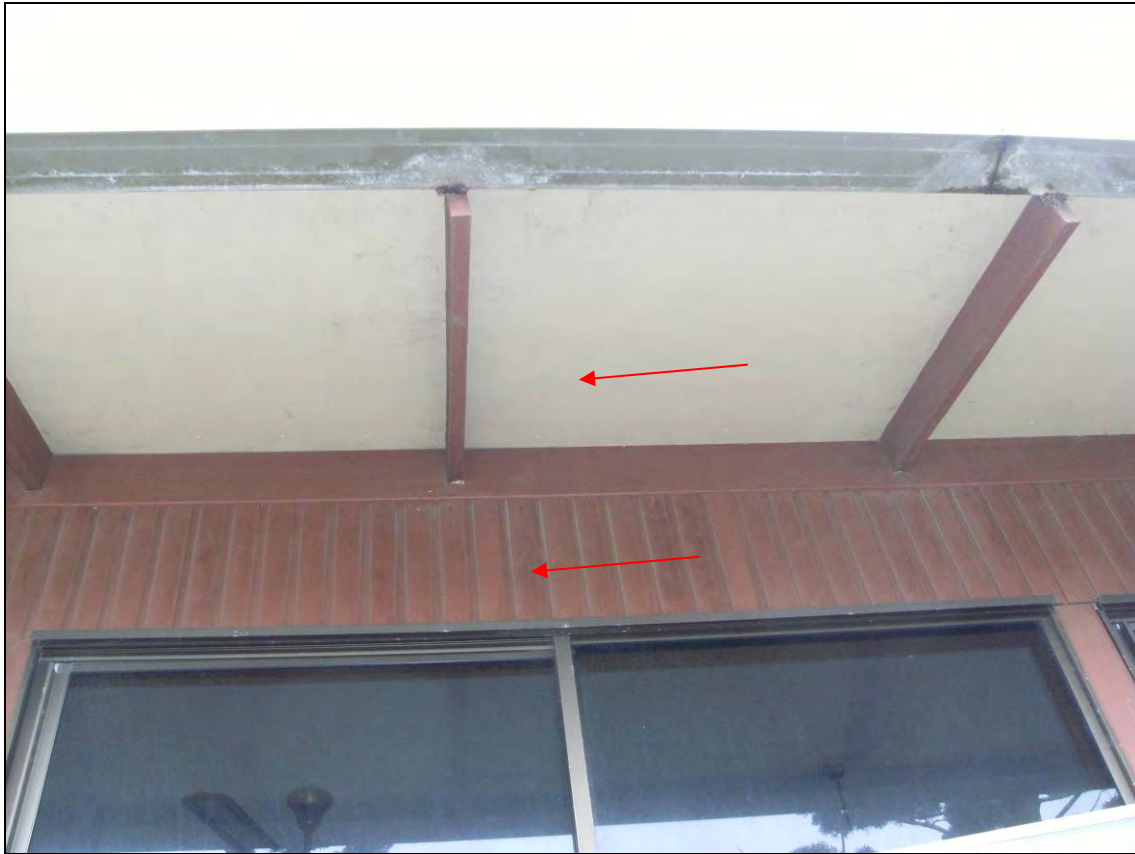
The eaves of the restaurant appeared to be asbestos cement sheeting – No Sample Available – **Asbestos Detected**

The maroon sections of the external walls present on the eastern, northern and southern frontages of the building are fibrous cement sheet – Sample R1 – No Asbestos Detected

Print 1
Restaurant Eaves and External Wall Panels

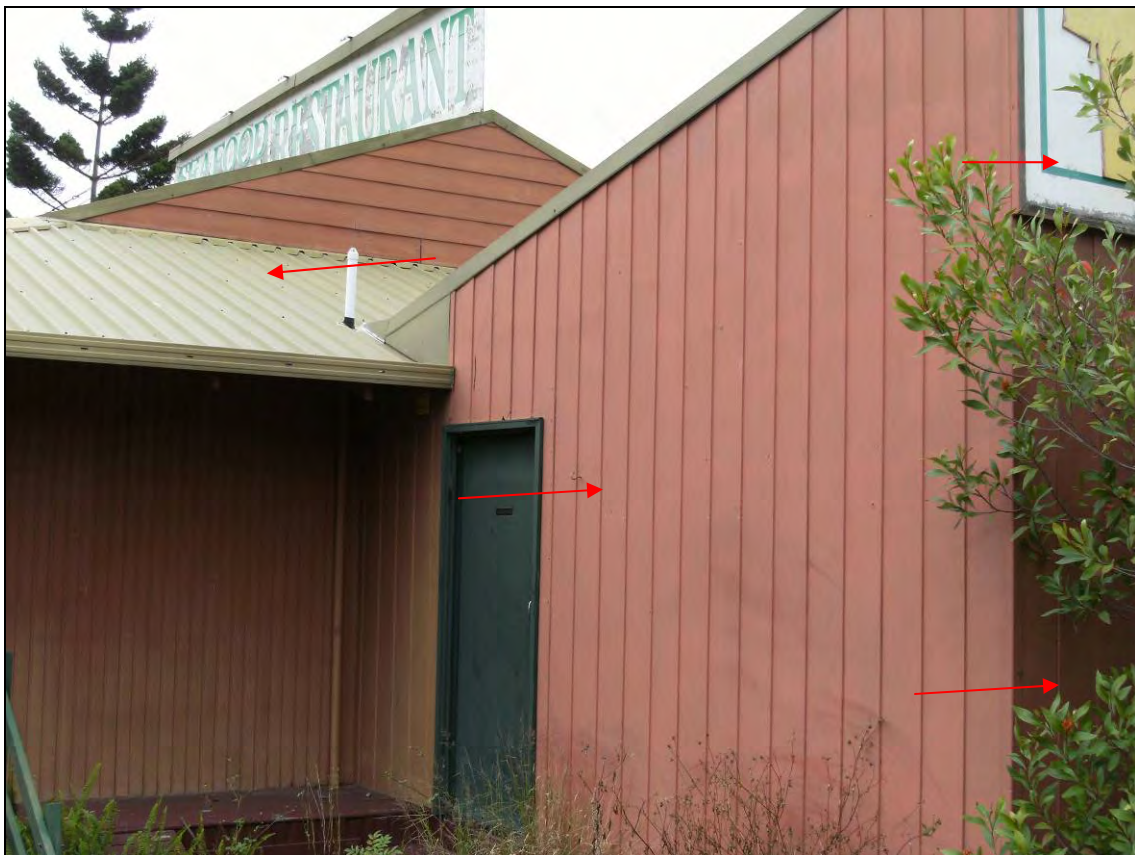
The maroon external walls of the western frontage of the building, including the cool room appeared to hardy plank – Sample R3 - No Asbestos Detected

The roof of the building is of tin construction – No Asbestos Detected

The western frontage advertising sign is of timber construction - No Asbestos Detected

Print 2
Western Section of Restaurant. Note Wall Panels Advertising Sign and Roof

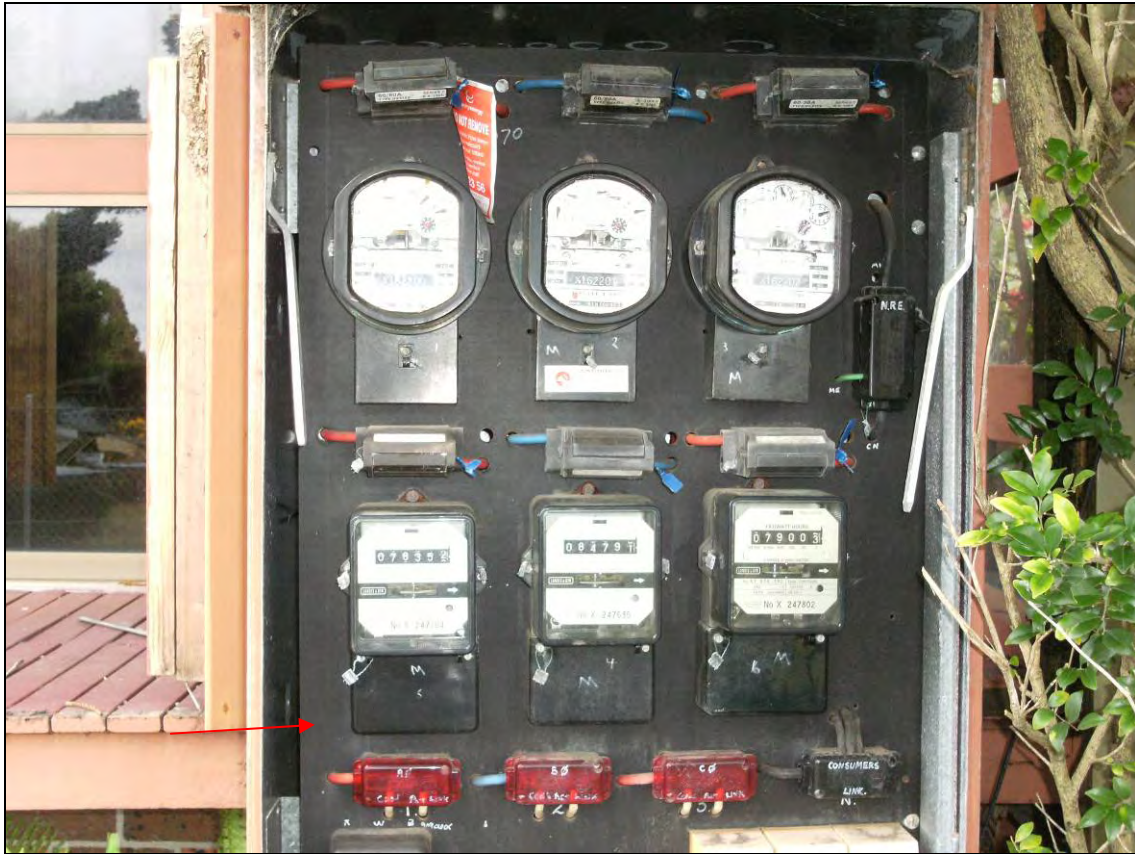
Print 3

The electrical distribution board present on the eastern frontage of the building contains an asbestos containing Zelminite backing board – No Sample Available - **Asbestos Detected**

Restaurant External Asbestos Containing Electrical Distribution Board

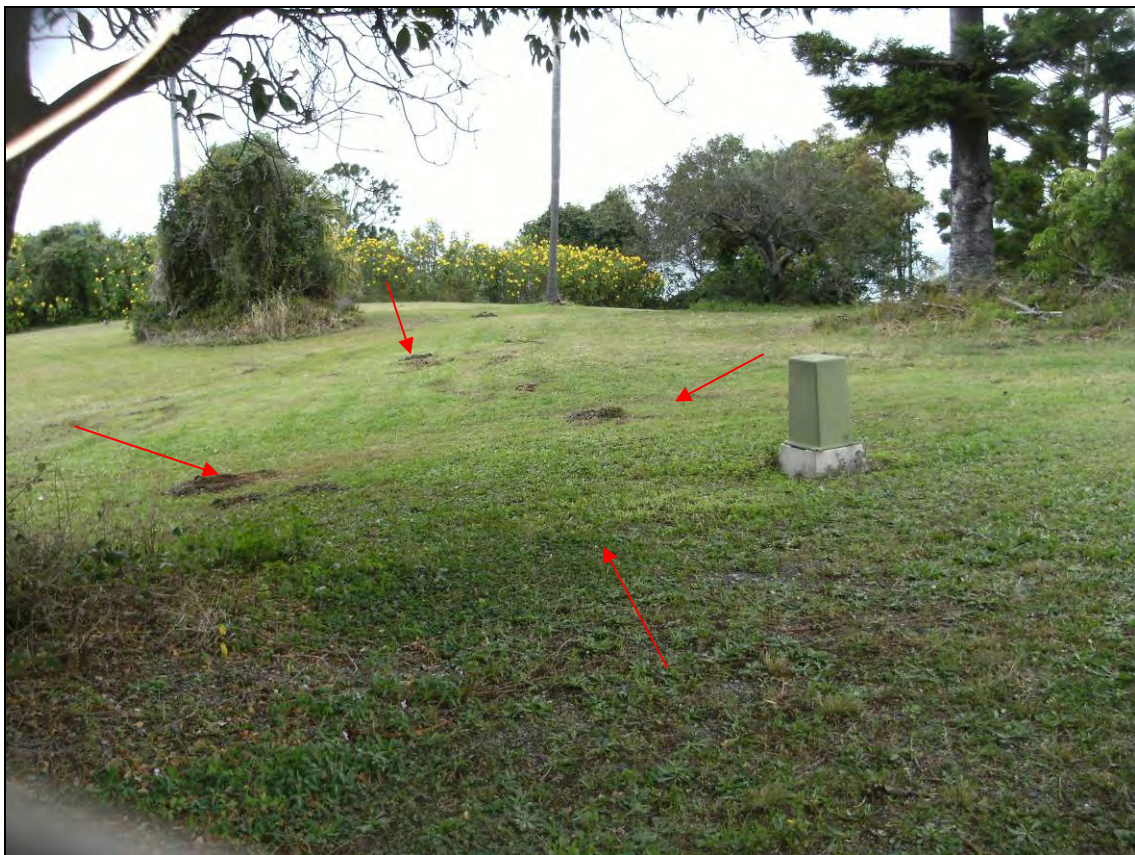
Print 4

Asbestos containing fibro fragments were found within a layer of fill located in the elevated plateau area to the east of the restaurant. The fill covers an area of approximately 150m² to a maximum depth of 0.3m. Soil samples collected from the fill and immediate surrounds did not indicate the presence of either fibrous or bonded asbestos containing materials – Sample C9-2 - **Asbestos Detected**

Asbestos Containing Fill Area

The removal of any asbestos contained within a building or soil, should be undertaken by a professional licensed contractor in accordance with the methods and procedures as outlined in the *Guide to Control of Asbestos Hazards in Buildings and Structures* [NOHSC: 3002(1998)], the *Code of Practice for the Safe Removal of Asbestos* [NOHSC: 2002(1988)] and *Guidance Note on the Membrane Filter Method for Estimating Airborne Asbestos Dust* [NOHSC: 3003 (1988)] and the *Waste Guideline* (NSW EPA 2008).

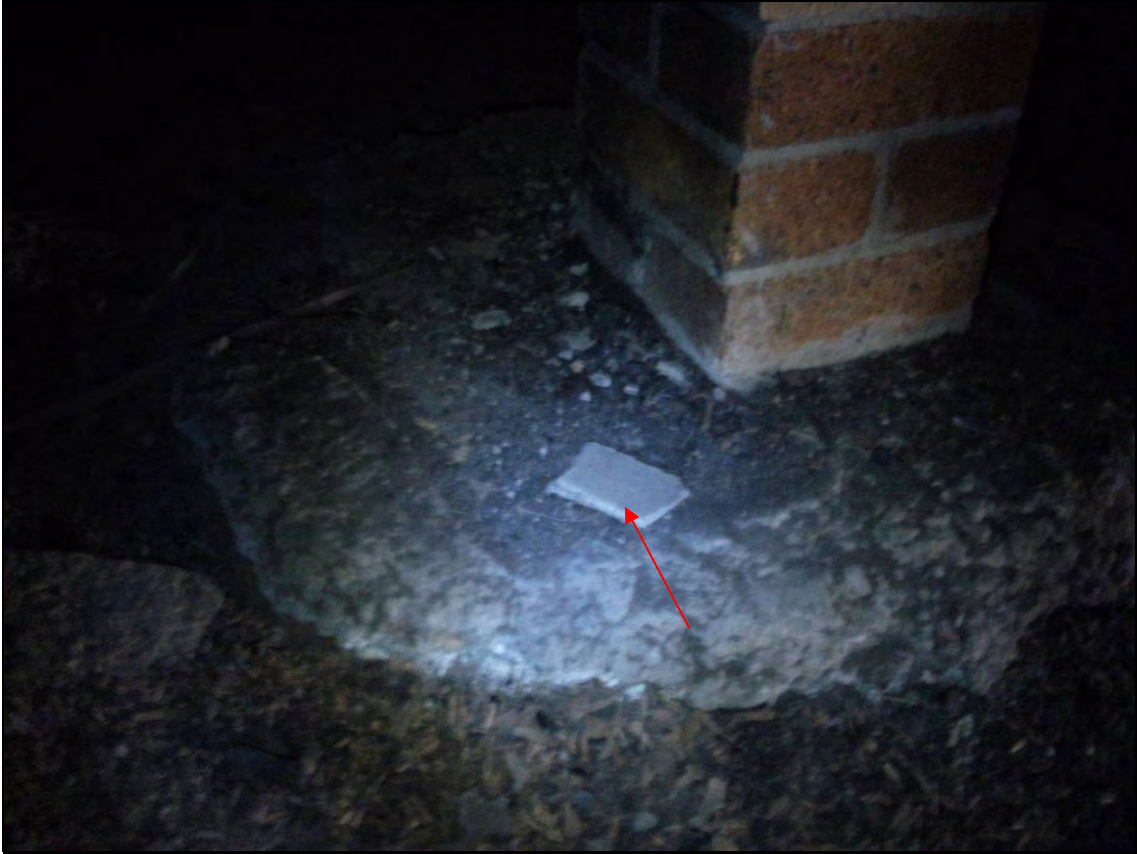
Fragments of fibrous cement sheet were scattered on the ground within the subfloor area – Sample R2 - **Asbestos Detected**

Print 5
Restaurant Subfloor Asbestos Fragment

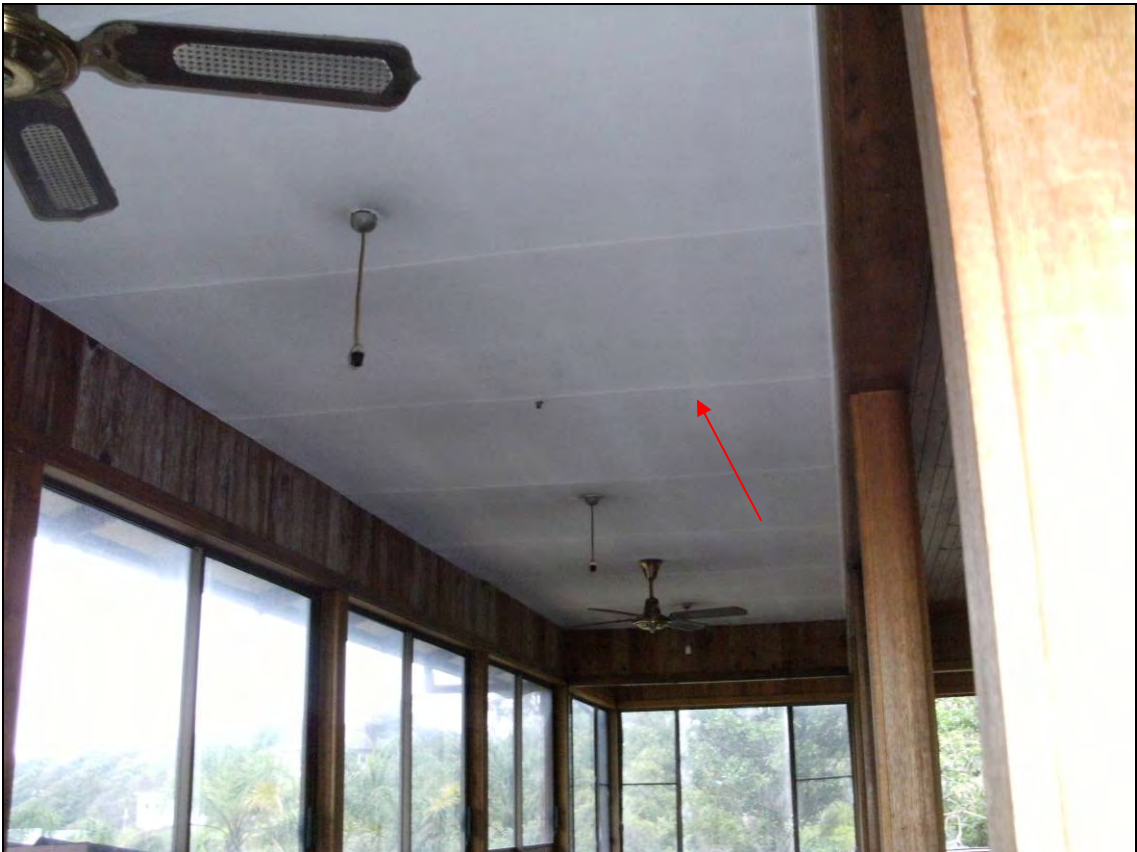
The eastern portion of the ceiling within the dining room is fibrous cement sheet – Sample R4 – **Asbestos Detected**

Print 6
Restaurant Asbestos Containing Ceiling

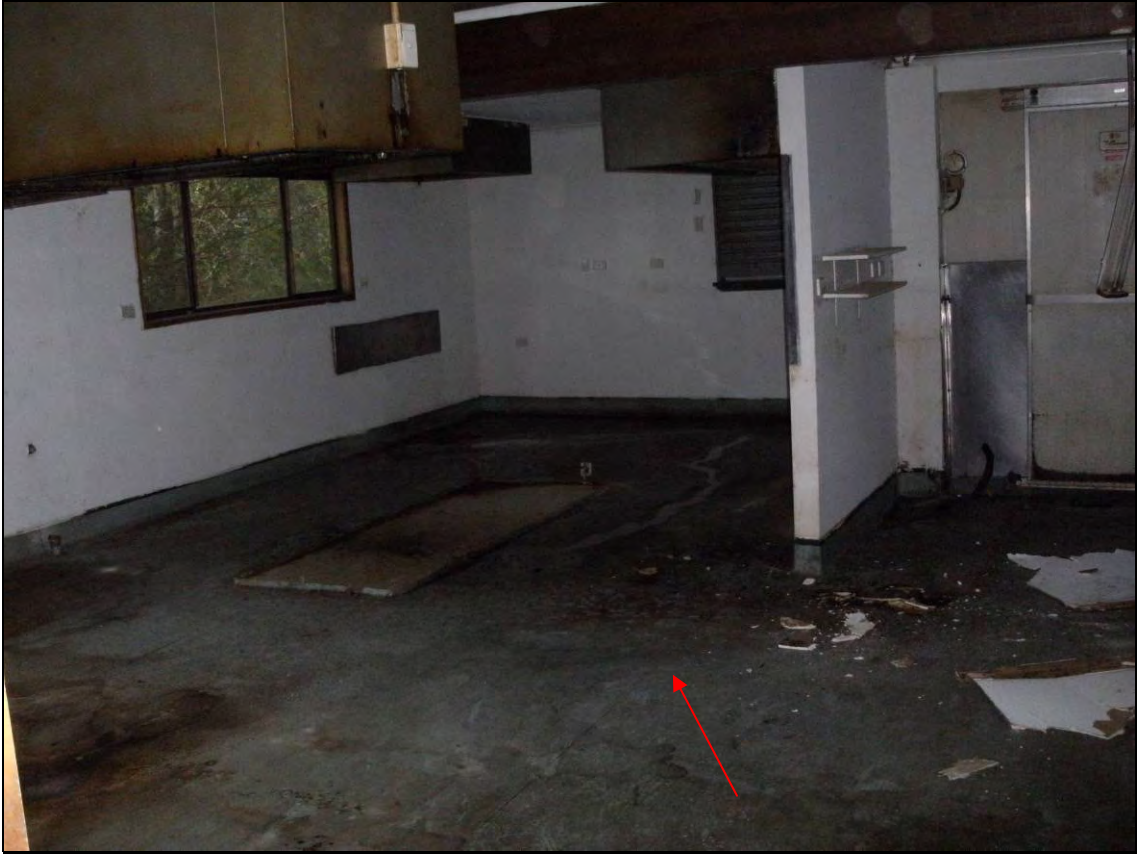
The kitchen appeared to have been recently renovated, with walls and ceilings of plaster construction – No Asbestos Detected.

The floor within the kitchen, cool rooms, adjoining office and store rooms appeared to be a green vinyl covering – No Asbestos Detected

Print 7
Restaurant Kitchen Floor Covering

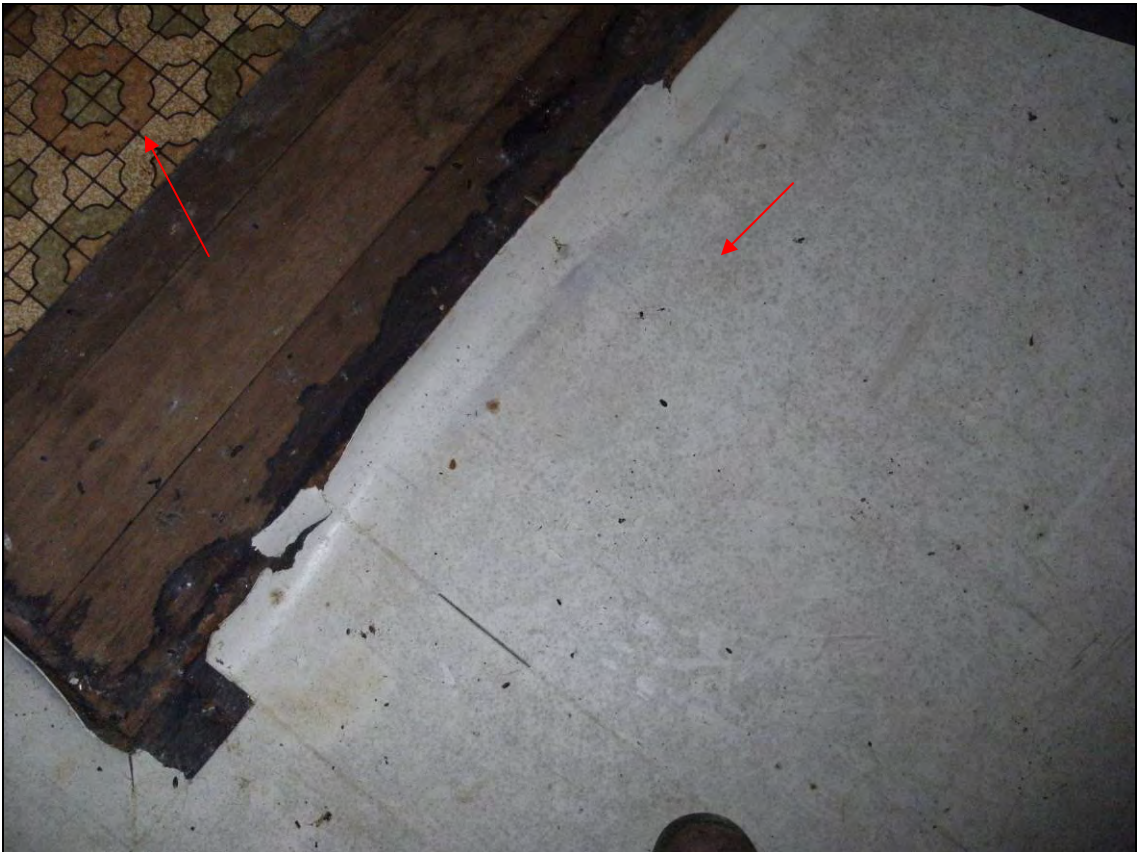
The floor within the bar was covered by two different vinyl floor coverings. A brown covering – Sample R5 – No Asbestos Detected, was present overlying a brown patterned covering – Sample R6 – No Asbestos Detected.

Print 8
Floor Covering within Bar Area

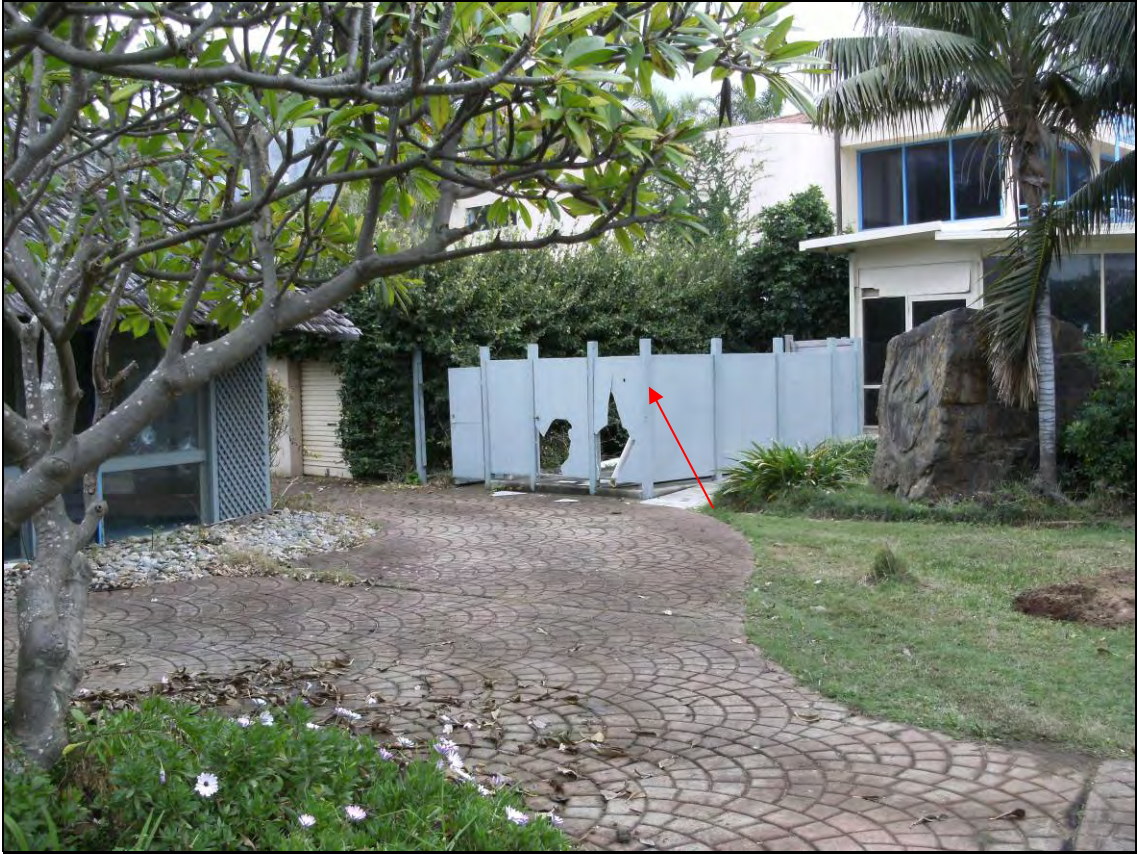
The veranda panelling and external court yard walls appeared to be of fibrous cement construction – Sample Resort 2 – No Asbestos Detected

Print 9
Resort Panelling

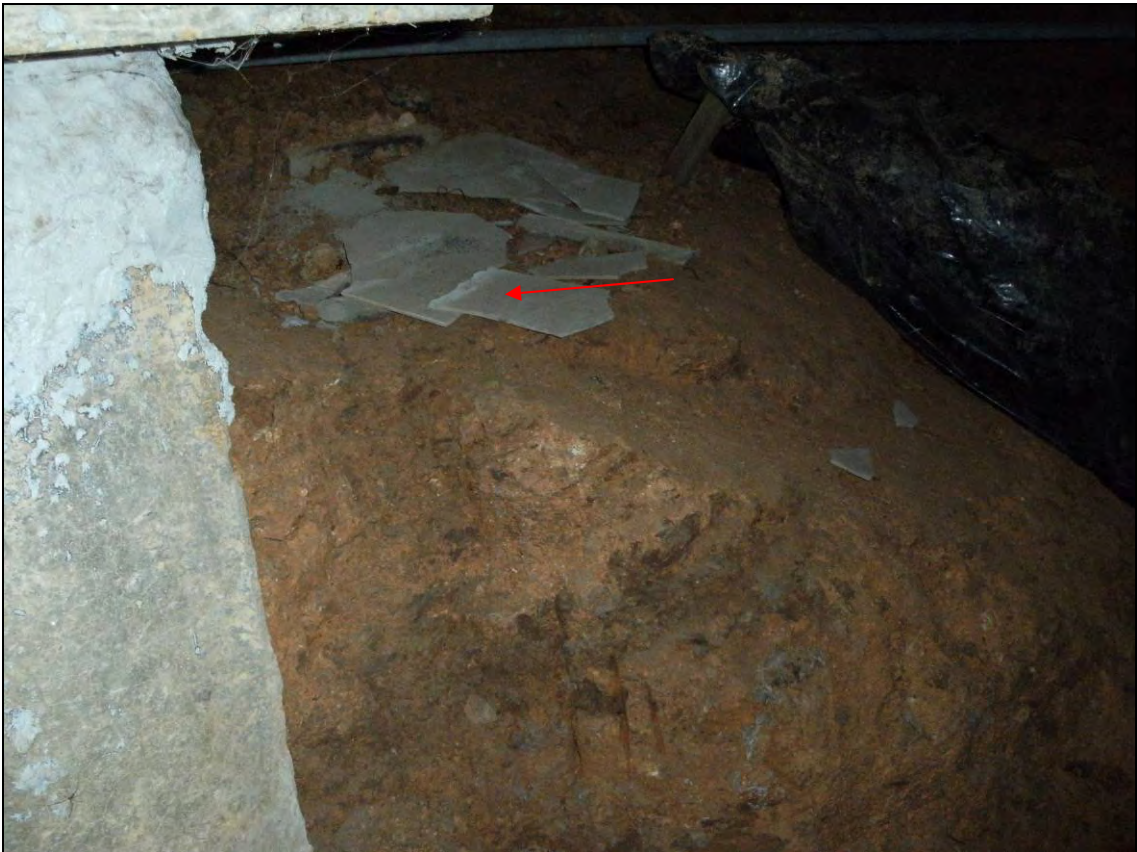
Fragments of what appeared to be fibro cement material were located within the sub floor area accessed via the main reception – Sample Resort 1 – No Asbestos Detected.

Print 10
Resort Sub Floor Fibro Fragments
