# D1 Supplementary Asbestos Assessment

WFY:jlb  
Project 71102.02  
19 July 2010

**FACTUAL LETTER REPORT  
SUPPLEMENTARY ASBESTOS ASSESSMENT  
WASTE AND RESOURCE MANAGEMENT FACILITY  
ORCHARD HILLS**

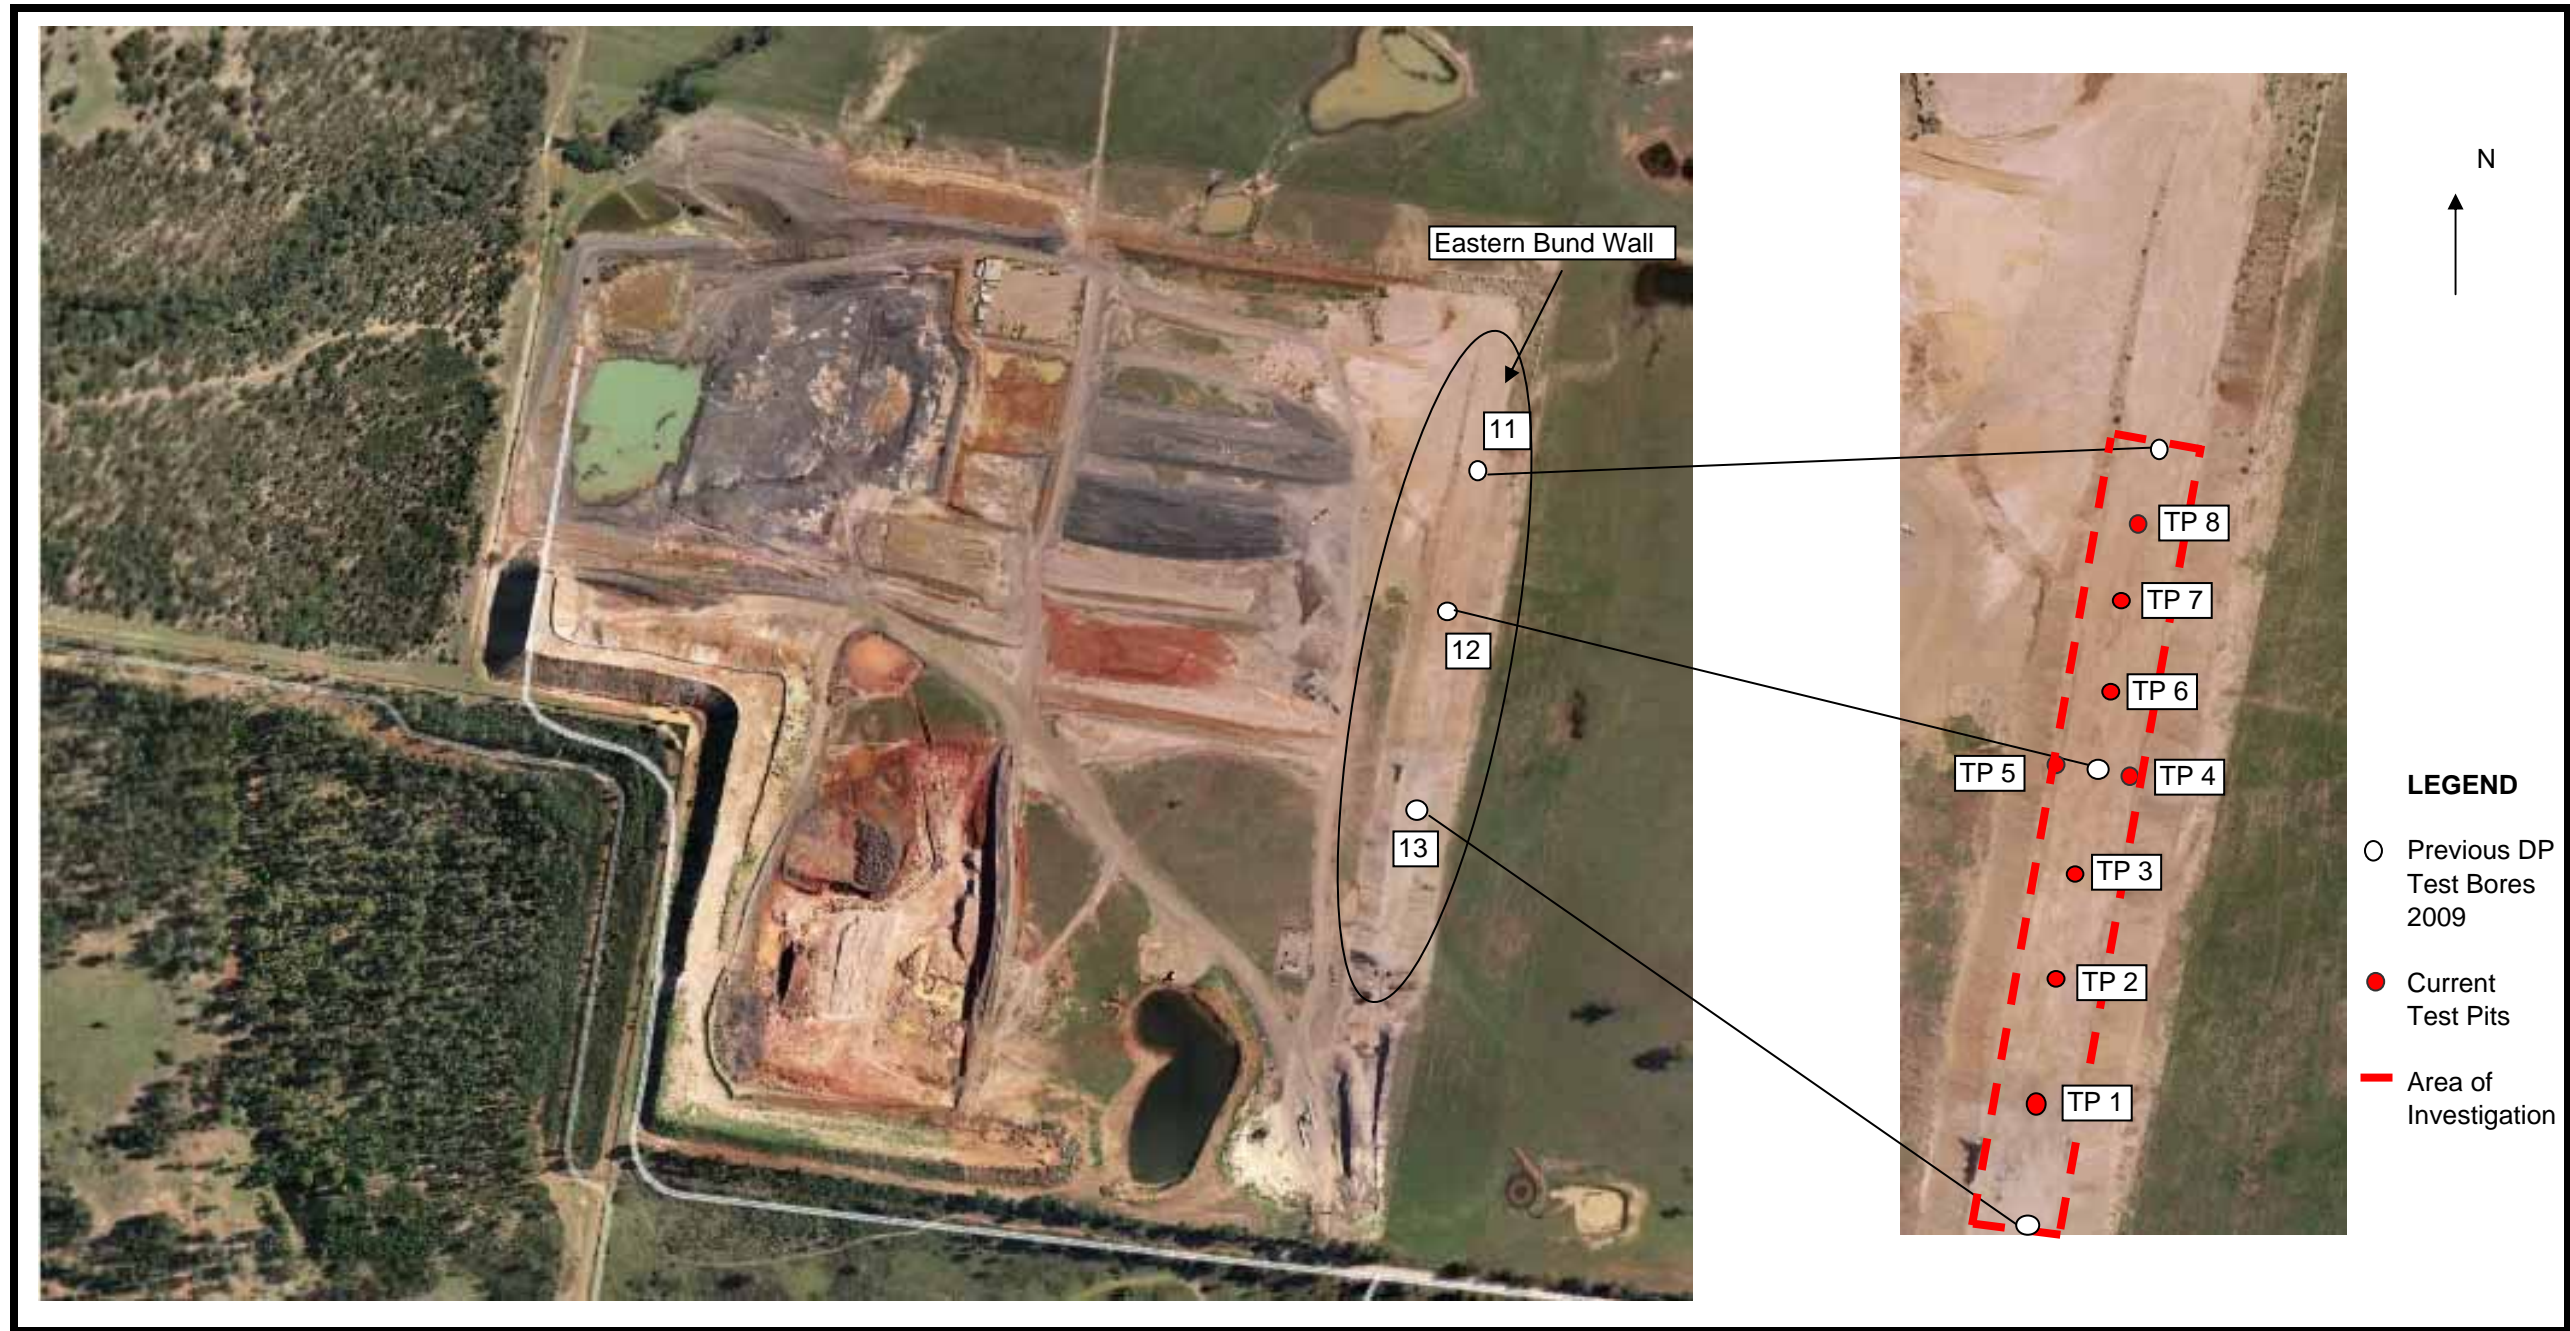
Eight test pits were excavated on 31 May 2010 as shown on Drawing 1 attached.

It should be also noted that the current investigation is limited to the area within the vicinity of BH12 and limited by bores BH11 and BH13 as marked in Drawing 1 and does not extend beyond this area.

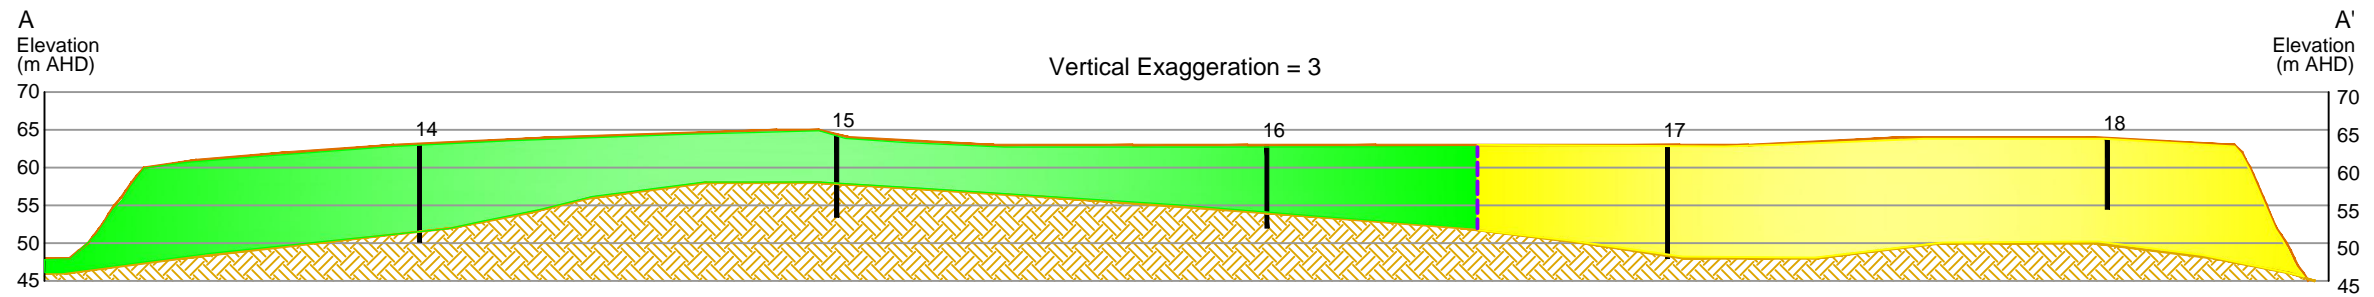
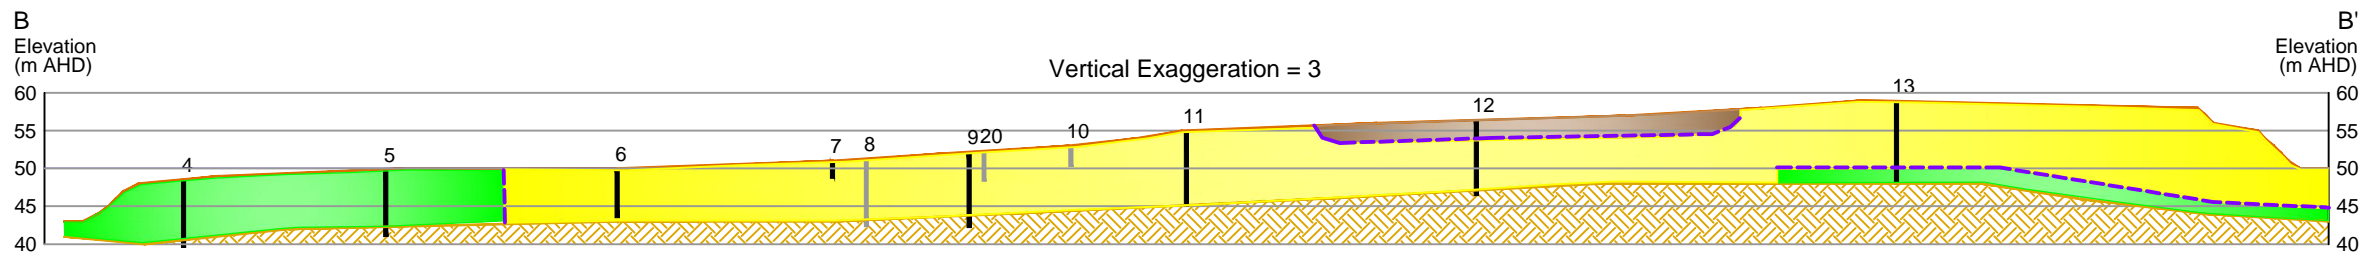
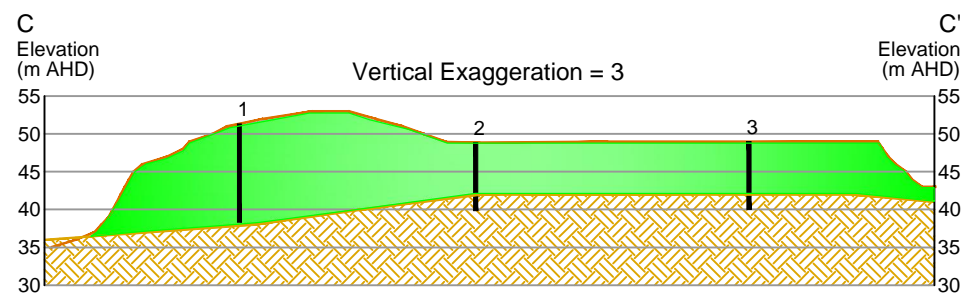
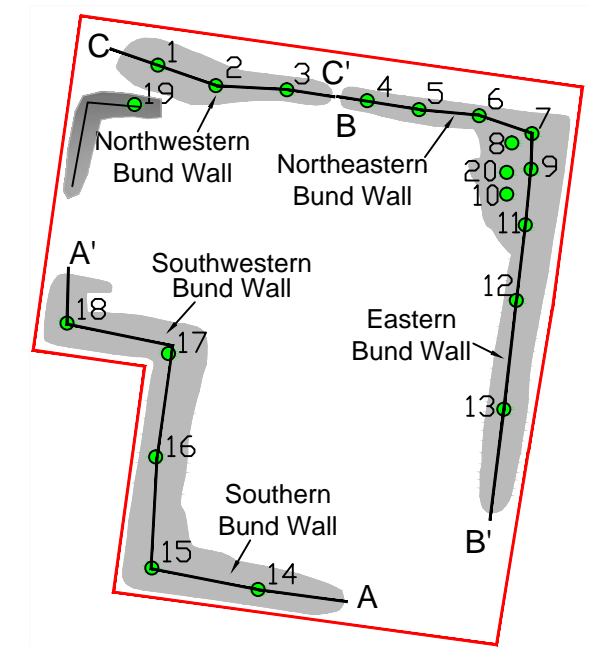
Figure 3  
 BUND WALL SECTIONS

*The Waste Classification Guidelines* (NSW DECC, 2008, revised 2009) defines asbestos waste as 'any waste that contains asbestos' and is classified therein as 'Special Waste'. The approximate vertical and horizontal distribution of Special Waste in the bund walls as identified in the August 2009 report by DP is shown on Figure 3 attached hereto.

It should be noted that the depiction of the Special Waste materials shown on Figure 3 as extracted from DP's August 2007 report is indicative only. The August 2009 report recommended that further step-out sampling be undertaken to examine the lateral and vertical extent of Special Waste.

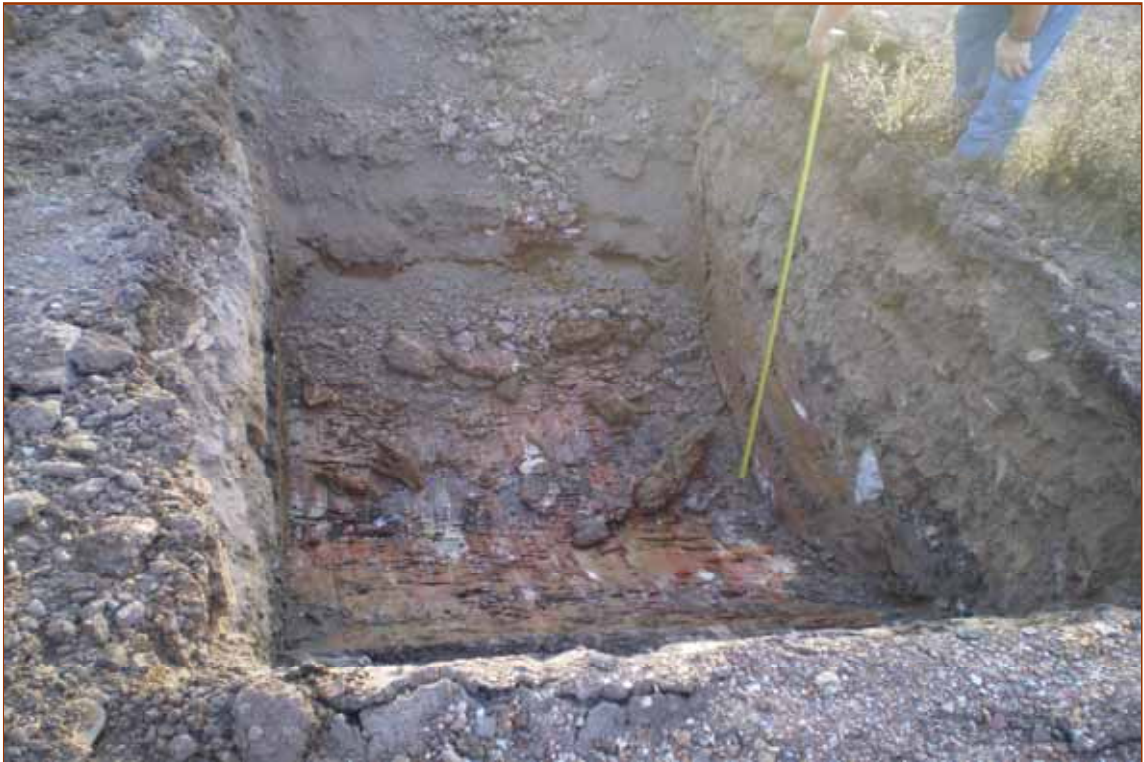
PHOTO 2: Test Pit 2

**REMARKS:** \*2 small pieces of fibre-cement fragments found - sample taken

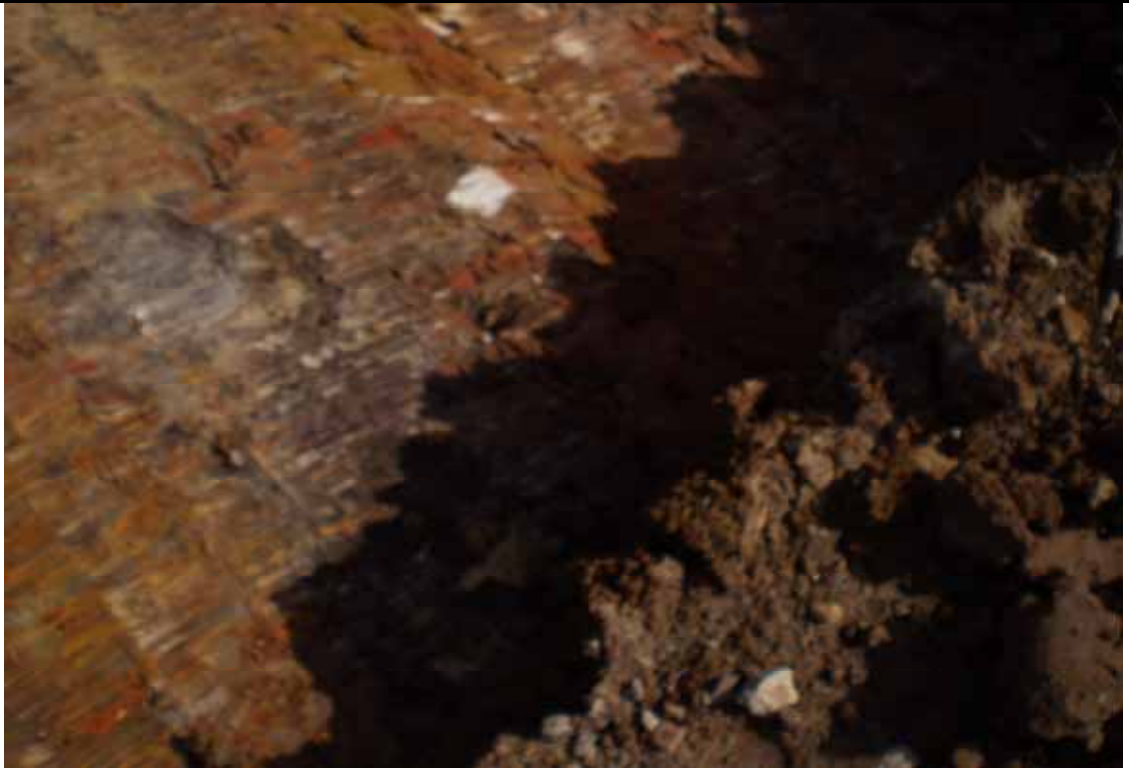
PHOTO 3: Test Pit 3

**REMARKS:** \*4 pieces of fibre-cement fragments found - sample taken  
 \*\*4 pieces of fibre-cement fragments found - sample taken

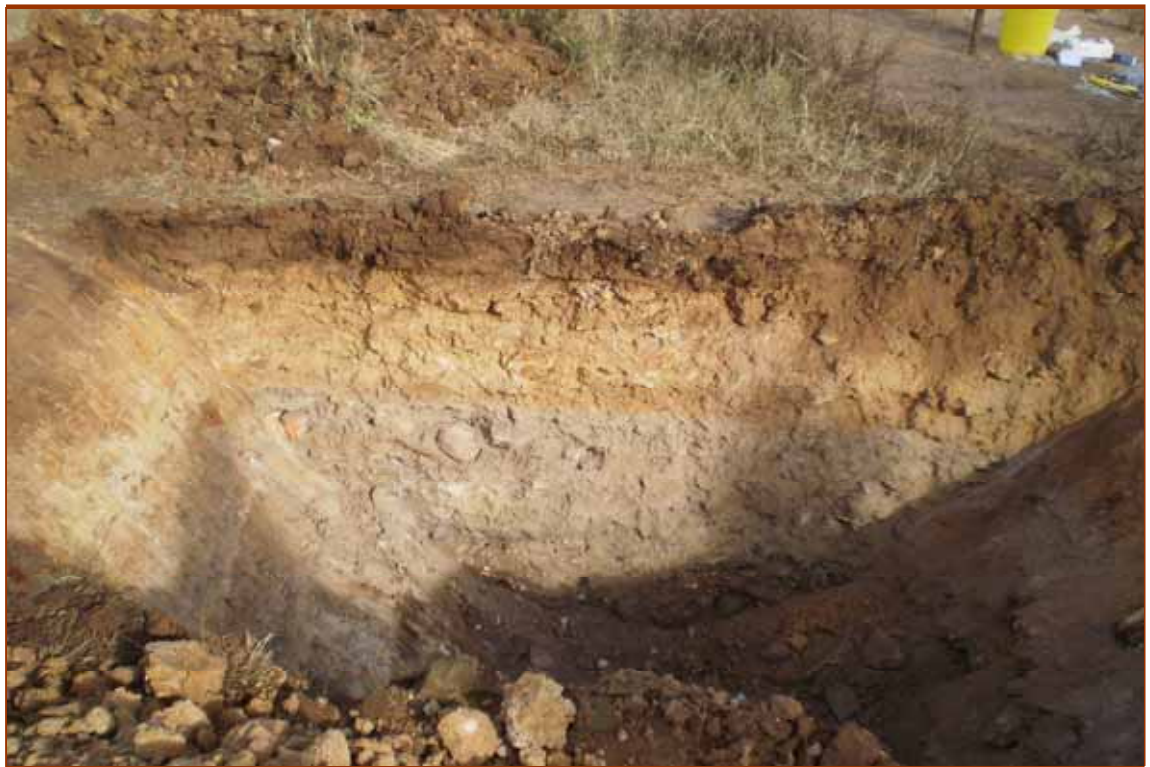
PHOTO 4: Test Pit 4

**REMARKS:** \*A piece of fibre-cement fragment found - sample taken

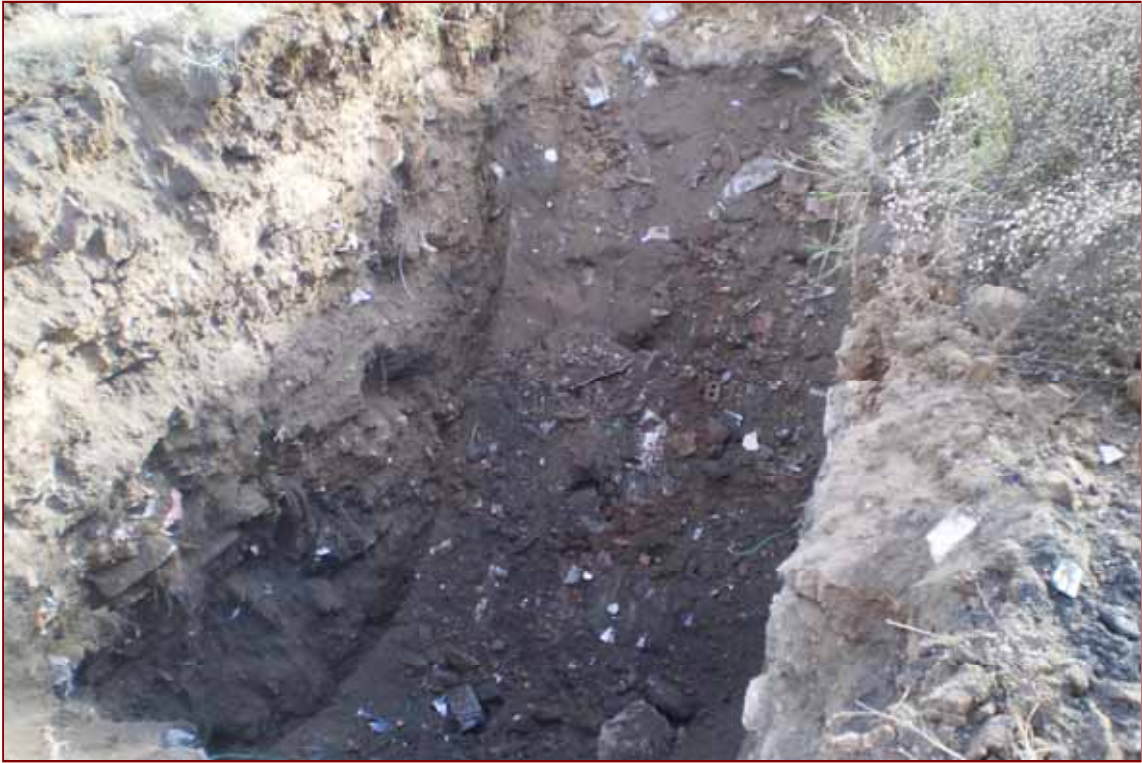
PHOTO 5: Test Pit 5

REMARKS: \*4 pieces of fibre-cement fragments found - sample taken

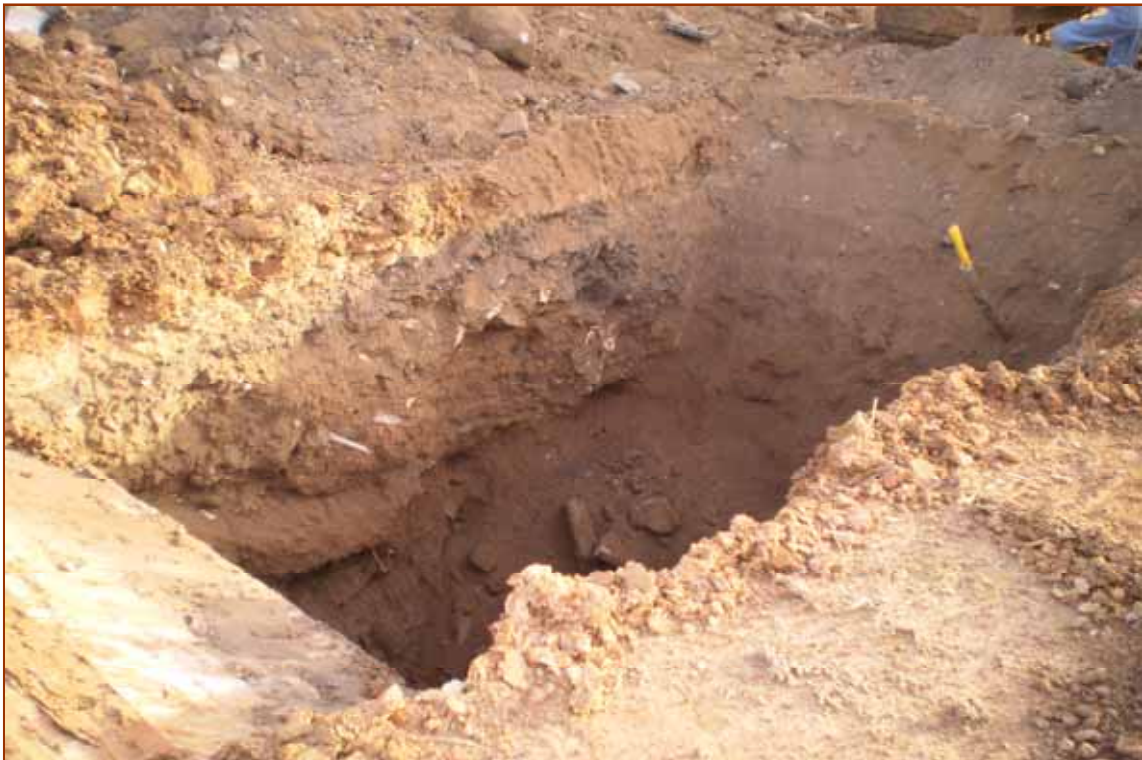
PHOTO 6: Test Pit 6

**REMARKS:** \*2 pieces of fibre-cement fragments found - sample taken

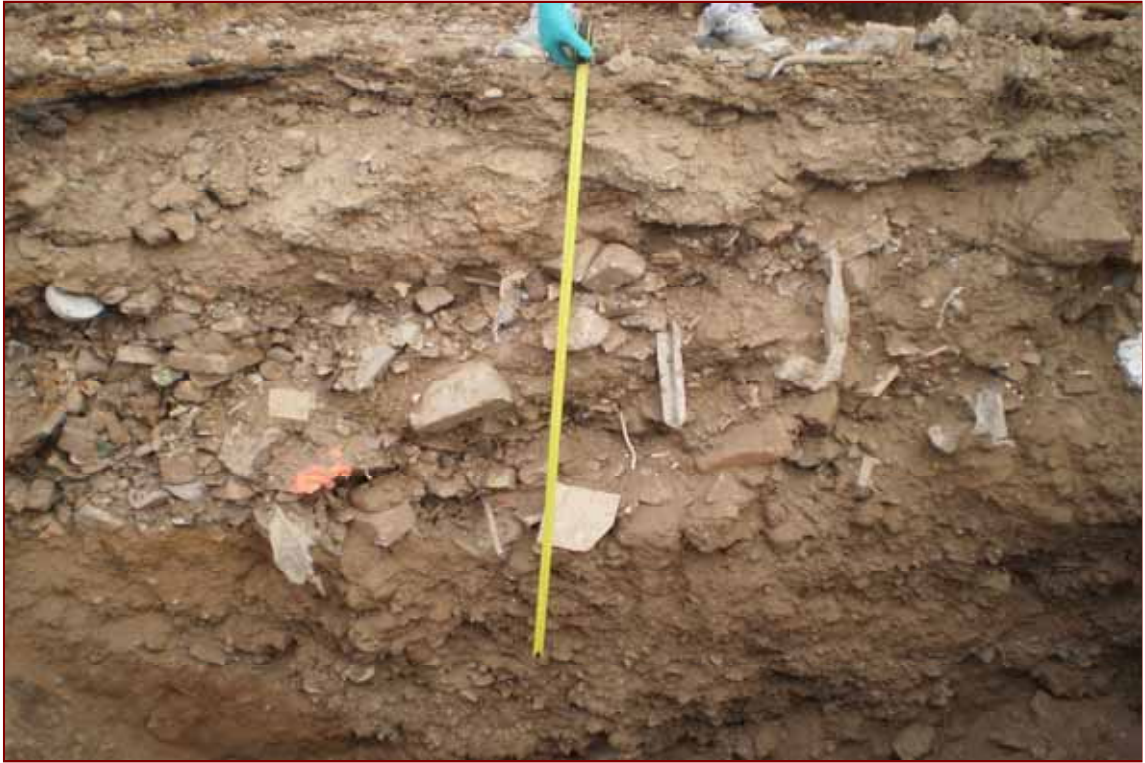
PHOTO 7: Test Pit 7

**REMARKS:** \*A piece of fibre-cement fragment found - sample taken  
 \*\*2 pieces of fibre-cement fragments found - samples taken

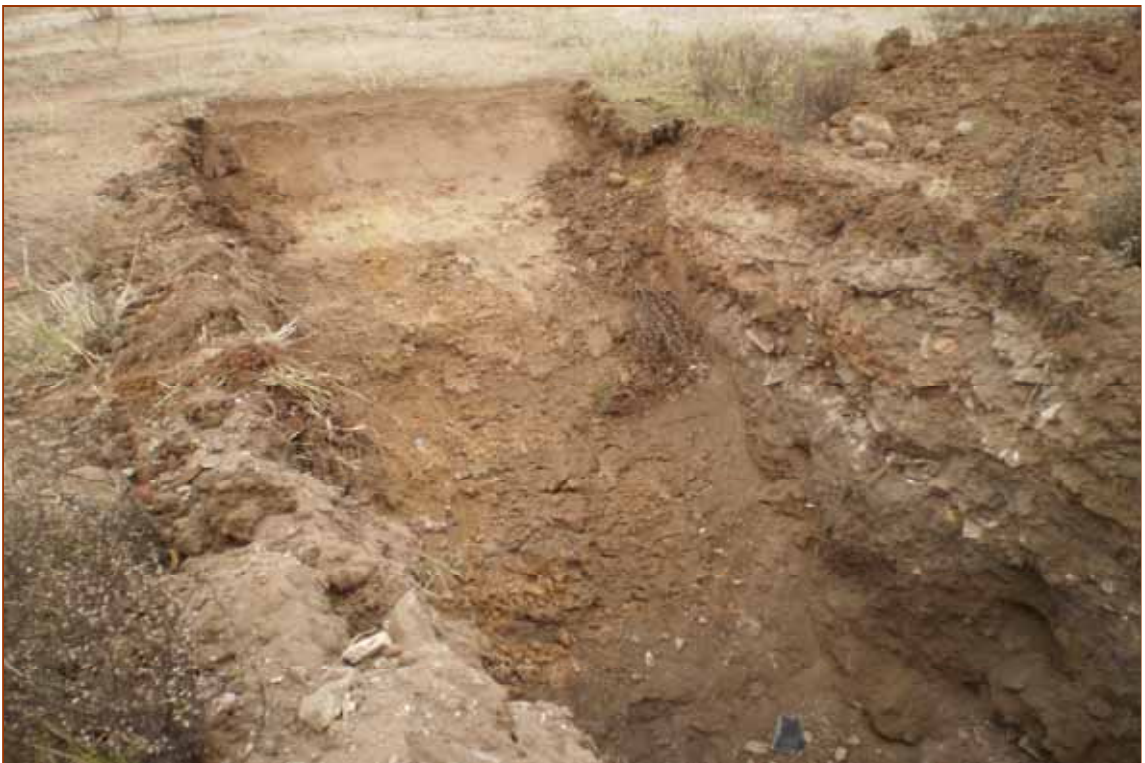
PHOTO 8: Test Pit 8

One selected sample of fibrous cement from Test Pit 8 was analysed for asbestos fibres and was found to contain chrysotile asbestos. All other fibre-cement fragments observed in the field and noted in Table 1 are also considered likely to contain asbestos indicating that all test pits except TP1 are asbestos bearing to a greater or lesser extent.

REMARKS: \*4 pieces of fibre-cement fragments found - samples taken

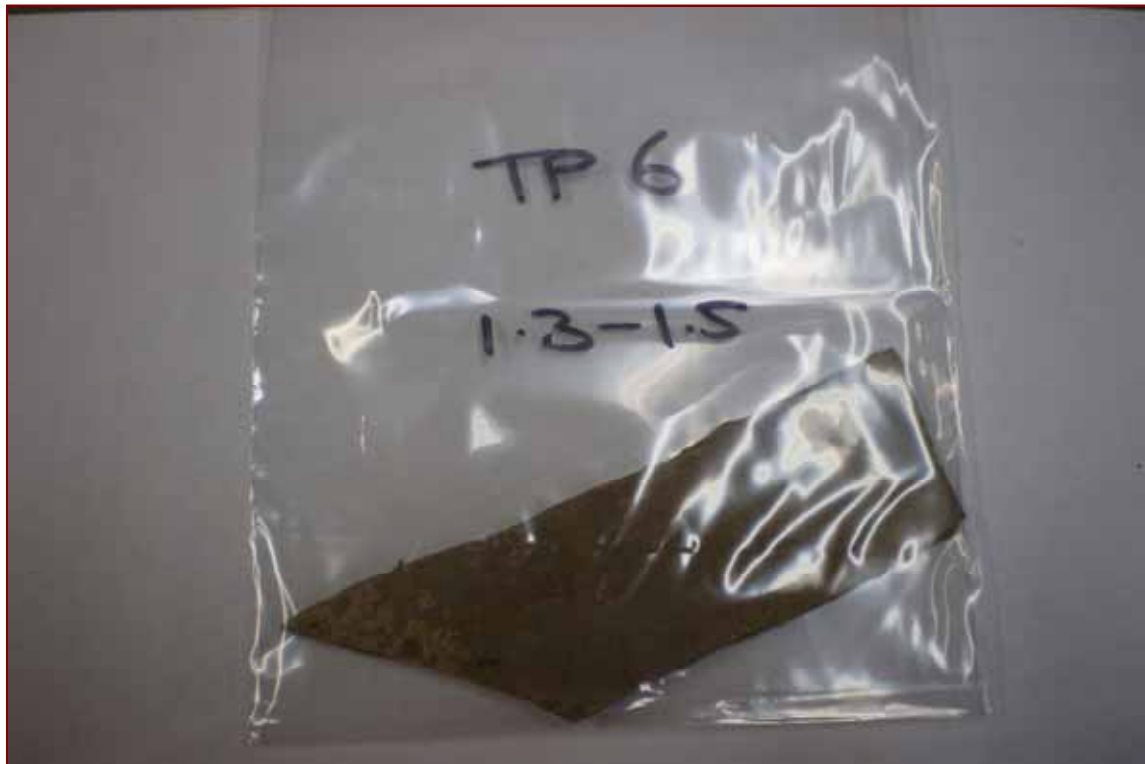
Fibre cement fragments were observed in all test pits except Test Pit 1. The dimensions of fibre-cement fragments generally range from 50 x 10 mm (Photo 10) to 90 x 40 mm (Photo 9). It should be noted that the observations made in Table 1 do not necessarily reflect the analytical presence of fibres in the matrix as fibres are generally more difficult to visually identify during fieldwork than are fibre-cement fragments.

PHOTO 9: A fibre-cement fragment found in TP6 between 1.3 and 1.5 m. Dimension: 90 x 40 mm

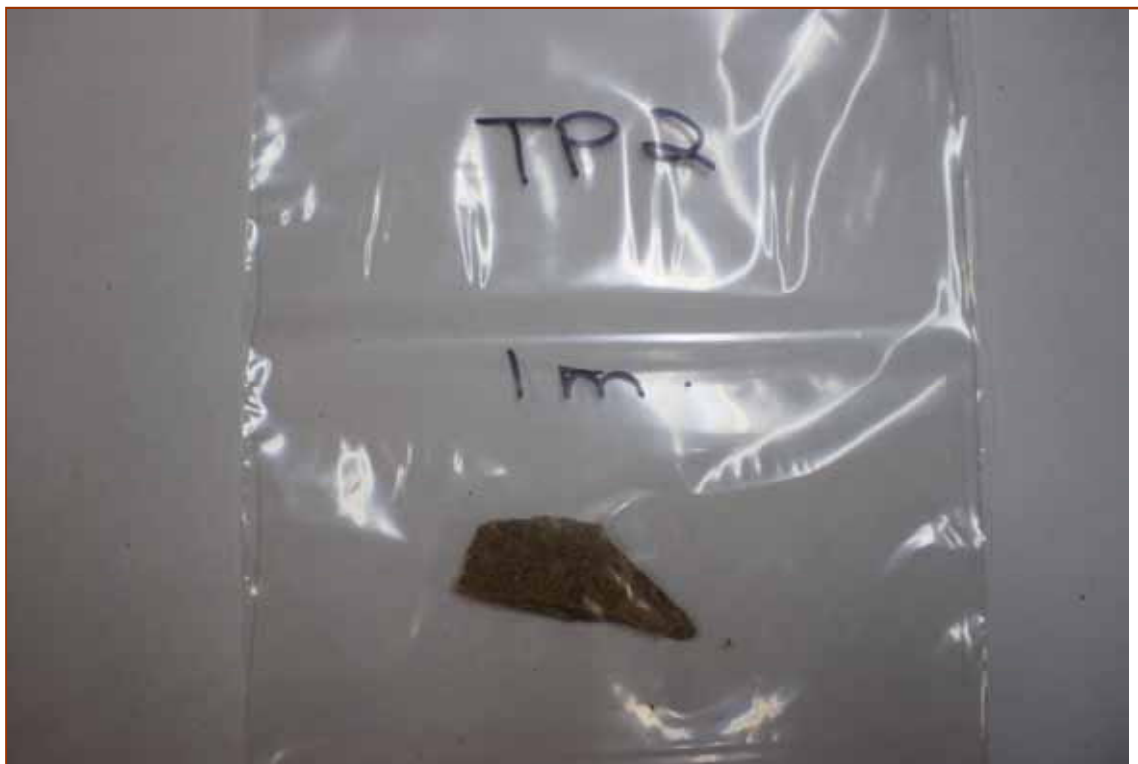
PHOTO 10: A fibre-cement fragment found in TP2 at 1 m. Dimension: 50 x 10 mm
