| Location | Wallace Wurth Building Upgrade UNSW. |
| Document Type | Arboriculture Assessment for Project Application |
| Date/Time | 15 <sup>th</sup> June 2010 |

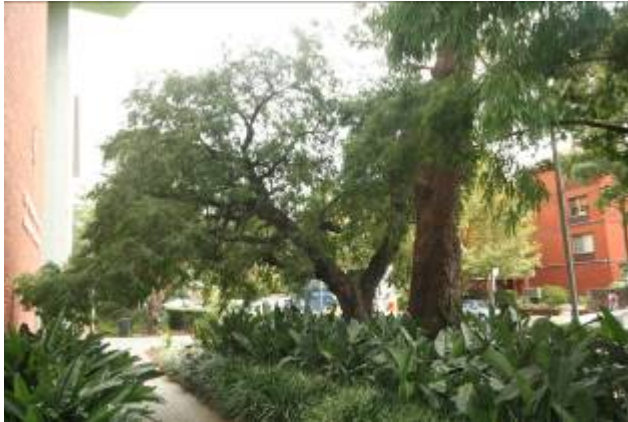
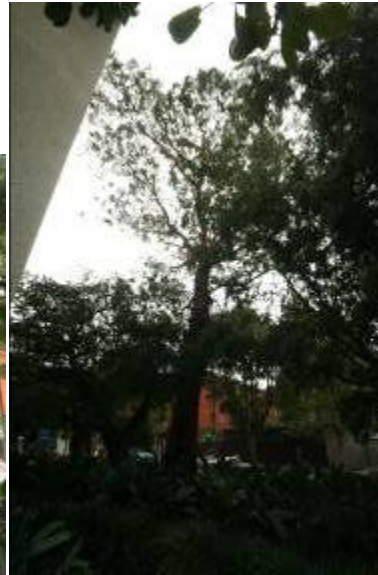
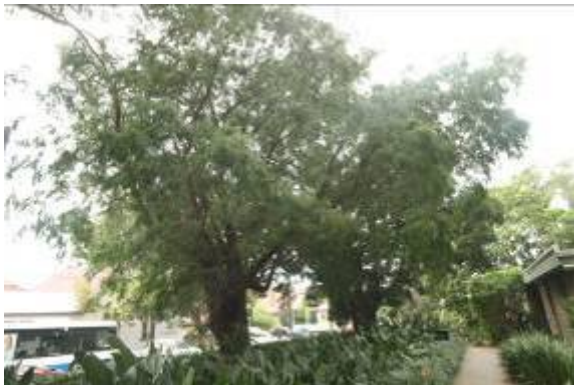
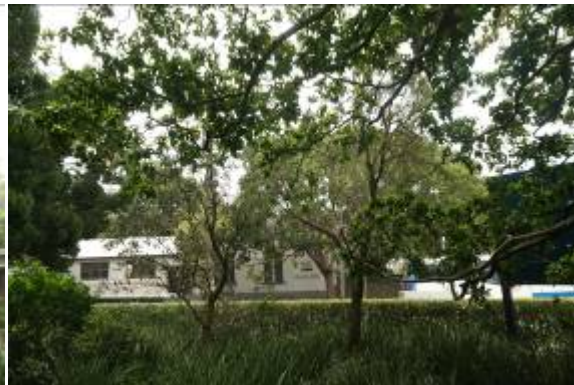
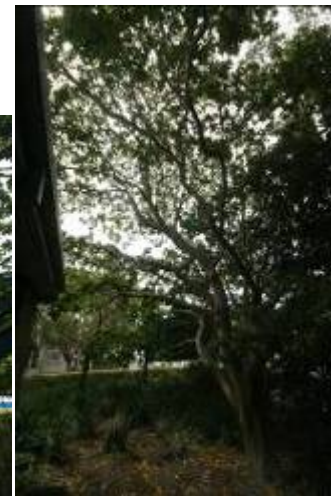
| Tree No | Species | Height (m) | Trunk Diameter (DBH*) | Canopy Spread (m) | Estimated Age Class | TPZ ** | SULE *** | Observations and comments |
|---|---|---|---|---|---|---|---|---|
| 1 | <i>Agonis flexuosa</i> | 7 | .59 | 8 | Mature | 7m<br>SRZ 3.2 | Medium | This semi mature tree is located close to the existing building, has average health and average form for the species. The tree has no significant defects evident. |
| 2 | <i>Eucalyptus scoparia</i> | 18 | .90 | 10 | Mature | 10m<br>SRZ 4.5m | Medium | This mature tree is located close to the existing building, has average health and average form for the species. The tree has strong reaction wood and a lean to light but no significant defects evident. |
| 3 | <i>Agonis flexuosa</i> | 8 | .71 | 9 | Mature | 8.4m<br>SRZ 3.5 | Medium | This semi mature tree is located close to the existing building, has average health and average form for the species. The tree has no significant defects evident. |
| 4 | <i>Podocarpus falcatus</i> | 14 | .70 | 12 | Mature | 8.4m<br>SRZ 3.5 | Medium | This mature tree is located near an existing building, has average health and average form for the species. The tree has no significant defects evident. |
| 5 | <i>Banksia integrifolia</i> | 5 | .10 | 2 | Semi mature | 1.5m<br>SRZ 1.5m | Medium | This semi mature tree is located near an existing building, has average health and average form for the species. The tree has no significant defects evident. |
| 6 | <i>Callistemon viminalis</i> | 7 | .10 | 4 | Semi mature | 1.5m<br>SRZ 1.5 | Medium | This semi mature tree is located near an existing building, has average health and average form for the species. The tree has no significant defects evident. |
| 7 | <i>Calodendron capense</i> | 13 | .55 | 12 | Mature | 6.5m<br>SRZ 3.25m | Medium | This semi mature tree is located near an existing building, has average health and average form for the species. The tree has no significant defects evident. |

Pictured above left tree 1 on site. Pictured above right tree 2 on site. Pictured below left are trees 3 & 4. Pictured below centre are trees 5 & 6. Pictured below right is tree 7.

It is recommended that trees 1 – 3, tree 10, tree 24 and tree 25 are retained in good condition for the duration of the works using the Australian Standard AS4970 2009 Protection of trees on development sites. Regular site inspections by a level 5 Arborist should be completed to ensure the appropriate tree protection measures and recognised horticultural practices are being utilised to keep these trees in good condition for the duration of the works.

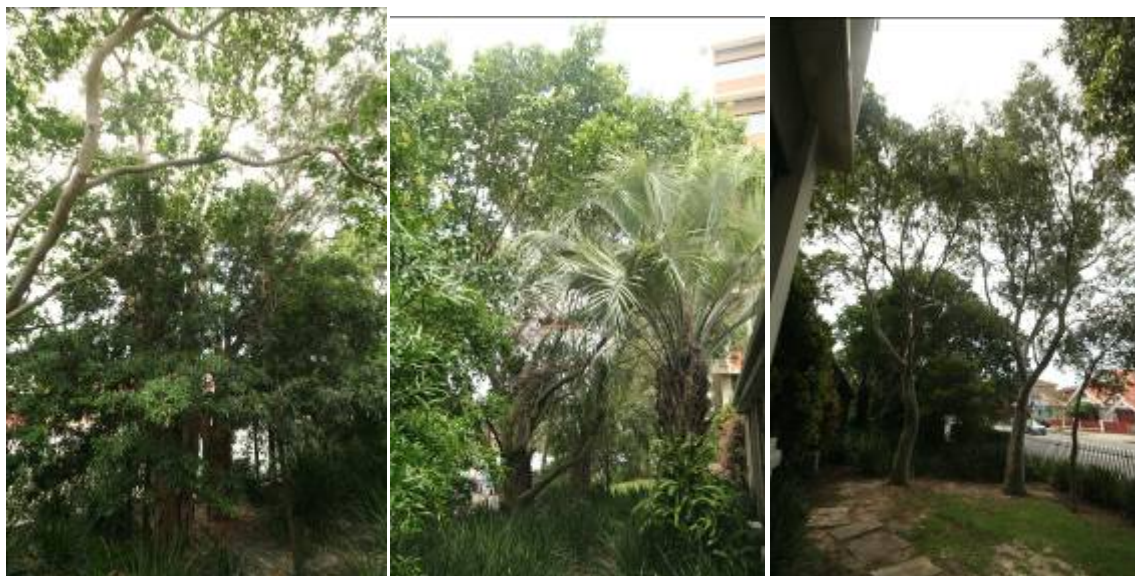
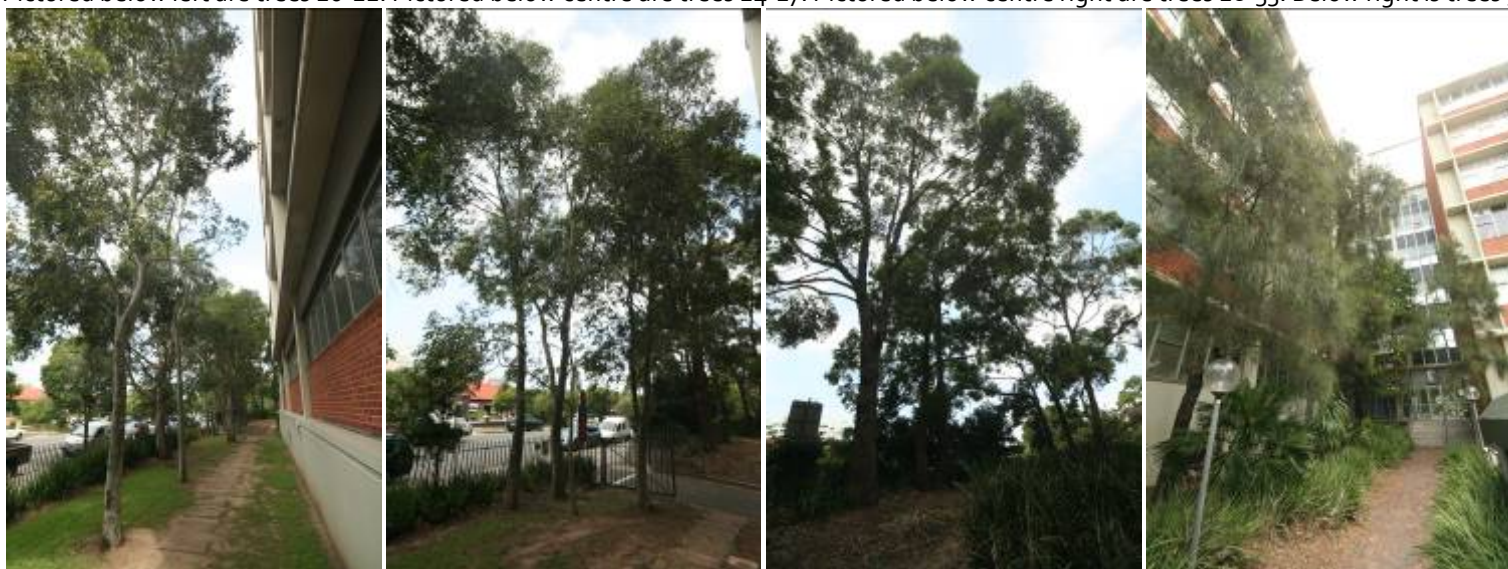
Pictured above right are trees 8 & 9 with smaller trees 10,12,13,14. Above centre are trees 11 & 15. Pictured above right are trees 19 & 18. Pictured below left are trees 20-22. Pictured below centre are trees 24-27. Pictured below centre right are trees 28-33. Below right is trees 34-38.

It is recommended that trees 4-9, trees 11- 23 and trees 26 -38 are removed due to their position in relation to the works. It would be difficult to recommend replacing these trees as the UNSW has an excellent tree planting policy in place and there is little or no room on this site for more trees. Trees 12 – 17 are small trees that can be relocated on site.
