MACDONALDTOWN GASWORKS REMEDIATION

Structural stability assessment of southern gasholder

Preliminary phase

RailCorp NSW

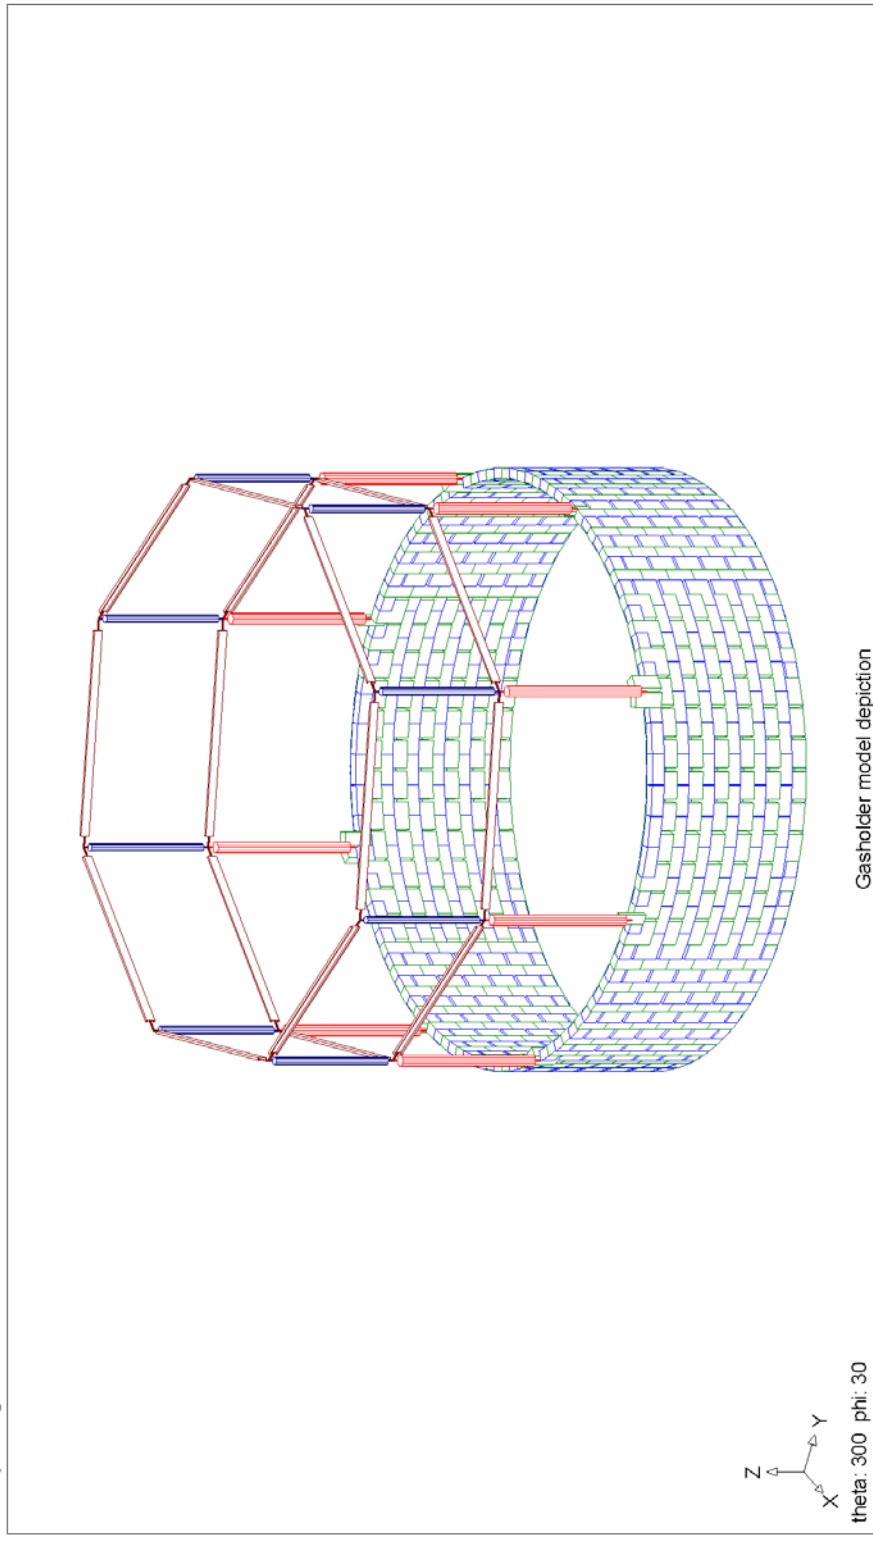
Figure 1: Microstran model used for preliminary analysis

A depiction of the model used is at Figure 1.

The analysis results show that soil excavation can proceed around the gasholder to the depth of the brickwork providing the gasholder is first emptied of water.

In order to determine the limits for excavation with water not removed, analyses have also been carried out with three metre and one metre sections of the soil outside the annulus structure excavated and the water still in the tank. This was done to simulate excavation required for further investigation, again in a “worst case” scenario as no trench is likely to exceed an excavator bucket width at right angles to the wall. The three metre excavation produced tensile stresses in the brickwork which could be too high; the one metre excavation was acceptable, with only minimal tensile stresses which should not be maintained for a period. It is therefore considered prudent that investigation trenches be kept narrow and backfilled as soon as possible.

For planning purposes, the depth of excavation during remediation beside the gasholder should be limited to the depth to the bottom of the brickwork (yet to be determined) and sloped away from the base at angle of 45°.
