4.5 Heritage Aspects

5 Review of Previous Investigations

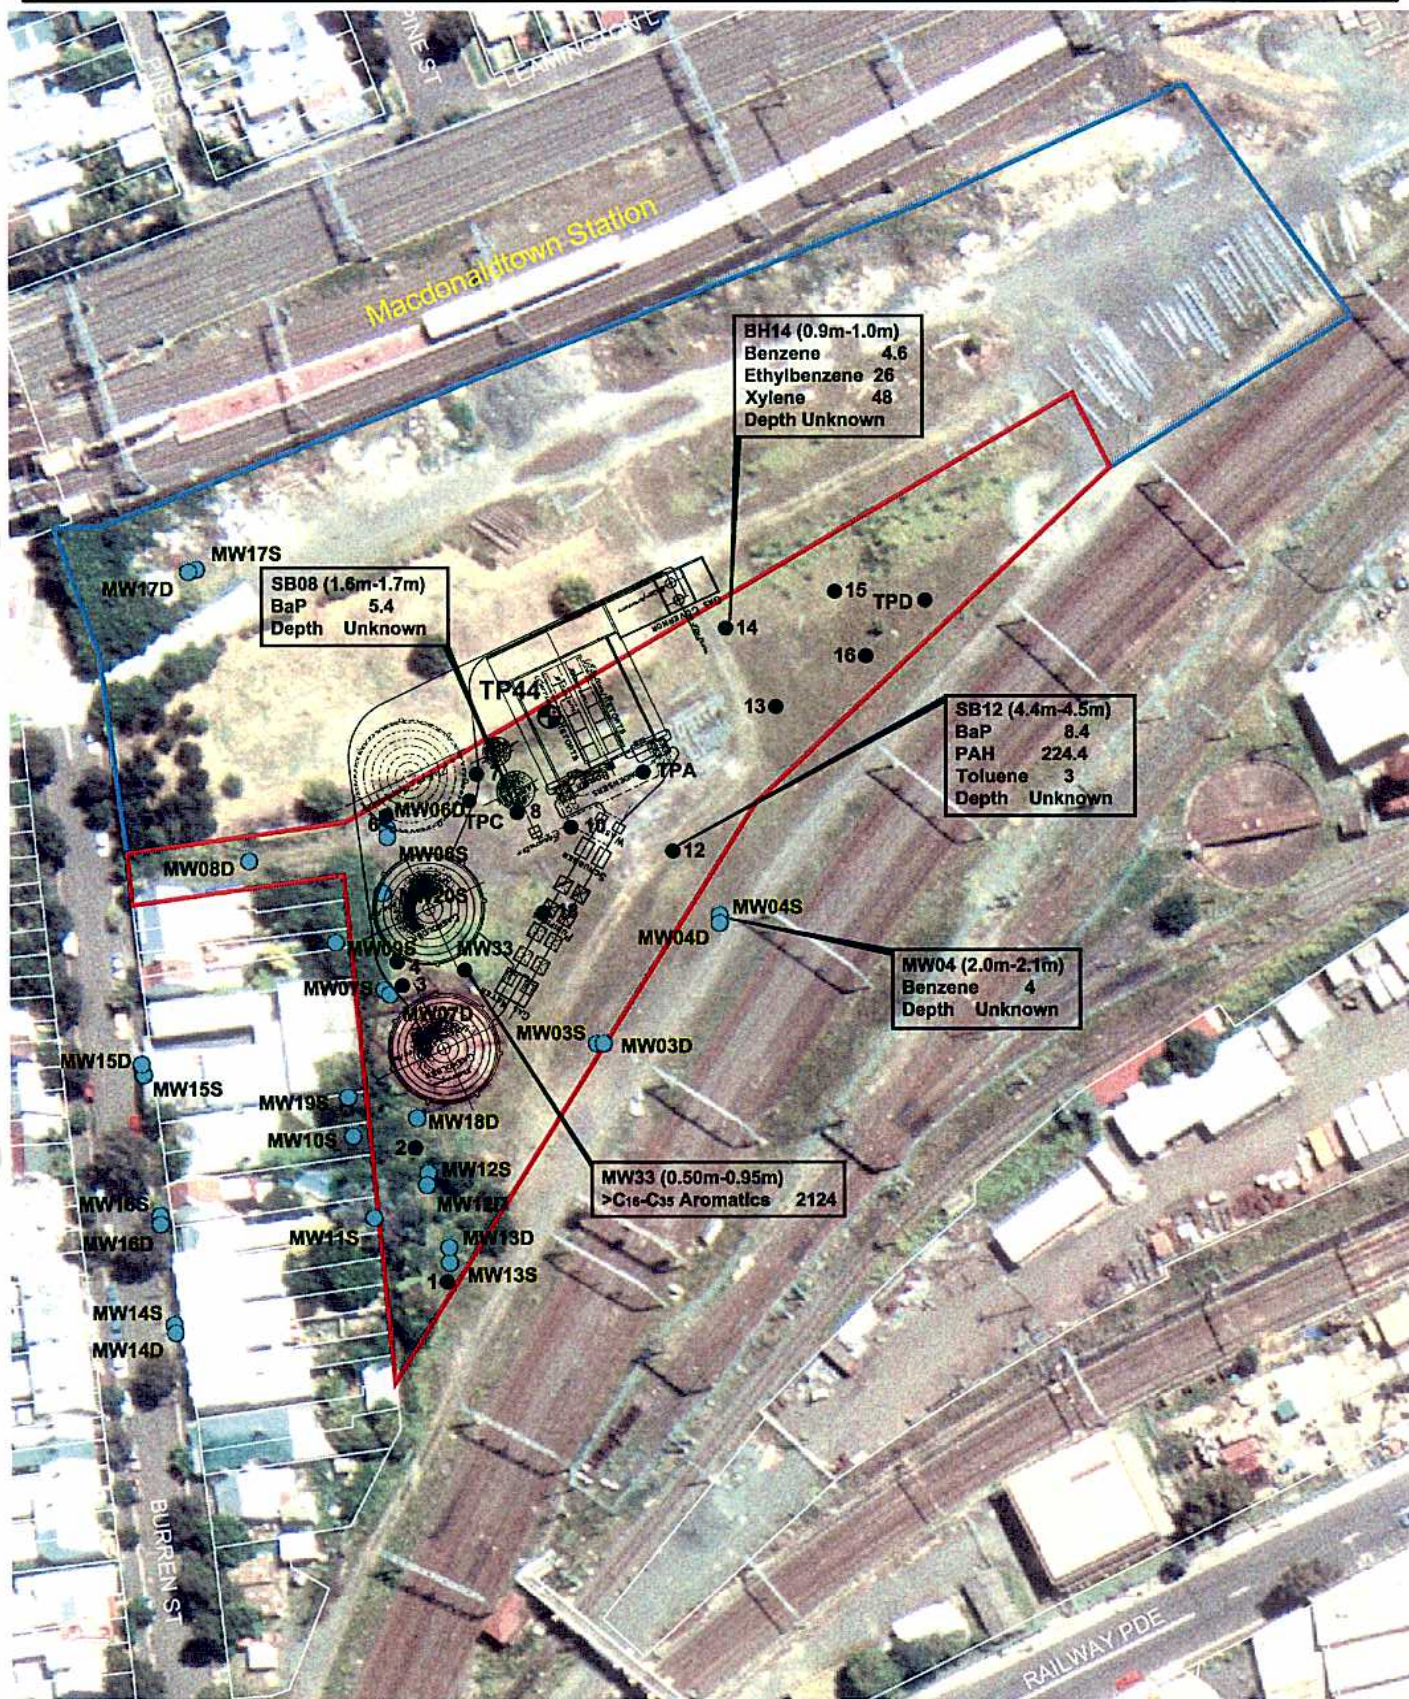
The locations where contamination was found by previous investigations to exceed Investigation Levels are shown in **Figures 7** and **8**, with copies of figures from earlier reports showing all sampling locations provided in **Appendix G**.

- Fill material was found to be widespread across the Former Gasworks area, varying between 0.1 to 3.2m in depth.
- Contamination including TPH, PAH and BTEX is widespread throughout the fill material but not in the underlying natural soils, as shown in **Figures 7 and 8**.
