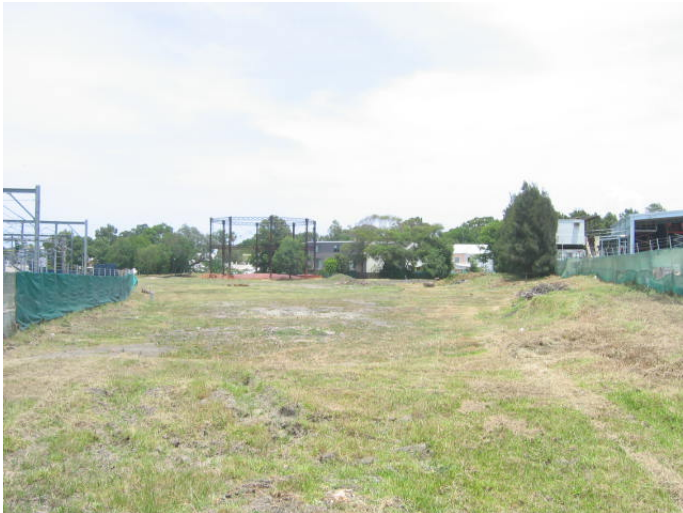
Photo 1 (Dec 06) – Overall view of the site, looking west

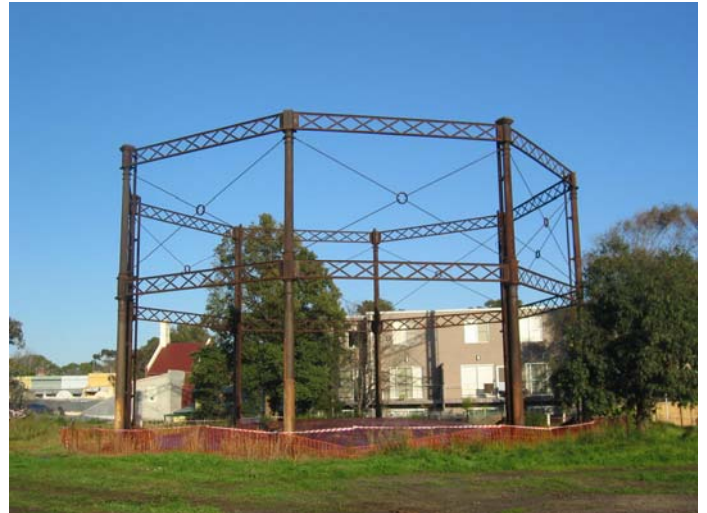
Photo 2 (Dec 06) – The existing (southern) gasholder

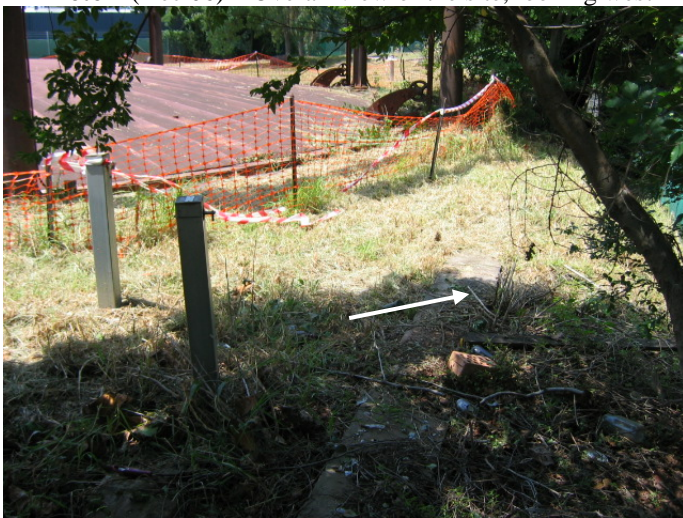
Photo 3 (Dec 06) – Communications cables located within ground level concrete trough, behind gasholder annuli (2m from fence which adjoins Burren St properties)

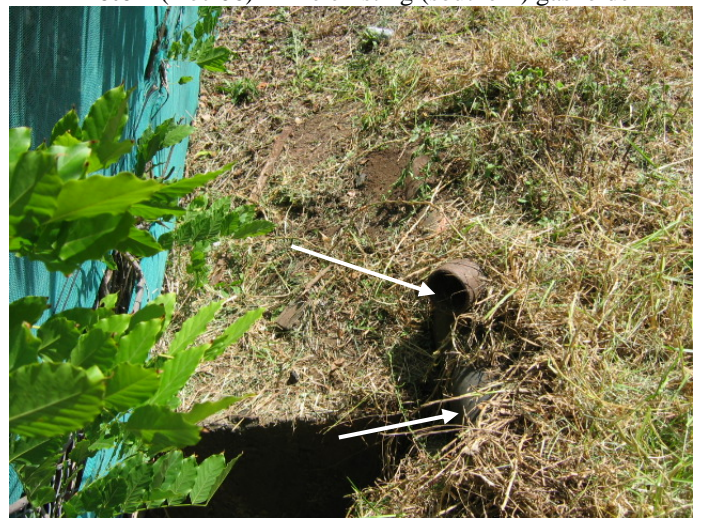
Photo 4 (Dec 06) – Sydney Water sewer line located under embankment (1m from fence which adjoins Burren St properties). Disused gasworks pipework also buried in embankment

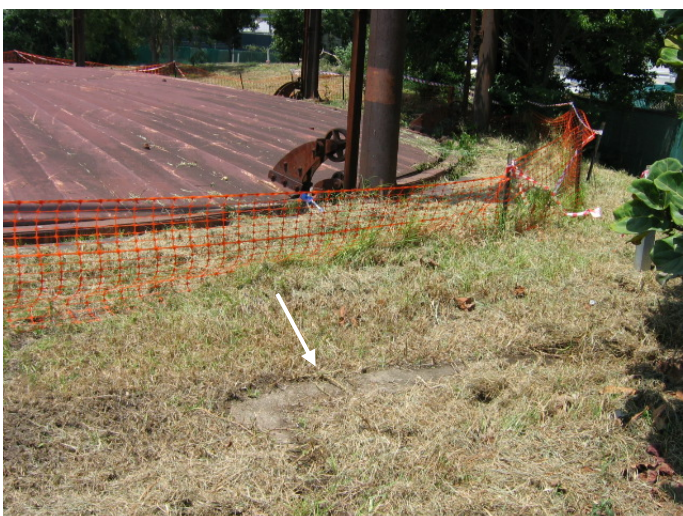
Photo 5 (Dec 06) – Concrete structure appears to be buried between the two gasholder annuli

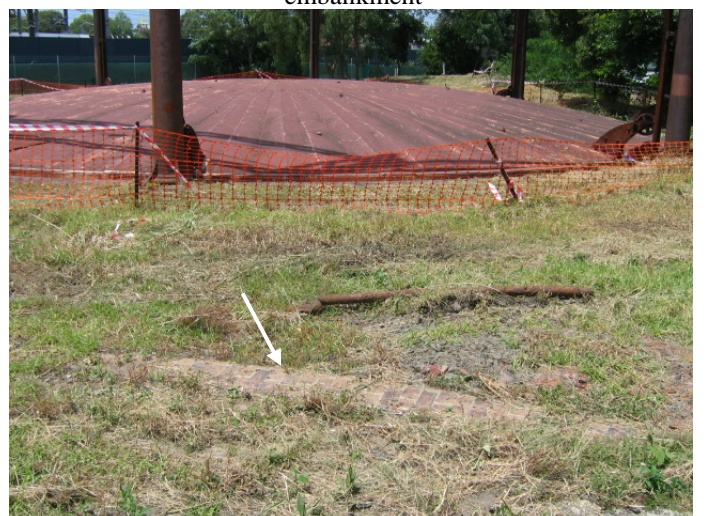
Photo 6 (Dec 06) – Annulus of demolished gasholder remains in situ, to the north of the existing gasholder

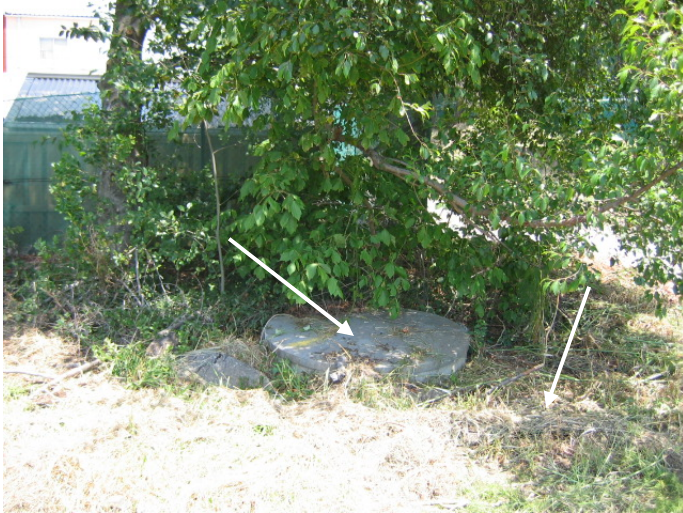
Photo 7 (Dec 06) – Cable pit (0.5m deep) which services communications cables, is located within 0.5m of the northern gasholder annulus (immediately behind 43 Burren St)

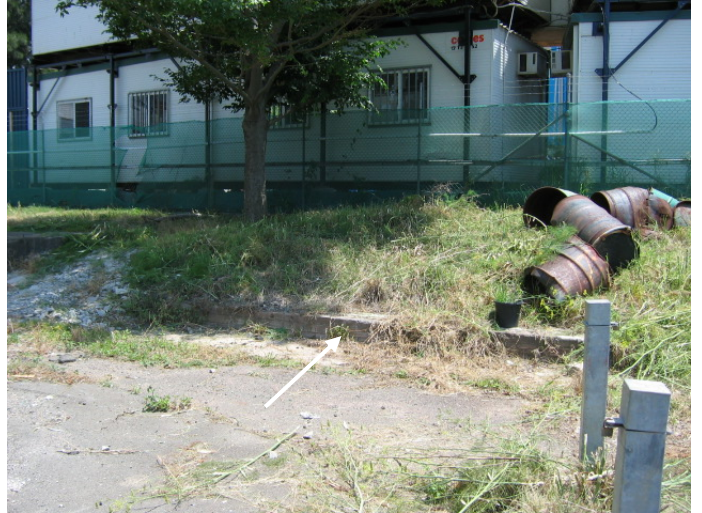
Photo 8 (Dec 06) – Low brick wall and concrete / tiled structure in the north west site area

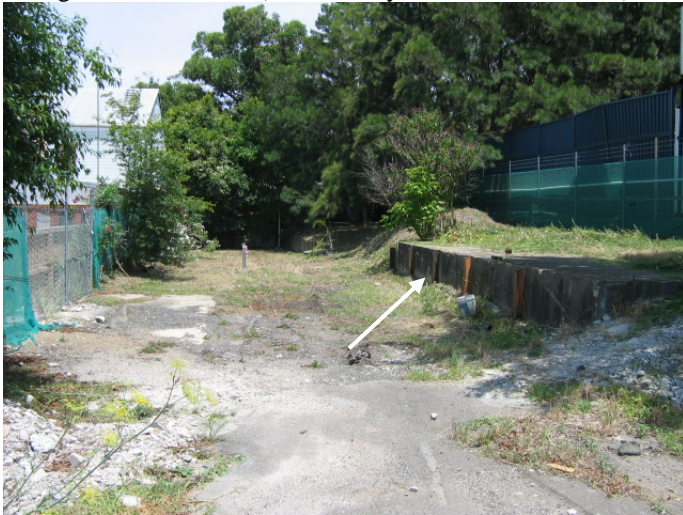
Photo 9 (Dec 06) – Concrete structure in the north west site area

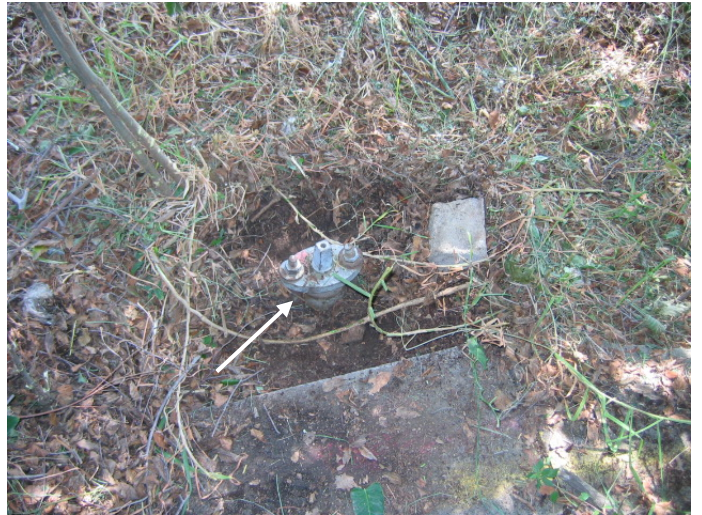
Photo 10 (Dec 06) – Pipework fitting located next to concrete troughing behind 43 Burren St

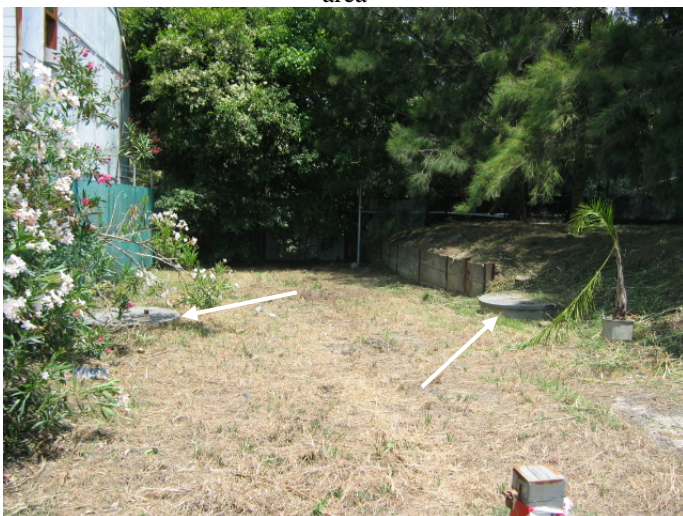
Photo 11 (Dec 06) – Cable pits servicing communications cables next to 43 Burren St (in north west site area)

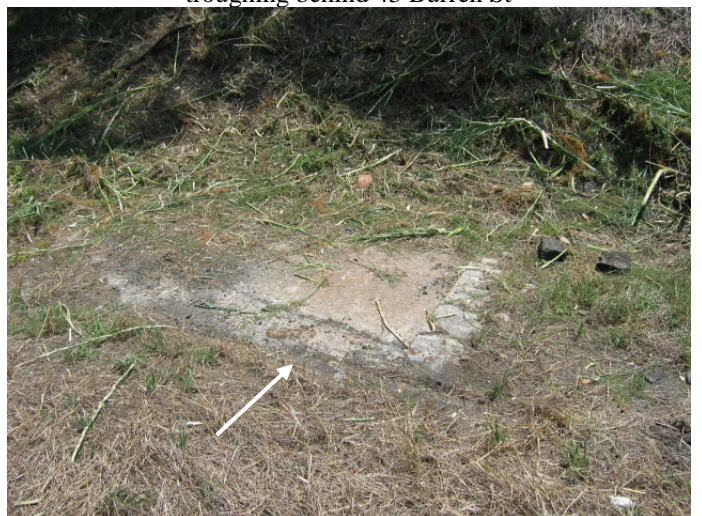
Photo 12 (Dec 06) – Buried concrete / brick structure in north west site area
