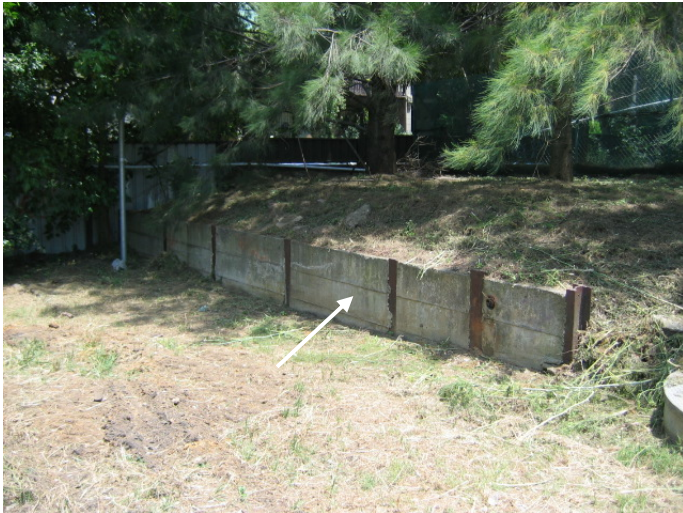
**Photo 13** (Dec 06) – Concrete retaining wall (with steel rails)

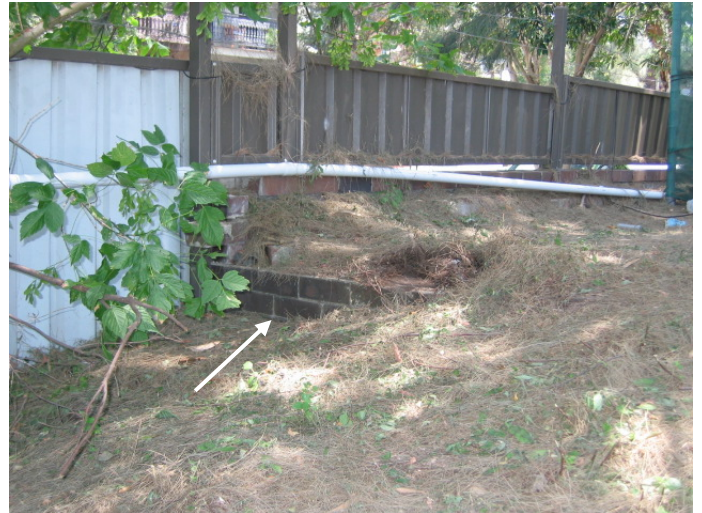
**Photo 14** (Dec 06) – Additional level of brickwork on top of retaining wall area

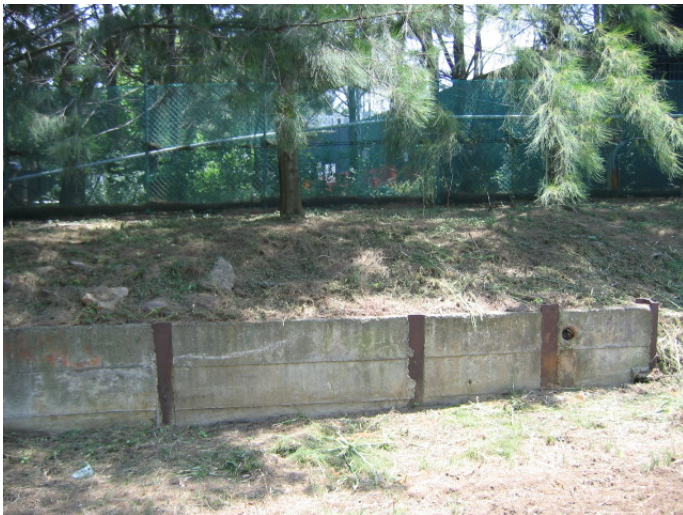
**Photo 15** (Dec 06) – Note difference in levels in north west area. Site is level with Burren Street, however area on top of retaining wall (and Stabling Yard surface level) is ~1.5m higher

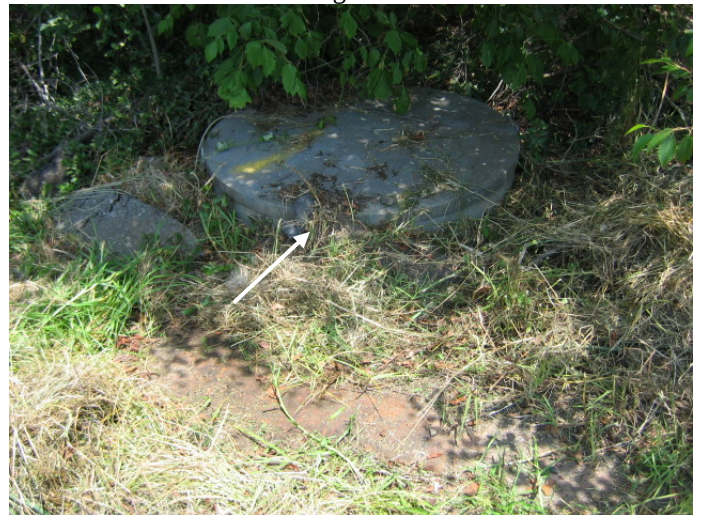
**Photo 16** (Dec 06) – Cable pit servicing communications cables in north west site area

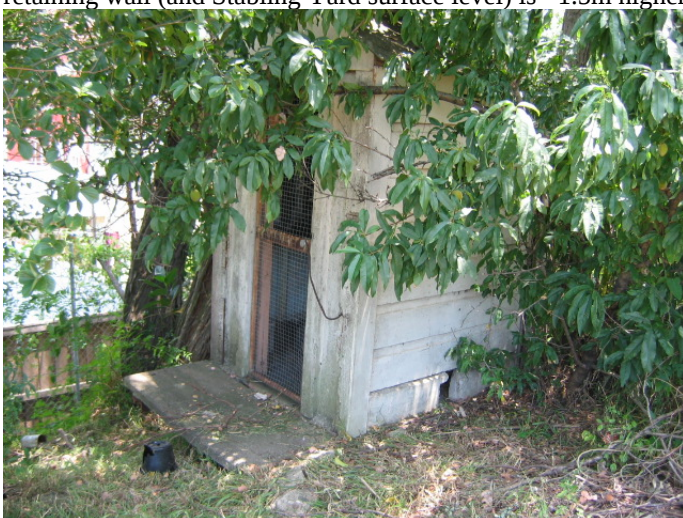
**Photo 17** (Dec 06) – Old electrical shed on embankment, south of the existing gasholder

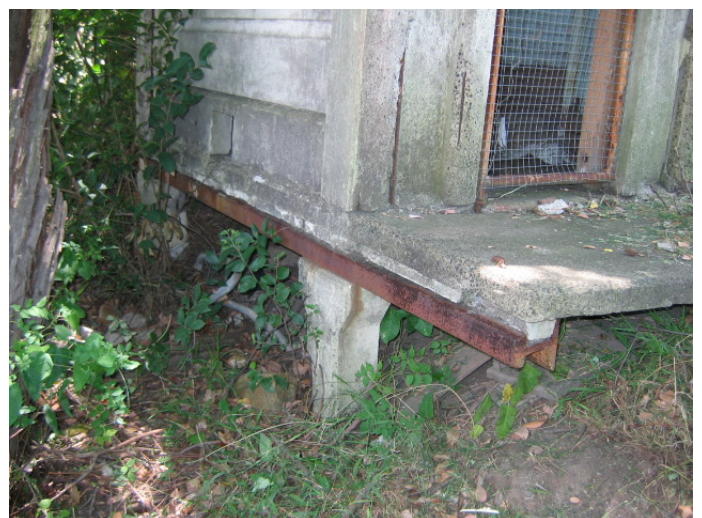
**Photo 18** (Dec 06) – Old electrical shed on embankment, south of the existing gasholder

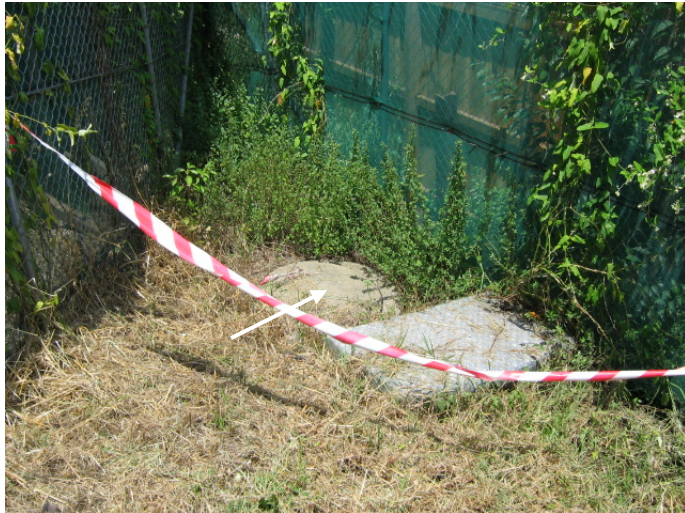
**Photo 19** (Dec 06) – Sydney Water sewer pit located in south west corner of site

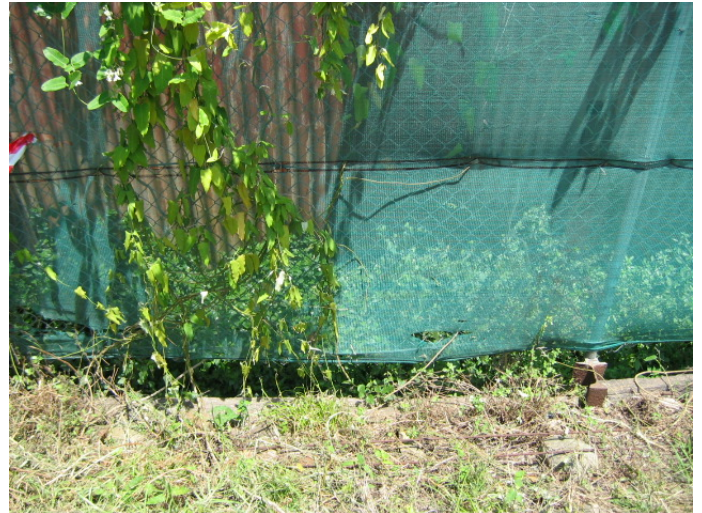
**Photo 20** (Dec 06) – Open drain located between western fenceline, and rear of Burren St properties. Drain is in poor condition and overgrown, and lies approx 1m below embankment level

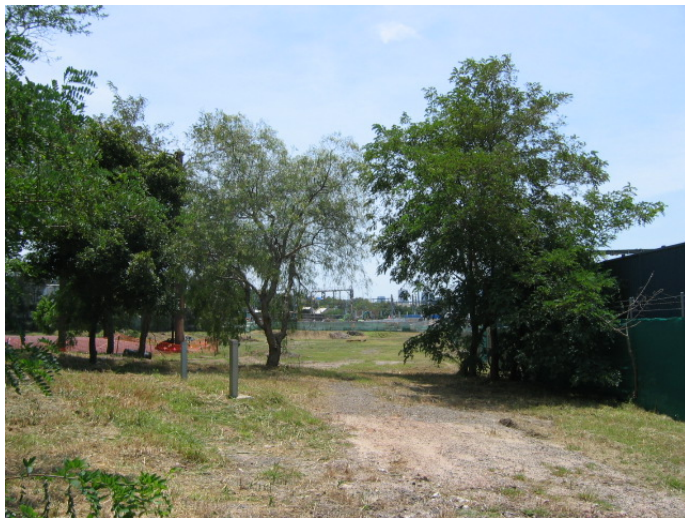
**Photo 21** (Dec 06) – Trees located to the south of the existing gasholder

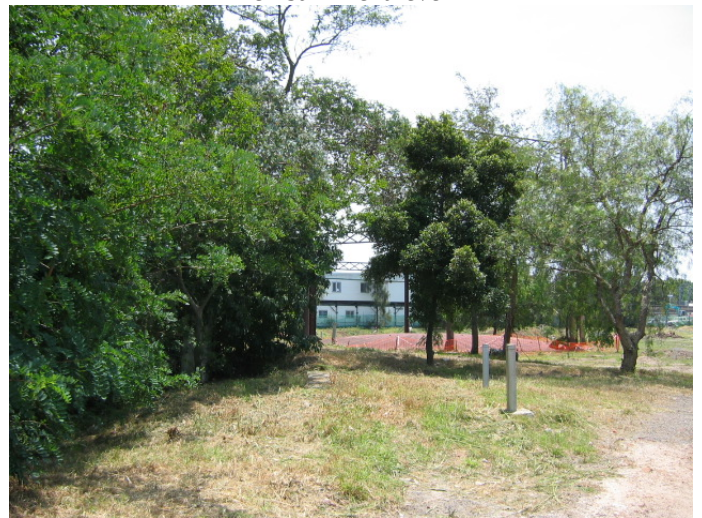
**Photo 22** (Dec 06) – Trees located along top of embankment, in south western site area

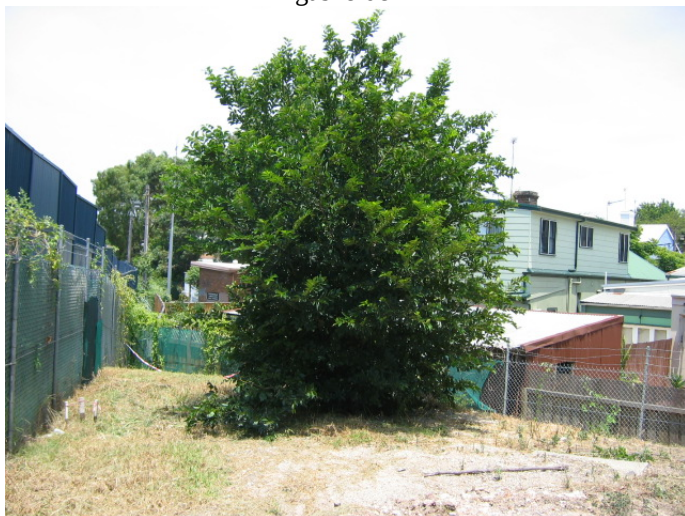
**Photo 23** (Dec 06) – Tree located in south western corner of site

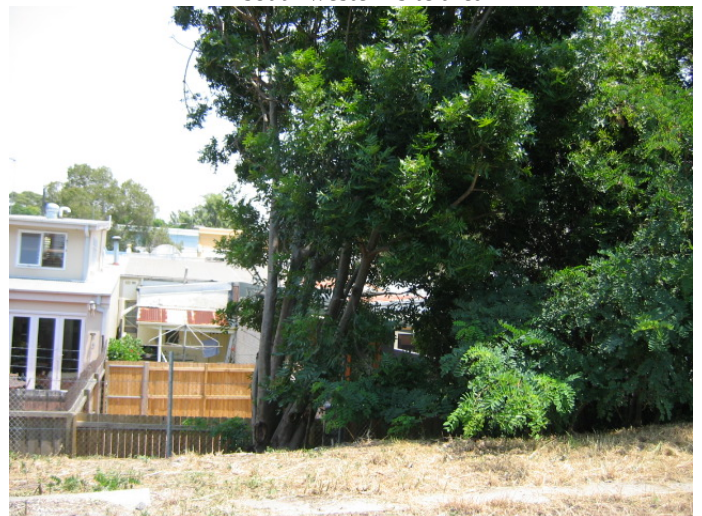
**Photo 24** (Dec 06) – Trees located across embankment, to the south of the existing gasholder
