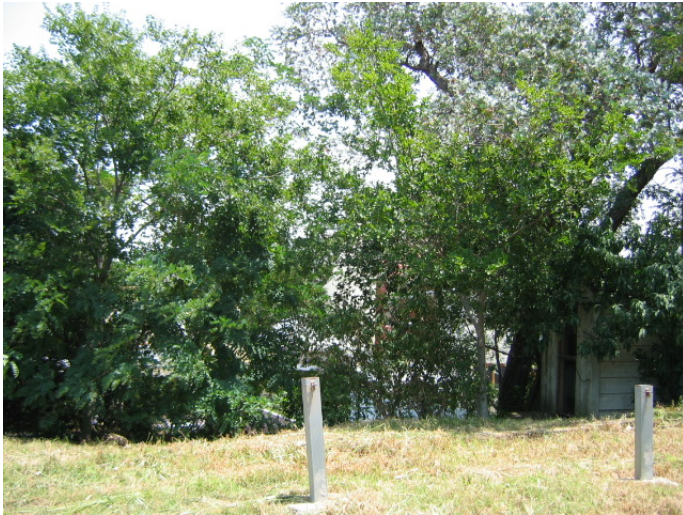
Photo 25 (Dec 06) - Trees and weeds located across embankment, to the south of the existing gasholder

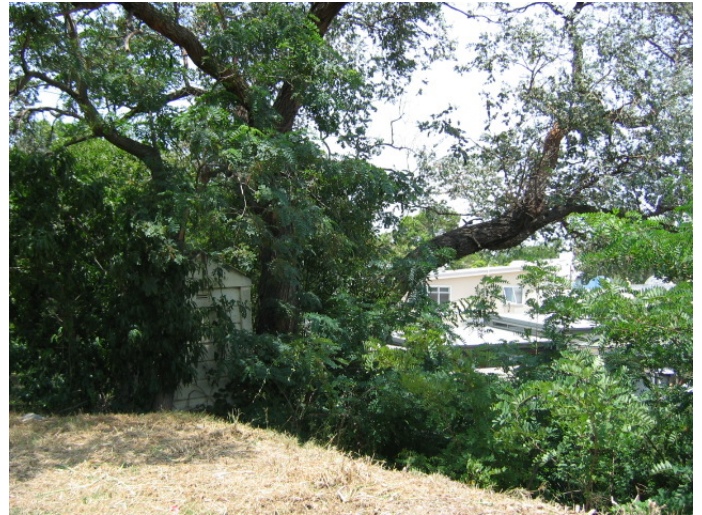
Photo 26 (Dec 06) – Large tree located next to old electrical shed, south of existing gasholder

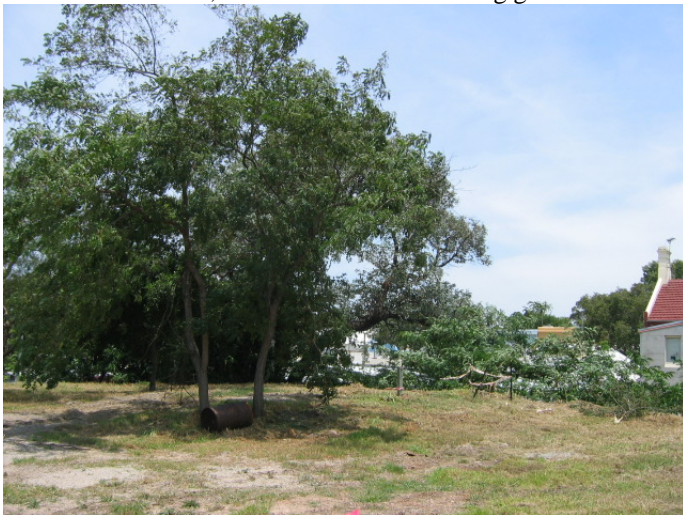
Photo 27 (Dec 06) - Trees located to the south of the existing gasholder

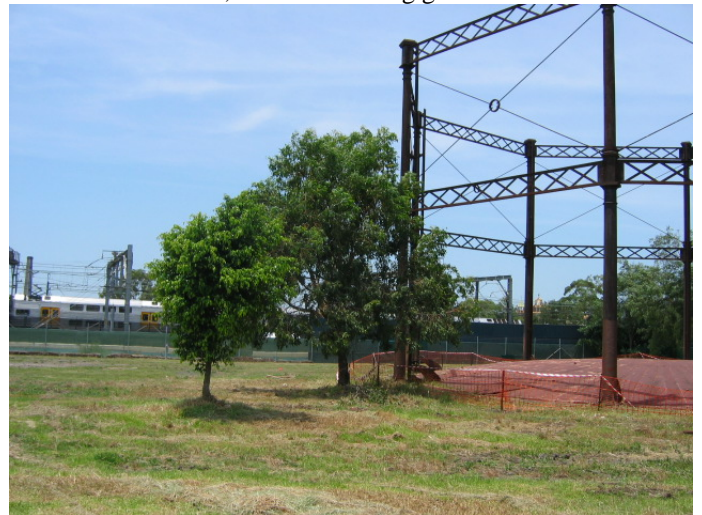
Photo 28 (Dec 06) – Trees located east of the existing gasholder

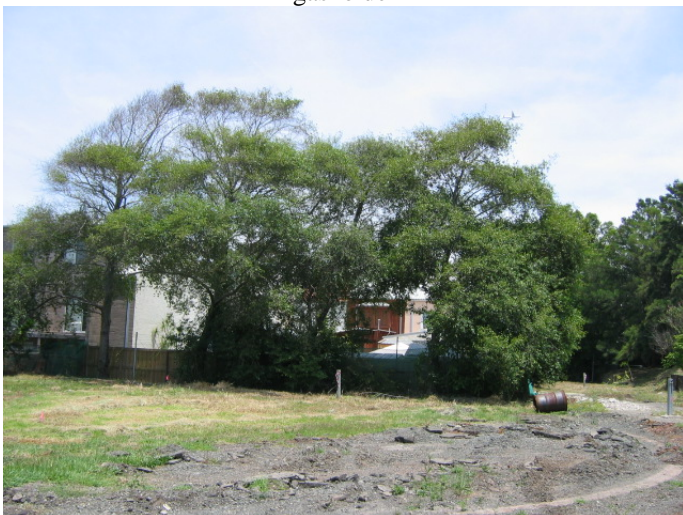
Photo 29 (Dec 06) – The annulus of the northern gasholder, and trees located behind 37 – 43 Burren St

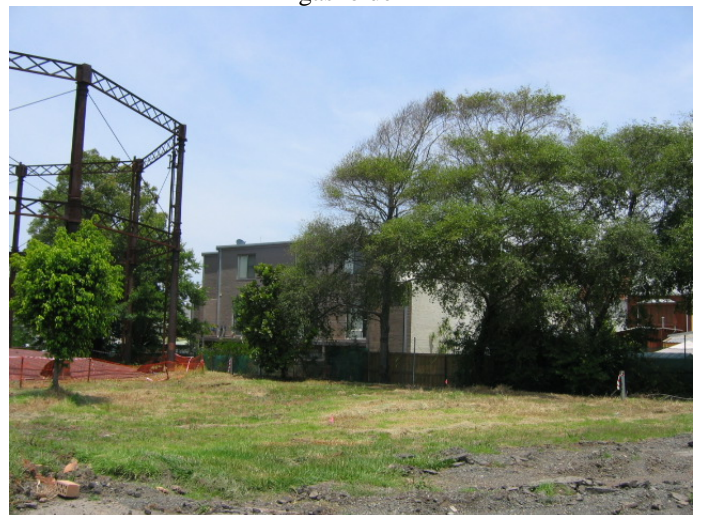
Photo 30 (Dec 06) – Trees located behind 31-35 Burren St (double storey buildings)

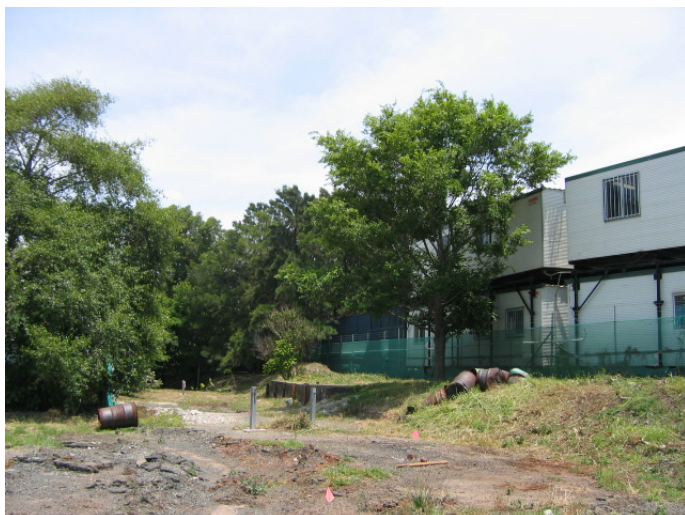
Photo 31 (Dec 06) – Trees located in north west site area

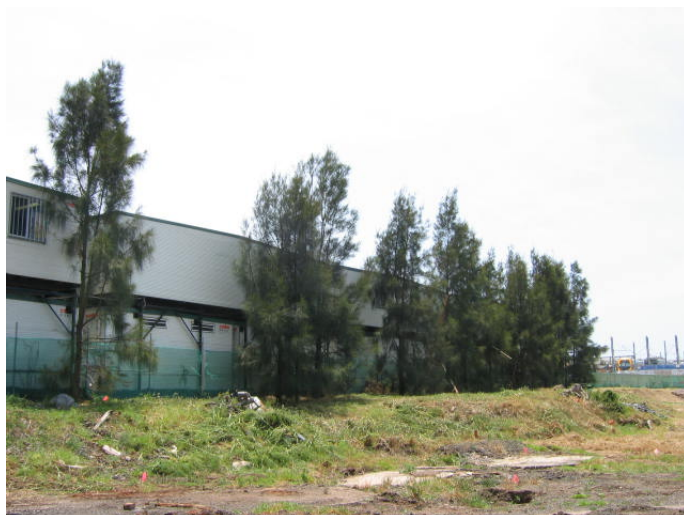
Photo 32 (Dec 06) – Embankment and trees located along northern site boundary (adjacent to stabling yard)

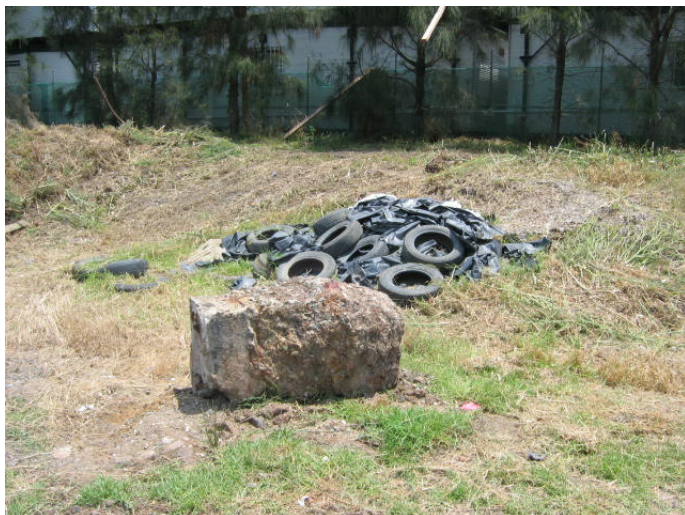
Photo 33 (Dec 06) – Some waste materials on site

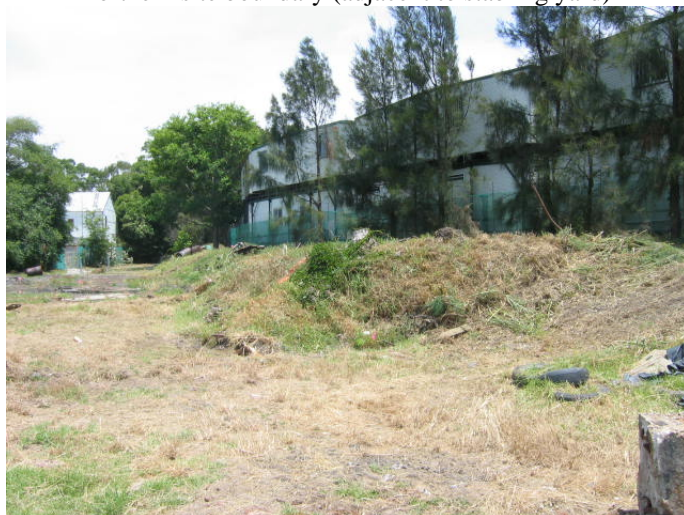
Photo 34 (Dec 06) – Embankment and waste materials in northern site area (adjacent to stabling yard)

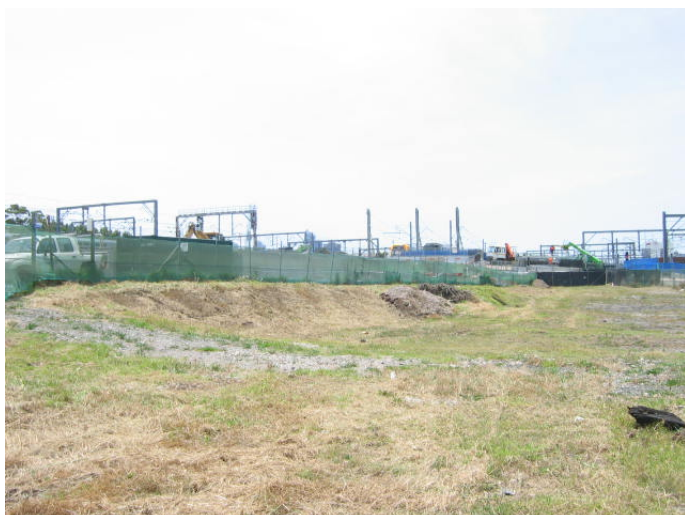
Photo 35 (Dec 06) – Embankment along boundary of north eastern site area

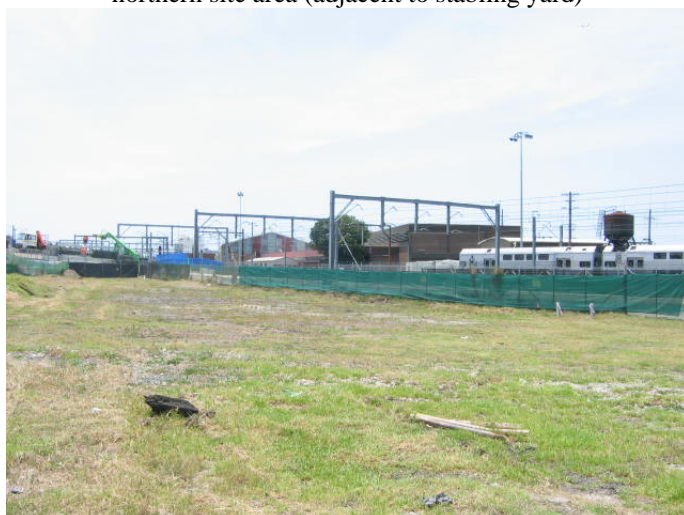
Photo 36 (Dec 06) – The eastern site area
