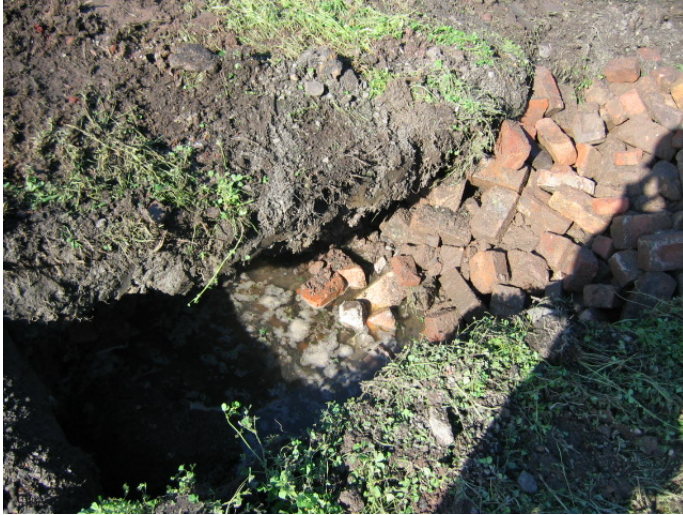
Photo 37 (Aug 06) – Demolition materials and significant perched water within northern gasholder annulus (MG04)

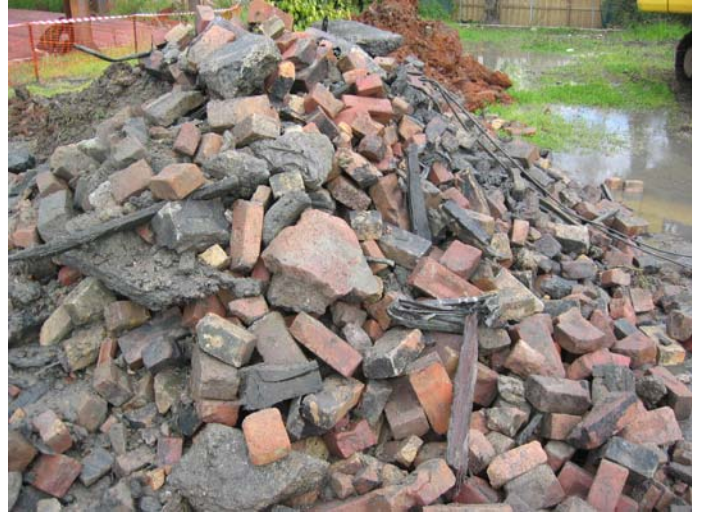
Photo 38 (Aug 06) – Waste materials within testpit MG04, inside northern gasholder annuli

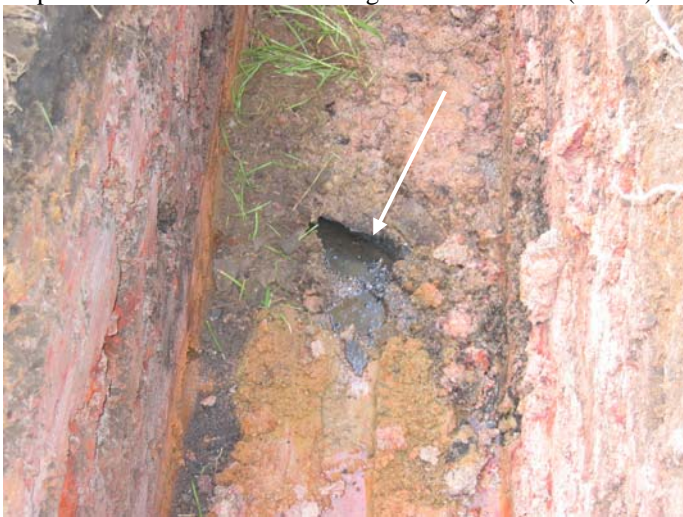
Photo 39 (Aug 06) – Tar pipe and fill layers in testpit MG02, between the two gasholder annuli

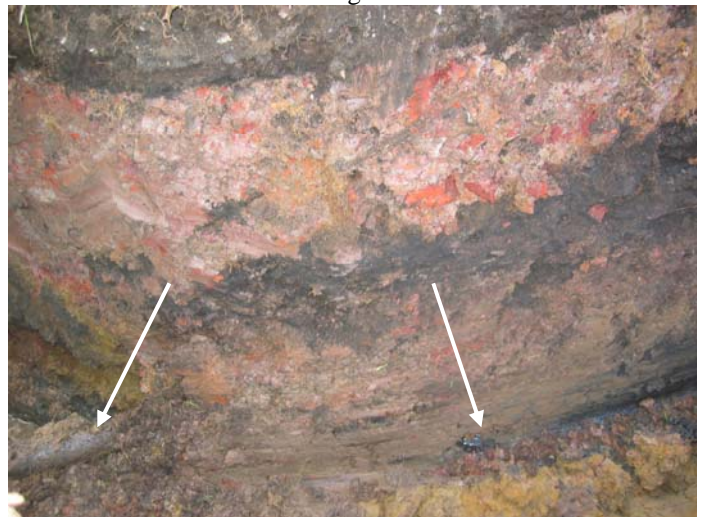
Photo 40 (Aug 06) – Tar pipe, fill layers and tar seepage in testpit MG02, between the two gasholder annuli

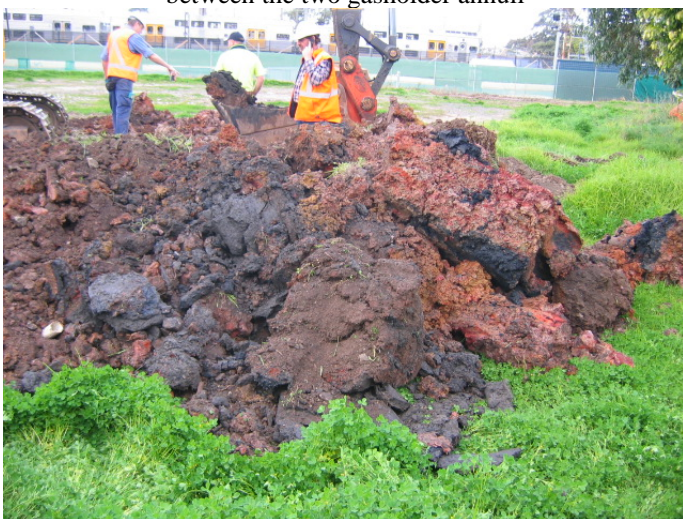
Photo 41 (Aug 06) – Material excavated from area adjacent to northern gasholder annulus

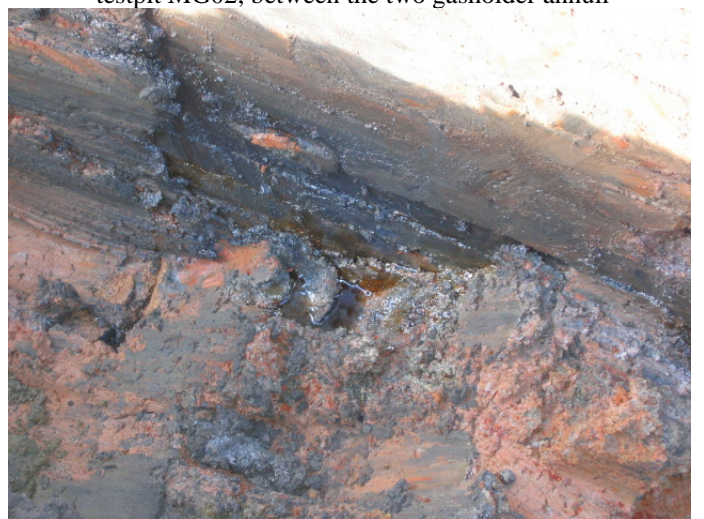
Photo 42 (Aug 06) – Tarry / oily wastes on brickwork – outside of northern gasholder annulus (MG05)

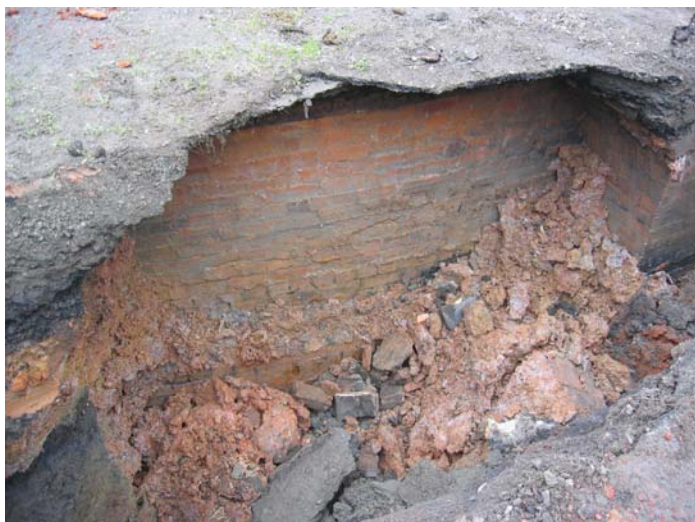
Photo 43 (Aug 06) – The outside of the northern gasholder annulus, exposed in testpit MG05

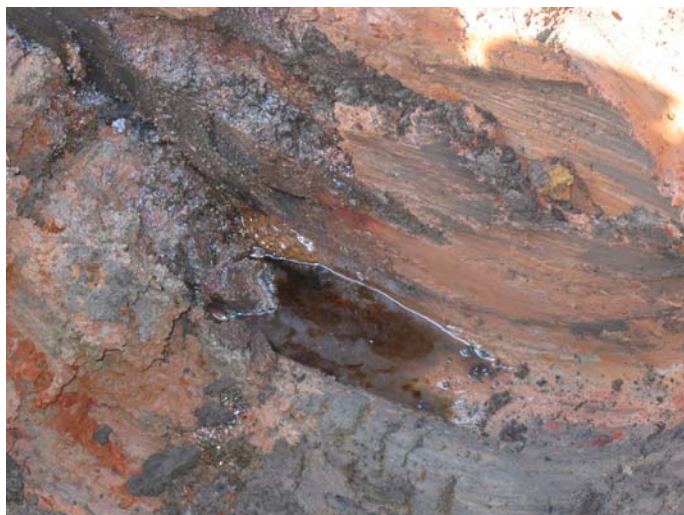
Photo 44 (Aug 06) – Tar and oil seeping into testpit MG05, outside the northern gasholder

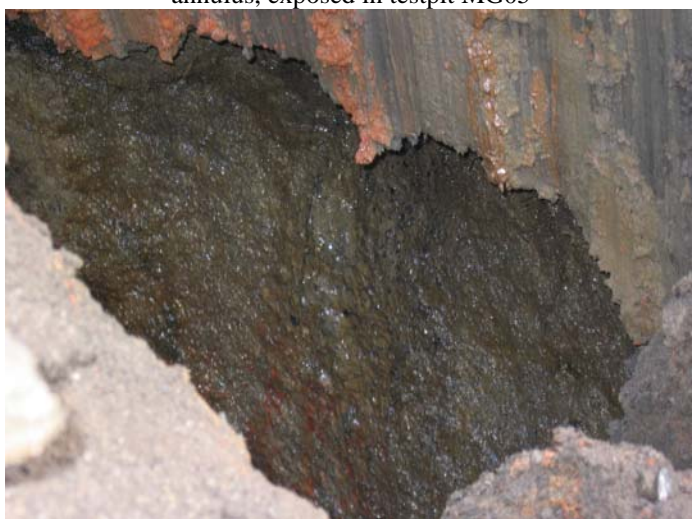
Photo 45 (Aug 06) – Tar and oil seeping into testpit MG05, outside the northern gasholder

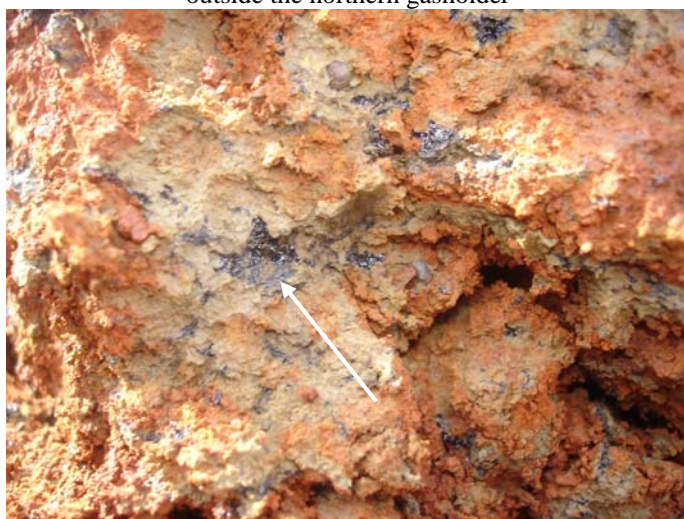
Photo 46 (Aug 06) – Tar within soils pores in natural clay (exact location not documented)

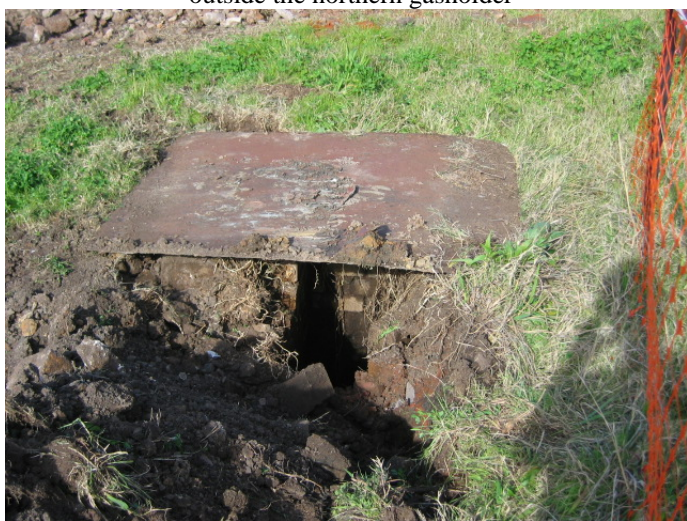
Photo 47 (Aug 06) – Pit located immediately to the south of the existing gasholder

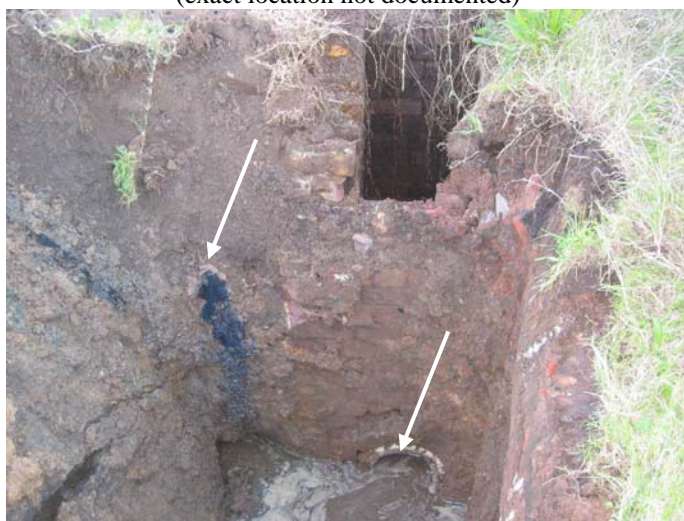
Photo 48 (Aug 06) – Pit located immediately to the south of the existing gasholder
