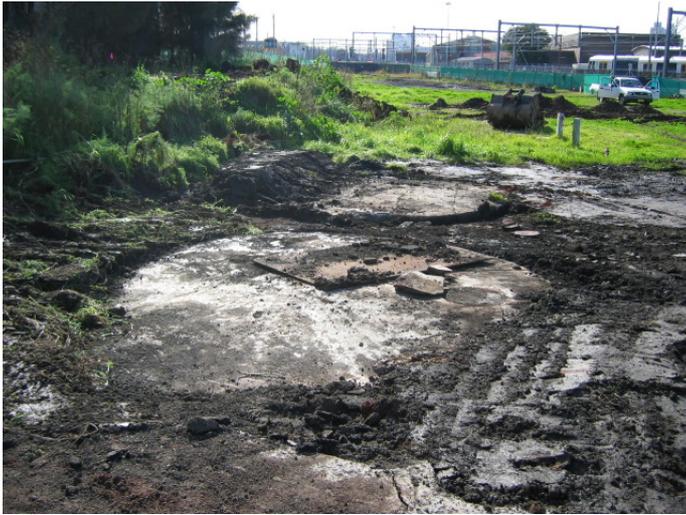
**Photo 49** (Aug 06) – Two tar pits with concrete lids, in north west site area

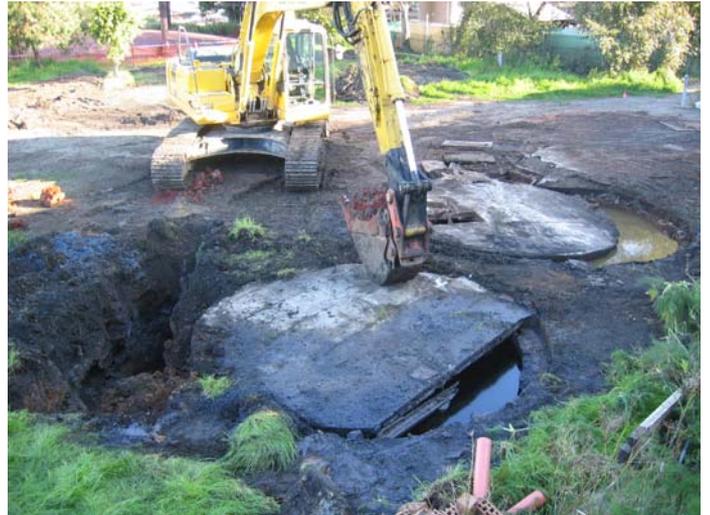
**Photo 50** (Aug 06) – The location of testpit MG06, adjacent to the tar wells

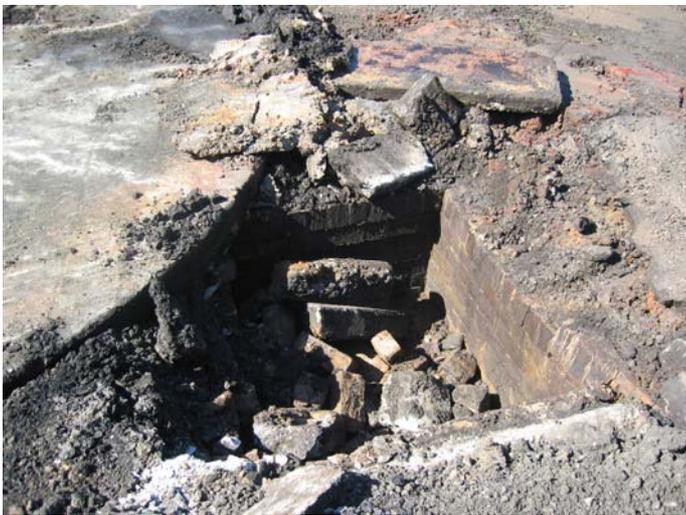
**Photo 51** (Aug 06) – Brick structure adjacent to western tar well

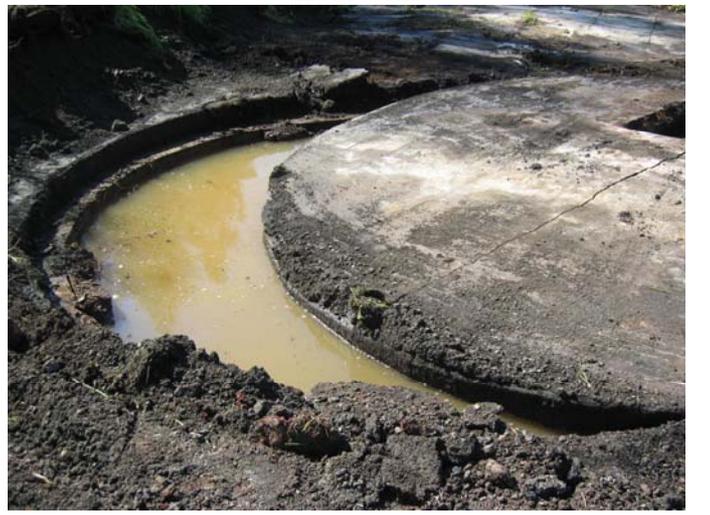
**Photo 52** (Aug 06) – Water within the tar well (floating on top of tarry waste)

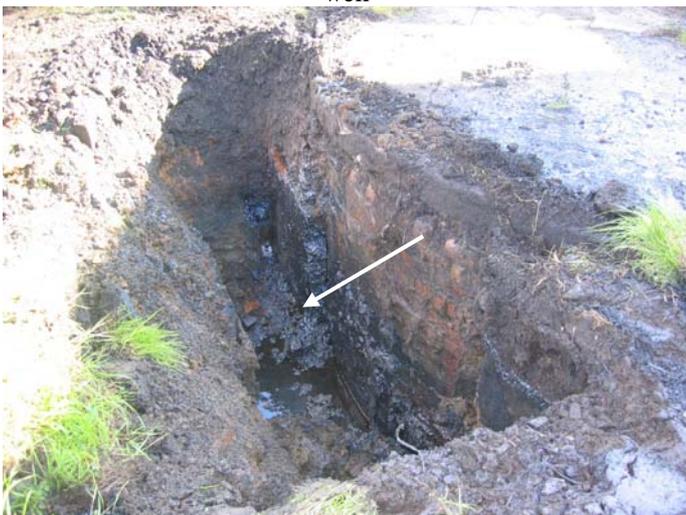
**Photo 53** (Aug 06) – Tar seeping through the brick wall of the tar pit (into testpit MG06)

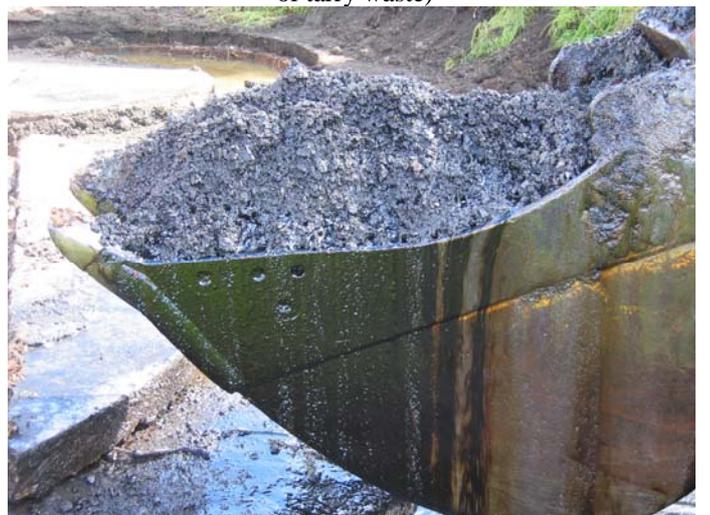
**Photo 54** (Aug 06) – Tarry waste within the tar wells

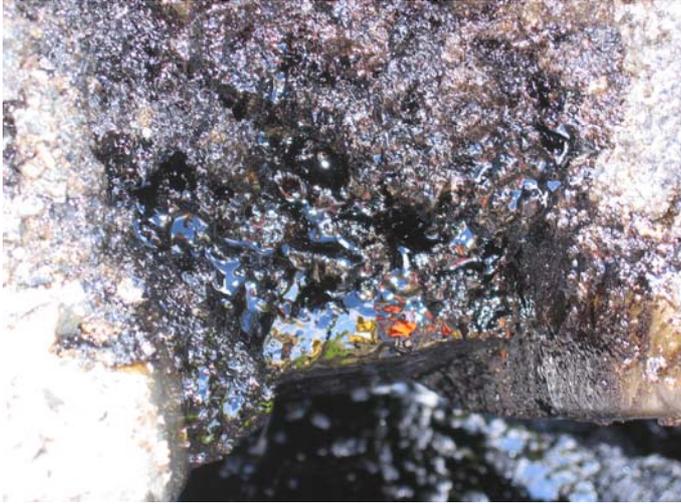
**Photo 55** (Aug 06) – Tarry waste within the tar wells

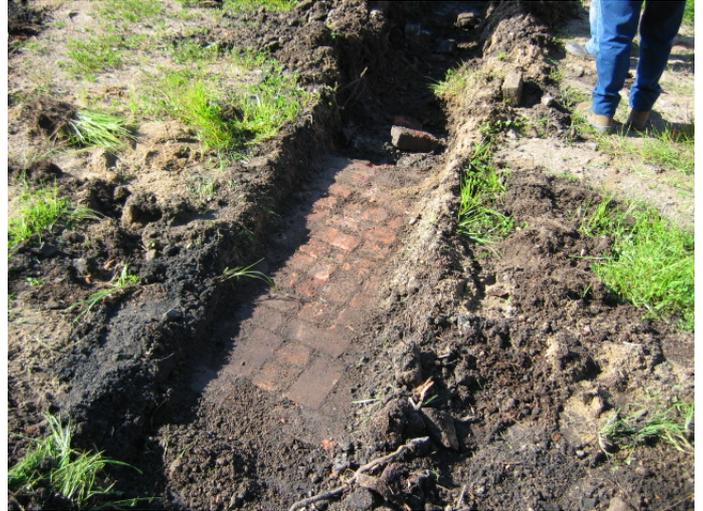
**Photo 56** (Aug 06) – Brickwork beneath former retort house

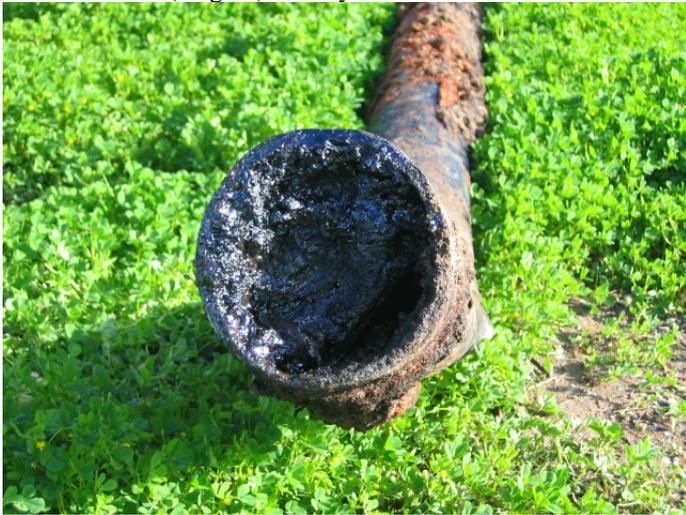
**Photo 57** (Aug 06) – Tar within pipework removed from testpits beneath former retort house

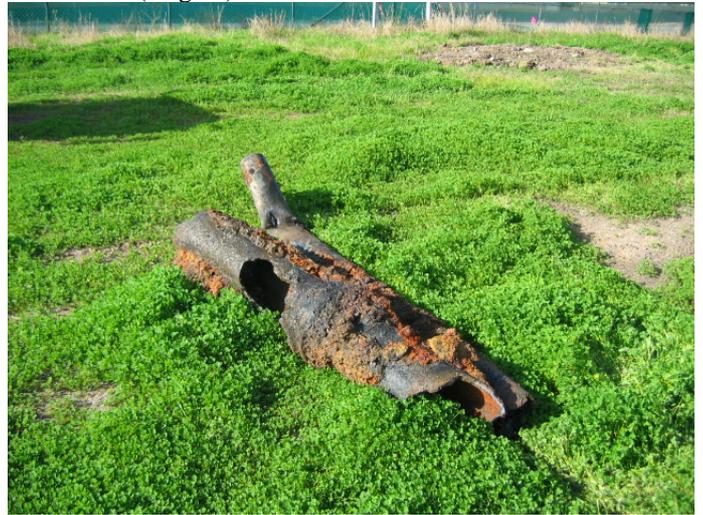
**Photo 58** (Aug 06) – Pipework removed from testpits beneath former retort house

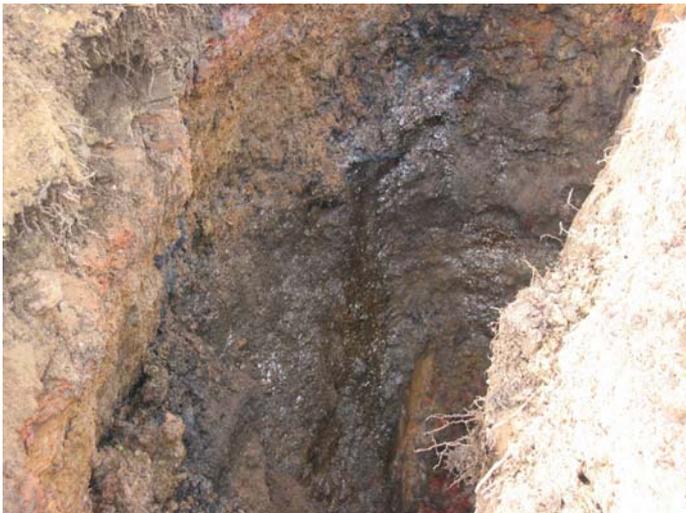
**Photo 59** (Aug 06) – Tar within testpit MG08, beneath the former retort house

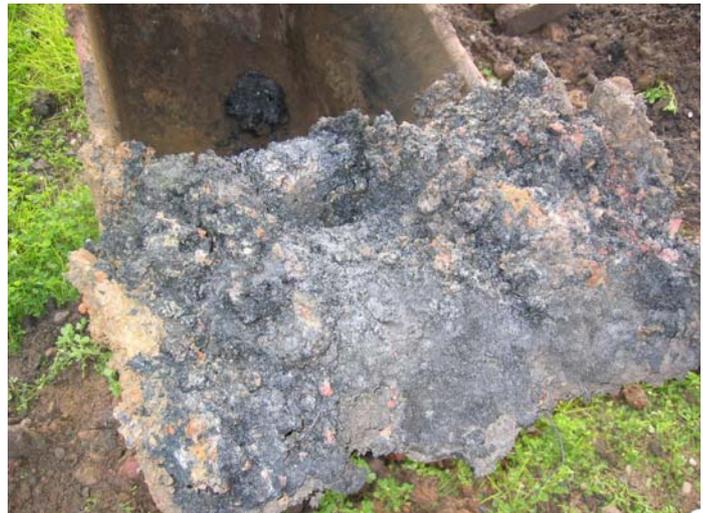
**Photo 60** (Aug 06) – Tarry soils within testpit MG08, beneath the former retort house
