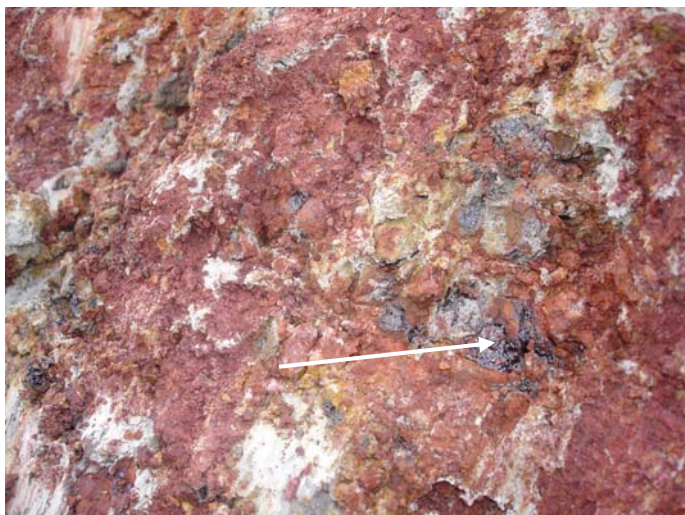
Photo 61 (Aug 06) – Tar within soil pores in natural clay, from testpit MG08 beneath former retort house

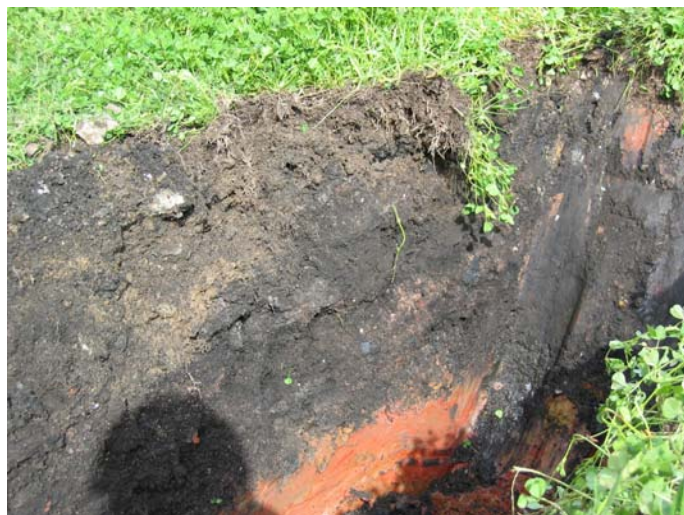
Photo 62 (Aug 06) – Fill profile in testpit MG10, beneath eastern edge of former retort house

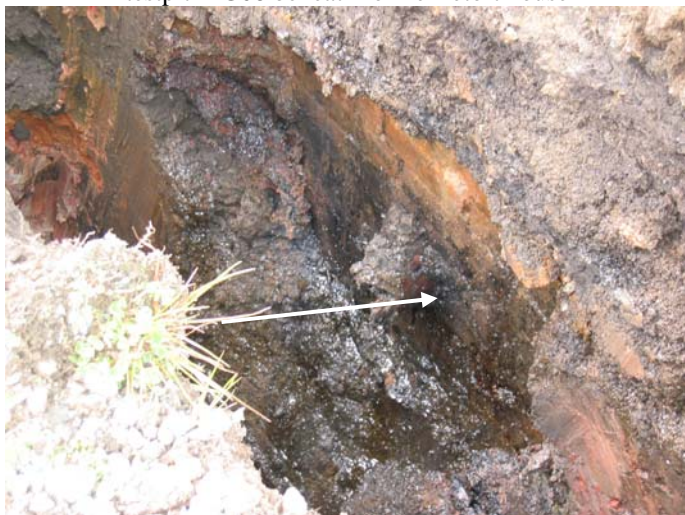
Photo 63 (Aug 06) – Tarry materials and a buried brick structure within testpit MG10, beneath eastern edge of former retort house

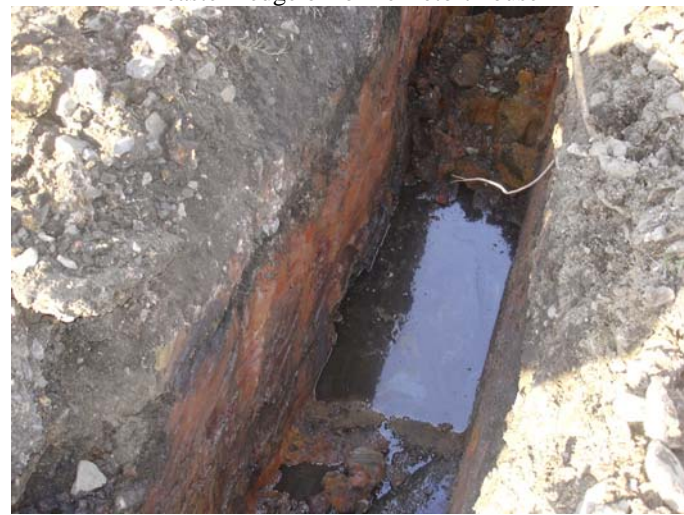
Photo 64 (Aug 06) – Fill profile in testpit MG11, near location of former purifiers

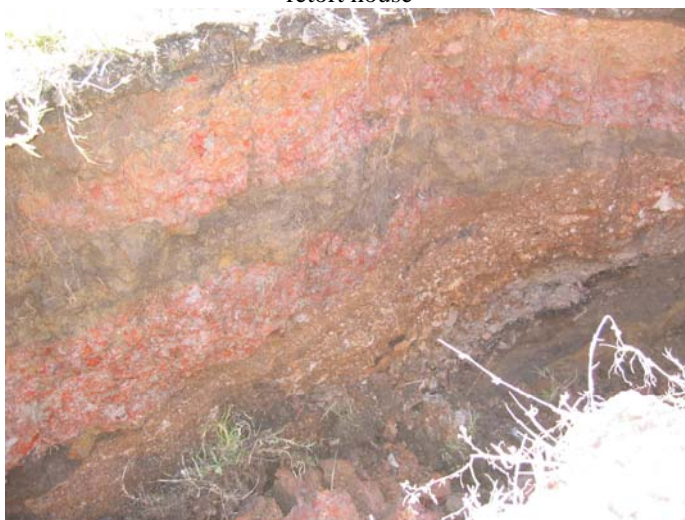
Photo 65 (Aug 06) – Fill layers in testpit MG01, south of existing gasholder

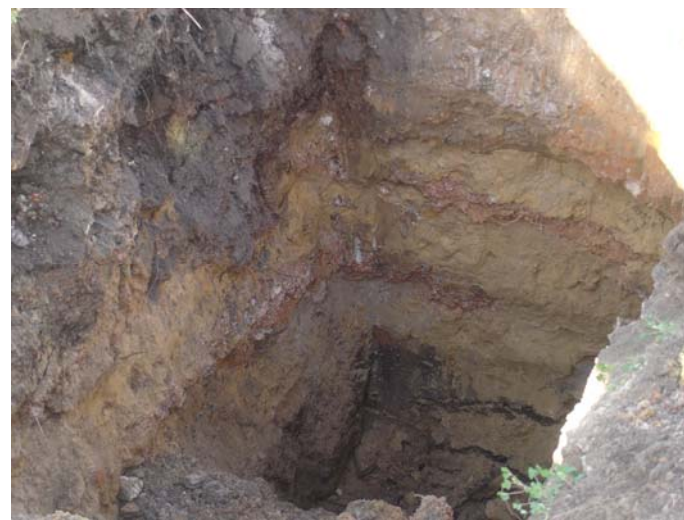
Photo 66 (Aug 06) – Fill profile in testpit TP01, in south western corner of site

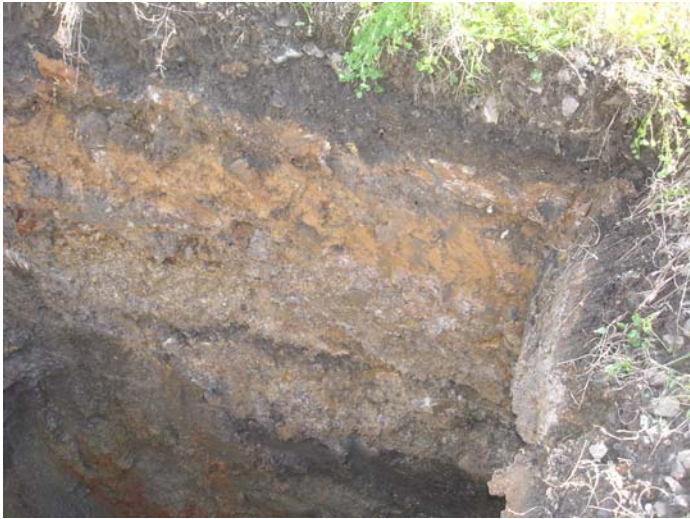
Photo 67 (Aug 06) – Fill profile in testpit TP03, along southern site boundary

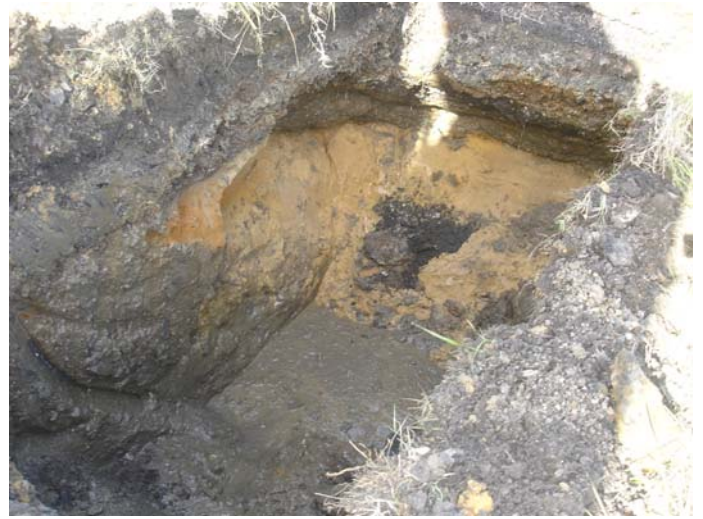
Photo 68 (Aug 06) – Fill profile in testpit TP05, along southern site boundary

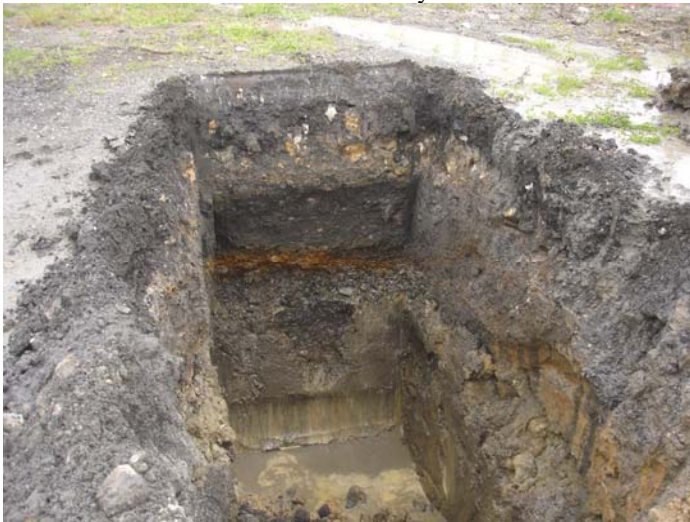
Photo 69 (Aug 06) – Fill profile in testpit TP06, in eastern site area

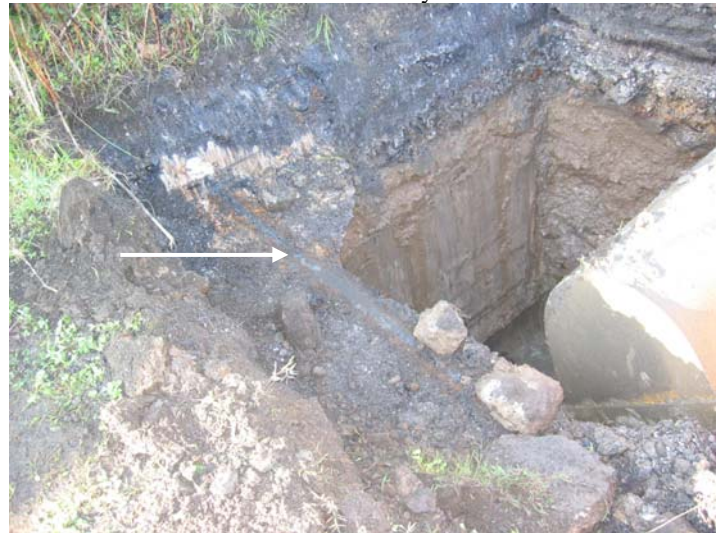
Photo 70 (Aug 06) – Fill profile in testpit TP07, in south eastern site area, including an old buried rail line

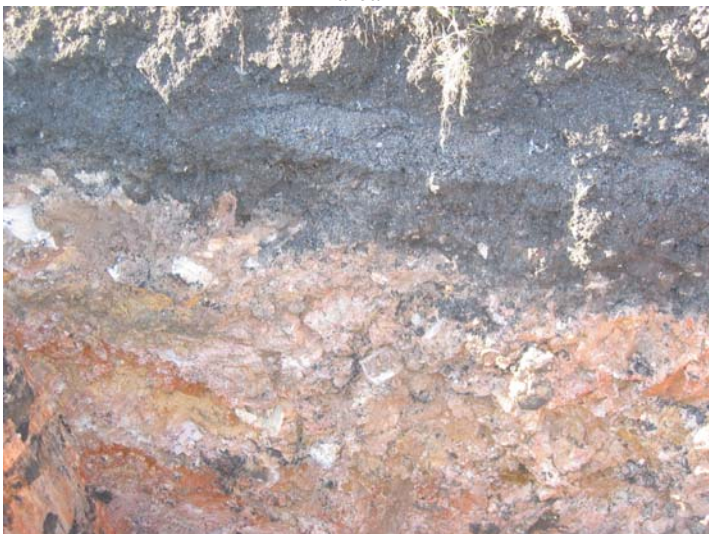
Photo 71 (Aug 06) – Fill profile in testpit TP08, in eastern site area

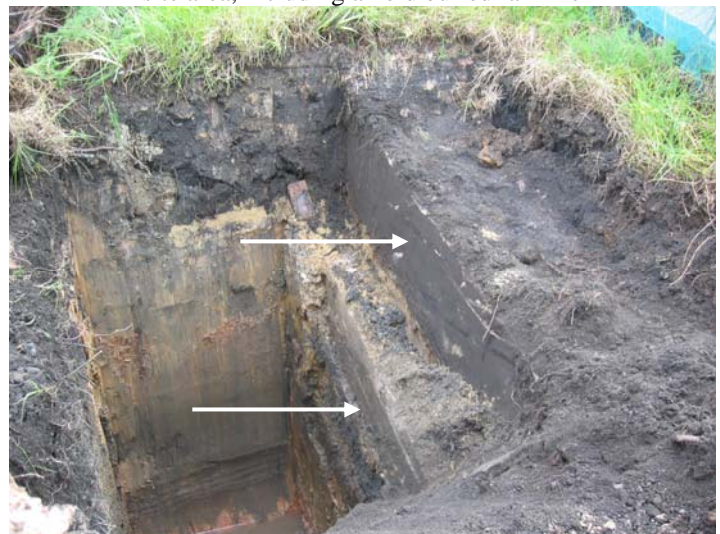
Photo 72 (Aug 06) – Fill profile in testpit TP10, on northern site boundary, including two stepped retaining wall
