CHULLORA HERITAGE ASSESSMENT, 1990

MACHINERY/PLANT

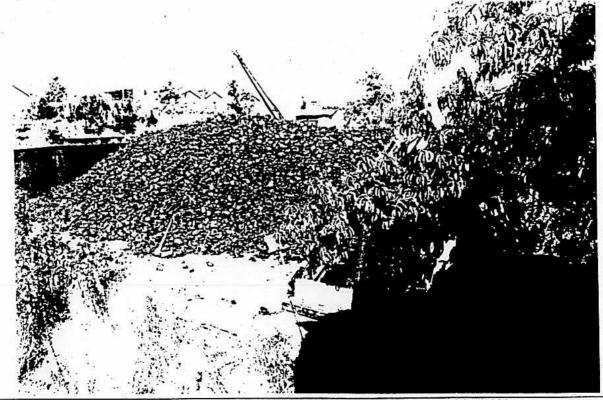
No. M10	Map Ref: M10	
140. 14110	map ici.	
Location: South-west of	of Perway Workshops No. 2, near Crane 3.	ecinct C

Description: Coal Stage - This dump supplies the three steam cranes. It is located adjacent to the track and has a concrete floor raised about 800mm above the track to facilitate loading. Two sides and the back of the dump are surrounded by a 1.5m high wall of recycled sheets of 7mm mild steel.

SIGNIFICANCE ASSESSMENT	2/5	INFORMANTS:	
Historic Association	2/5		
Technological Importance	2/5	€ .	3
Structural Integrity	2/5	REFERENCES:	
Relative Rarity	3/5		
Operational Ability	3/5		
Interpretive Ability	3/5		-
RECOMMENDATION: Record		PHOTOGRAPHS:	* · · · · · · · · · · · · · · · · · · ·
		B & W : 90-038-8-19

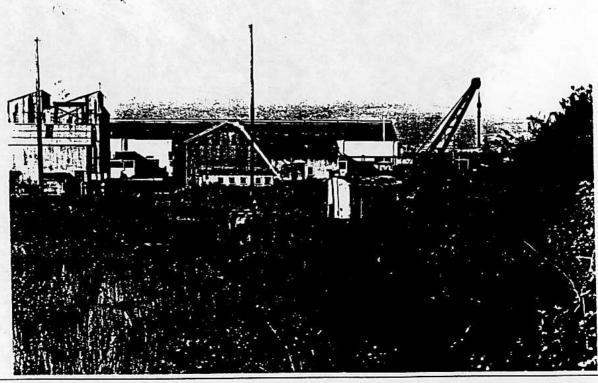
No. C4 M12	Map Ref: M12		
Location: West of Main	workshops per way No.2	Precinct C	والتأت عناج
Condition:

Description: P1010 - GRAFTON ENGINEERS BEDFORD - No's on 542, 362. CRANE No. 2151. 361 on Base.

A grafton steam crane with its beam intact. The beam is raised and lowered by twin tension rods with pulleys at the base end, around which the raising chains pass. The crane is not operational but is similar to crane 1 in most respects. If anything, more of the original fabric is evident on this machine.

SIGNIFICANCE ASSESSMENT Historic Association Technological Importance	4/5 4/5 4/5		
Structural Integrity Relative Rarity Operational Ability	3/5 4/5 1/5	REFERENCES:	
Interpretive Ability	4/5	. äk	Junequed vs. Ability
RECOMMENDATION: Conserve	Plantotout.	PHOTOGRAPHS: B & W: 90-038-2-11	RECOMMENDATION: Sho

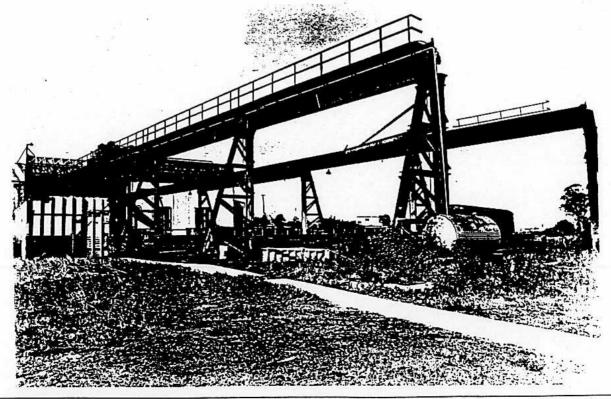
No. M19	Map Ref:		
Location:	North of central workshop crane tracks.	Precinct D	
Condition:	Fair	7%

Description: This pressure vessel appears to have been located inside a building at one stage. It is an air receiver numbered A989. It rests on a concrete machine bed on its eastern end. It appears that it would once have been used in the sand blasting of materials used in construction units by the Per Way Workshops.

SIGNIFICANCE ASSESSMENT	2/5	INFORMANTS:	
Historic Association	2/5		
Technological Importance	2/5		
Structural Integrity	2/5		
Relative Rarity	2/5	REFERENCES:	
Operational Ability	2/5		
Interpretive Ability	2/5	31 =	
RECOMMENDATION: Record		PHOTOGRAPHS:	, , , , , , , , , , , , , , , , , , ,
X.		B & W:	Slides:
