CHULLORA HERITAGE ASSESSMENT, 1990

NAME OF ITEM: Travelling Backleg Crane (Hillside)	
No. M18 C7	Map Ref:
Location: Behind Manufacturing Centre	Precinct D
Condition: Out of service but still in working order.	
Associated Items:	
<p>Description: The maker's plate is inscribed "P1072 LOAD NOT TO EXCEED 20 TONS UP TO 50' RADIUS, 15 TONS UP TO 67' RADIUS". The crane appears to be purpose built and it may have been constructed by the workshops. It is operated by electric power supplied by a trailing cable. The beam and backlegs, basic frame and wheel mountings are all made of welded angle sections with plate reinforcing. One vertical member contains rivetted angle reinforcing and some cast elements such as brackets. It would appear that the basic cab and equipment are older than the beams and other elements. This crane is no longer used because the operators consider it to be unsafe. This is unusual in that it is a stiff legged derrick crane which runs on rails. Most derrick cranes are stationary.</p>

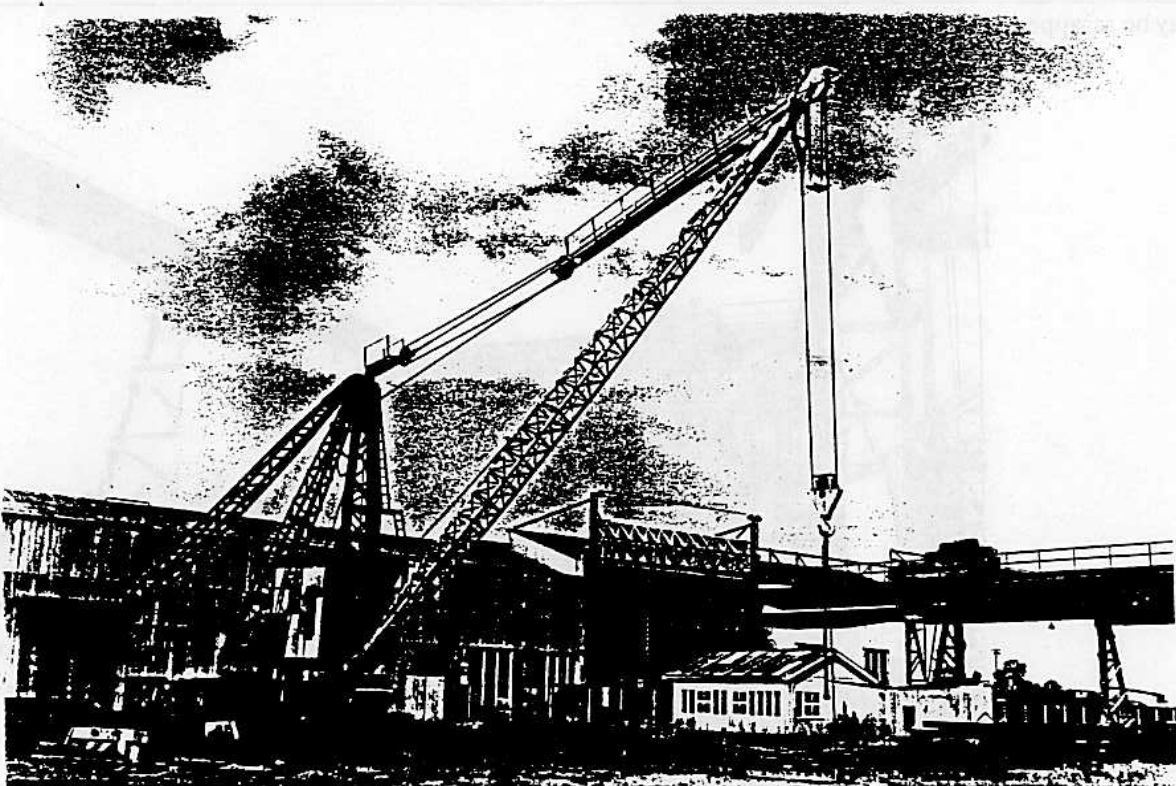
SIGNIFICANCE ASSESSMENT Historic Association 3/5 Technological Importance 3/5 Structural Integrity 4/5 Relative Rarity 3/5 Operational Ability 4/5 Interpretive Ability 4/5	INFORMANTS: Charles Caruana REFERENCES:
RECOMMENDATION: Further Research required	PHOTOGRAPHS: B & W: Slides:

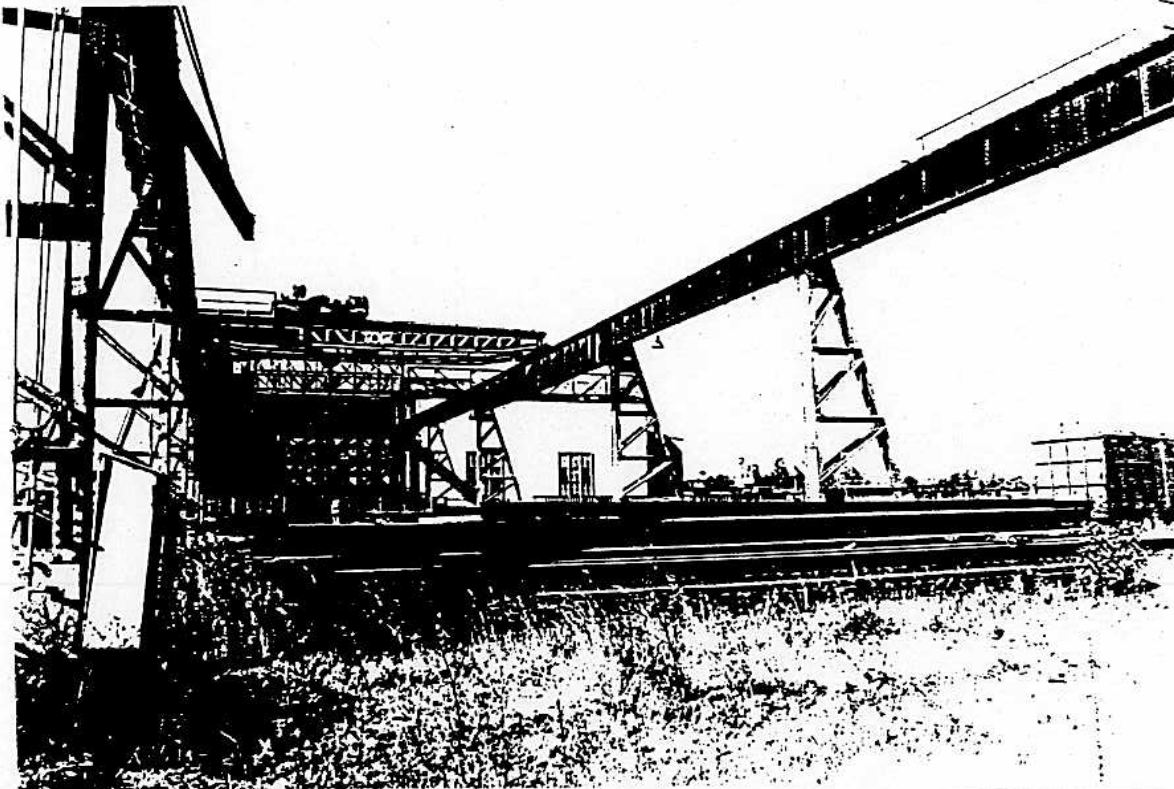
NAME OF ITEM: Wagon Centre Overhead Cranes (x2)		
No. M16 & M17 C5 & C6	Map Ref:	
Location: Central track of Per Way Workshop No. 2		Precinct D
Condition: In service.		
Associated Items:		
<p>Description: These are electric cranes which run on rivetted plate girders supported by rivetted triangular braced frames. The vertical RSJ was made by DORMAN LONG. The crane maker's plate is numbered and inscribed "P1151 Man hoist 25 tons : Aux Hoist 10 tons. Built at Per Way Shops Chullora 1949". The rail is continuous through the manufacturing centre. The doors close by dropping vertically to the rails and sliding doors close the entrance beneath the rails. The crane will remain in use but the crane rail girder will be scrapped when the land is sold.</p>		
SIGNIFICANCE ASSESSMENT Historic Association Technological Importance Structural Integrity Relative Rarity Operational Ability Interpretive Ability	3/5 2/5 3/5 3/5 1/5 4/5 4/5	INFORMANTS: REFERENCES:

RECOMMENDATION: The crane should remain in use, however the external crane rail should be recorded and may be scrapped.		PHOTOGRAPHS: B & W:

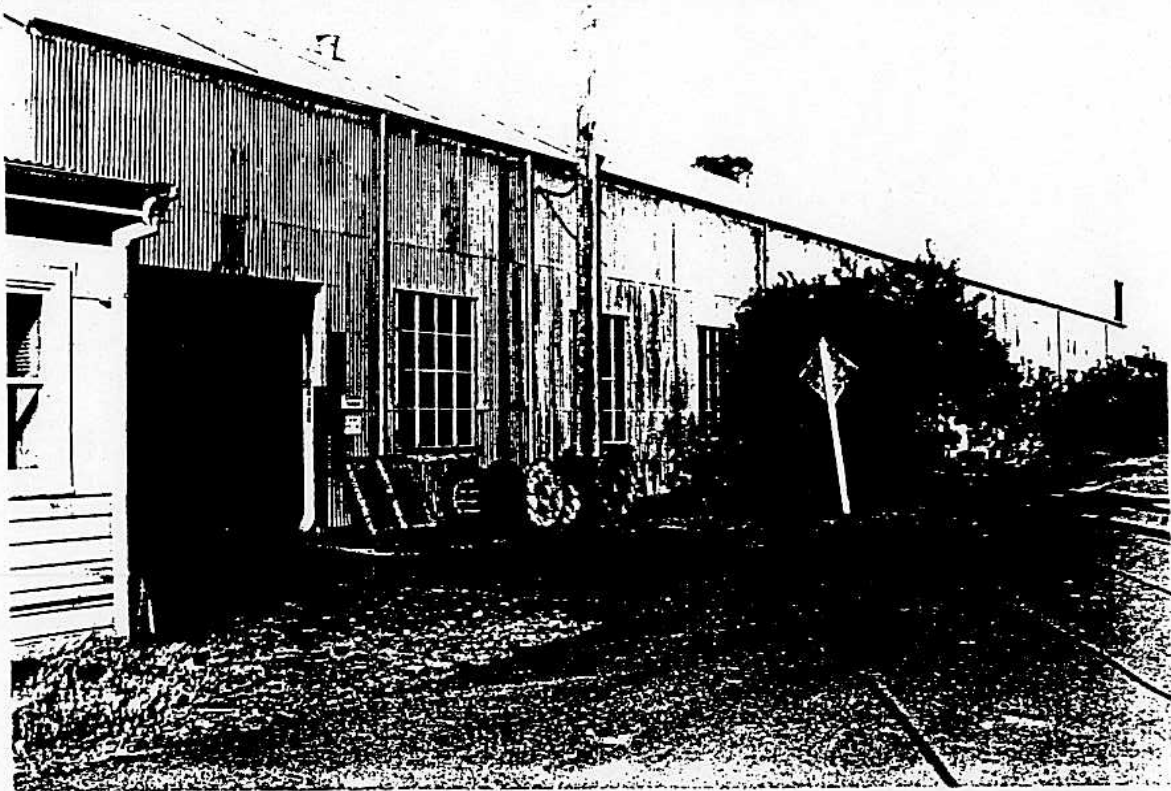
NAME OF ITEM: Chain Shop	
No. B37	Map Ref:
Location: North/west corner Per way No. 2	Precinct E
Condition:	
Associated Items:	
<p>Description: The Chain Shop is a steel and timber framed building clad in corrugated iron. The building has a gable roof which is supported by steel trusses. There are 11 16 pane cast steel double centre opening windows along the length of the west side of the shop and 5 on the east side. There are two skillion roofed annexes on the eastern side of the building. It has an overhead electric 3 ton crane which runs on crane rail beams cantilevered from the main RSJ building structure. The transverse motion of the crane is by hand chain. The crane is operated from the floor. (PHOTOS OF O/H CRANE NOT GOOD ENOUGH FOR INDIVIDUAL MENTION) M38</p>	
SIGNIFICANCE ASSESSMENT Aesthetic Value 2/5 Historic Association 4/5 Technological Importance 2/5 Structural Integrity 3/5 Interpretive Ability 2/5 Social Significance 1/5	INFORMANTS: Theo REFERENCES:

RECOMMENDATION: Record	PHOTOGRAPHS: B & W: 90-038-4-34 Slides:

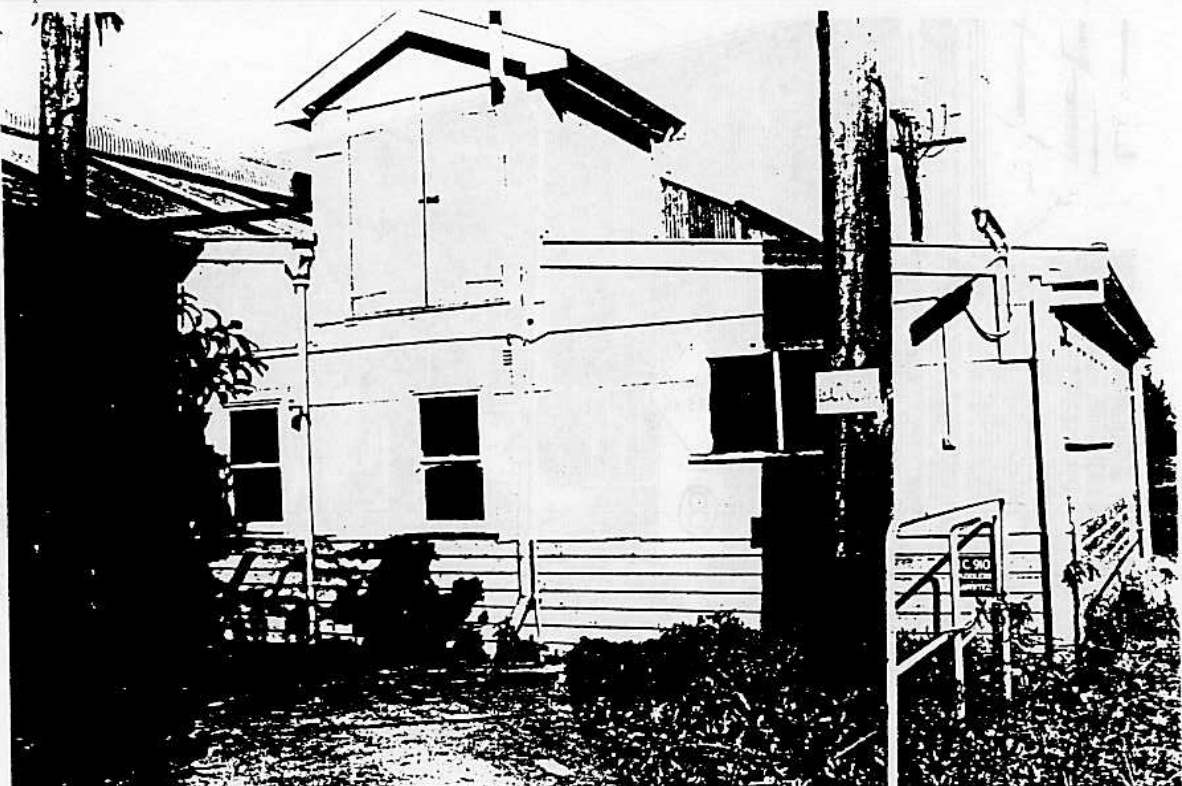
NAME OF ITEM: Changerooms													
No. B39	Map Ref:												
Location: Besides Electricians Shop	Precinct E												
Condition: Good													
Associated Items:													
<p>Description: Timber framed weatherboard and fibro, skillion roofed building. The skillion is pierced centrally by a small gable structure which houses a hot water cylinder. The building houses washbasin, toilets and lockers.</p>													
<p>SIGNIFICANCE ASSESSMENT</p>

Historic Association	2/5	Technological Importance	4/5	Structural Integrity	2/5	Interpretive Ability	3/5	Relative Rarity	2/5	Operational Ability	2/5	<p>INFORMANTS:</p> <p>REFERENCES:</p>
Historic Association	2/5												
Technological Importance	4/5												
Structural Integrity	2/5												
Interpretive Ability	3/5												
Relative Rarity	2/5												
Operational Ability	2/5												
RECOMMENDATION: Record	<p>PHOTOGRAPHS:</p> <p>B & W: 90-038/5/14 Slides:</p>

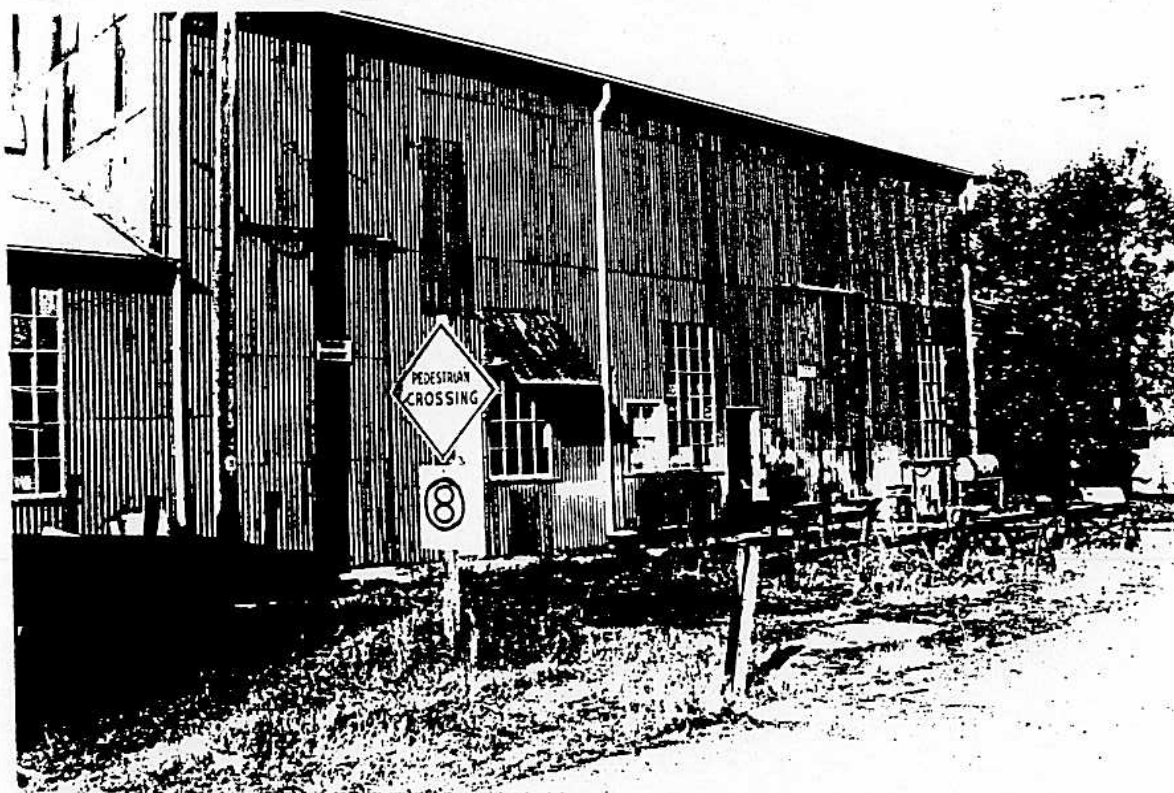
NAME OF ITEM: Paint Shop	
No. B40	Map Ref:
Location: North of Chain shop	Precinct E
Condition: Now operating as a store room	
Associated Items:	
Description: Very tall single storey timber framed corrugated iron clad, gable roofed building. The raised (2 storey high) roof structure is obviously a later addition. The original one storey gabled end wall still exists within the building. The building continues one storey high on either side of the paint shop.	
SIGNIFICANCE ASSESSMENT Aesthetic Value 2/5 Historic Association 4/5 Technological Importance 2/5 Structural Integrity 3/5 Interpretive Ability 2/5 Social Significance 1/5	INFORMANTS: Theo REFERENCES:
RECOMMENDATION: Record	PHOTOGRAPHS: B & W: 90-038-4-27 Slides:

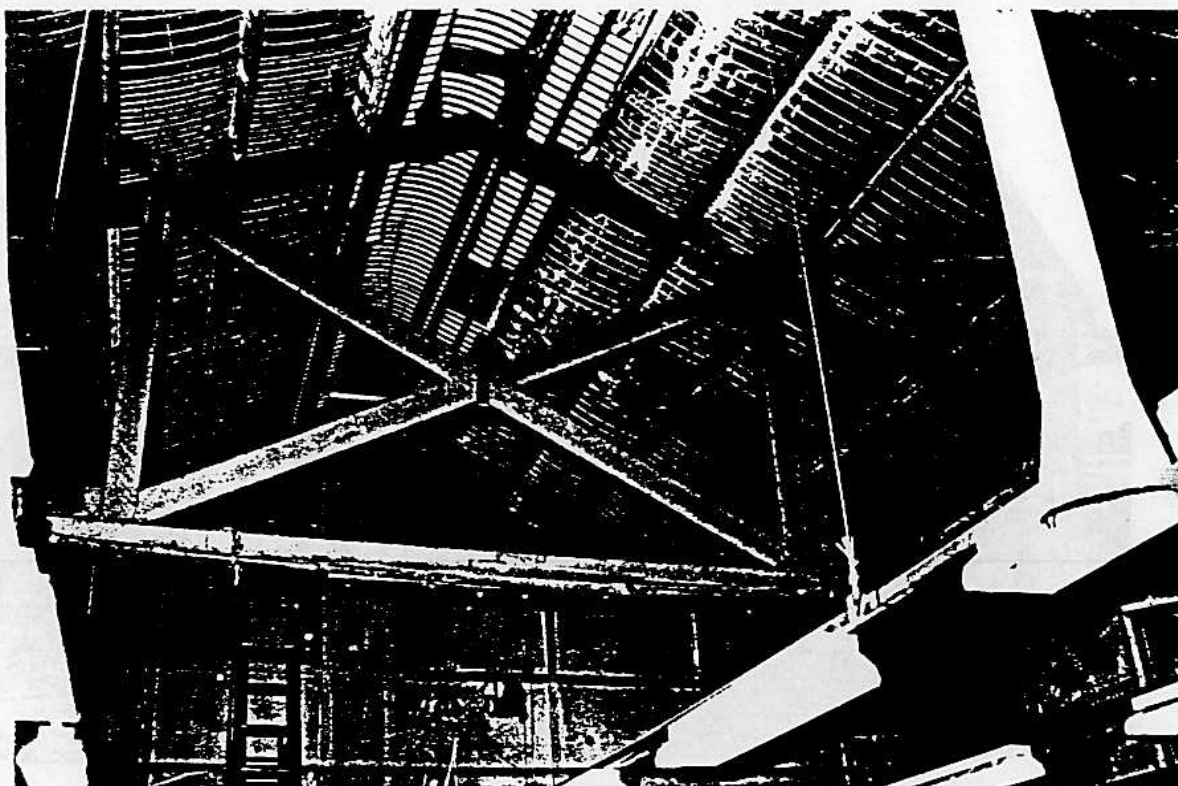
NAME OF ITEM: Electricians Shop former Saddlers Shop

Description: A timber framed corrugated iron clad, one storey single gable shed. The roof is supported by a fine scissor braced timber truss which is centrally bolted. The internal walls are lined with caneite and the roof has recently had new insulation and foil laid.

2/5
Aesthetic Value	2/5
Historic Association	4/5
Technological Importance	2/5
Structural Integrity	3/5
Interpretive Ability	2/5
Social Significance	1/5

RECOMMENDATION: Record
