**CHULLORA**  
**HERITAGE ASSESSMENT, 1990**

**BUILDING/STRUCTURE**

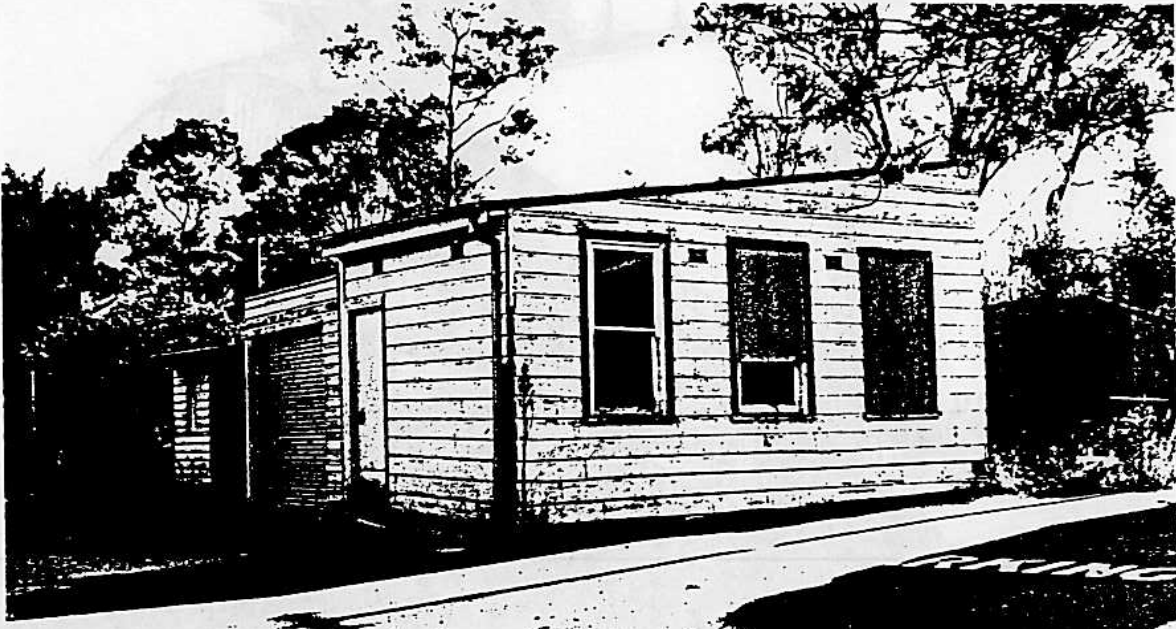
<b>NAME OF ITEM:</b> Conference Room	
<b>No.</b> B30	<b>Map Ref:</b>
<b>Location:</b> On the roadside of Carpenters Shop.	Precinct H
<b>Condition:</b>	
<b>Associated Items:</b>	
<b>Description:</b> Small weatherboard, clad, skillion roofed shed, used for meetings. This is a very basic building with three sliding windows on the eastern elevation and a roller door on the southern elevation.	
<b>SIGNIFICANCE ASSESSMENT</b> Aesthetic Value 2/5 Historic Association 1/5 Technological Importance 2/5 Structural Integrity 1/5 Interpretive Ability 3/5 Social Significance 1/5	<b>INFORMANTS:</b>  <b>REFERENCES:</b>
<b>RECOMMENDATION:</b> Record	<b>PHOTOGRAPHS:</b> B & W: 90-038-3 Slides:

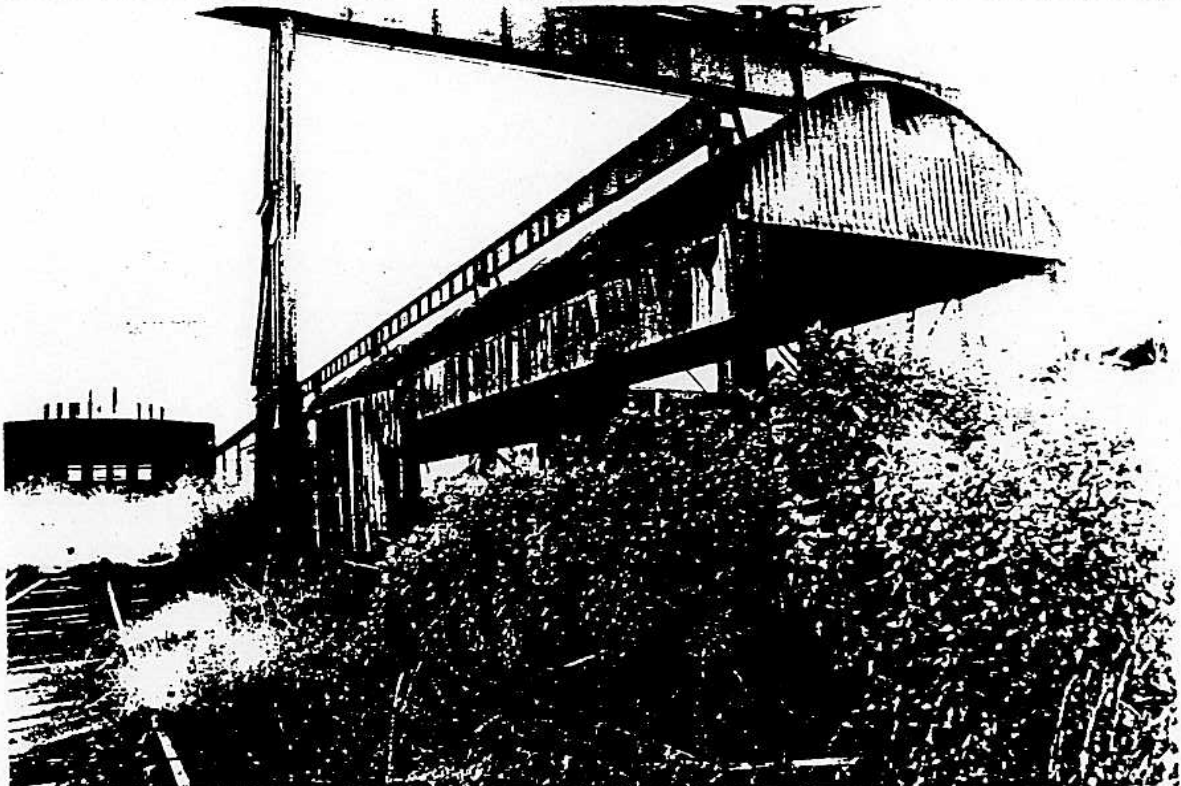
<b>NAME OF ITEM:</b> Break Down Room														
<b>No.</b> B32	<b>Map Ref:</b>													
<b>Location:</b> Beside Crane 8	<b>Precinct H</b>													
<b>Condition:</b> Dilapidated.														
<b>Associated Items:</b>														
<p><b>Description:</b> The breakdown room is located beside the timber yard. It consists of an RSJ frame and corrugated cladding with a curved roof. Logs travelled on skids into the breakdown room where they were cut and shaped. The building appears to have been out of service for some time. All equipment has been removed and the cladding is deteriorating.</p>														
<p><b>SIGNIFICANCE ASSESSMENT</b></p>

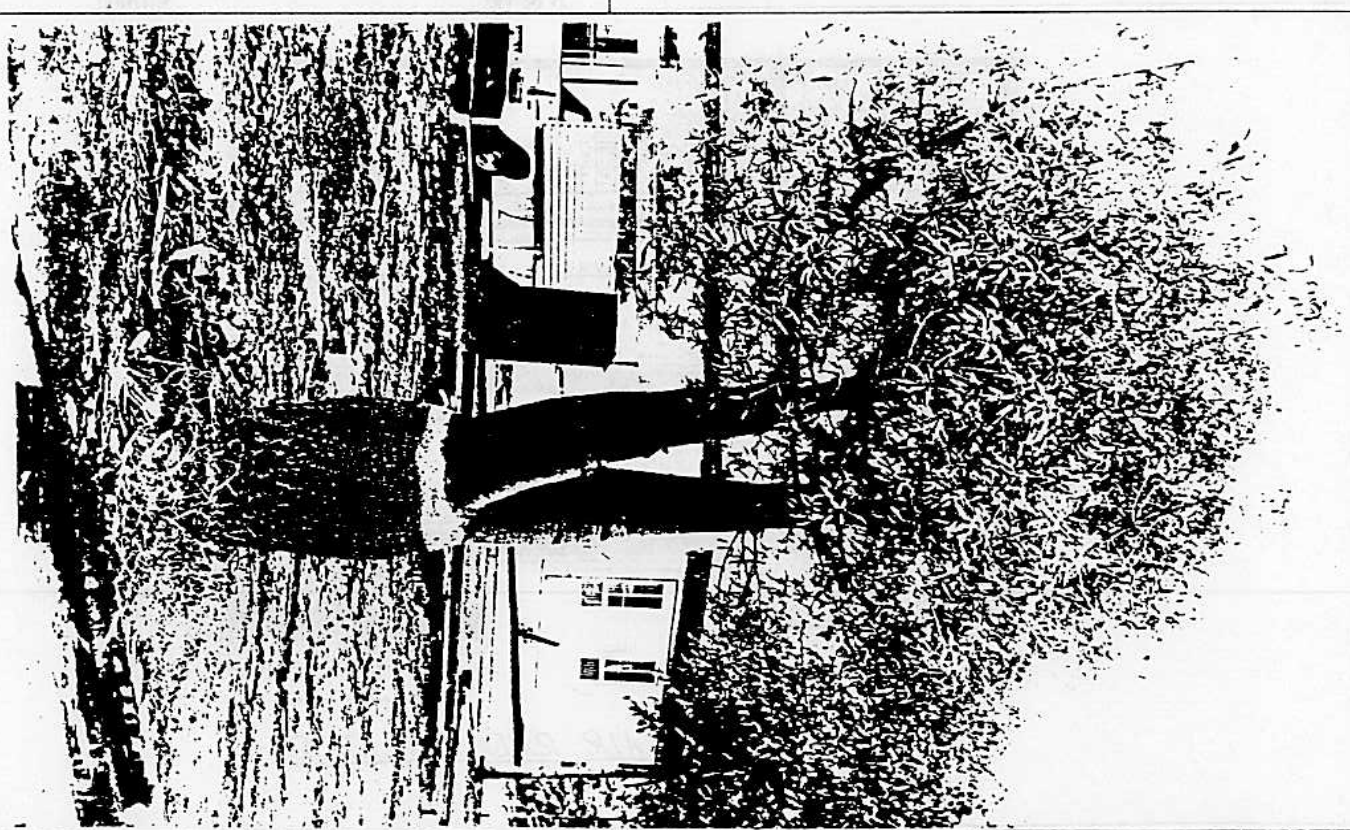
<b>NAME OF ITEM:</b> Boabaob Tree		
<b>No.</b> L1	<b>Map Ref:</b>	<b>Precinct J</b>
<b>Location:</b> Northern edge of entrance to Loco Maintenance Centre. South of the Rehabilitation Buildings.		
<b>Condition:</b>		
<b>Associated Items:</b>		
<b>Description:</b> The BOABAB tree is the remainder of a pair. Is is a relatively small specimen but is significant in surviving in a relatively inhospitable climate. Is is one of a very few specimens outside a Botanical garden setting.		
<b>SIGNIFICANCE ASSESSMENT</b> Aesthetic Value /5 Historic Association /5 Technological Importance /5 Structural Integrity /5 Interpretive Ability /5 Social Significance /5		<b>INFORMANTS:</b>      <b>REFERENCES:</b>
<b>RECOMMENDATION:</b> Conserve		<b>PHOTOGRAPHS:</b> B & W:                      Slides:

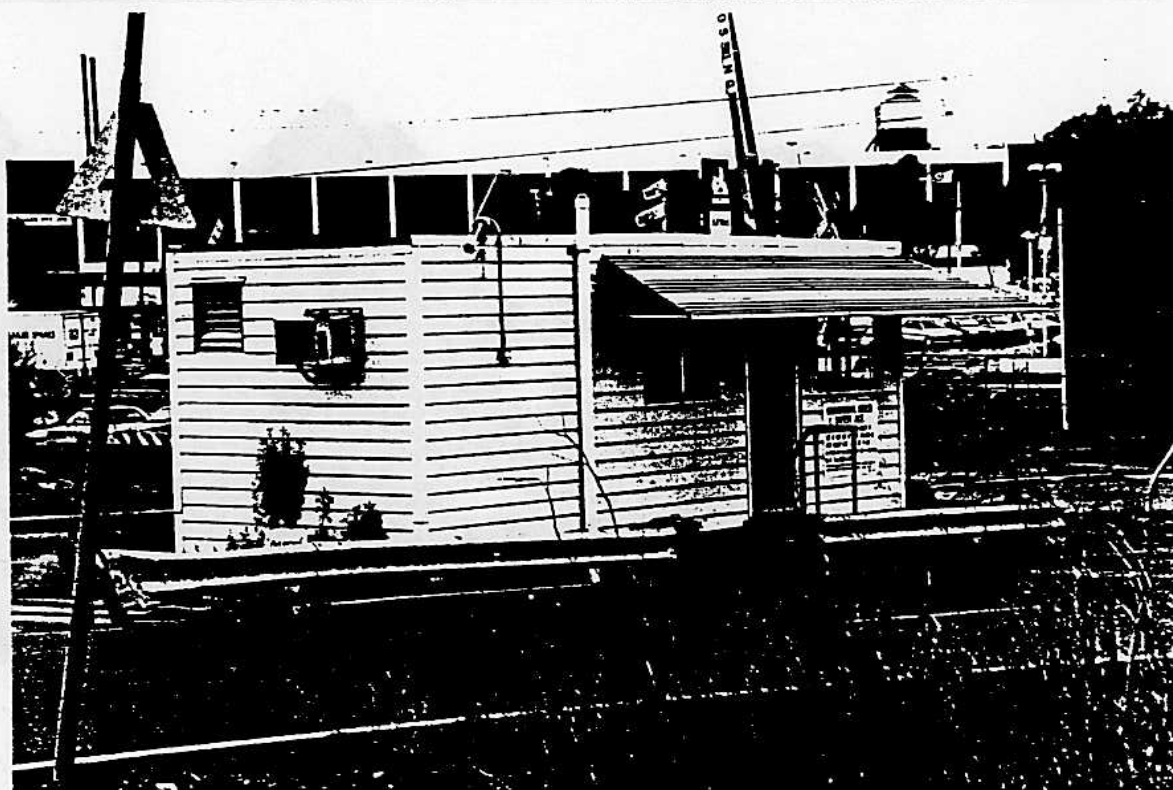
NAME OF ITEM: Watchmans Gatehouse

Condition: Good

Description: The gatehouse is a small relatively modern building typical of the type at Chullora. It is a timber framed, corrugated iron roofed building which is entered from a ramp on either side. It has sliding windows so the guard can interview prospective visitors. Unlike some of the other gatehouses this one is still manned and functional.

RECOMMENDATION: Record
