BAAL BONE UNDERGROUND

Annual Review 2019

Name of Operation	Baal Bone Colliery
Name of Operator	Baal Bone Colliery
Project Approval Number	09_0178
Name of Holder of Project Approval	The Wallerawang Collieries Ltd
Mining Lease Number/s	CCL749, MPL261, CL391, ML1302, ML1389, ML1607
Name of Holder of Mining Lease/s	The Wallerawang Collieries Ltd
Water Licence Number/s	10BL601816, 10BL601817, 10BL601877, 10BL601970, 80BL236132, 80BL236134, WAL27887, WAL34952.
Name of Holder of Water Licence/s	The Wallerawang Collieries Ltd
MOP Start Date	20 th December 2019
MOP End Date	31 st December 2025
Annual Review Start Date	1 st January 2019
Annual Review End Date	31 st December 2019

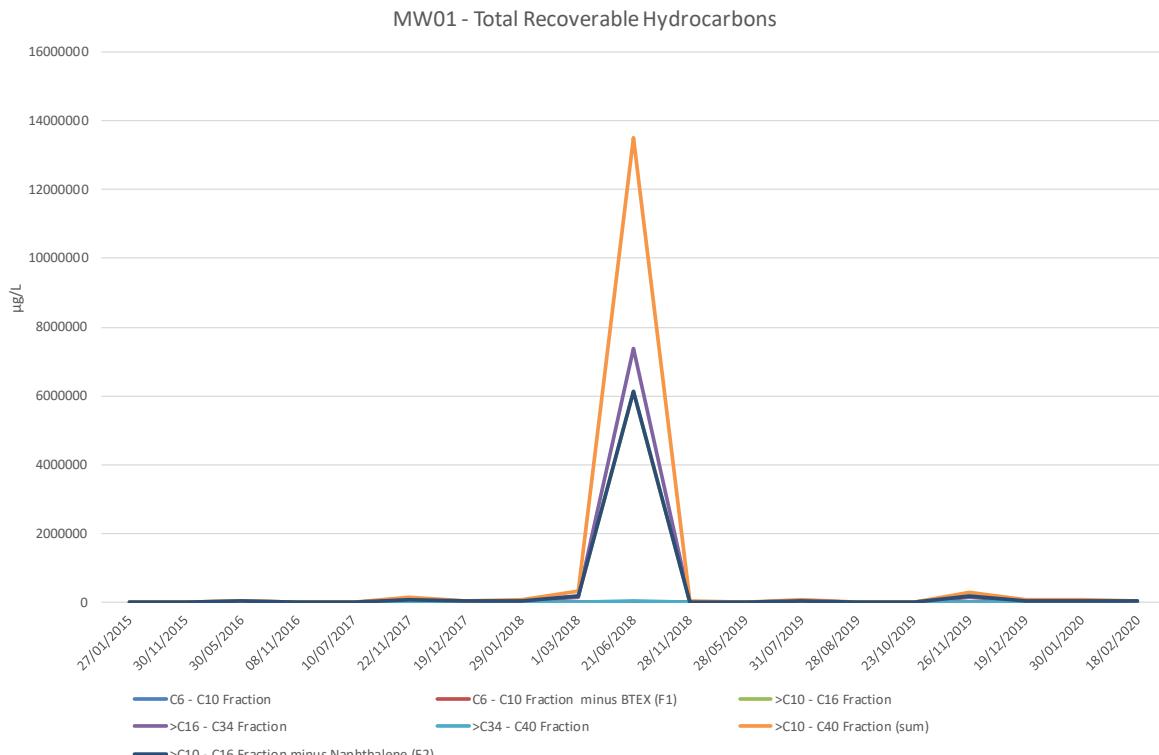
Figure 5.6: TRH results for MW01 (2015 to 2020)

Given the high concentrations of TRH at MW01, integrity testing of the 50,000L diesel UST and lines was conducted on 9 April 2018. The integrity test found no issues with the tank, however noted a small leak in a line and hand nozzle. A replacement line and hand nozzle was fitted the week following the integrity test. Further investigations on site detected a leak in a second fitting (banlaw fitting) – only evident when the line was pressurised. Subsequently, that line and banlaw fitting was removed.

Groundwater monitoring wells were sampled again in June 2018. The June 2018 sampling found that TRH levels at MW01 had increased significantly since the March 2018 sampling. MW03 and MW101 continued to return consistently low concentrations of TRH. Due to the continued increases of TRH at MW01, use of the underground diesel storage tank was discontinued in mid-2018 and an alternate small capacity above ground tank was utilised.

In May 2019, use of the diesel UST was recommenced due to mine closure works and increased diesel usage. Groundwater monitoring wells were sampled on an increased frequency during the remainder of 2019 and into 2020. Results show that MW03 has continued to return consistently low concentrations of TRH (MW101 has been unable to be sampled since mid-2019 due to damage to the well). MW01 TRH levels during 2019 and early 2020 were broadly consistent with historical levels, with the exception of an increase noted in November 2019. Since November 2019 TRH levels at MW01 have steadily declined. Regular sampling will continue during 2020.

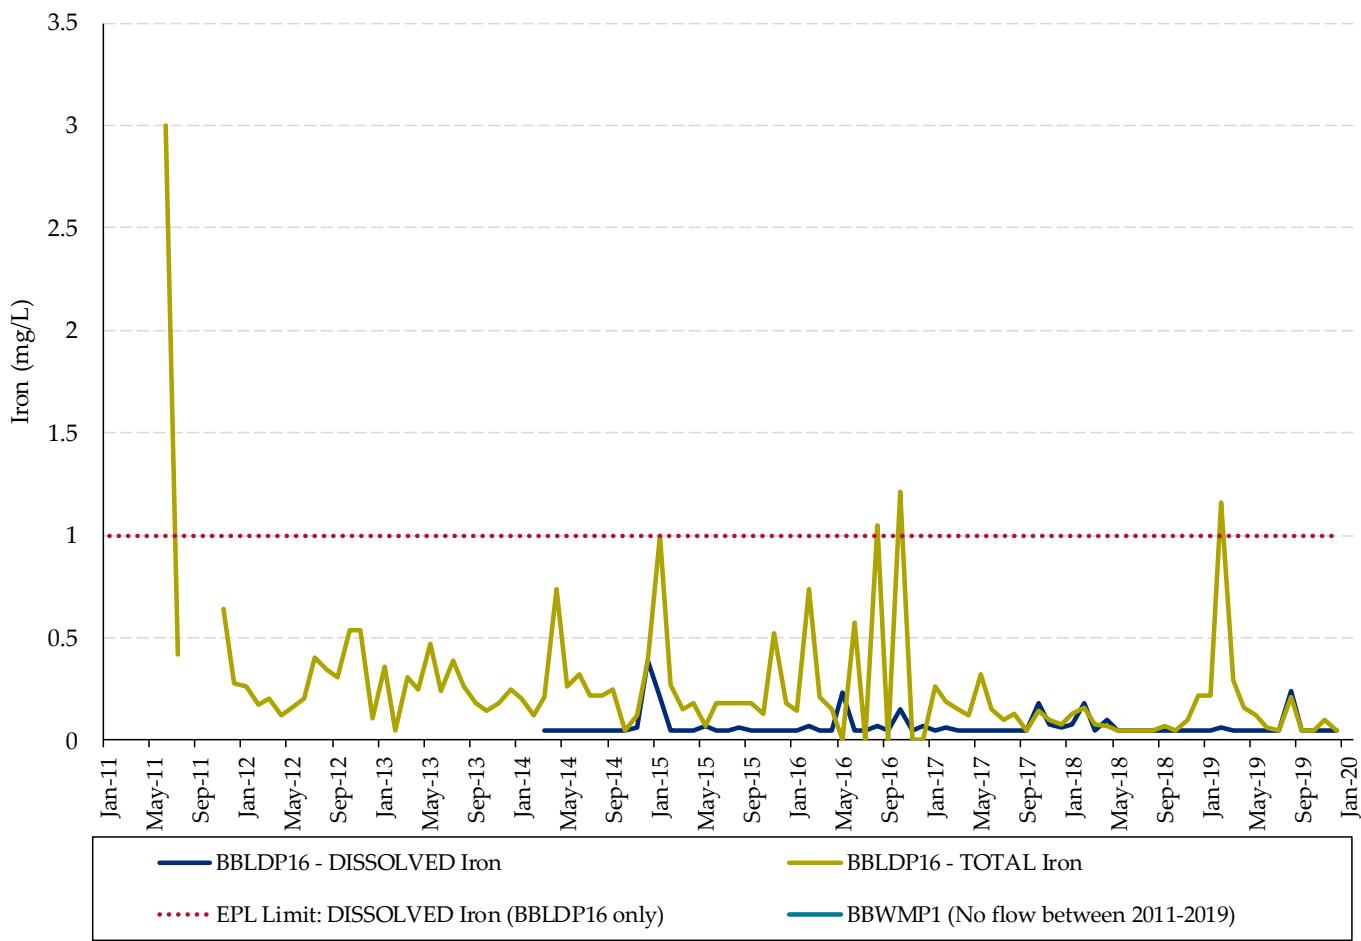
Figure 6.5: Iron – Total and Dissolved (2011 – 2019)

Figure 6.5 shows the iron level recorded at BBLDP16 from 2011 to 2019. From 1 August 2013 EPL 765 specifies a *dissolved* iron concentration limit of 1 mg/L at BBLDP16. Prior to this time, the iron concentration limit at BBLDP16 was 1 mg/L of *total* iron. Between 2011 and 2018 there has been one exceedance of the EPL iron concentration limit, in June 2011, with a reading of 3 mg/L. An investigation which included follow up testing of LDP1 and examination of water transfers could find no definitive reason for the isolated spike in iron levels.

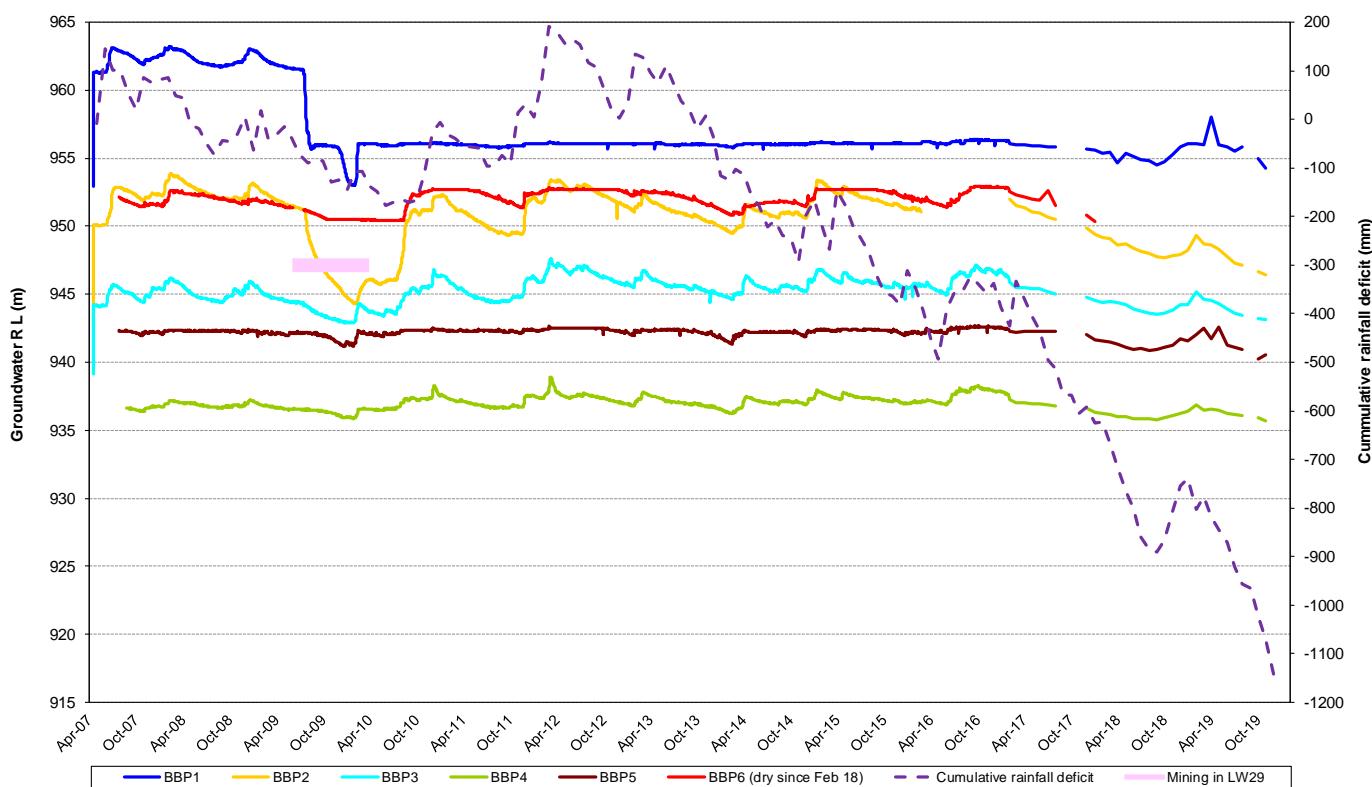
Figure 6.9: Coxs River Swamp groundwater levels and rainfall deficit

Note: BPPB6 groundwater levels dropped throughout 2017 in response to the dry conditions, and in February 2018 the piezometer has been recorded as dry. BPPB6 has remained dry from February 2018 until end 2019.

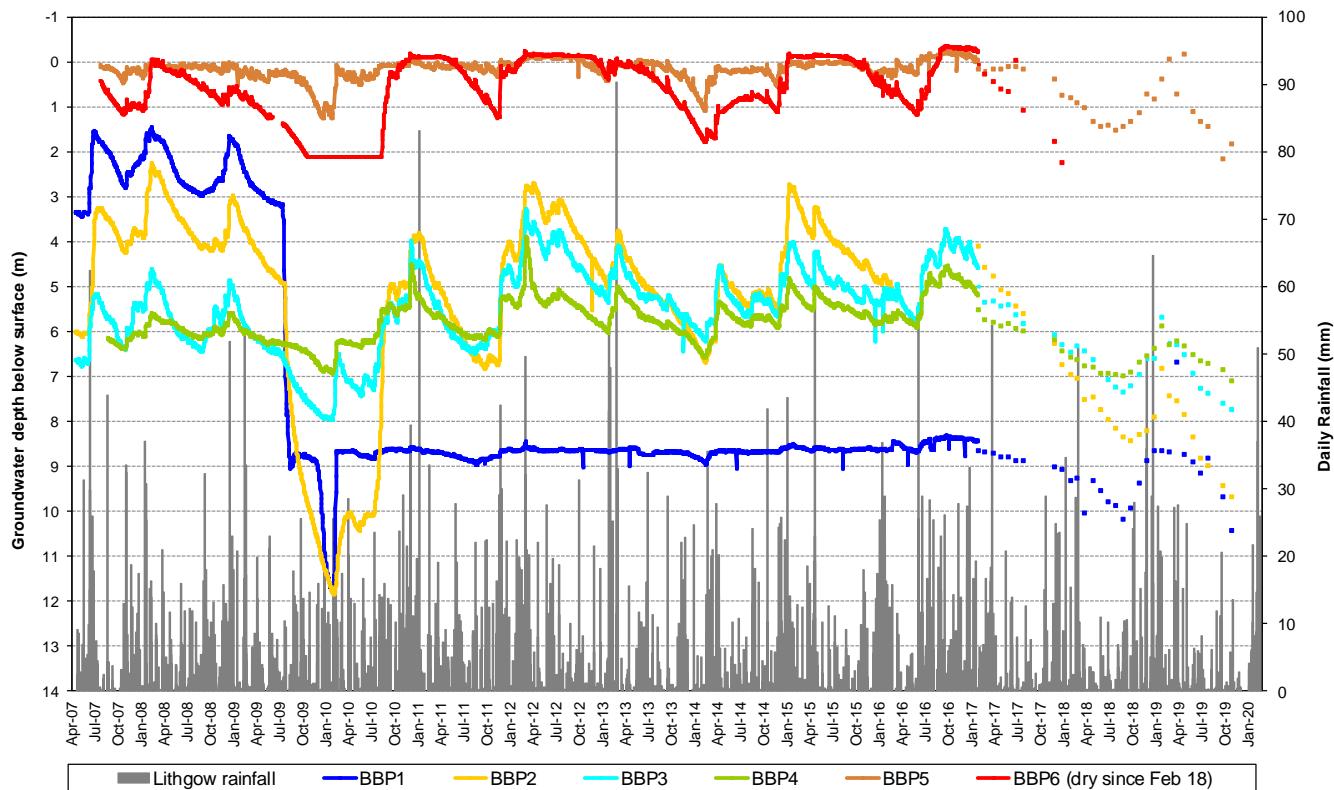
Figure 6.10: Longterm groundwater trends

Groundwater data are plotted on **Figure 6.9** and **Figure 6.10**. The north – to – south downstream groundwater gradient has been broadly maintained (highest level observed in BBPB1 and lowest level observed in BBPB4), indicating that overall flow has been maintained down through the swamp.

All groundwater levels appear to be approximately at pre-mining levels, with the only exception being at piezometer BBP1, where a groundwater level has re-stabilised at RL 956 m (approximately 5 m below pre-mining level).
