# BAAL BONE UNDERGROUND

**Annual Review**  
**2025**

| <b>Name of Operation</b> | Baal Bone Colliery |

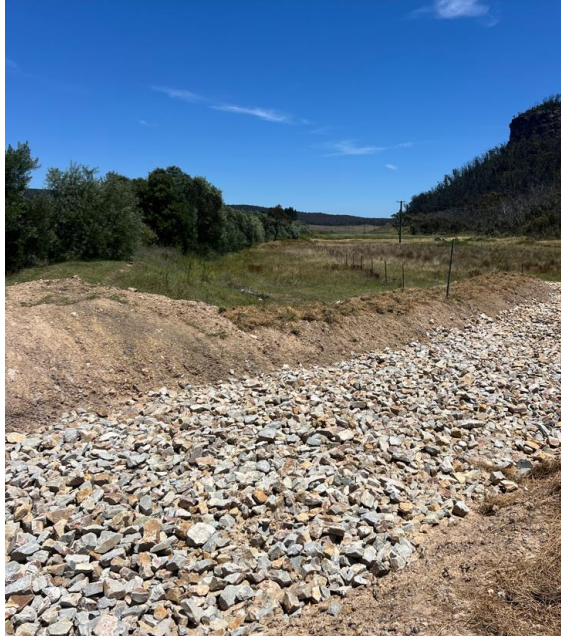
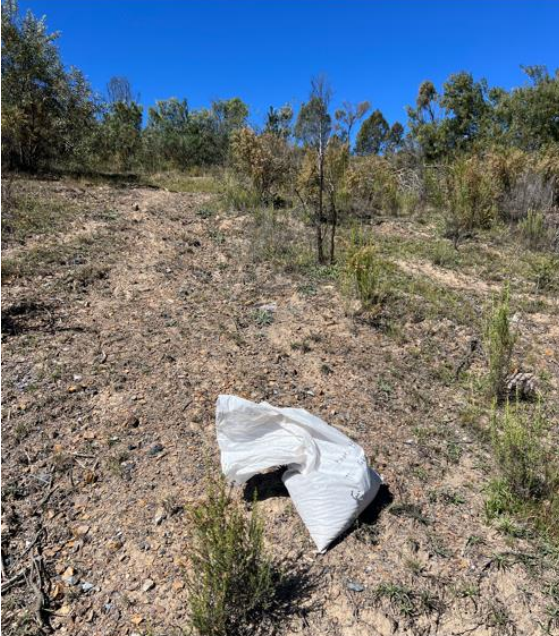
| <div>Northern Void Spillway</div> <div><div>DIRECTION33.252057°S150.061725°EACCURACY 3 mDATUM GDA94</div><div></div><div>Northern Void Spillway20/1/2025, 1:03:09 pm</div></div> | <div>Thistle Hill reseed</div> <div><div>DIRECTION33.260685°S150.055577°EACCURACY 4 mDATUM GDA94</div><div></div><div>Western side Thistle hillReseed by hand7/4/2025, 1:30:30 pm</div></div> |

During early 2025 a permanent spillway was constructed from the Northern Void towards Jews Creek. The permanent spillway replaces temporary steel pipelines at LDP17. A number of rehabilitation maintenance activities were also carried out in 2025 – refer to **Plate 1**.

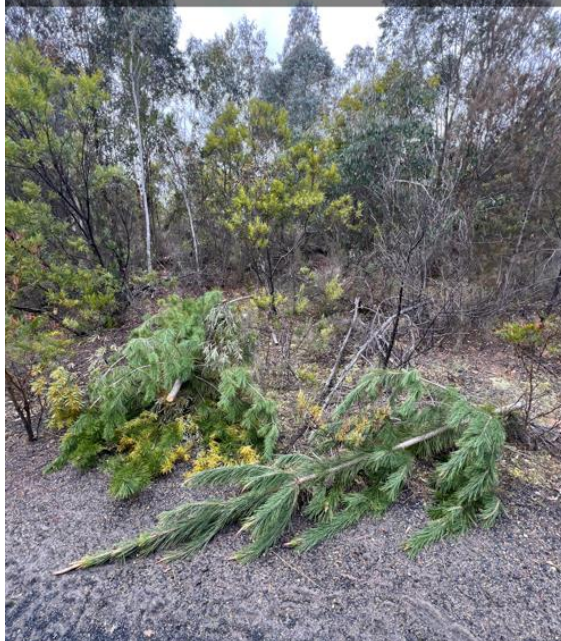
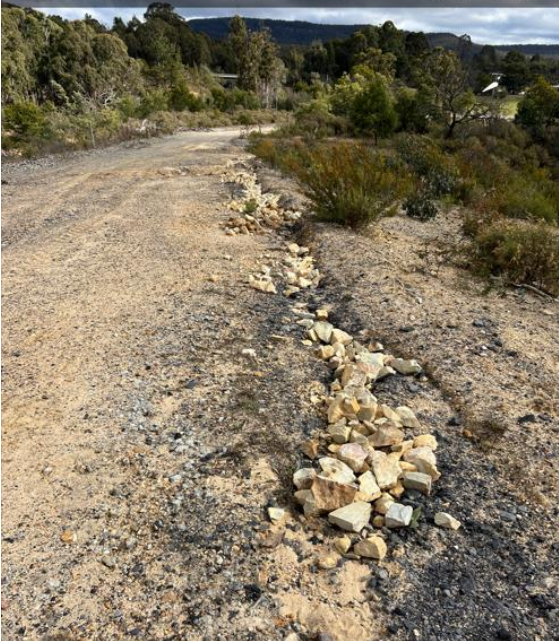
| <div>Pine tree removal</div> <div><div>DIRECTION33.262446°S150.052244°EACCURACY 5 mDATUM GDA94</div><div></div><div>Pine removal4/8/2025, 1:11:58 pm</div></div> | <div>Erosion and sediment repairs</div> <div><div>DIRECTION33.270095°S150.059450°EACCURACY 5 mDATUM GDA94</div><div></div><div>HelipadESC works23/6/2025, 11:10:22 am</div></div> |

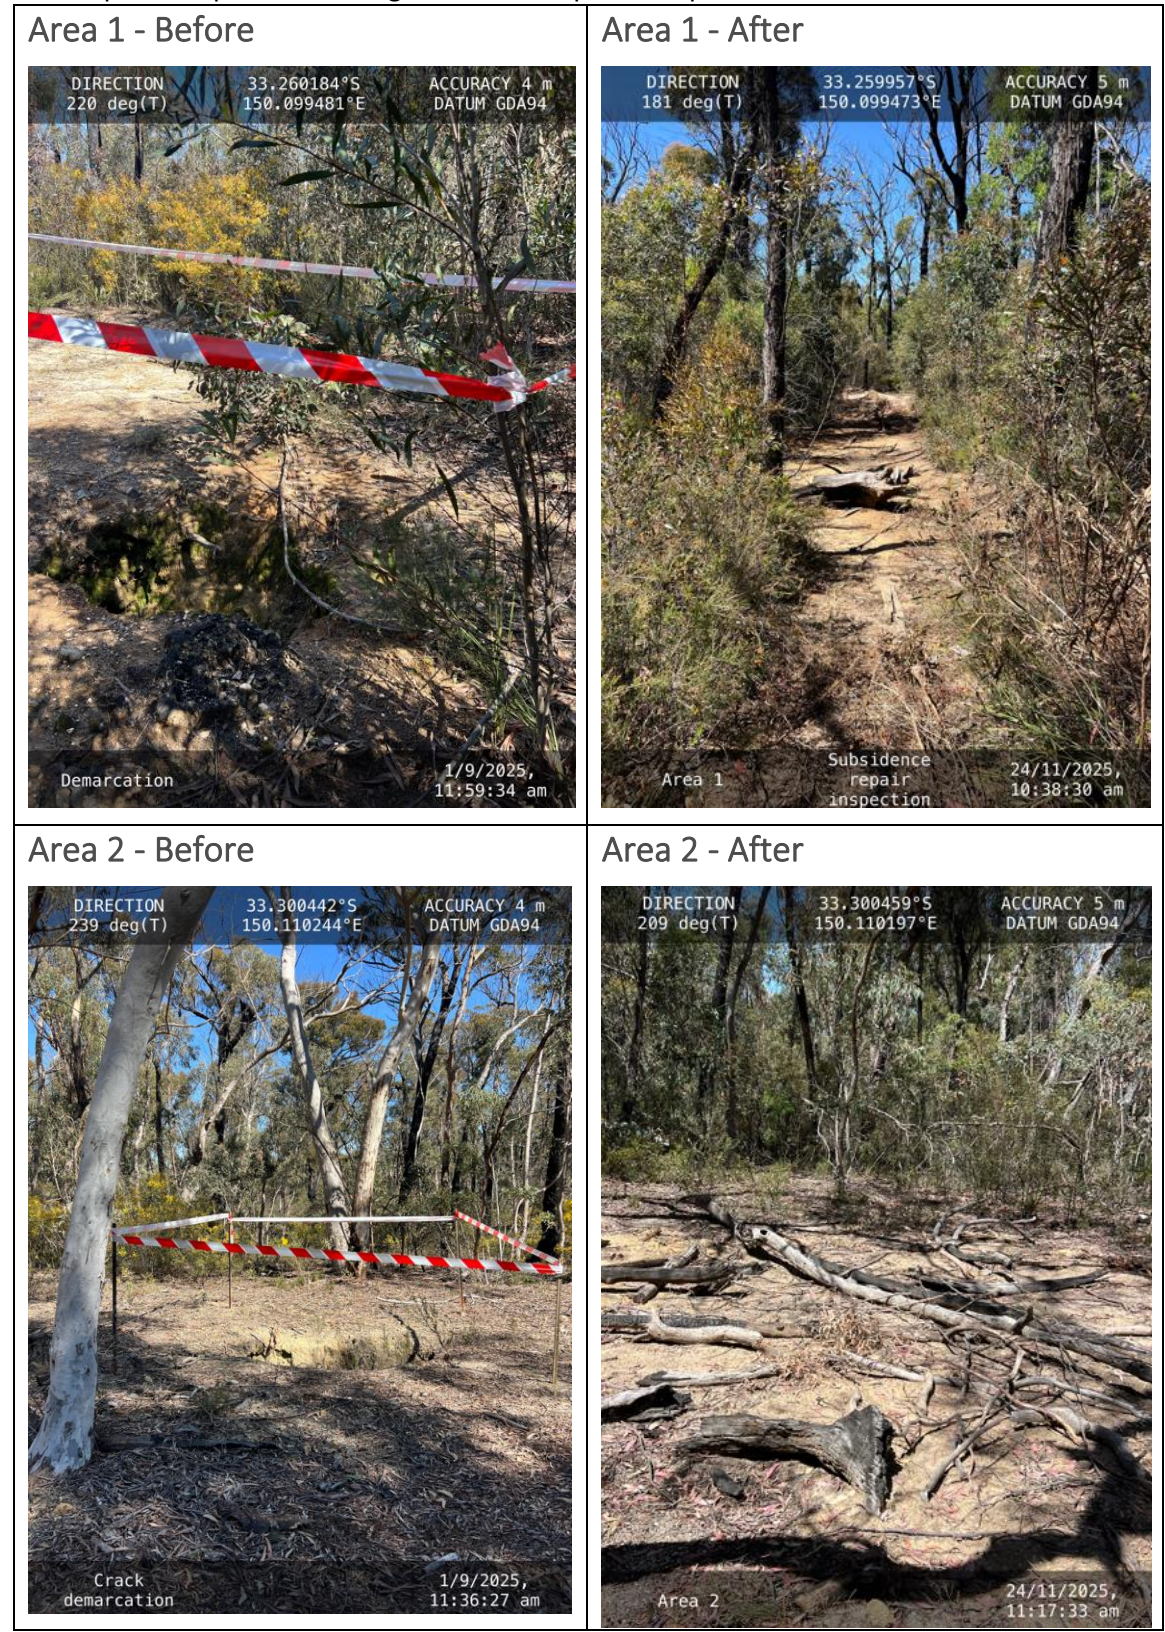
**Plate 2** provides photos showing subsidence repairs completed in 2025.

During 2025 subsidence repairs were carried out in two areas in the Gardens of Stone State Conservation Area, following consultation with NPWS. **Plate 2** provides photos showing before and after the subsidence repairs.
