MACQUARIE COAL

GLENCORE

# **Macquarie Coal Annual Review 2019**

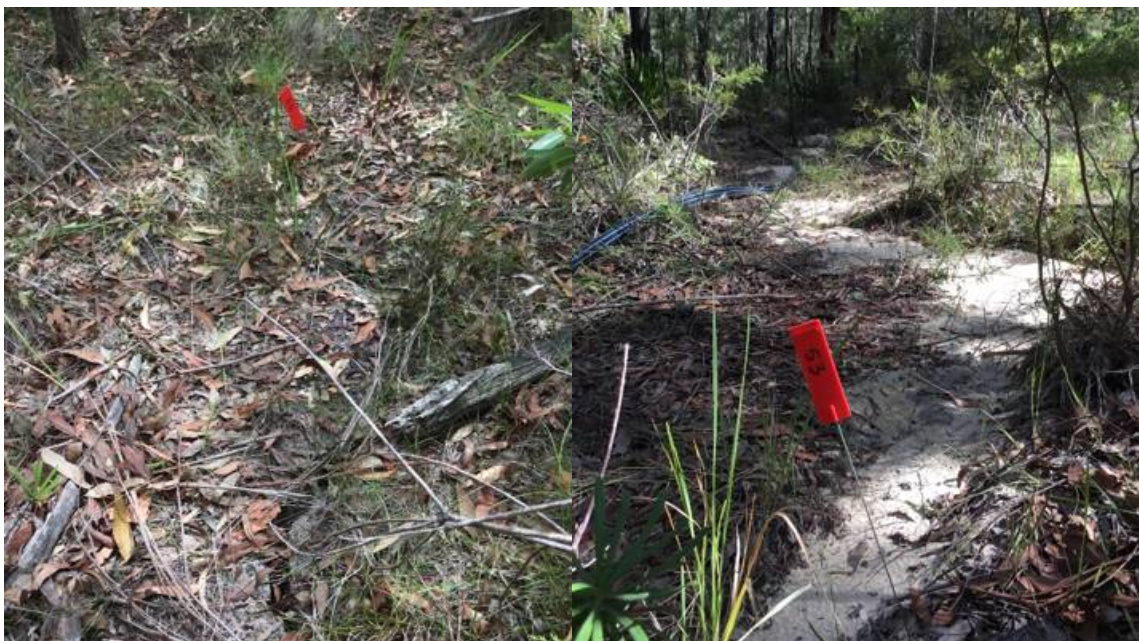
Based on the West Wallsend Continued Operations Project Mod 1 Environmental Assessment by Umwelt (2014) "maximum surface cracking widths of between 110 millimetres and 250 millimetres may potentially occur within the limits of mining and in areas with moderately undulating terrain (i.e. slopes <18degrees). Cracks of up to approximately 830 millimetres may occur on ridge crests due to rigid body rotations of steep slopes. Similar size 'scarps' or VBM's could also develop as a result of subsiding a steep slope by the same order of magnitude."

As mining ceased in 2016 no new cracks were formed, so comparison to predictions not applicable. See below **photos 1** and **2**, examples of subsidence cracks in the SSCA before and after remediation.

**Photo 1: Subsidence crack**

**Photo 2: Post remediation**

Subsidence remediation in the Sugarloaf State Conservation Area using liquefied sand commenced in February 2019. Approximately 33% of subsidence cracks located near Wakefield Forest Road and Aubs Ridge Road have been filled. Macquarie Coal is currently consulting with DPIE (formerly OEH) regarding the application of a sand binding product on top of sand filled subsidence cracks to prevent erosion. Remediation works are expected to be completed in 2021.

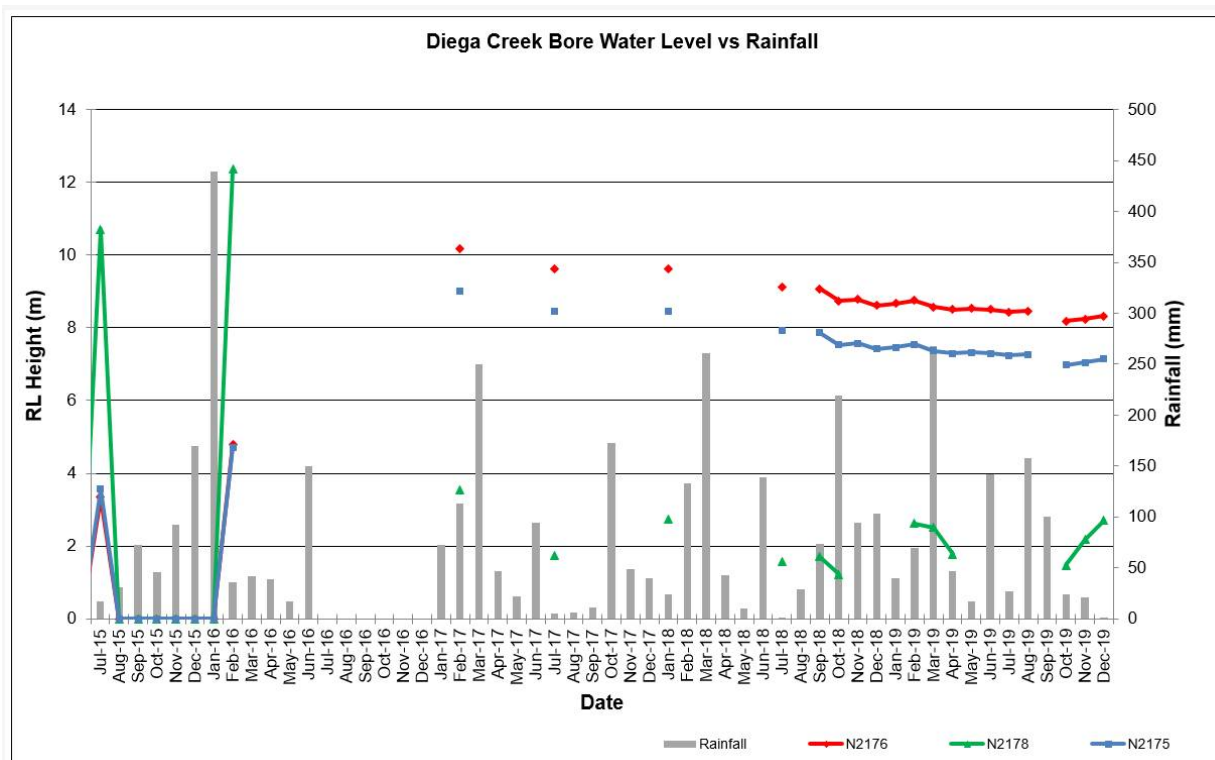
**Figure 7-5 – Diega Creek Bore Water Level vs Rainfall**

**Figure 7-5** indicates the groundwater levels in Diega Creek fluctuate when rainfall recharges the creek alluvium. The groundwater data indicates that there is no interconnected cracking from the longwall mining in the region of the creek system.
