Letter from JBS dated 9 February 2011

Further Refinement of Extent of Remediation Works on Headland Park, Barangaroo, NSW, Revision 1

Figure 13: Areas of Soil Requiring Relocation

Project: Barangaroo Headland Park

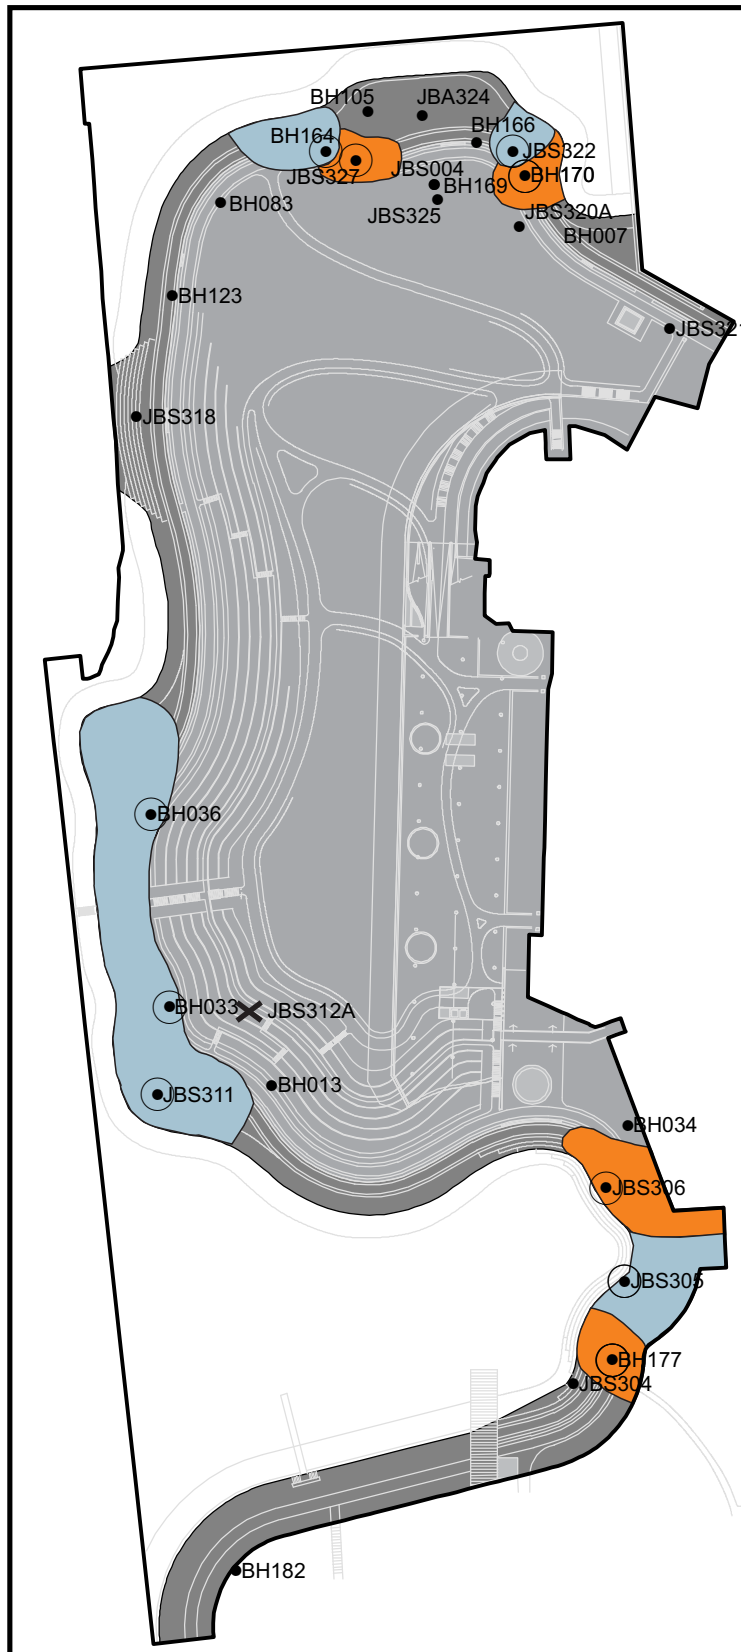
*The currently anticipated extent of in-situ contamination requiring remediation at the Headland Park Site shown in **Figure 13** by orange shading depicting soils considered inappropriate for use within 0.5 m of the final park surface. This is an approximate quantity of 1000 m³. The soils as identified on **Figure 13** and shown by blue shading, present over an approximate area of 6 000m², are considered inappropriate for use as growing medium.*

*In addition, a minor, isolated and localised area of tar impact was identified during geotechnical investigations at sampling location shown as JBS312A on **Figure 13**. Based on visual observations recorded on the borehole log, it is anticipated that this comprises an approximate quantity of 100 m³. Groundwater sampling and analysis has not indicated that significant groundwater impact is present underlying the Headland Park.*
