# **REDEVELOPMENT OF THE SYDNEY FISH MARKET PYRMONT**

## **Revised Arboricultural Assessment**

August 2010

**GARRY CLUBLEY**

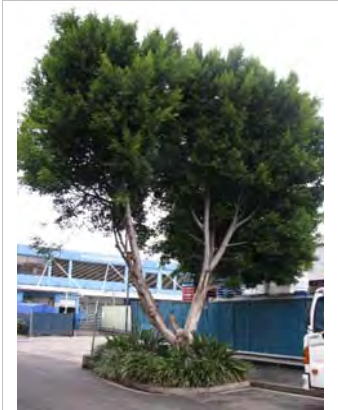
| Tree No. | Botanical Name | Common Name | Height (m)<br>Spread <sup>1</sup> (m)<br>DBH <sup>2</sup> (mm) | | | Age | Health | Structure | Horticultural Viability | Suitability for Retention | Transplant Suitability & Cost | Comments |
|---|---|---|---|---|---|---|---|---|---|---|---|---|
| | 17 <i>Ficus microcarpa</i> var. <i>hillii</i> | Hill's Weeping Fig | 10 | 13 | 480 | Semi-Mature | Fair-good | 1 | Poor | Poor | Remove and replace with better specimen in more appropriate location | Planted 1999. Located within parking bay. Very poor branch structure, typical of trees that suffer major limb failure in maturity. Very poor recent pruning – not in compliance with AS 4373. Recent failure of main scaffold branch has seriously compromised the longer term viability of this tree. The large wound adjacent to remaining limbs will lead to decay and likely failure of those branches over the next 20 years. Good performance of tree in structural soil. No apparent damage to adjacent bitumen surfaces, however some minor root break out between original trachyte kerbstones, where no structural soil was installed. |

| Tree No. | Botanical Name | Common Name | Recommended Action | Rationale |
|---|---|---|---|---|
| 17 | <i>Ficus microcarpa</i> var. <i>hillii</i> | Hill's Weeping Fig | Remove | Impacted on by proposed new road alignment. Poor branch structure liable to failure over medium term and young age indicate removal is preferred regardless of design. |

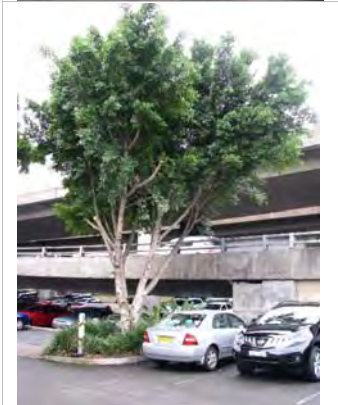
| Tree No. | Botanical Name | Common Name | Height (m)<br>Spread <sup>1</sup> (m)<br>DBH <sup>2</sup> (mm) | | | Age | Health | Structure | Horticultural Viability | Suitability for Retention | Transplant Suitability & Cost | Comments |
|---|---|---|---|---|---|---|---|---|---|---|---|---|
| | 18 <i>Ficus microcarpa</i> var. <i>hillii</i> | Hill's Weeping Fig | 10 | 11 | 460 | Semi-Mature | Good | 1 | Fair-good | Fair | Remove and replace with better specimen in more appropriate location | Planted 1999. Located within parking bay. Reasonable specimen but with deep bark inclusion between two codominant leaders. Very poor recent pruning – not in compliance with AS 4373. Good performance of tree in structural soil. |

| Tree No. | Botanical Name | Common Name | Recommended Action | Rationale |
|---|---|---|---|---|
| 18 | <i>Ficus microcarpa</i> var. <i>hillii</i> | Hill's Weeping Fig | Remove | Impacted on by proposed new road alignment. Poor branch structure liable to failure over medium term and young age indicate removal is preferred regardless of design. |

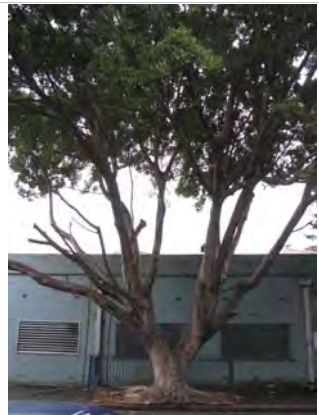
| Tree No. | Botanical Name | Common Name | Height (m)<br>Spread <sup>1</sup> (m)<br>DBH <sup>2</sup> (mm) | | | Age | Health | Structure | Horticultural Viability | Suitability for Retention | Transplant Suitability & Cost | Comments |
|---|---|---|---|---|---|---|---|---|---|---|---|---|
| | 19 <i>Ficus microcarpa</i> var. <i>hillii</i> | Hill's Weeping Fig | 15 | 20 | 890 | Mature | Fair to Good | 3 | Good | Moderate | Unsuitable for relocation (form, shallow root plate and under ground services) | Large specimen probably planted in the 1960s. No significant changes to this tree since the first review in 1998 other than a marked increase in shallow root uplift of adjacent footpath and an increase in crown spread and trunk diameter. Little or no change in the displacement of the original Bank St. kerb over the last 11 years. There have been no significant changes in the structure of the tree. Appallingly bad recent pruning. Clearly carried out by a contractor who doesn't understand the requirements of AS 4373 or the problems that arise with this species if these requirements are not adhered to. |

| Tree No. | Botanical Name | Common Name | Recommended Action | Rationale |
|---|---|---|---|---|
| 19 | <i>Ficus microcarpa</i> var. <i>hillii</i> | Hill's Weeping Fig | Consider removal unless more space for crown and rootzone can be provided. | The size of the tree, poor form, branch overhang to SW and ongoing root/infrastructure conflicts indicates that the fig will be in conflict with construction of proposed adjacent building. |

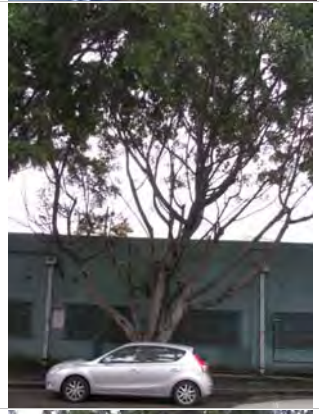
| Tree No. | Botanical Name | Common Name | Height (m)<br>Spread <sup>1</sup> (m)<br>DBH <sup>2</sup> (mm) | | | Age | Health | Structure | Horticultural Viability | Suitability for Retention | Transplant Suitability & Cost | Comments |
|---|---|---|---|---|---|---|---|---|---|---|---|---|
| | 20 <i>Ficus microcarpa</i> var. <i>hillii</i> | Hill's Weeping Fig | 14 | 20 | 600 | Mature | Fair to Good | 2 | Good | Moderate | Unsuitable for relocation (form, defect and under ground services) | Large specimen probably planted in the 1960s. No significant changes to this tree since the first review in 1998 other than a marked increase in shallow root uplift of adjacent and an increase in crown spread and trunk diameter. Little or no change in the displacement of the original Bank St. kerb over the last 11 years. There have been no significant changes in the structure of the tree. |

| Tree No. | Botanical Name | Common Name | Recommended Action | Rationale |
|---|---|---|---|---|
| 20 | <i>Ficus microcarpa</i> var. <i>hillii</i> | Hill's Weeping Fig | Consider removal unless more space for crown and rootzone can be provided. | The size of the tree, poor form, branch overhang to SW and ongoing root/infrastructure conflicts indicates that the fig will be in conflict with construction of proposed adjacent building. |

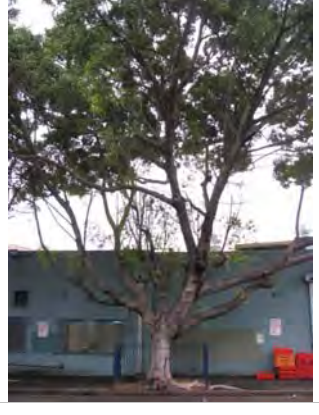
| Tree No. | Botanical Name | Common Name | Height (m)<br>Spread <sup>1</sup> (m)<br>DBH <sup>2</sup> (mm) | | | Age | Health | Structure | Horticultural Viability | Suitability for Retention | Transplant Suitability & Cost | Comments |
|---|---|---|---|---|---|---|---|---|---|---|---|---|
| | 21 <i>Ficus microcarpa</i> var. <i>hillii</i> | Hill's Weeping Fig | 13 | 20 | 710 | Mature | Fair to Good | 3 | Good | Moderate | Unsuitable for relocation (form, shallow root plate and under ground services) | Large specimen probably planted in the 1960s. No significant changes to this tree since the first review in 1998 other than a marked increase in shallow root uplift of adjacent footpath and an increase in crown spread and trunk diameter. Little or no change in the displacement of the original Bank St. kerb over the last 11 years. There have been no significant changes in the structure of the tree. |

| Tree No. | Botanical Name | Common Name | Recommended Action | Rationale |
|---|---|---|---|---|
| 21 | <i>Ficus microcarpa</i> var. <i>hillii</i> | Hill's Weeping Fig | Consider removal unless more space for crown and rootzone can be provided. | The size of the tree, poor form, branch overhang to SW and ongoing root/infrastructure conflicts indicates that the fig will be in conflict with construction of proposed adjacent building. |

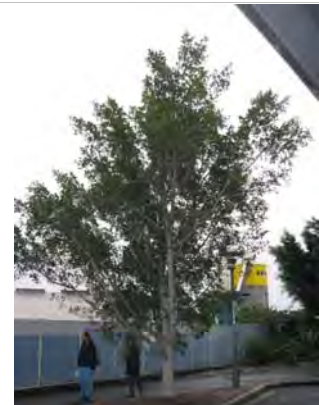
| Tree No. | Botanical Name | Common Name | Height (m) | | | Age | Health | Structure | Horticultural Viability | Suitability for Retention | Transplant Suitability & Cost | Comments |
|---|---|---|---|---|---|---|---|---|---|---|---|---|
| | 24 <i>Ficus microcarpa</i> var. <i>hillii</i> | Hill's Weeping Fig | 7 | 7 | 270 | Semi-Mature | Fair to Good | 4 | Good | Good | Suitable for relocation (approx. cost \$2000) | Planted 1999. Located within parking bay. This Fig has continued to be a less vigorous specimen. It has the sparsest leaf cover of all of the figs planted in 1999. The tree was not planted into structural soil and the shallow underlying rock and kerb / road have restricted available root zone. Generally the form and structure of the tree is good and it would be suitable for transplanting. The condition and viability of this fig is likely to improve if provided with a favourable root zone. |

| Tree No. | Botanical Name | Common Name | Recommended Action | Rationale |
|---|---|---|---|---|
| 24 | <i>Ficus microcarpa</i> var. <i>hillii</i> | Hill's Weeping Fig | May be suitable for relocation. Reassess suitability in context of Master Plan | Reasonable specimen. Requires formative pruning. |

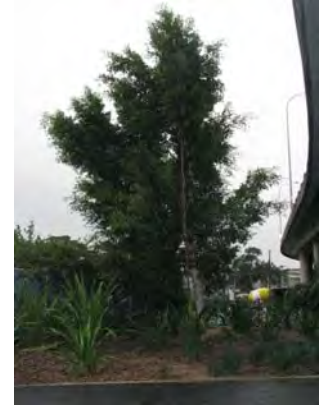
| Tree No. | Botanical Name | Common Name | Height (m) | | | Age | Health | Structure | Horticultural Viability | Suitability for Retention | Transplant Suitability & Cost | Comments |
|---|---|---|---|---|---|---|---|---|---|---|---|---|
| | 25 <i>Ficus microcarpa</i> var. <i>hillii</i> | Hill's Weeping Fig | 8 | 7 | 225 | Semi-Mature | Fair to Good | 4 | Good | Good | Suitable for relocation (approx. cost \$2000) | Planted 1999. Located within garden bed. This Fig has continued to be a less vigorous specimen. It has more leaf cover than tree 24 but smaller size than the other figs planted in 1999. The shallow underlying rock has led to restricted available root zone. Generally the form and structure of the tree is good and it would be suitable for transplanting. The condition and viability of this fig is likely to improve if provided with a favourable root zone. |

| Tree No. | Botanical Name | Common Name | Recommended Action | Rationale |
|---|---|---|---|---|
| 25 | <i>Ficus microcarpa</i> var. <i>hillii</i> | Hill's Weeping Fig | May be suitable for relocation. Reassess suitability in context of Master Plan | Reasonable specimen. Requires formative pruning. |

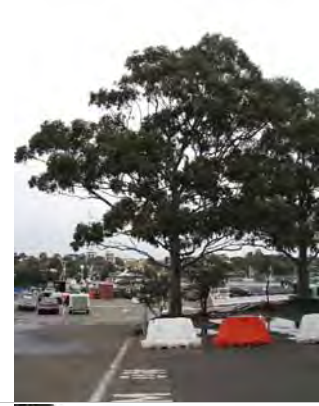
| Tree No. | Botanical Name | Common Name | Height (m) | | | Age | Health | Structure | Horticultural Viability | Suitability for Retention | Transplant Suitability & Cost | Comments |
|---|---|---|---|---|---|---|---|---|---|---|---|---|
| | 26 <i>Eucalyptus saligna</i> | Sydney Blue Gum | 14.5 | 15.2<br>5 | 625 | Mature | Fair to Good | 5 | Fair to Good | Good | Species unsuitable for relocation | There has been significant growth in the crown spread and trunk diameter of this tree since 2003. This mature specimen is located in bitumen pavement however numerous cracks in the bitumen have permitted good water infiltration. Previous observation of this tree suggests that the main factor affecting its condition is whether it is subject to water stress. Although the tree is planted in fill there appears to be sufficient soil volume but restricted soil depth. Roots are further constrained by the retaining wall. If the tree is retained there will have to be numerous root protection measures put in place to avoid root damage or a restriction in the available root zone. |

| Tree No. | Botanical Name | Common Name | Recommended Action | Rationale |
|---|---|---|---|---|
| 26 | <i>Eucalyptus saligna</i> | Sydney Blue Gum | Reassess suitability in context of Master Plan | Mature tree. Good specimen. Restricted rootzone on western side. |

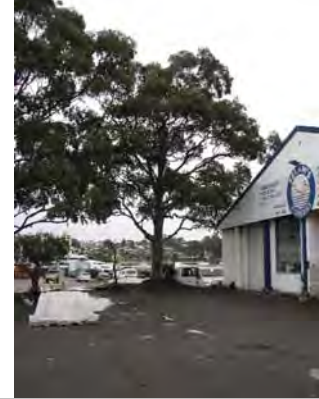
| Tree No. | Botanical Name | Common Name | Height (m) | | | Age | Health | Structure | Horticultural Viability | Suitability for Retention | Transplant Suitability & Cost | Comments |
|---|---|---|---|---|---|---|---|---|---|---|---|---|
| | 27 <i>Eucalyptus saligna</i> | Sydney Blue Gum | 13.7 | 12.5 | 710 | Mature | Fair To Good | 4 | Fair to Good | Good | Species unsuitable for relocation | There has been significant growth in the crown spread and trunk diameter of this tree since 2003. This mature specimen is located in bitumen pavement however numerous cracks in the bitumen have permitted good water infiltration. Previous observations of this tree suggest that the main factor affecting its condition is whether it is subject to water stress. Although the tree is planted in fill there appears to be sufficient soil volume but restricted soil depth. Roots are further constrained by the retaining wall. If the tree is retained there will have to be numerous root protection measures put in place to avoid root damage or a restriction in the available root zone. |

| Tree No. | Botanical Name | Common Name | Recommended Action | Rationale |
|---|---|---|---|---|
| 27 | <i>Eucalyptus saligna</i> | Sydney Blue Gum | Reassess suitability in context of Master Plan | Mature tree. Good specimen. Restricted rootzone on western side. |

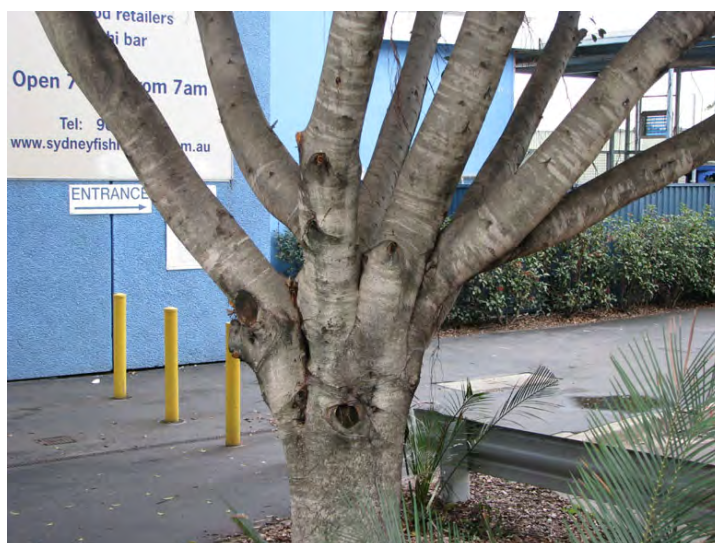
| Tree No. | Botanical Name | Common Name | Height (m) | | | Age | Health | Structure | Horticultural Viability | Suitability for Retention | Transplant Suitability & Cost | Comments |
|---|---|---|---|---|---|---|---|---|---|---|---|---|
| | 12 <i>Ficus microcarpa</i> var. <i>hillii</i> | Hill's Weeping Fig | 10 | 12 | 370 | Semi-Mature | Good | 2 | Fair | Poor | Remove and replace | Planted 1999. Located in garden bed. Generally in good health. No apparent damage to adjacent footpath. Very poor recent pruning – not in compliance with AS 4373. Very poor branch structure, typical of trees that suffer major limb failure in maturity. |

*Figure 1: Hills Fig No. 12 exhibiting typically poor branch structure among most of these trees.*

| Tree No. | Botanical Name | Common Name | Recommended Action | Rationale |
|---|---|---|---|---|
| 12 | <i>Ficus microcarpa</i> var. <i>hillii</i> | Hill's Weeping Fig | Remove and replace with better specimen | Not affected by current Redevelopment proposal. Poor branch structure liable to failure over medium term and young age indicate removal is preferred regardless of design. |

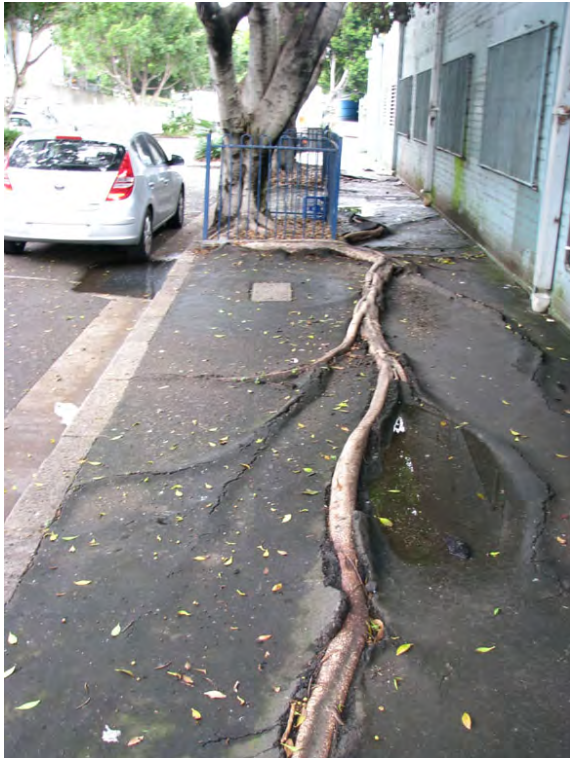
- 2.2.3 The three figs (nos. 19 to 21) continue to cause damage to pavement and other infrastructure. The figs continue to have defects that are of a low to moderate risk of failure over the medium to longer term however the extent of decay in the trunk or branch junctions had not been investigated at this stage.

- The three mature Hills Weeping Figs (nos. 19, 20, 21) adjacent to the Di Costi building display a similar health and condition to that observed in 2003. Their overall dimensions have increased and the problems associated with uplift of the adjacent

footpath by roots has become worse. The increased diameter of trunks and branches of these trees has alleviated some of the potential defects and risk of failure since the inspection 11 years ago however the problems described in 1999 remain and it is not known to what extent decay may have developed in the zones where the main branches attach to trunks. Generally, the form and structure of these trees is poor. This is partly due to poor pruning over recent years, which has resulted in numerous pruning wounds and weaker branch attachment. Their appearance can be described as fair to good and are readily visible from the adjacent approach to Anzac Bridge.

*Figure 2: Hills Fig No. 20, together with 19 & 21, has continued to cause significant pavement damage*

- It may be feasible to retain these three figs through the construction of a raised walkway on the eastern side, and limiting root damage by decreasing encroachment of the building on the western side. However the likely impact of pruning would further detract from the overall appearance of the trees and would exacerbate existing structural defects, increasing the risk of failure of some branches. The fast growth of the adjacent Hills Figs, planted in more favourable growing conditions 11 years ago, demonstrates that superior, longer lived specimens can be grown in the same location if suitable conditions are provided for the replacement trees.

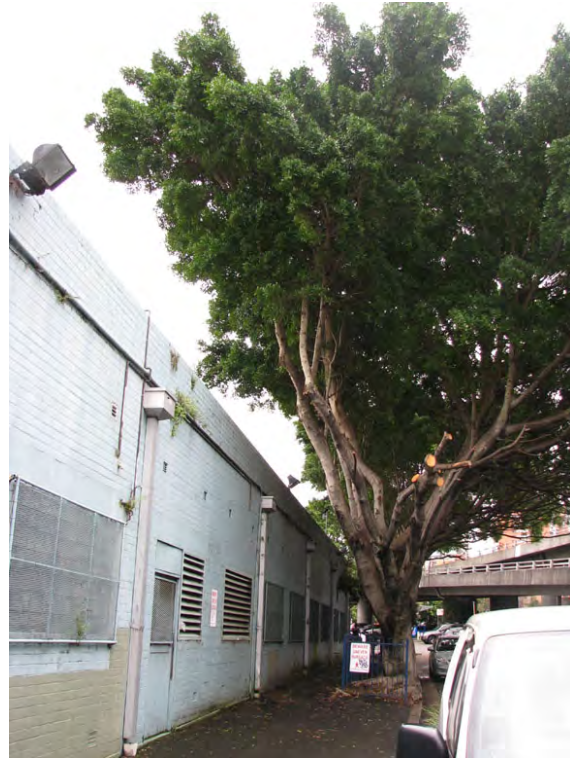
*Figure 3: Hills Fig No. 19 showing proximity to the existing building (and line of proposed Carpark)*

- The current design proposal shows the retention of the three Hills Weeping Figs (nos. 19, 20, 21). The proposal indicates the construction of a new footpath on the eastern side of the trunks and the construction of a new carpark along the approximate line of the existing building. However the proximity of the new building would require extensive pruning to the branches on that side to permit construction (including the erection of scaffolding) and potential root damage during excavation and construction of footings. The proposed bus bay on the eastern side is also likely to require the removal of large diameter lower branches to provide vehicle clearance.

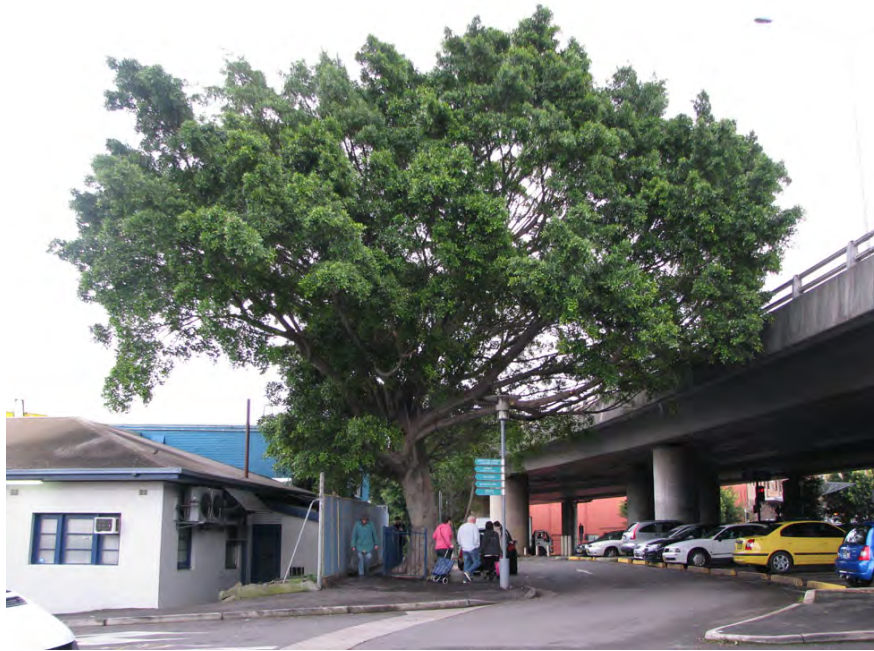
- The large Hills Fig (no. 23) at the northern end of the site remains the most prominent specimen on the site due to its size, appearance and good health and proximity to the adjacent approach to Anzac Bridge. The impacts on the adjacent footpath, described in 1999, have not changed significantly since then. In the proposed redevelopment of the site the layout of the new roadway and carpark entry would require the removal of this tree.

*Figure 4 Hills Fig No. 23 is prominent due to its proximity to the raised roadway.*

The transplantation of this specimen is not considered feasible.

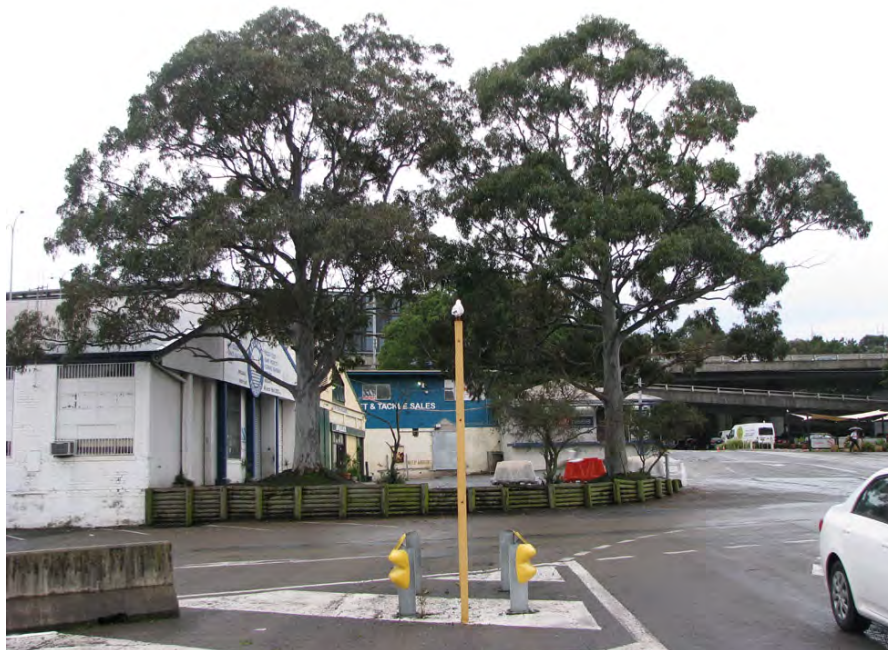
No significant (large diameter) deadwood was identified in the trees at this stage although deadwood in trees 26 and 27 do contain potentially hazardous dead branches that do require removal. It is recommended that as the development proceeds, the retained trees should be reassessed for any changes in tree condition and all deadwood greater than 50 mm diameter in tree crowns overhanging areas that can be readily accessed by workmen on site or the public be removed.

- The two mature Sydney Blue Gums (nos. 26 and 27) have grown significantly in terms of crown spread and trunk diameter and have performed well in spite of the poor soil conditions. The form and appearance of these two trees provide considerable amenity to the site.

The trees are growing in fill retained by a timber retaining wall running along the southern side of the trees. As a result most of the root mass will be contained in the level area of fill to the north east of the trees. It will be essential to minimise impacts on the root zones to ensure a longer term viability of these specimens.

*Figure 5 Sydney Blue Gums Nos. 26 & 27 exhibit good form and health.*

- It is proposed to retain the two Sydney Blue Gums within a hard paved pedestrian area. In spite of the restricted soil conditions that the trees are currently growing in, the existing bitumen pavement is extensively cracked and lifted by shallow tree roots. This has allowed easy infiltration of surface water and air into the existing root zone. Any changes to the levels around the trees, construction of stairs or a change to impervious surface materials should allow for the retention of most of the existing soil surrounding these trees and no significant change to water and air infiltration.
