Building Assessment Report

North Sydney Zone Substation
70 Berry Street, North Sydney NSW

25 November 2009

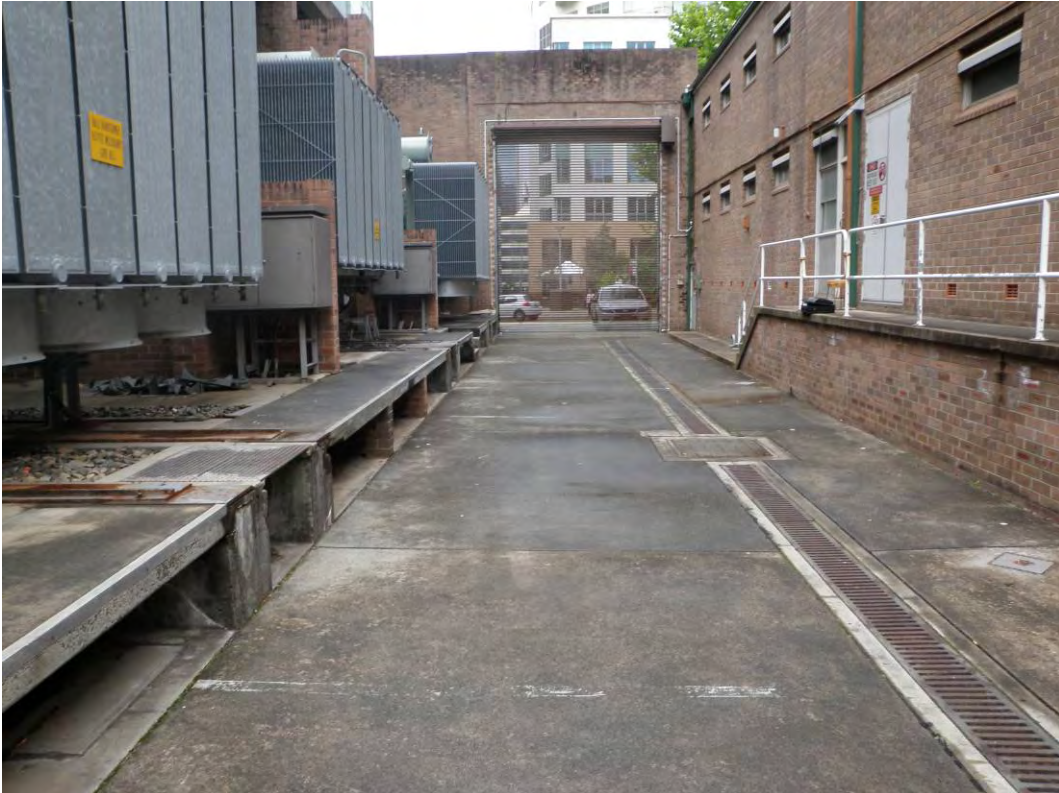
Plate P 1 Entrance to Substation

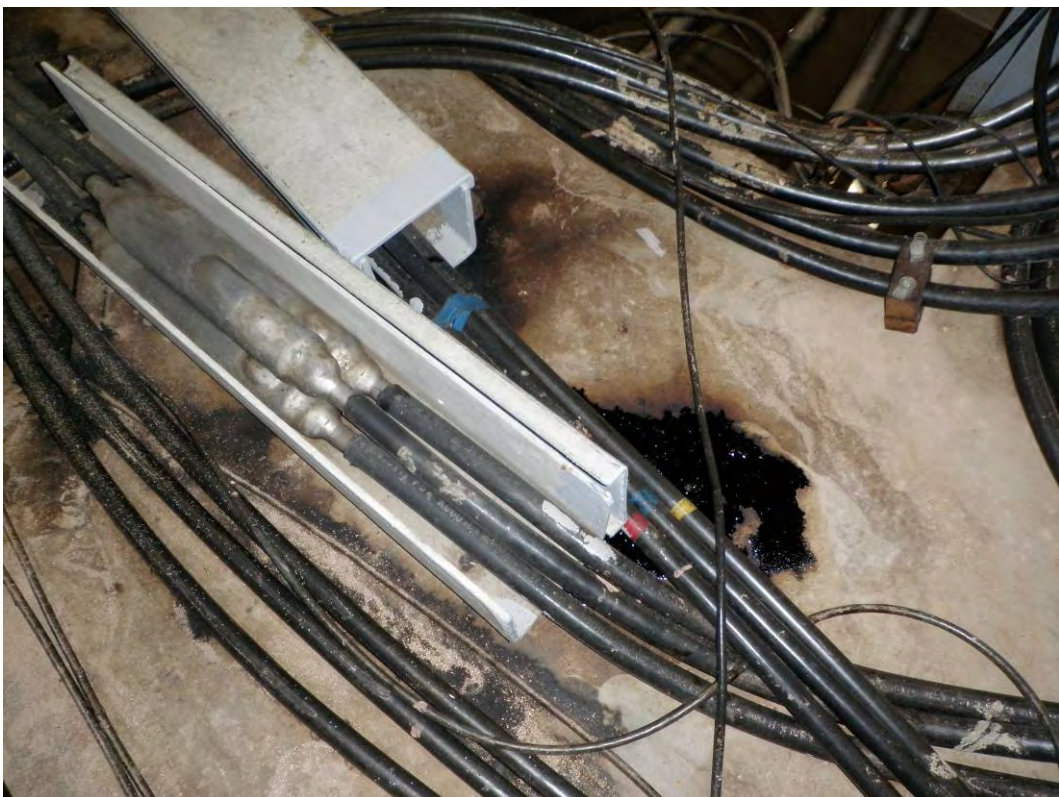
Plate P 2 Cable Room - Asbestos Boxing and Tar Leak

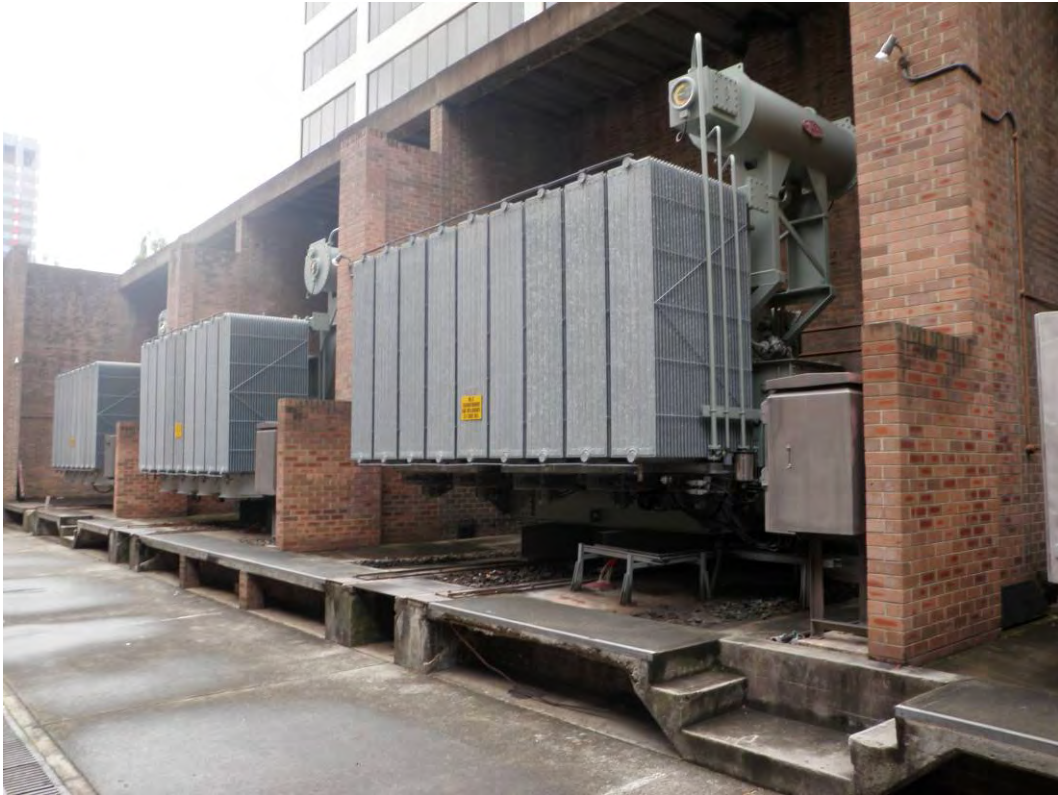
Plate P 3 Row of Transformers

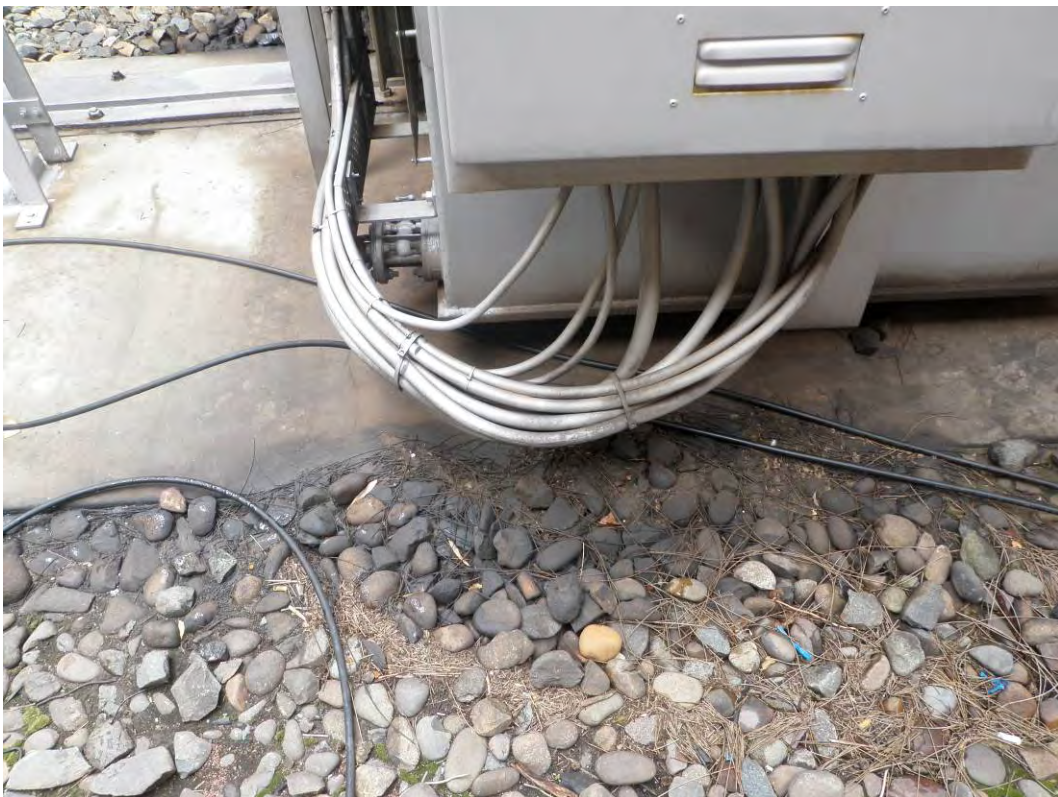
The site investigation identified oil spillages which potentially contain PCBs in the areas surrounding and beneath the transformers. These spills may pose a risk to soil and groundwater quality, in both on-site, and off-site environments. PCB contamination from the Site may pose a further potential risk to stormwater quality by migration through run-off to off-site environments.

It is possible that more extensive contamination from historical seepage of transformer oils containing PCBs may exist in collection pits below the transformers. This potential risk should be considered in the event that any excavations of these areas are undertaken.

Plate P 4 Oil Staining beneath Transformer
