Geotechnical investigation and road pavement design

The intersection of Hartwood Street and Milford Street on Priory Tank Road,
Nymagee NSW

Ref: R14212-1.1g
Date: 23 May 2014

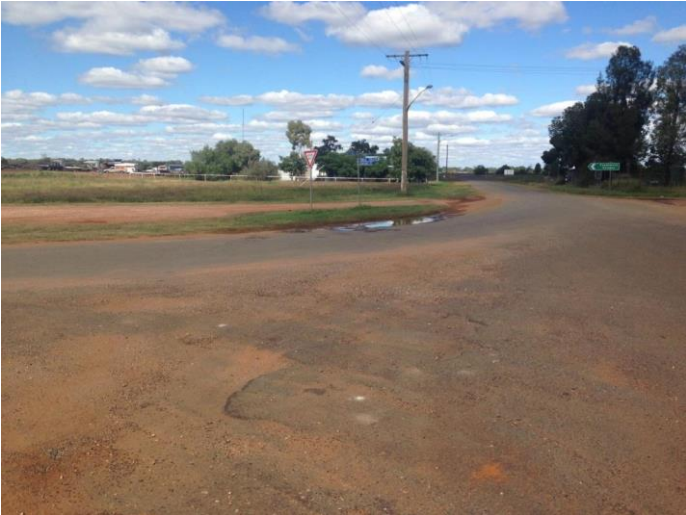
Looking south west over the intersection

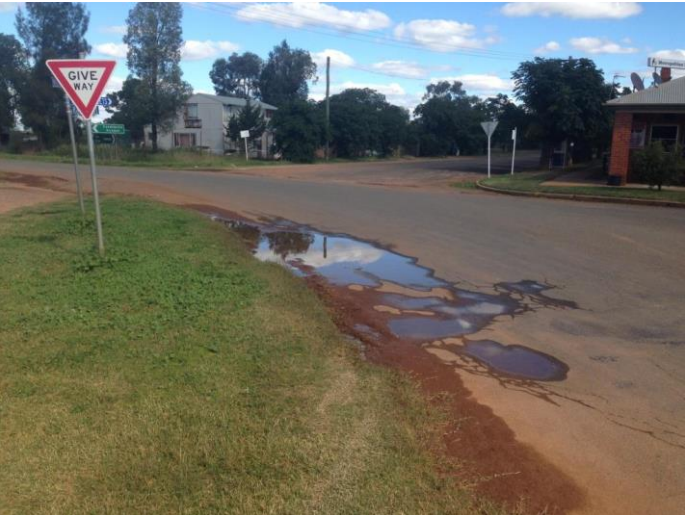
The existing intersection pavement was a densely graded granite aggregate bitumen seal. The bitumen seal was estimated to be 20mm in depth. The pavement wearing layer contained some minor cracking and deformation. Pavement shape loss was observed in the south east section of the intersection in an area of approximately 5m by 2m with surface water pooling.

Water pooling at southeast section of the intersection

Sealing of road shoulders is recommended to minimise migration of water into the pavement layers and to provide structural support on the pavement edge.

Roadside table drains should be constructed to divert water from the pavement.

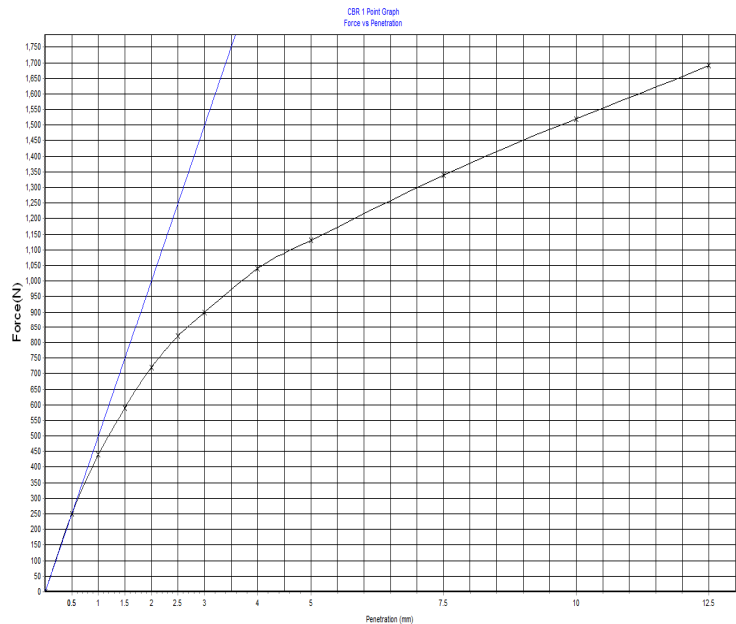
CBR Surcharge (kg) :	4.5	CBR 2.5mm (%) :	6
Oversize (%) :		CBR 5.0mm (%) :	6
Oversize Material Replaced (%) :		CBR Value (%) :	6

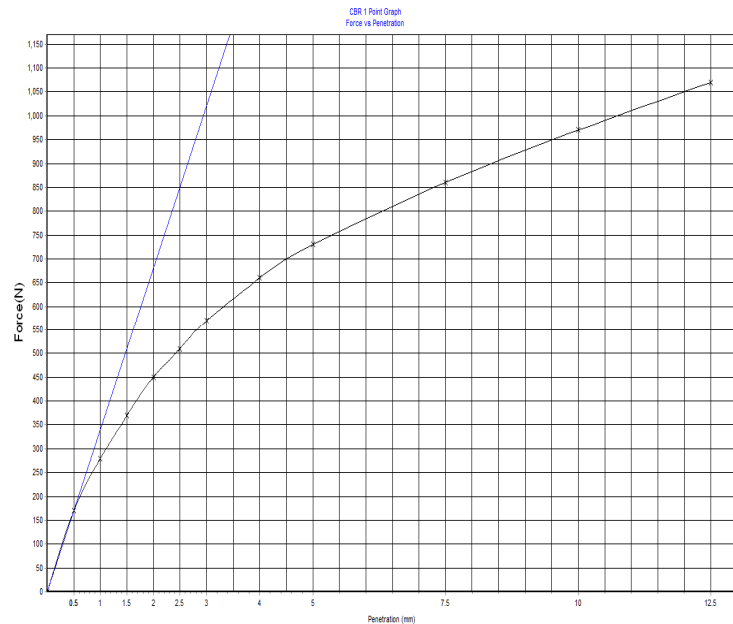
CBR 2.5mm (%) :	4
CBR 5.0mm (%) :	3.5
CBR Value (%) :	4
