## **Geotechnical investigation and road pavement design**

The intersection of Nymagee Street and Nyngan Street on Nymagee-Hermidale Road, Hermidale NSW

Ref: R14212-2.1g  
Date: 23 May 2014

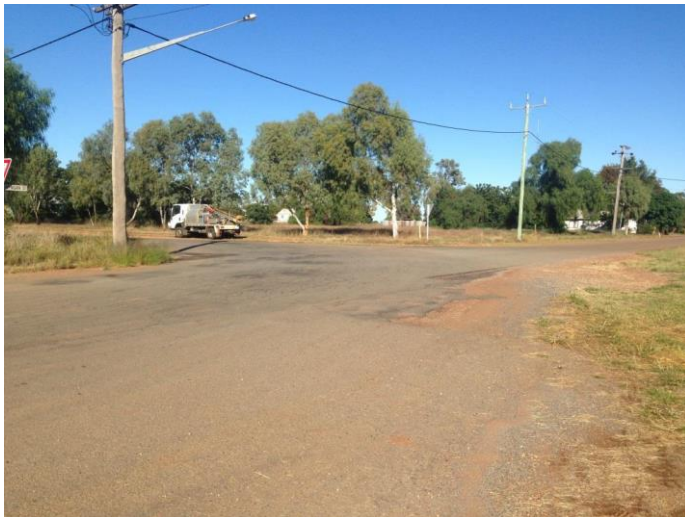
Looking south west over the intersection

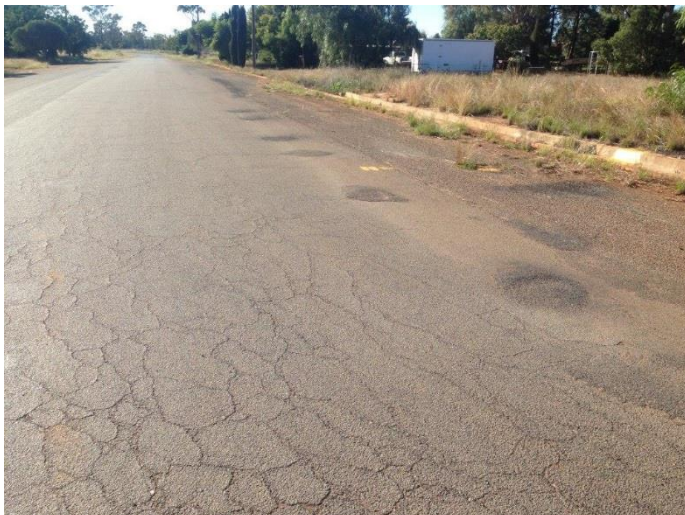
The existing intersection pavement was a densely graded granite aggregate bitumen seal with sub angular alluvial gravels. The bitumen seal was estimated to be 20mm in depth. The pavement wearing layer contained some minor cracking and deformation on the edges.

Cracking and deformation on the southern section of the intersection

The existing pavement contains 100mm of road base and subbase and is not suitable to adequately manage the increased axle movements and vehicle loads at the intersection. Upgrade to the intersection is recommended.

The existing intersection pavement wearing layer, base and subbase requires stripping to a design subgrade level.
