**STAGE 1 ENVIRONMENTAL SITE ASSESSMENT**

**PROPOSED WARNERVALE TOWN CENTRE**

**SPARKS AND HAKONE ROADS  
WARNERVALE, NSW**

**PROJECT 41118A  
March, 2006**

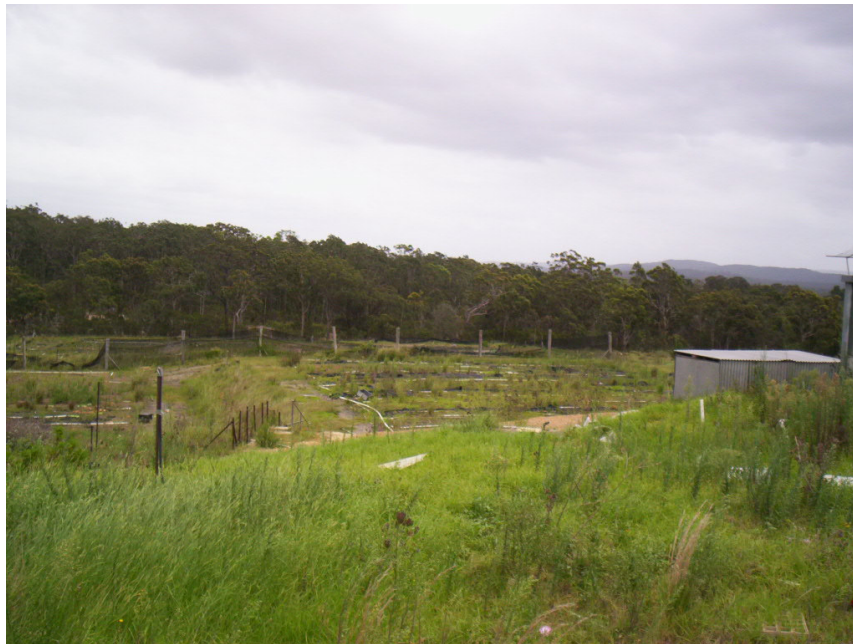
**Photo 1**

The former nursery land uses consisted of several derelict and partially demolished buildings, levelled cleared land and several dams. Buildings at the site consisted of brick veneer cottage, corrugated iron storage sheds and a glass house. Areas around the buildings were generally gravel surface with smaller areas of bitumen spray seal and concrete pavements. The areas marked as “cleared” on Drawing 1B appeared to be the former growing beds and were generally surfaced with gravels and geofabric (Photo 1). The greenhouses observed in the 2001 aerial photograph had been removed. Surface levels of the former growing beds had been modified to create level working areas. Visual inspection indicated that the level working platforms are likely to be the result of on-site cutting and filling.

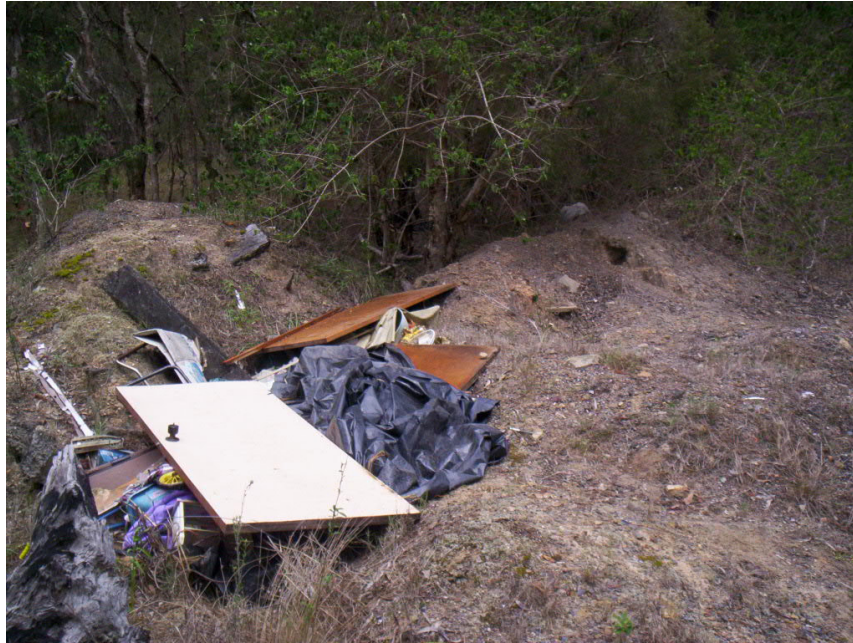
**Photo 4**

As noted in Ref 7 various materials had been dumped along the side of the access trails and extended up to approximately 30 m into the surrounding bushland in some locations. The materials observed were generally considered to be consistent with those recorded in Ref 7 and included excavated soils, concrete, road construction materials, general garbage, engine parts and demolition waste including bricks, tiles, fibrous cement sheets/pipes (Photo 4)

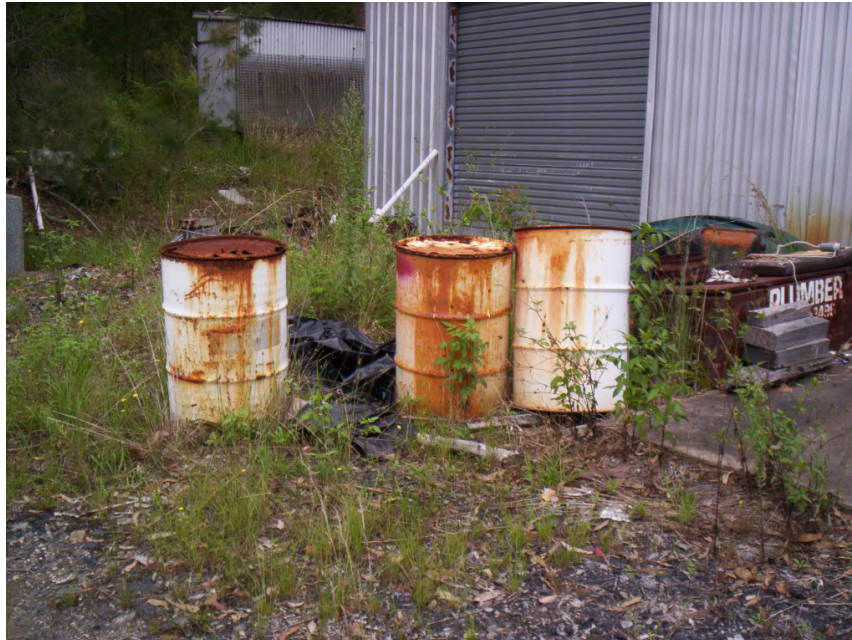
**Photo 10**

Visual inspection identified various mechanical parts, oil drums, batteries and other miscellaneous items placed on the ground surface in the area directly to the west of the large metal shed (Photo 10). Ref 7 noted various pieces of machinery and construction materials including fibrous cement sheeting and piping in this area.

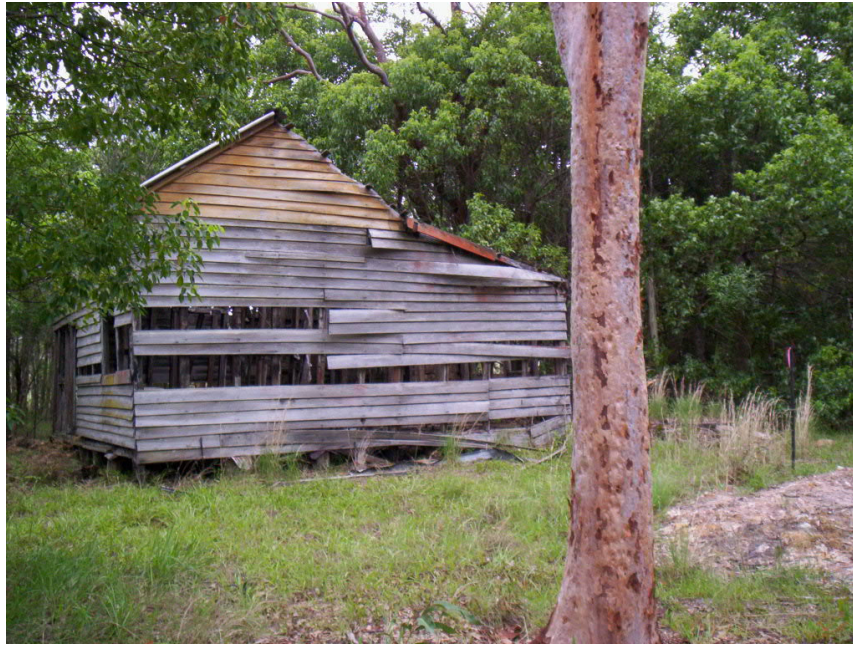
**Photo 11**

Entry to Lot 3 was via the old Sparks (Wallarah) Road alignment. Site topography generally slopes up to the north. As noted in Ref 7, the site appears largely undeveloped, with dense vegetation covering the majority of the site. A small cleared area adjacent to the southern boundary leads to a derelict timber cottage (Photo 11). Ref 7 noted a burnt out car was located in the south of the site, although inspection only encountered several car body panels. Evidence of a recent test pit excavation was noted adjacent to the derelict cottage and was considered to be associated with Ref 9.
