**PRELIMINARY  
TREE ASSESSMENT REPORT**

**WOLLONGONG HOSPITAL  
348-352 CROWN STREET, WOLLONGONG**

**October 2010**

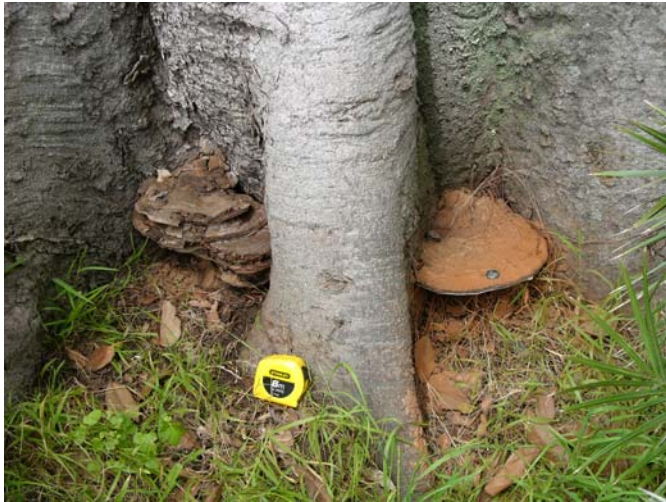
- 4.3.4 The tree displays fair health and vigour with thinning crown and some dieback with approx 5% to 10% deadwood and some epicormic growth (mainly from old pruning wounds). The foliage is small (stunted) for the species with fairly poor extension growth (refer Plate 4). Two large fruiting bodies of a pathogenic decay fungus (*Ganoderma sp.*) are located on the northern side of the trunk close to ground level (refer Plates 1 & 2). *Ganoderma* is a butt rot disease affecting the butt (lower trunk) and root crown of a tree. Environmental stress and injuries to the roots or basal area of a tree can pre-dispose it to infection. Infection may occur from root to root contact and fruiting bodies may not form for several years after infection. As the fruiting bodies are large, the original infection probably occurred many years ago (more than a decade).

4.4.1 The presence of Ganoderma on the lower trunk of T1 (Moreton Bay Fig) is a significant issue. This disease causes dysfunction in the root system which explains the general poor appearance of the tree. Ganoderma also affects the structural integrity of the butt and root plate, which may lead to structural failure under wind loading at or close to ground level. The extent of infection in T1 could not be verified by external visual examination, but the size of the fruiting bodies suggests that the infection has been present for many years, perhaps a decade or more. As such, the decay associated with the infection is likely to be extensive. The ability of the disease to spread from root to root contact, and similar symptoms apparent in T2 would suggest the disease may also be present to some extent in this tree also. This is exacerbated by proximity of the trees and the possibility of root grafting. Ganoderma attacks live tissue, is very aggressive and cannot be treated. If decay in the lower trunk and root crown is extensive, the trees should be removed for safety reasons.

- 8.1.2 T1, a large Moreton Bay Fig on the northern side of the site has Ganoderma Butt Rot disease. This disease affects the structural integrity of the butt and root crown and will eventually lead to the failure of the tree. The disease cannot be treated. T2 whilst showing no external signs of infection exhibits similar symptoms of root dysfunction, including sparse foliage cover, undersized leaves, and poor shoot extension. It is probable given the proximity of the trees and the nature of the disease that both trees have been infected through root grafting. Given the significance of the trees, further site investigation and diagnostic testing has been recommended to verify the extent of decay in the butt and root crown area. Subject to the results of these tests, consideration should be given to the removal of these trees

Plate 1 - T1 (Moreton Bay Fig) showing large fruiting bodies of *Ganoderma sp* (Ganoderma Butt Rot) on lower trunk.

2. Further diagnostic testing of T1 & T2 is recommended using a Picus Sonic Tomograph to evaluate the structural integrity of the trunk. Two tests should be undertaken, one close to ground level and the other at approximately 1.2-1.5 metre from ground level to enable extrapolation of the data. The Picus Sonic Tomograph can be carried out by Australian Tree Consultants (refer to [www.australian-treeconsultants.com.au](http://www.australian-treeconsultants.com.au) for more information) or Moore Trees ([www.mooretrees.com.au](http://www.mooretrees.com.au)).

3. Further investigation of the root crown area of T1 & T2 is recommended using an Airspade device. This should be used to expose selected areas of the root crown and underside of major primary roots to evaluate the extent of decay in the root crown area. This work can be carried out by Glochidion Arboriculture (contact Mr Ken Cantor on 0408 821 177)

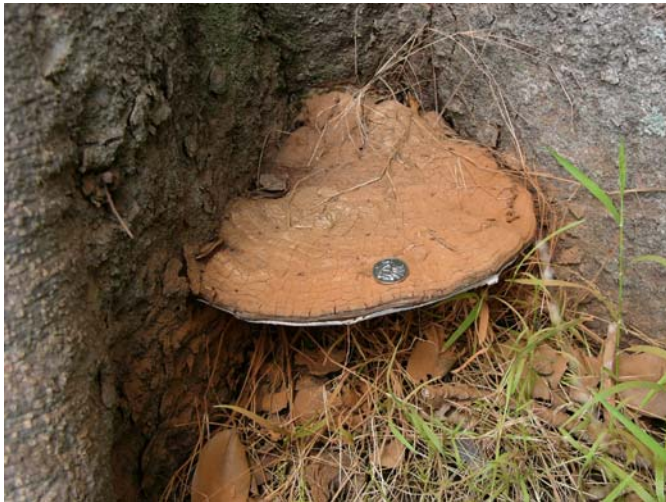
Plate 2 – T1 – Close up of fungal fruiting body

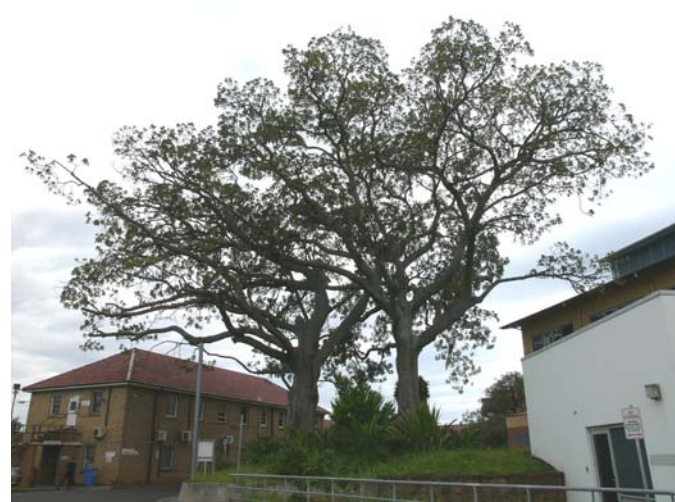
4.3.2 The tree exhibits a single trunk, dividing into two secondary trunks at 2 metres with a broad rounded crown with ascending branching habit (refer Plate 3). The tree has a typical buttressed basal area and visible woody surface roots (refer Plate 8). The tree is also located in a 'garden' area, close to T1. There is some evidence of soil disturbance on the south side of the tree, possibly associated with previous construction work, but no obvious evidence of root damage or injury.

Plate 3 - T1 & T2 (Moreton Bay Figs) showing thinning crowns & low vigor

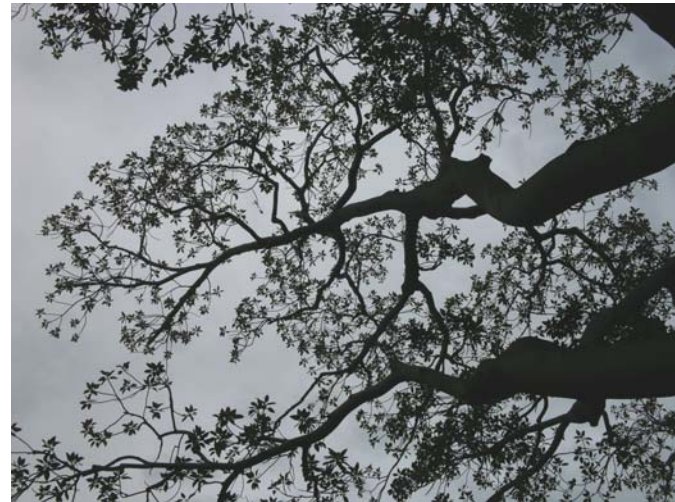
Plate 4 – T1 – View of upper crown showing sparse foliage cover

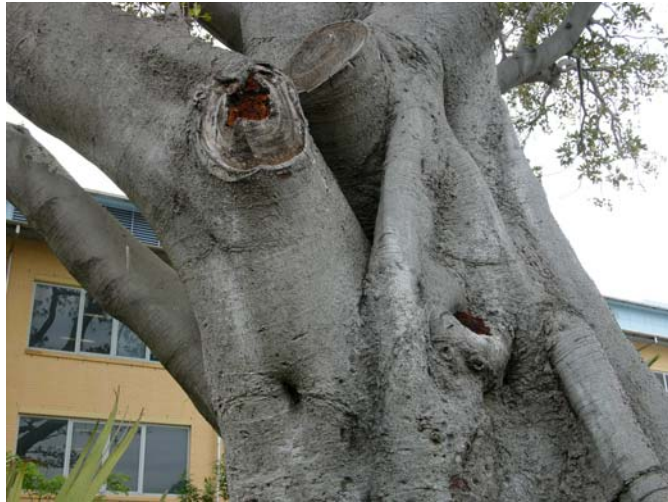
- 4.3.8 The tree appears stable with fair branching structure. The crown is somewhat suppressed on the south side due to crowding with T2 (the crowns are intertwined). A number of primary and secondary branches have been removed and a few reduced, resulting in multiple wounds at the branch collars. Some of the older pruning wounds exhibit signs of decay at the branch collar. A number of tertiary limbs on the west side over the roadway have also been reduced. There is a moderate bark inclusion between the trunk and primary limb at 1.5 -2 metres (refer to Plate 5). The tree exhibits a moderate wound on a primary limb at 4-6 metres due to previous branch loss (tear wound) with some decay evident (refer Plate 7). There is also an axial wound on a primary limb at approximately 8 metres on the west side over the roadway (possibly due to a sunscald injury). Two small cavities in branch collars on the northern side of the tree have been previously filled with expanding polyurethane foam (refer Plate 5).

Plate 5 - T2 (Moreton Bay Fig) showing moderate bark inclusion at junction of trunk and primary limb.

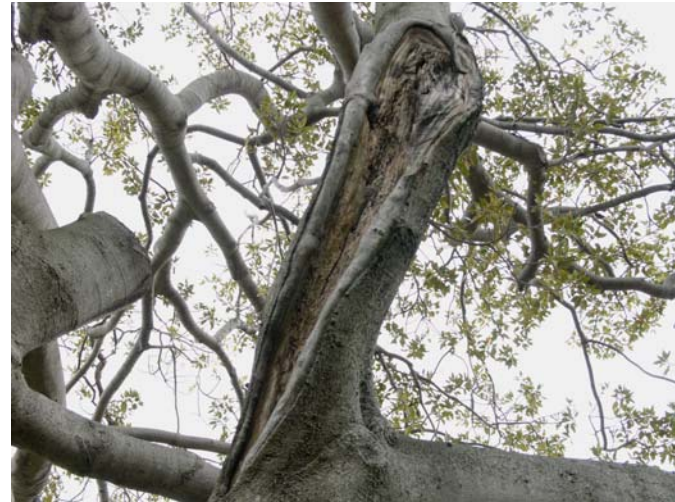
Plate 7 - T2 showing wound on primary limb

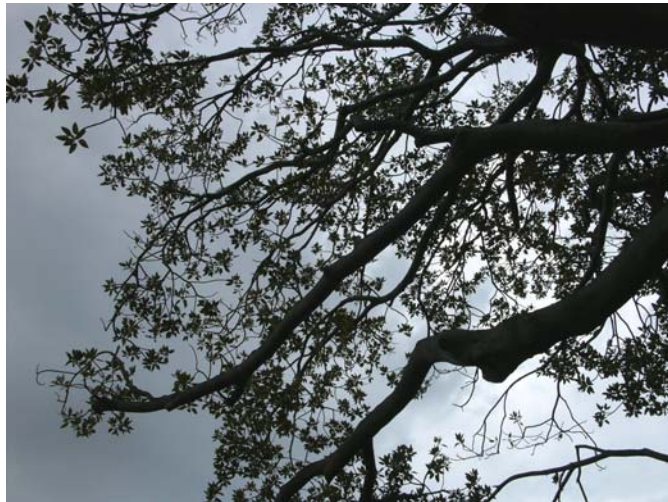
- 4.3.9 The tree displays fair health and vigour with thinning crown and some dieback with approx 5% to 10% deadwood (especially on the western side) and 5% epicormic growth. The foliage is small (stunted) for the species with fairly poor extension growth (refer to Plate 6). There is no visible evidence of any disease or pest infestation, however the tree has a suspected fungal infection in the root crown. Given the proximity to T1 and the common symptoms of both trees (sparse crowns, undersized foliage, poor shoot extension & dieback in some terminal branches especially on more exposed sides), it is probable that T2 is also infected with *Ganoderma*, but fruiting bodies have not yet formed.

Plate 6 – T2 showing dieback and sparse foliage cover in western crown

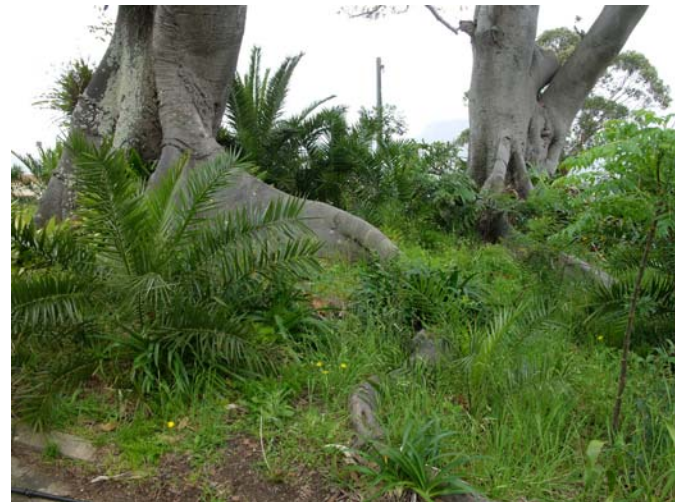
Plate 8 – Showing general area surrounding base of T1 & T2

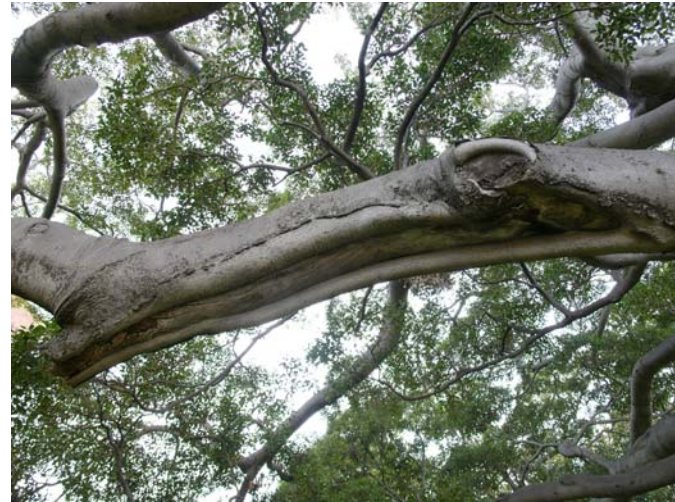
- 4.3.13 The tree appears stable with fair branching structure. There are a number of small wounds throughout the crown at branch collars due to previous pruning, mainly from the removal of tertiary branches. There is also a moderate axial wound on the underside of a primary limb on the north side, possibly associated with an old mechanical injury (refer Plate 11). The upper crown exhibits minor branch loss due to storm damage.

Plate 11 - T29 showing wound on primary limb

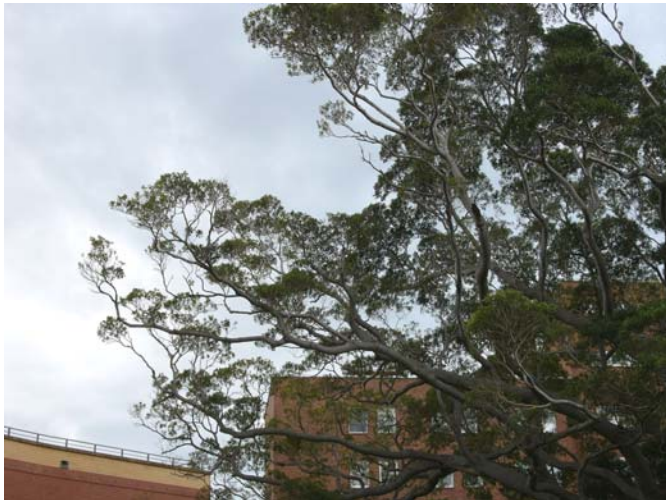
- 4.3.14 The tree displays fair health and vigour with slightly thinning crown and some dieback on the western side of the tree (refer Plate 10). The foliage is normal size and colour for the species with normal extension growth. There is no visible evidence of any disease or pest infestation.

Plate 10 – T29 showing thinning crown on western side

4.4.3 T29 (Hills Fig) whilst showing some signs of environmental stress, exhibits no serious structural defects. This tree should be retained and the health improved by a program of aeration and fertilising (as recommended following). Any new works in the vicinity of this tree should be designed in consideration of the recommended Tree Protection Zone, without any incursion to the canopy. No diagnostic testing on this is recommended.

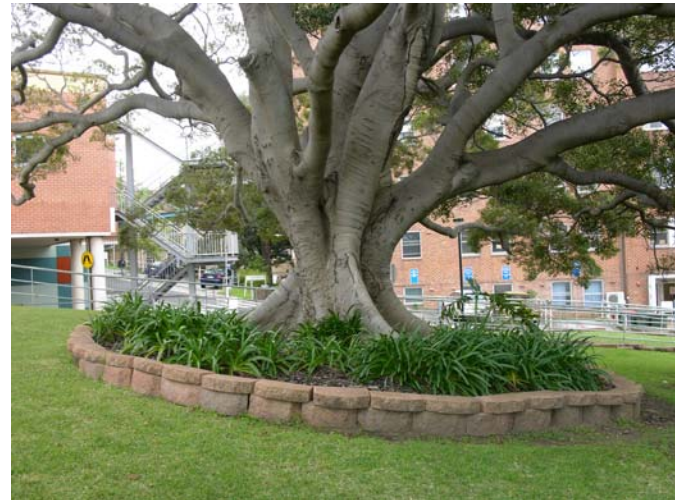
- 4.3.11 This tree is a mature specimen of approximately 14 metres in height and 30 metres canopy spread with a trunk diameter of 1800mm.
- 4.3.12 The tree exhibits a single trunk, dividing into multiple extended lateral primary limbs at 1-2 metres forming a broad rounded crown (refer Plate 9). The tree has a typical buttressed basal area and is located within an open lawn area, but surrounded by a low masonry retaining wall (approx 4-5 metres radius) (refer Plate 12).

Plate 12 – Showing general area surrounding base of T29

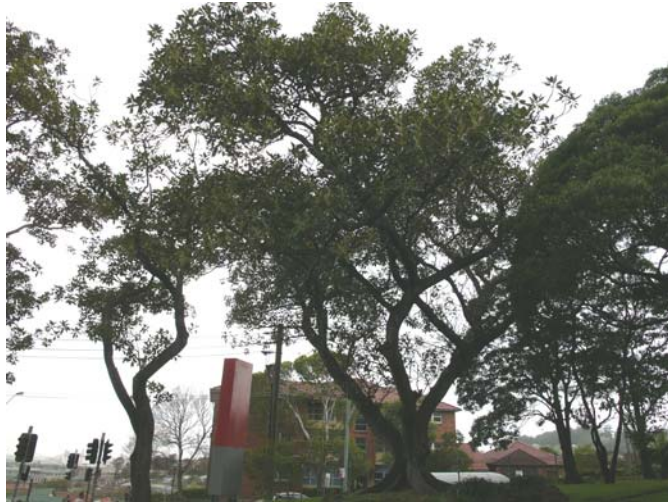
Plate 13 – T30 (right) & T31 (left) (Moreton Bay Figs). Note suppressed crown of T31.

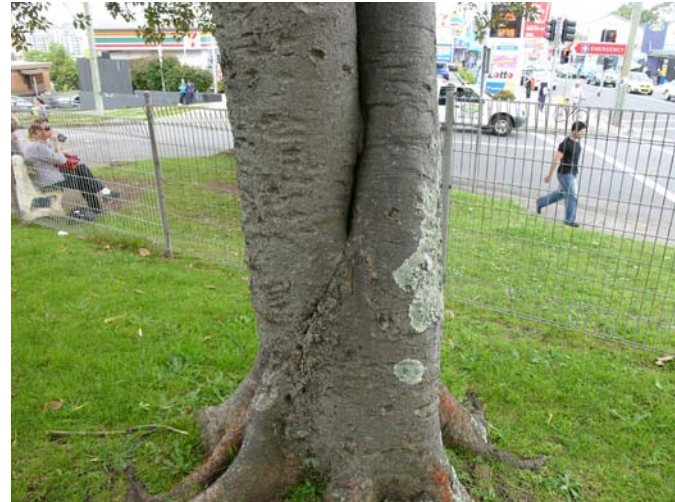
Plate 15 - basal area of T31 showing moderate bark inclusion

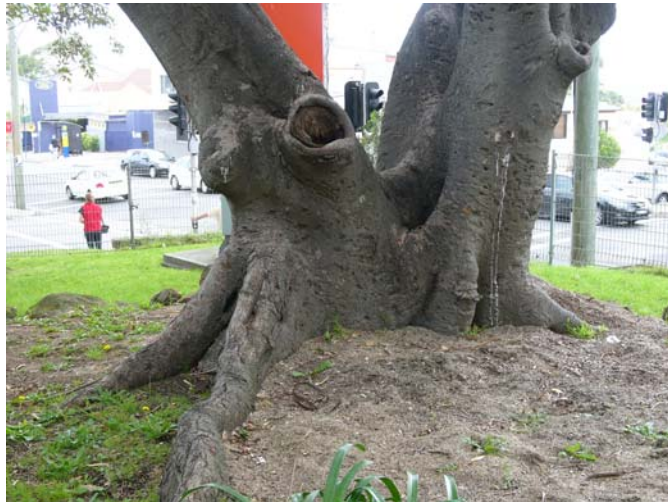
Plate 14 – Showing basal area of T30, note wounds from previous pruning

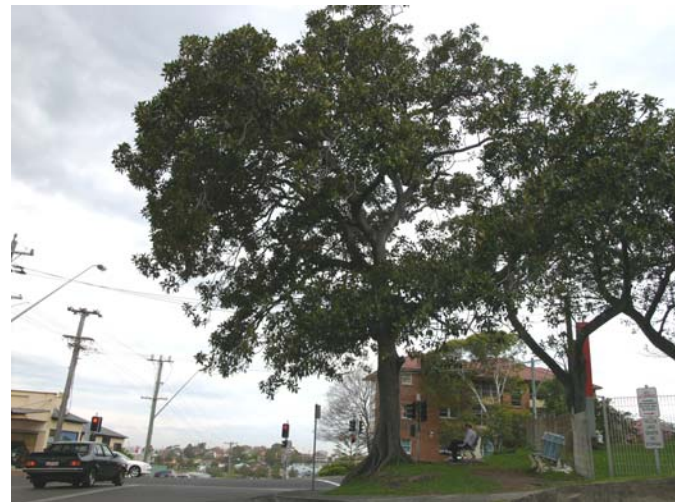
Plate 16 – T32 (Moreton Bay Fig)

4.3.25 The tree exhibits a single trunk, with rounded crown and ascending branching habit (refer to Plate 16). The tree appears stable with sound branching structure. There are multiple small wounds on primary and secondary limbs due to sunscald. This may have occurred after a period of defoliation, possibly due to previous Fig Psyllid infestation. The tree has been previously selectively crown thinned and deadwooded. The tree is located close to the roadway and footpath and the root crown is partially exposed on the eastern side of the tree due to a steep embankment (refer Plate 17 & 18). The exposed roots exhibit some minor injuries but generally appear to be intact.

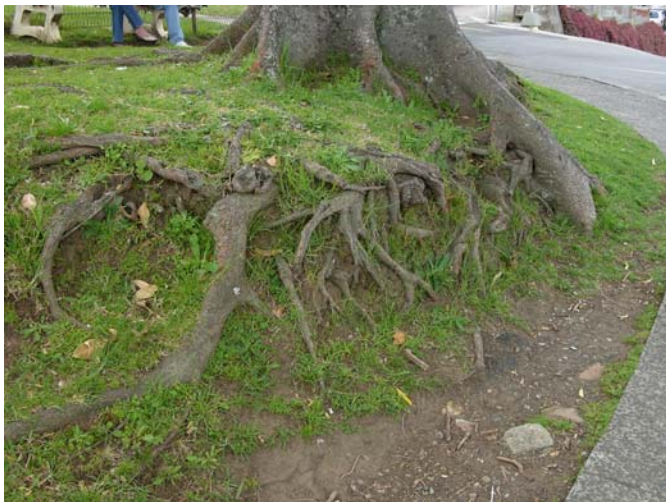
Plate 18 – showing basal area of T32. Note exposed roots and proximity to path
