BANK STREET COMMERCIAL WHARF – DRY WORKS

POST-CONSTRUCTION DILAPIDATION REPORT

July 22nd 2020

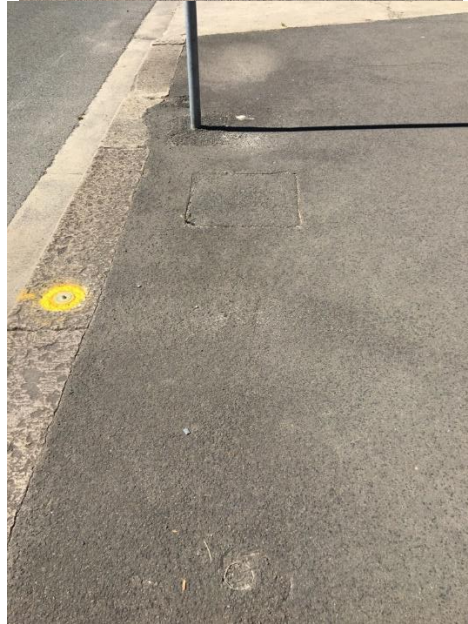
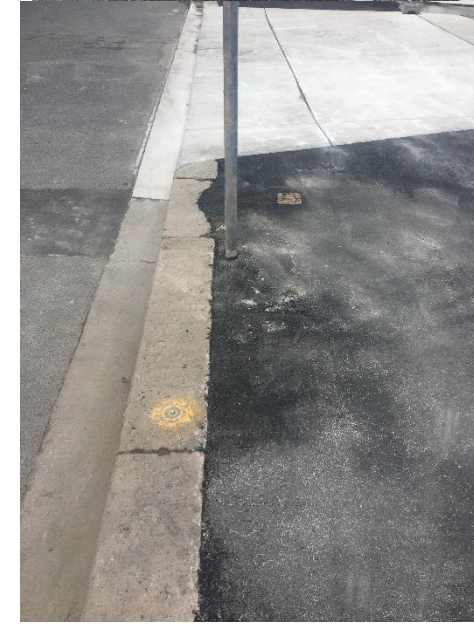
13

For reference,
permanent
restoration works
post-construction

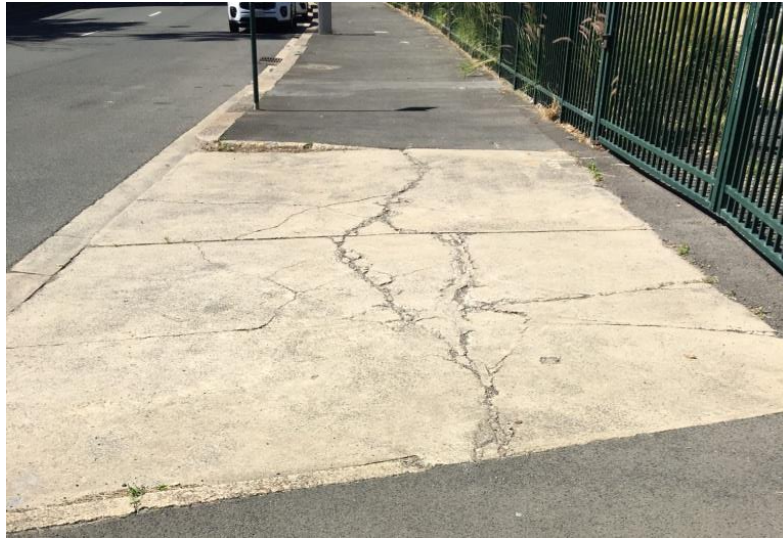
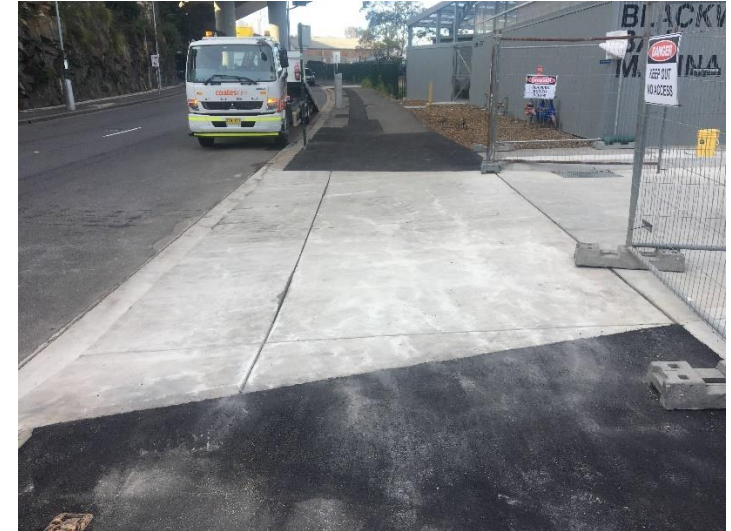
14

For reference, new driveway and layback as per COS Specifications.

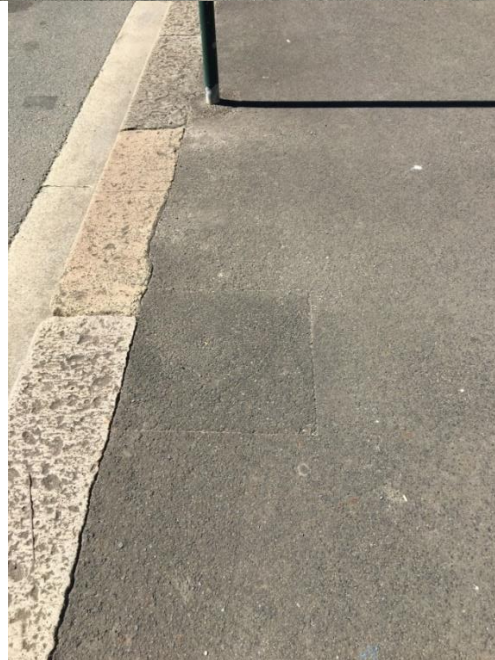
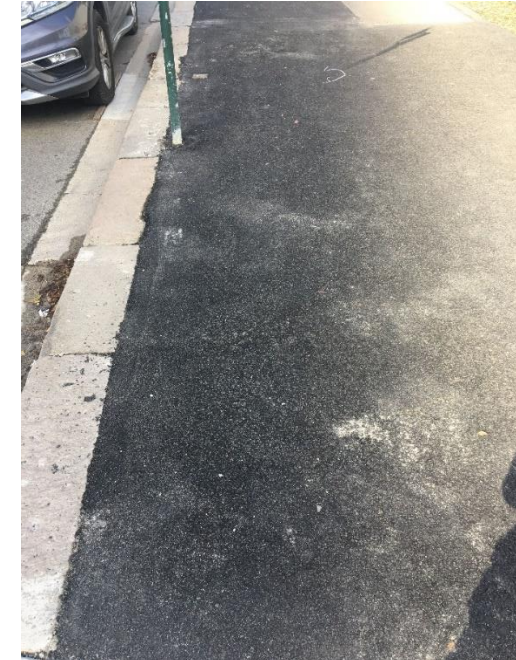
15

For reference, permanent restoration works post-construction

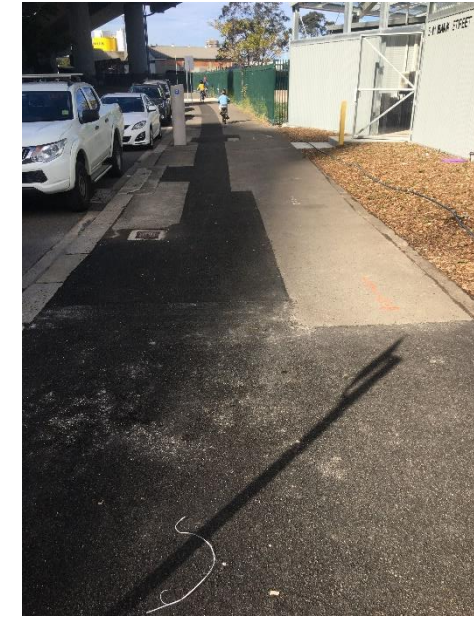
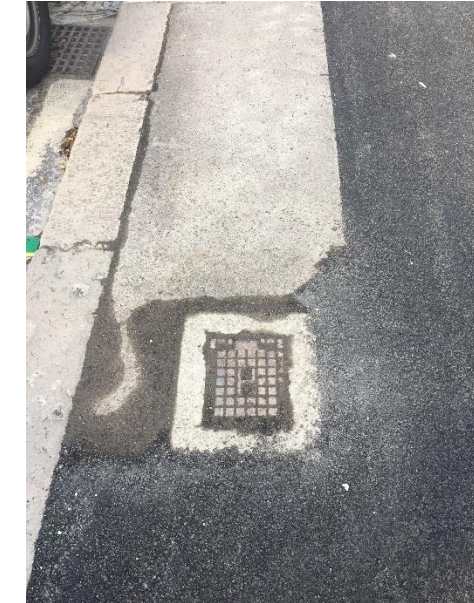
17

For reference,
permanent
restoration works
post-construction

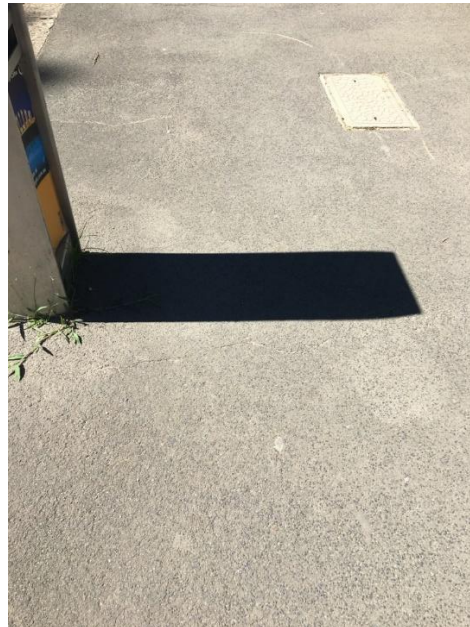
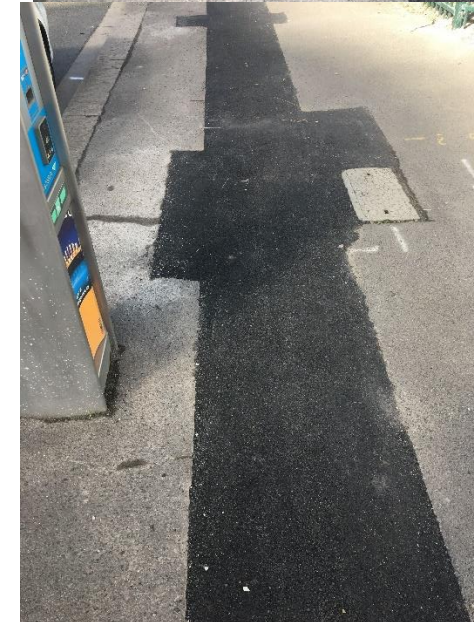
19

For reference,
permanent
restoration works
post-construction

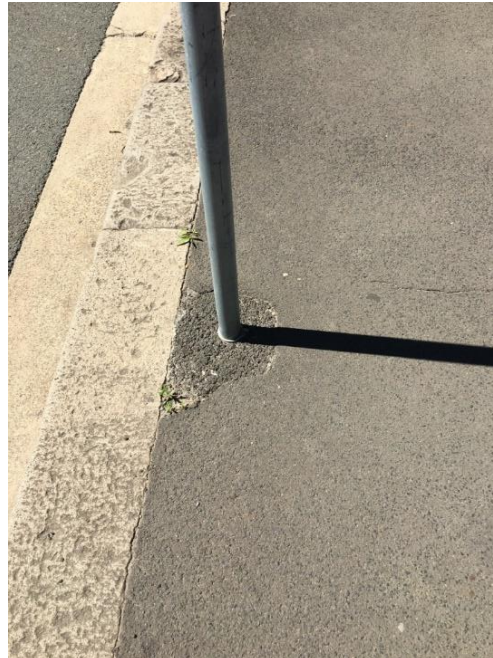
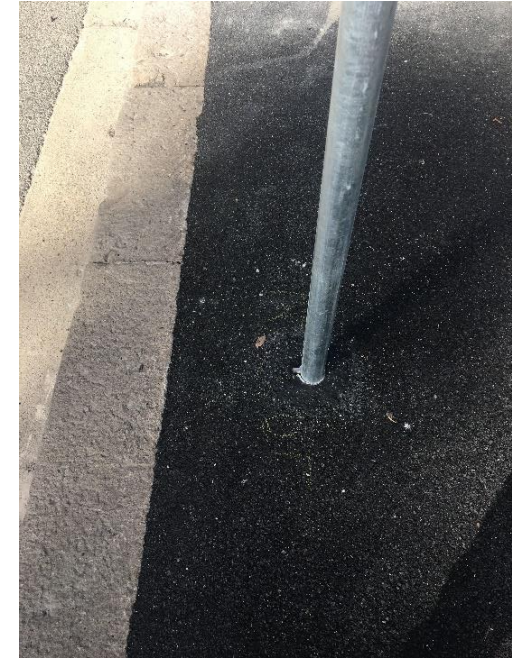
26

For reference,
permanent
restoration works
post-construction

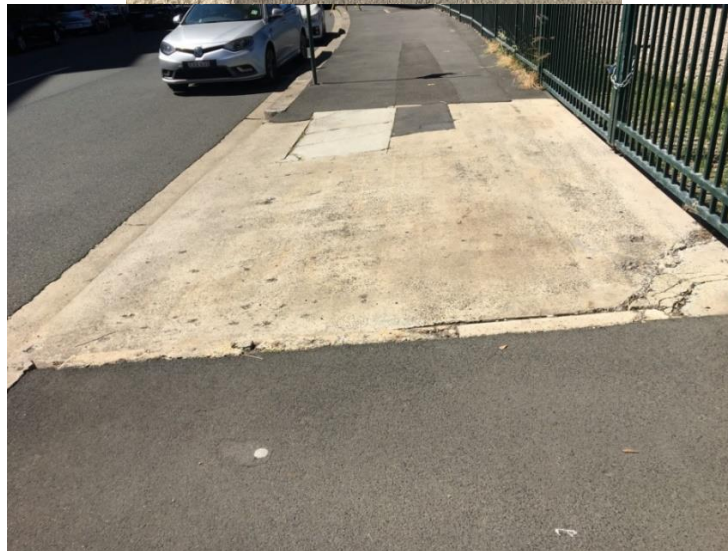
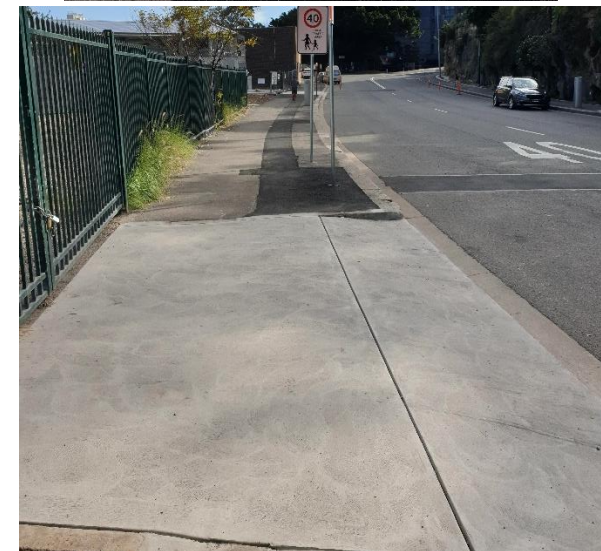
27

For reference,
permanent
restoration works
post-construction
