# **Hazardous Materials Survey Report**

Inspira Property Group Pty Ltd

Hurstville Private Hospital

October 2012  
JBS 42209- 52163  
JBS Environmental Pty Ltd

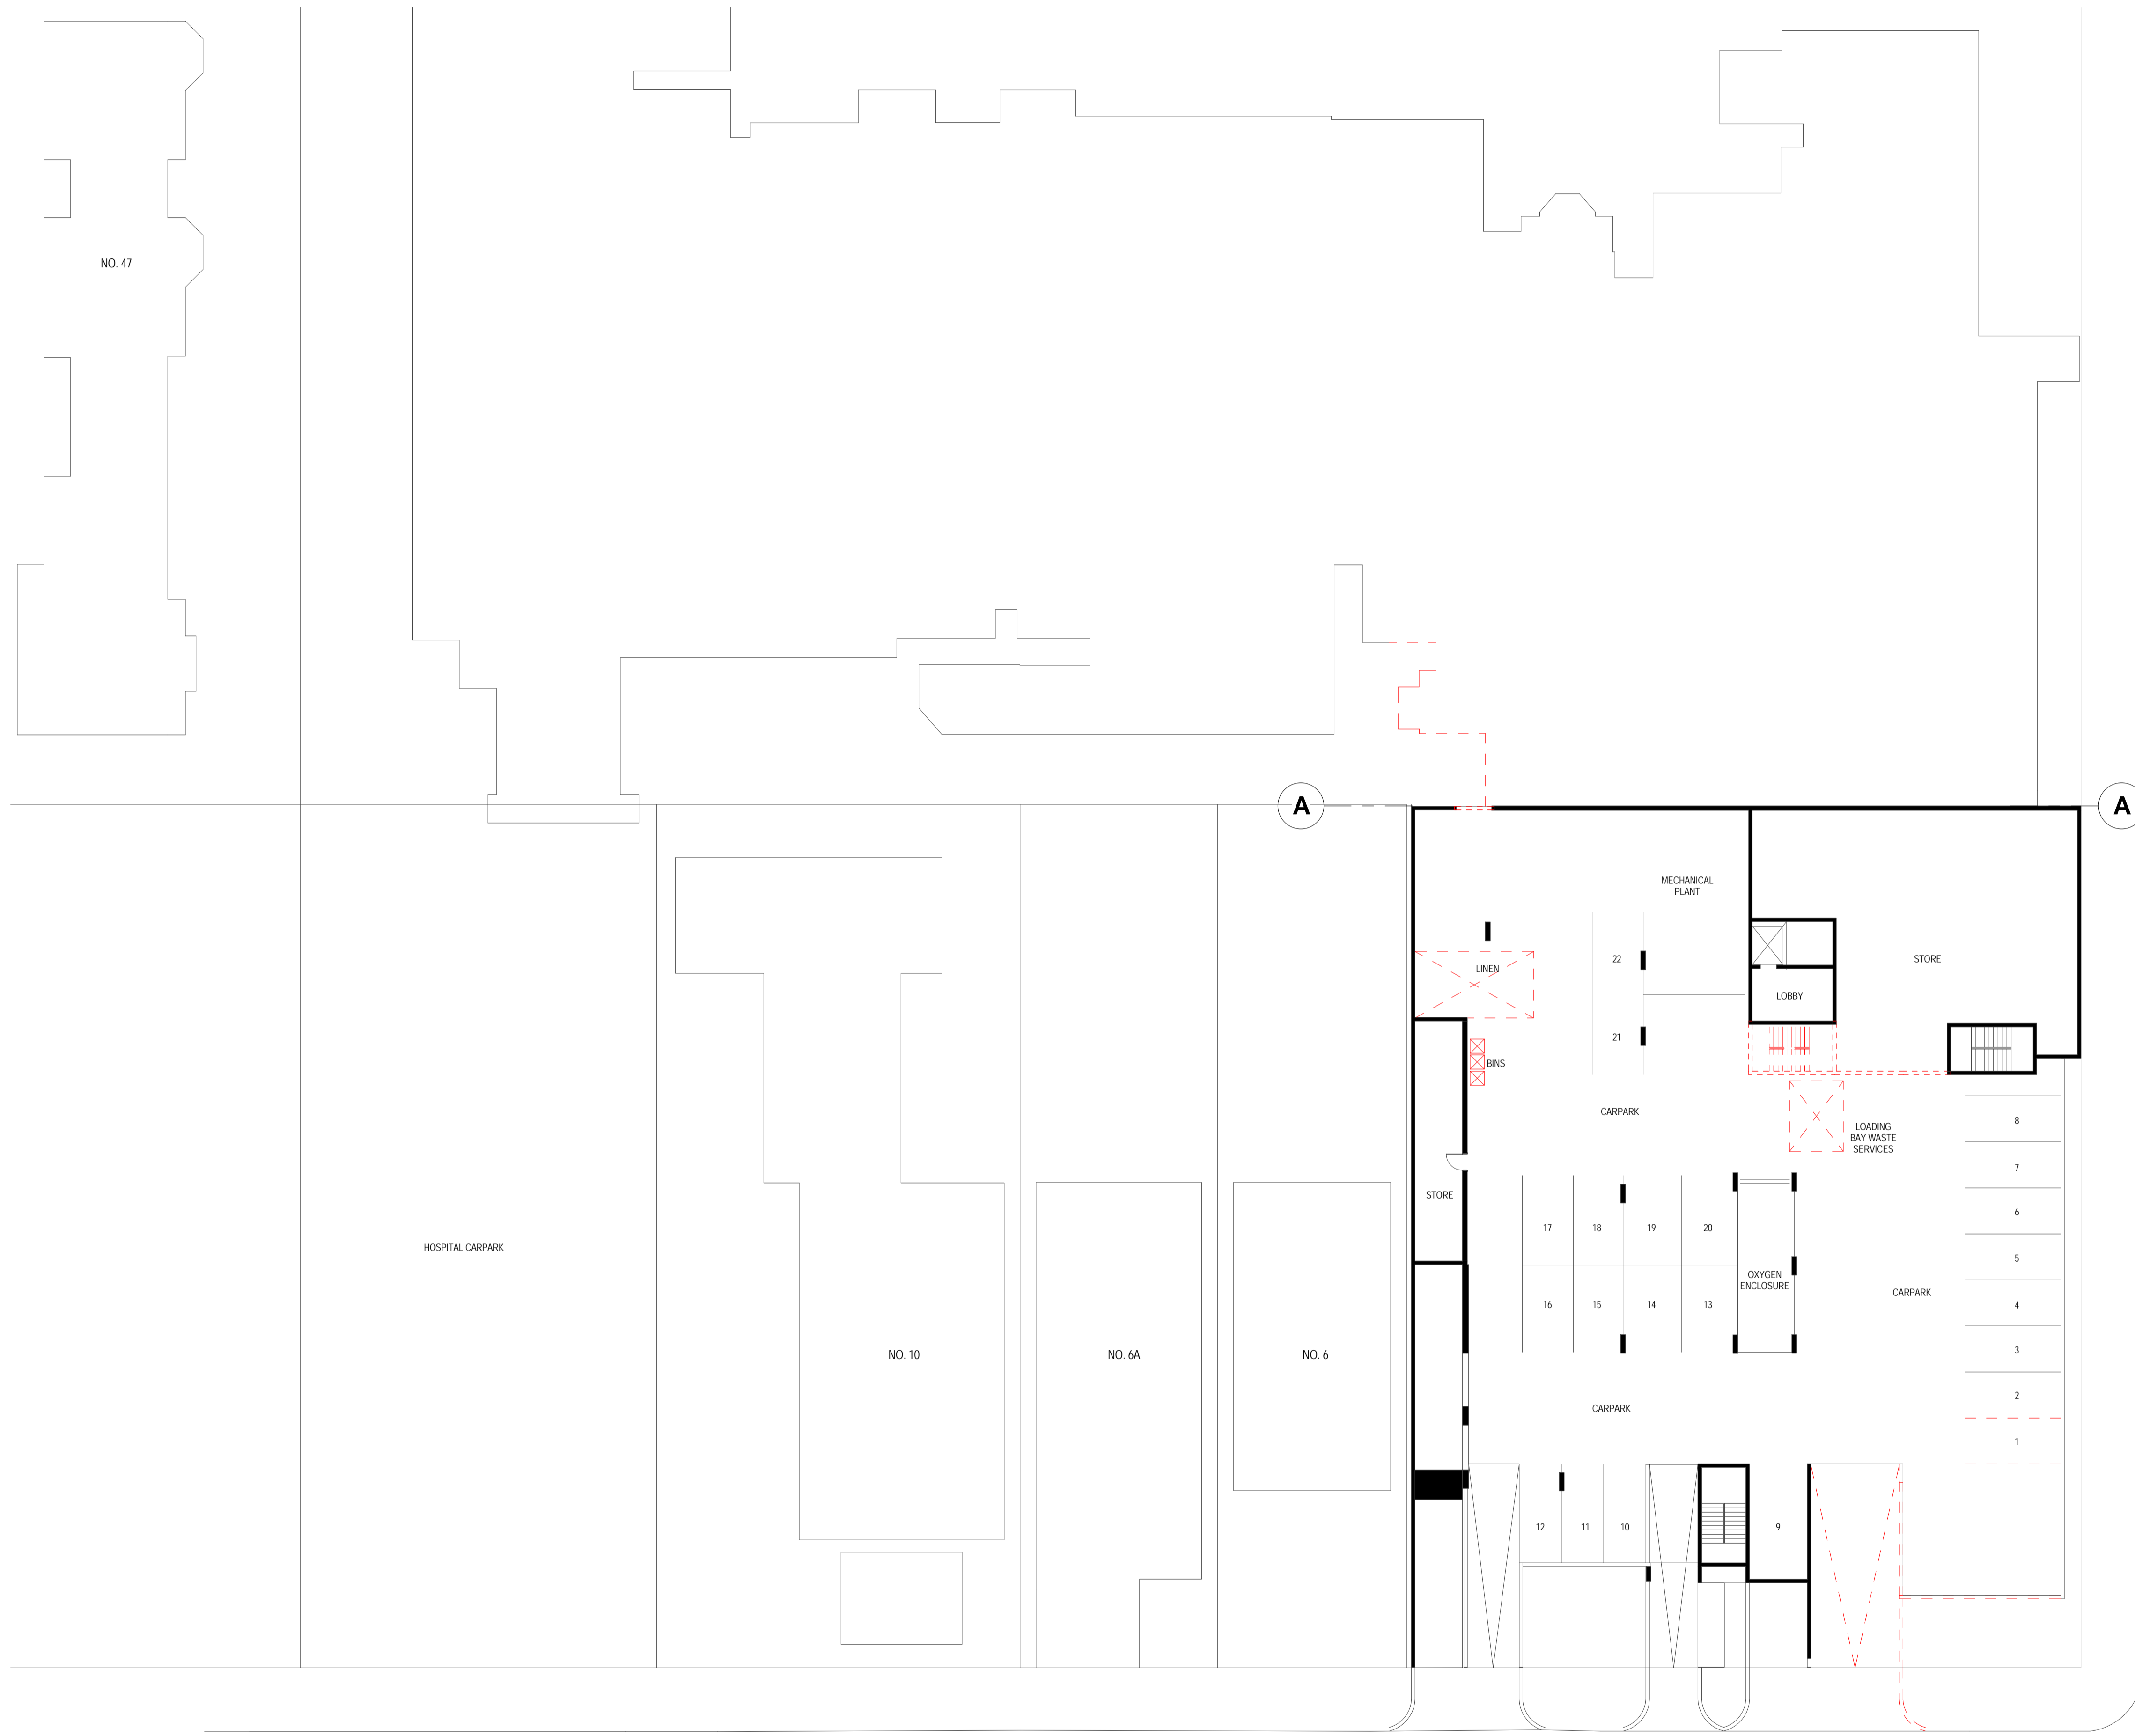
DRAWING No:  
**DA005**

The areas of the lower basement proposed for demolition were currently being used as a carpark, a document storage area and a clinical waste storage area. These areas comprised asphalt paved carpark, concrete slab floor and roof lining, a combination of concrete and brick walls, exposed PVC and copper piping and modern lighting in good condition that was not expected to contain PCBs. There was exposed synthetic mineral fibre ceiling insulation in the adjacent 'Mechanical Plant' area.

Synthetic Mineral Fibre (SMF) insulation was observed in the 'Mechanical Plant' area of the Lower Basement.

Any Synthetic Mineral Fibres identified in **Section 4.3** or observed during demolition works, should be handled in accordance with *National Standard for Synthetic Mineral Fibres [NOHSC: 1004(1990)]* and *National Code of Practice for the Safe Use of Synthetic Mineral Fibres [NOHSC: 2006(1990)]*.

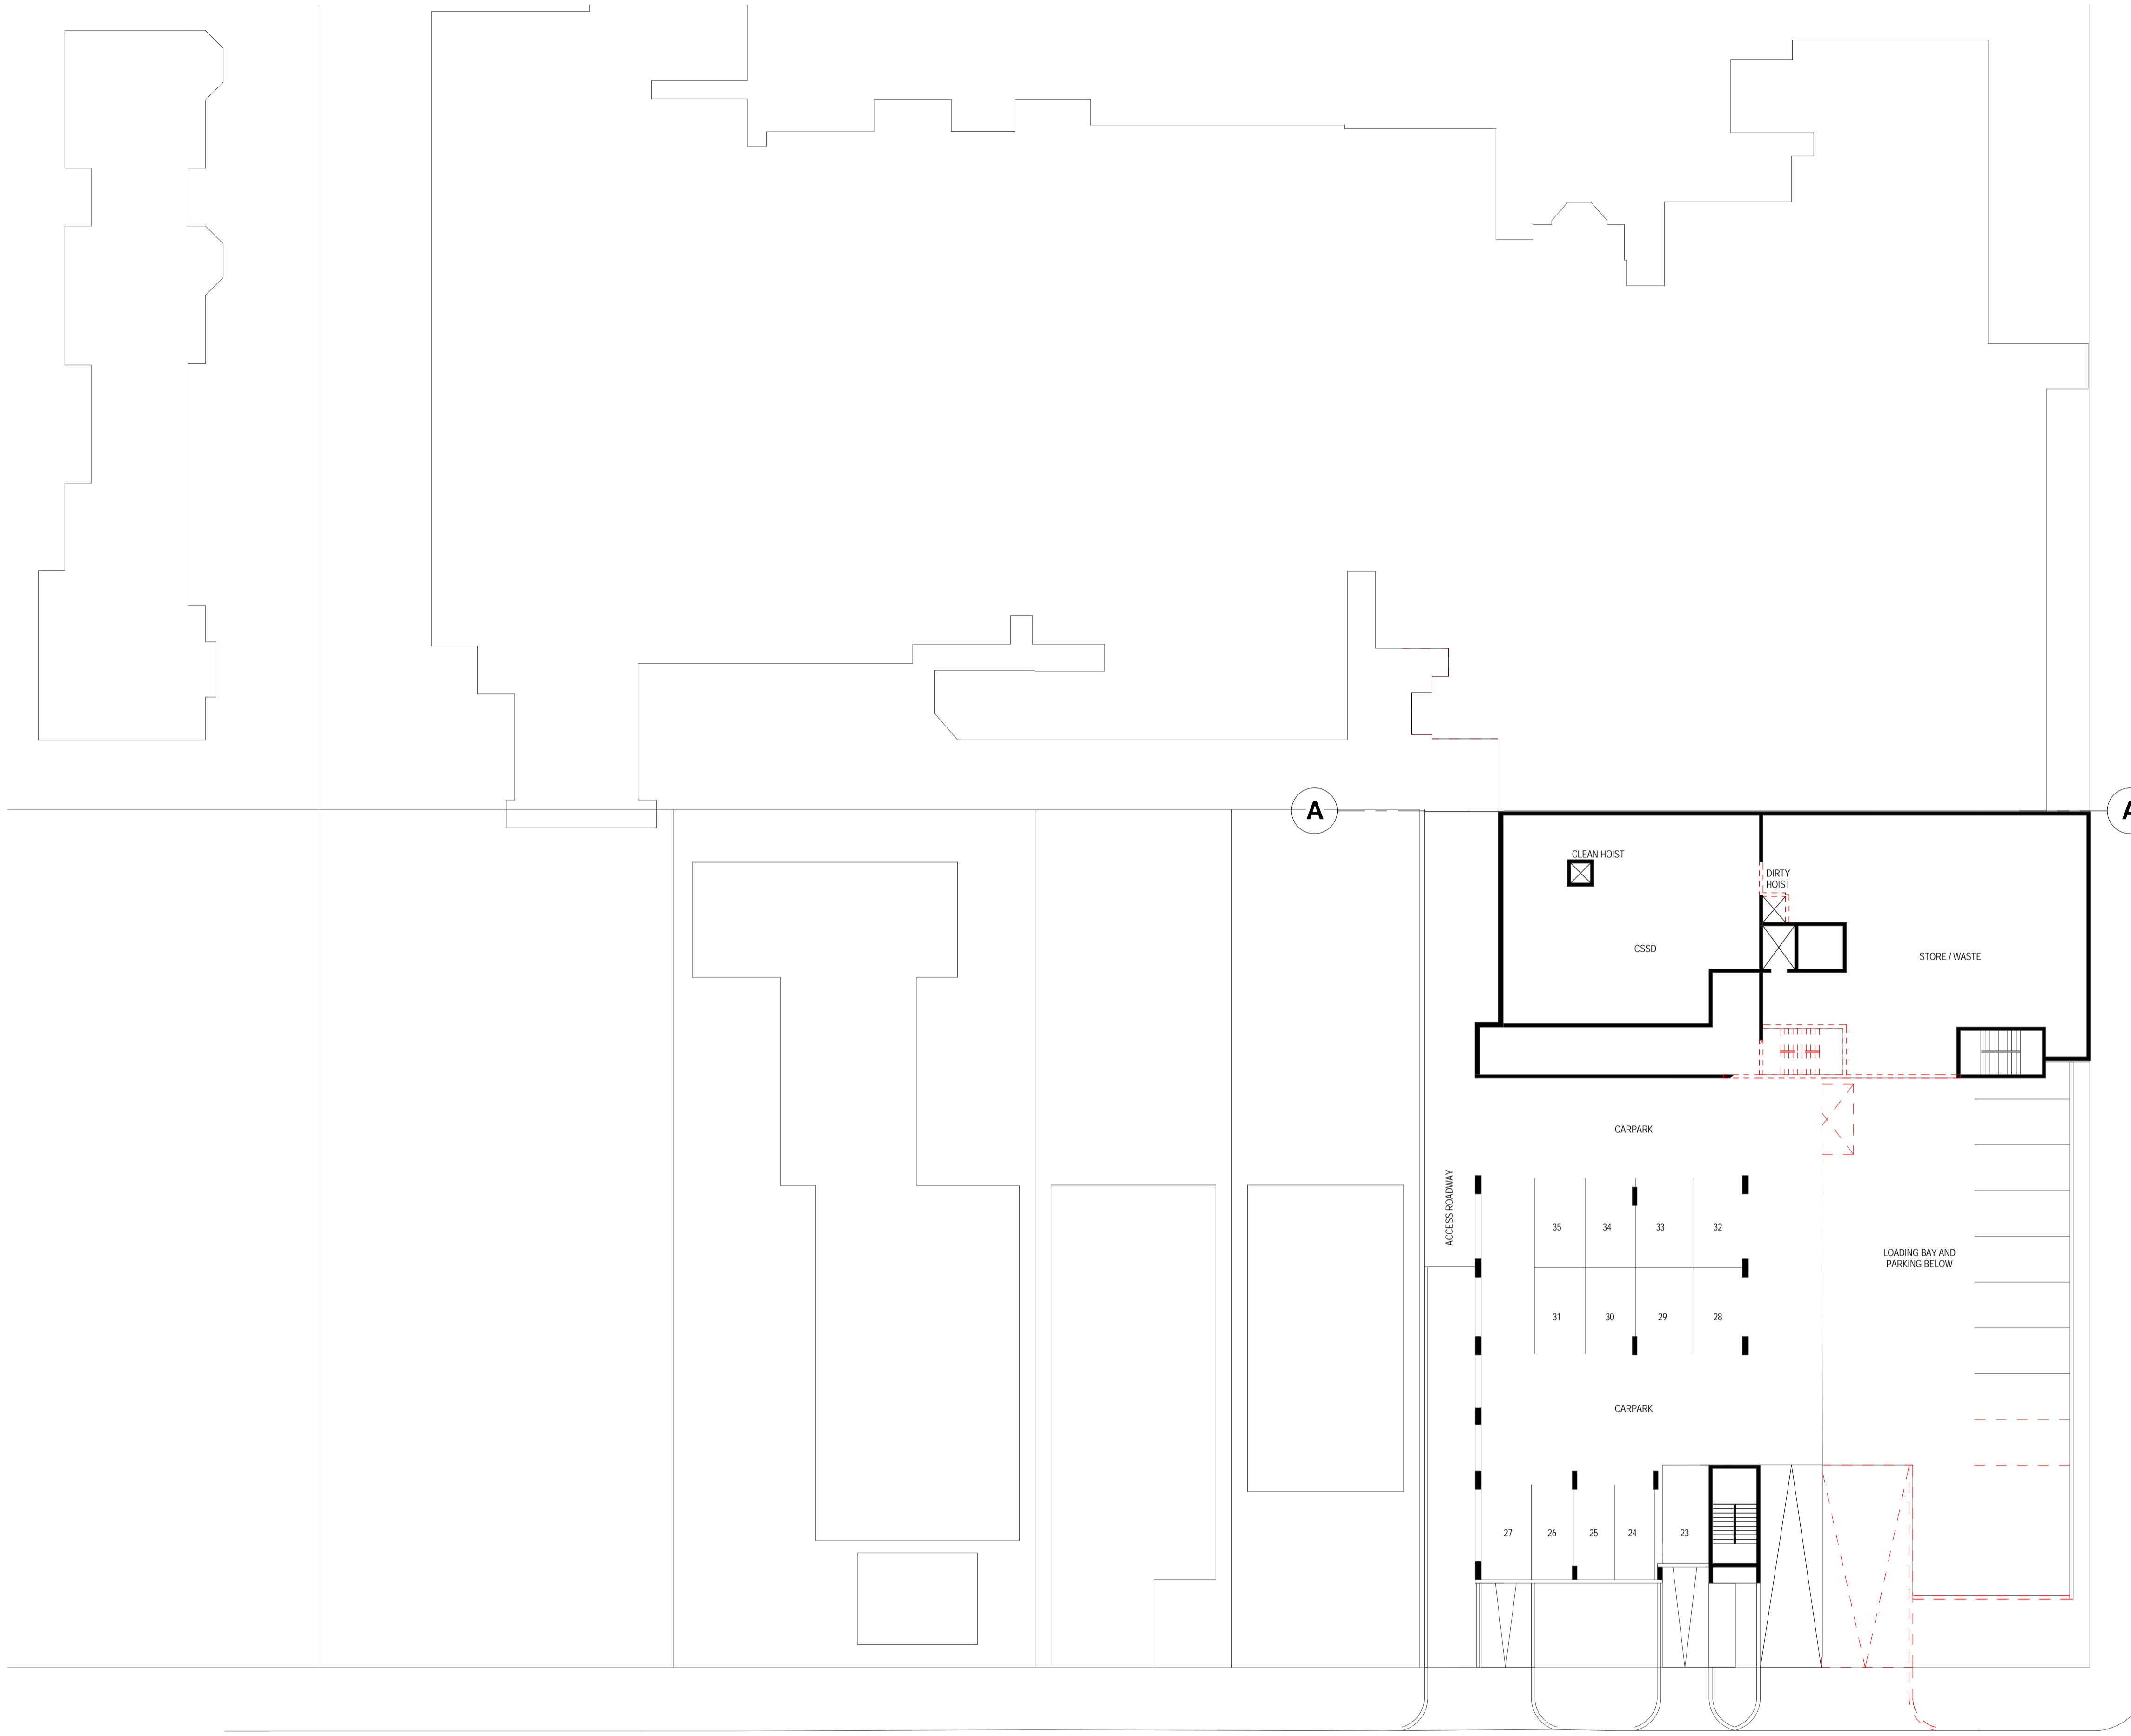
DRAWING No:  
**DA006**

A small elevator known as a 'Dirty Hoist' located at the rear of the main elevator was proposed for demolition on the Upper Basement level. The interior shaft of the 'dirty hoist' could not be inspected.

It should be presumed that the lift mechanisms within the 'dirty hoist' contain asbestos containing materials, including clutches and brake pads. No other suspected hazardous materials were identified during the survey of the Upper Basement areas proposed for demolition.

- Upper Basement Level – Asbestos containing lift mechanisms within the 'Dirty Hoist' including clutches and brake pads with an estimated area of less than 1 m<sup>2</sup>. These materials should be considered to be friable asbestos; and
- Ground Floor Proposed Lift Area – Suspected asbestos core fire safety door, with an estimated area of approximately 1.5 m<sup>2</sup> and is presumed to be classed as bonded asbestos provided the door is maintained intact and fittings (handles and hinges) are not removed. Removal of the fittings or damage to any face of the door may result in exposure of friable asbestos.

- A licensed asbestos assessor or competent person should be engaged to sample the suspected ACM for laboratory analysis to confirm the presence of asbestos within suspected materials identified in **Section 4.1**; or

- An appropriate licensed asbestos removalist (Class A [friable] or Class B [non-friable]) should be engaged to remove the suspected friable and non-friable asbestos containing materials described in **Section 4.1**. The materials should be disposed of in an appropriately licensed landfill in accordance with the *Waste Classification Guidelines Part 1: Classifying Waste (DECC 2008)*, with *Work Health and Safety Act (2011)*, *Work Health and Safety Regulation (2011)*, the SafeWork Australia publication *How to Safely Remove Asbestos Code of Practice (2011)* and the National Occupational Health and Safety Commission (NOHSC) publication *Code of Practice for the Safe Removal of Asbestos 2<sup>nd</sup> Edition [NOHSC: 2002(2005)]*.

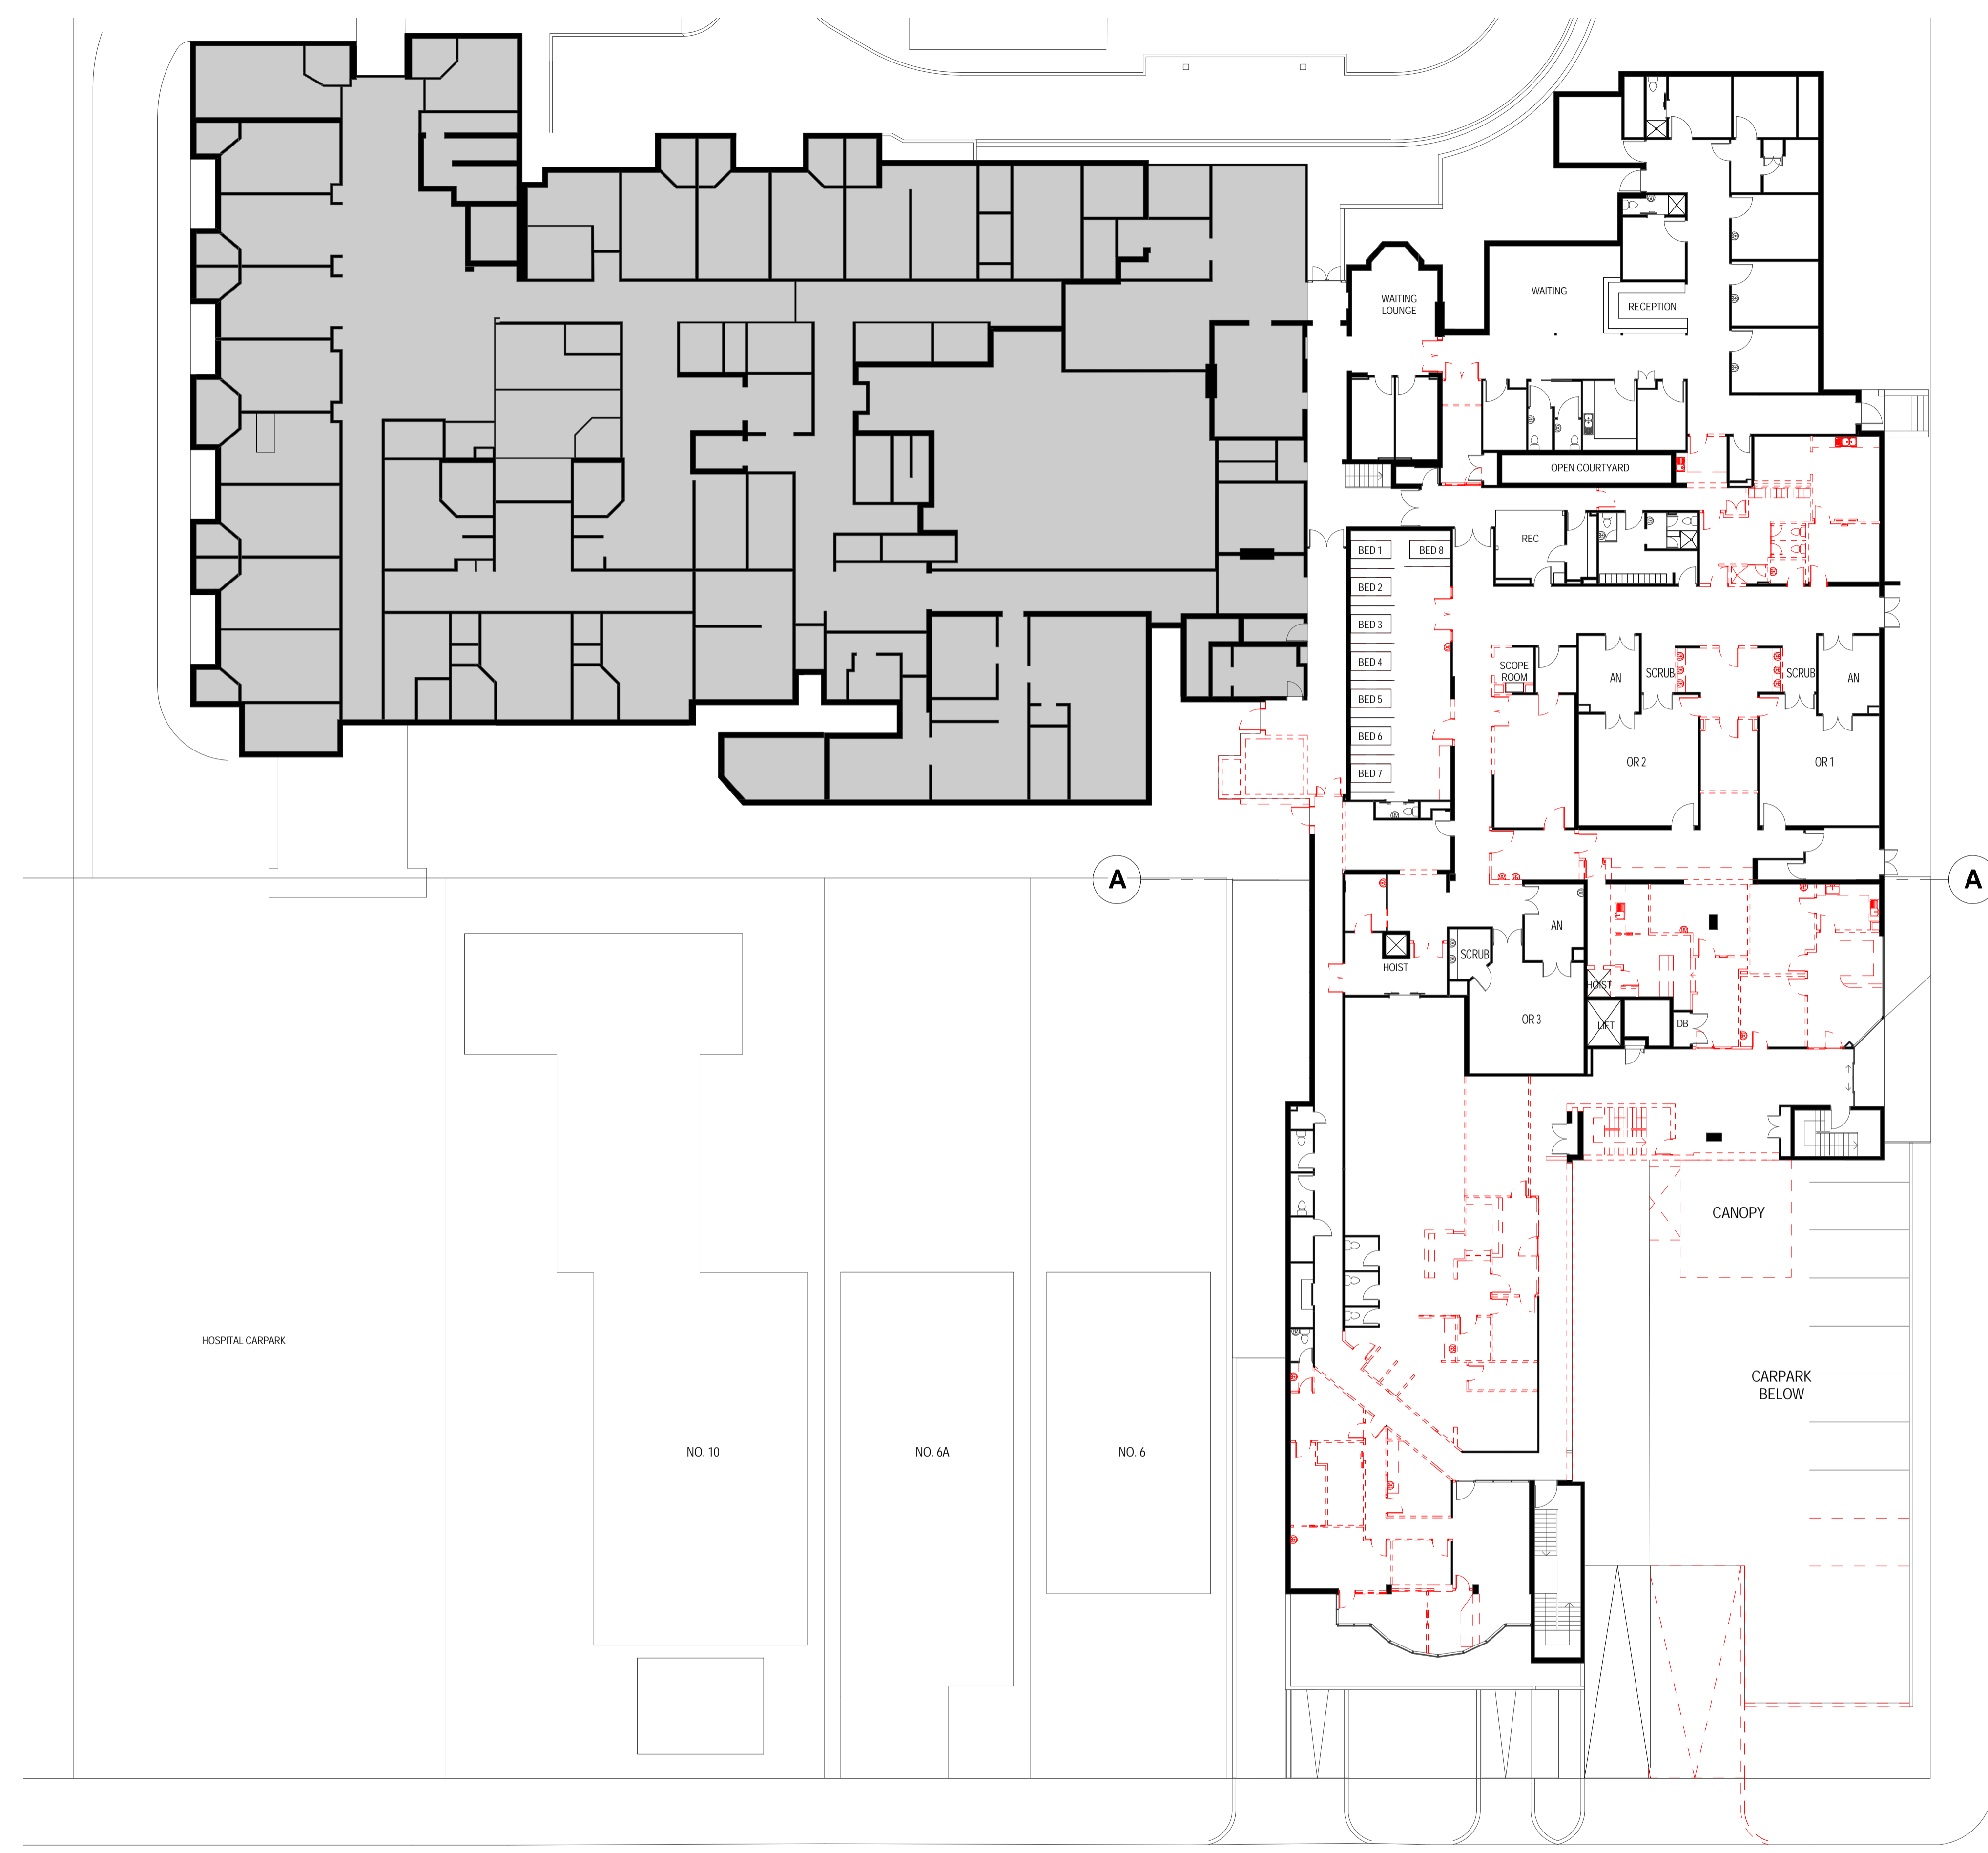
DRAWING No:  
**DA007**

The proposed lift area was utilised as an exit area to the exterior of the building. It comprised concrete slab floor with carpet overlay, cream painted plasterboard walls, a suspended ceiling with fibrous ceiling panels and modern lighting in good condition that was not expected to contain PCBs and a suspected asbestos core fire safety door.
