CONDITION OF THE FABRIC OF THE ADMINISTRATION BUILDING

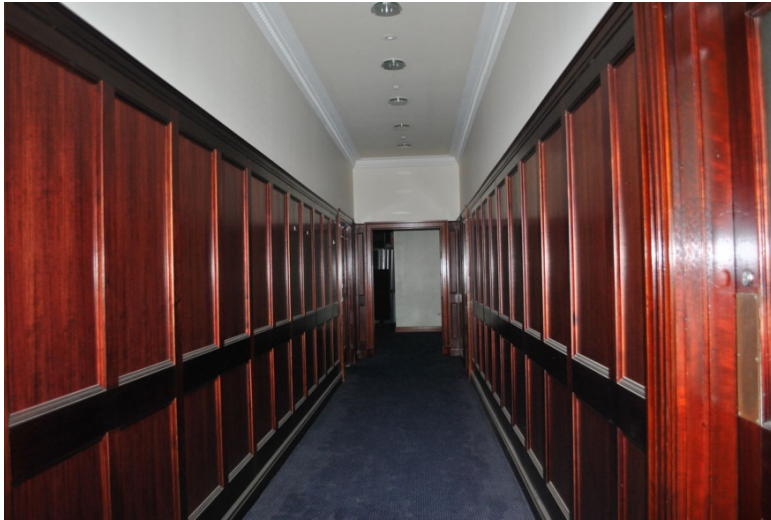
Figure 56. The panelling continues along the corridor to the Boardroom. A different timber has been used to that found elsewhere in the building, suggesting that it was installed at a different time.

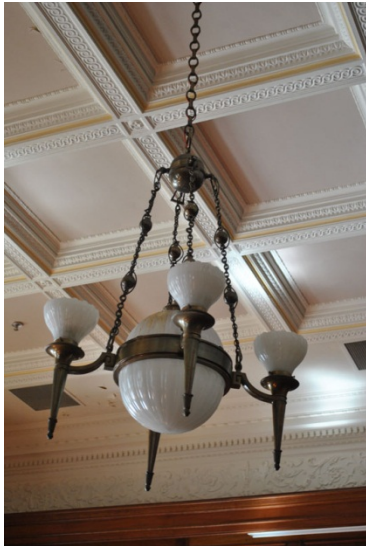
Figure 62. (left) The pendant light fittings are from the 1930s refurbishment of the building.

Executive bathroom intact – all fittings. Good condition.
	Light fittings throughout the Board Room area original and largely intact.
	Light switches original and intact.
Significant element: Stair and lift	Intact to period of installation (layered element) Paneling sound and in good condition Stairs in good condition Lift – not operational.
Significant element: Show Bar (level 1)	Intact to installation period (1930s) Timber paneling intact Bar and fridges intact Carpet laid over floor: not possible to inspect Windows intact
Significant element: main entrance to building	Good condition Stairs replaced with granite Walls re-clad in polished granite Hand rails fixed to side walls Timber-framed inserted (non-original) door case with fully glazed double doors. Good condition Glazed semi-circular highlight with worked iron grille – later 20C detailing
Remainder of building	
Walls and ceilings	External walls in good condition.

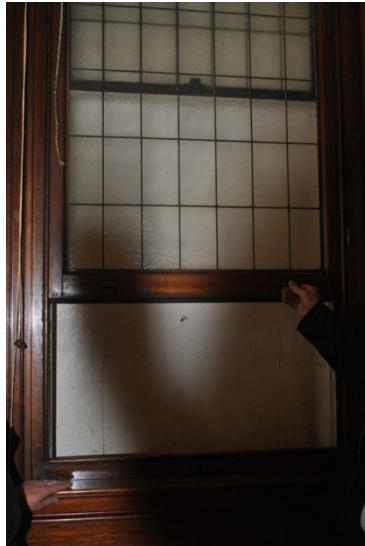
Figure 63. (right) This window originally opened to a light well, but became a blind opening when the extension was added to the south in the 1950s. ,

Building Interiors	<p>The structural condition and integrity of the Main Entry Gateway has been assessed by Simon Wiltshire from Mott McDonald Pty Ltd and has been rated as sound, with defects being superficial.</p> <p>Appear to be structurally sound, prevailing being late 20th Century office fitout.</p> <p>Identified significant rooms are substantially intact and in very good condition (see below).</p> <p>Late 20th C office fitout is in fair condition, superficial damage in places to lightweight materials.</p> <p>Exterior walls in good condition other than where demolished for earlier extensions.</p>
Significant element: Board Room	<p>Intact to 1930s layer. Windows double glazed.</p> <p>Wall paneling Queensland Maple – well maintained and in good condition.</p> <p>Ceiling detailing intact except where penetrated for services</p> <p>Windows double glazed: intact with brass hinges. Good dampering effect.</p> <p>Window frames in generally sound condition but showing evidence of superficial deterioration due to solar exposure.</p> <p>Doors original.</p> <p>Fireplace intact – functionality not tested.</p> <p>Floor covering is parquet border with large carpet rug laid over raw floorboards. All appears to be intact and in generally sound condition. Some lifting pieces of timber in the floor.</p> <p>Blind window to former lightwell (infilled when extension to south constructed).</p>

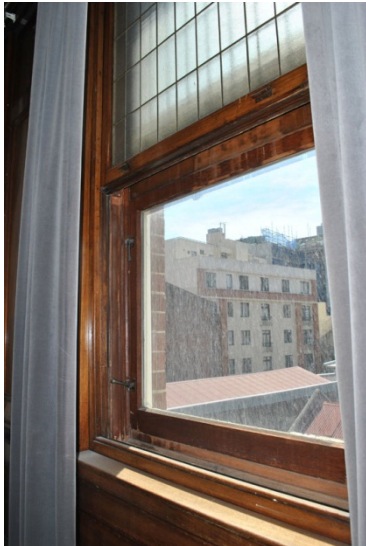
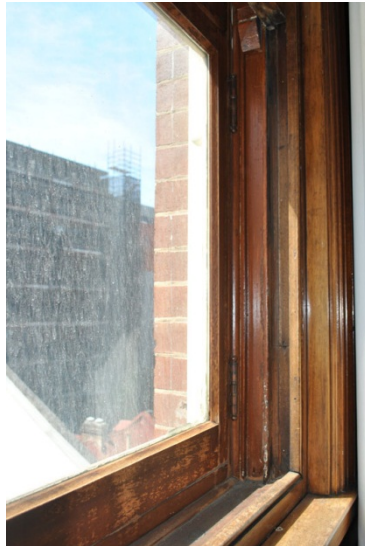
Figure 64. and 65. The windows to the Boardroom are double-glazed sash windows set into separately operable tracks.

Element	Comment
Building exterior walls	<p>- The exterior of the Administration Building is generally sound and in good condition with the exception of the southern wall, which has been removed as part of the demolition of the non-contributory buildings and elements throughout the former brewery complex.</p> <p>The exposed opening has been clad in lightweight material to protect the integrity of the remaining part of the building from the elements.</p> <p>Copper drainpipes to lower levels removed in the past and have been replaced by PVC. Most of these have been broken allowing rainwater to run down the wall. This is leading to loss of mortar and growth of algae in affected areas.</p> <p>The remaining exterior brickwork appears to be generally sound.</p>
Building exterior windows and doors	<p>- Most original windows remain in situ and are intact. Some, particularly on the lower level to the street, have been blocked by masonry infill which has been painted to match the brickwork.</p> <p>The windows to sensitive spaces such as the Board Room have intact double glazing systems.</p>

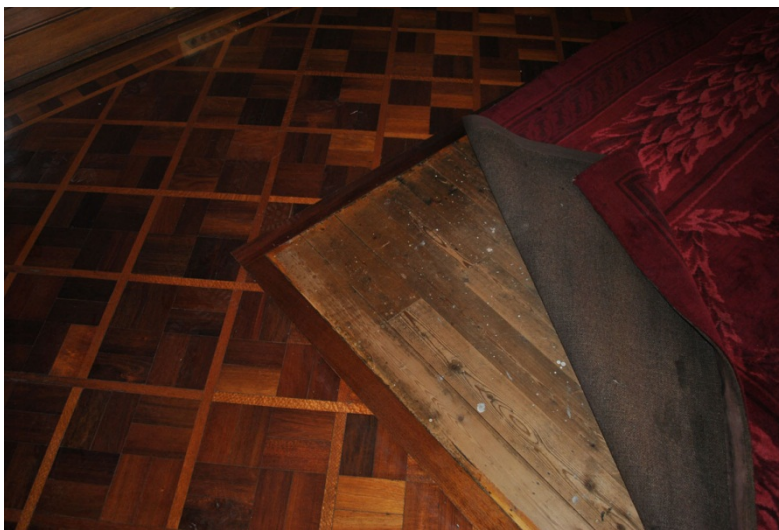
Figure 68. The parquetry, although visually rich, is limited to a band around the perimeter of the room, with the centre area (and concealed by the large carpet area) laid in simple unfinished floorboards.

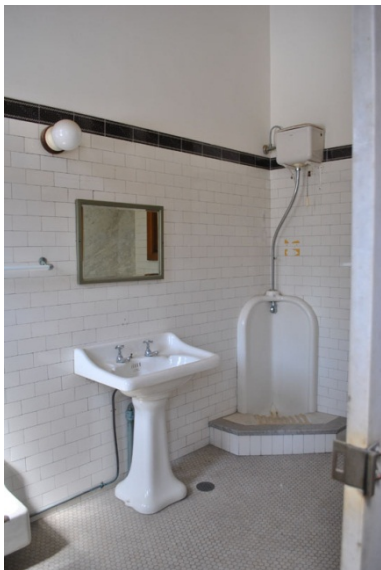
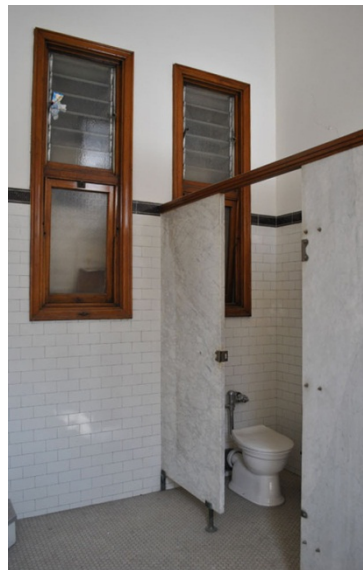
Figure 69 and 70. A private bathroom was provided for board members. The room and its fittings are also intact.

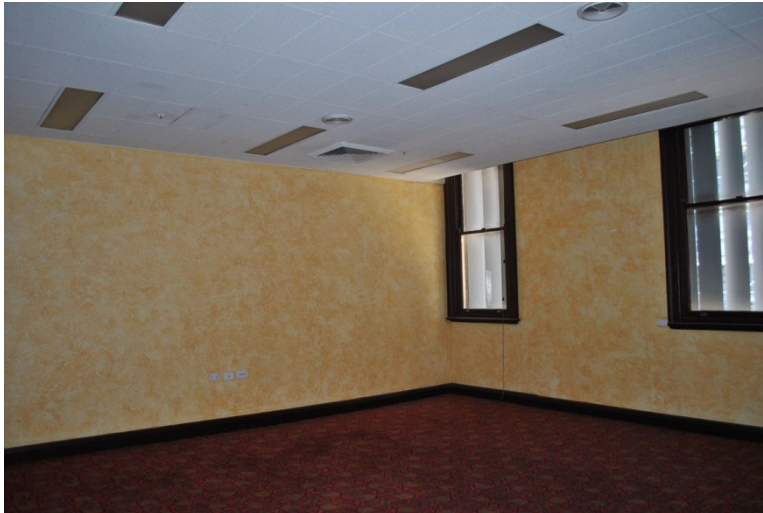
Figure 71. The former executive dining room has been refitted as a contemporary office space. It is not known whether panelling survives behind the contemporary finishes. Note also the adverse impact of the lowered ceilings relative to the sill height.

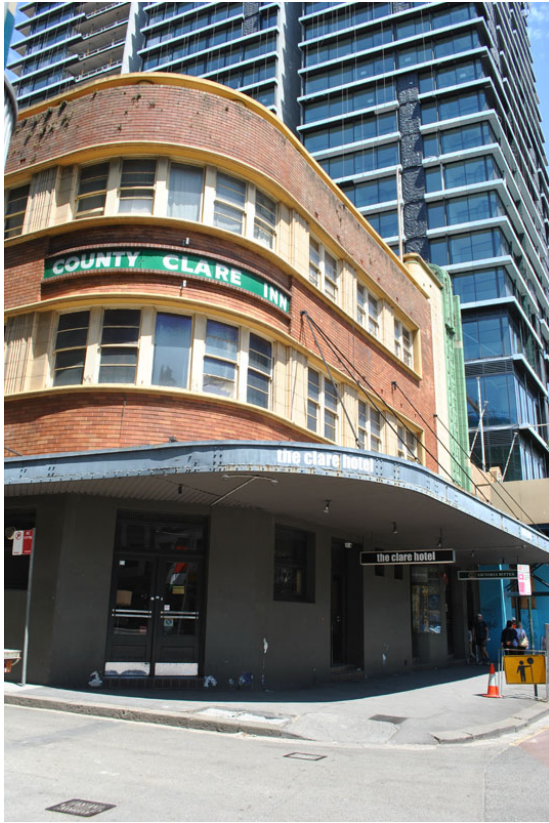
The street elevation below the suspended awning has lost its original glazed tiles, now having a rendered cement finish, but the remaining form and detailing of the facade is consistent with the original design, including elements such as curved glazing and art deco detailing to windows and other elements such as ventilation ducts etc.

Figure 78. The County Clare Hotel is substantially intact, with the only significant loss of fabric being the external wall tiles at street level. This part of the facade has now been clad in grey render. The multiple entrances are typical of the inner city hotel of the era.. The main door addresses the corner, with secondary doors and windows on each frontage. Separate entrances are also provided to the bottle shop, saloon bar and access to the upper levels of the building.

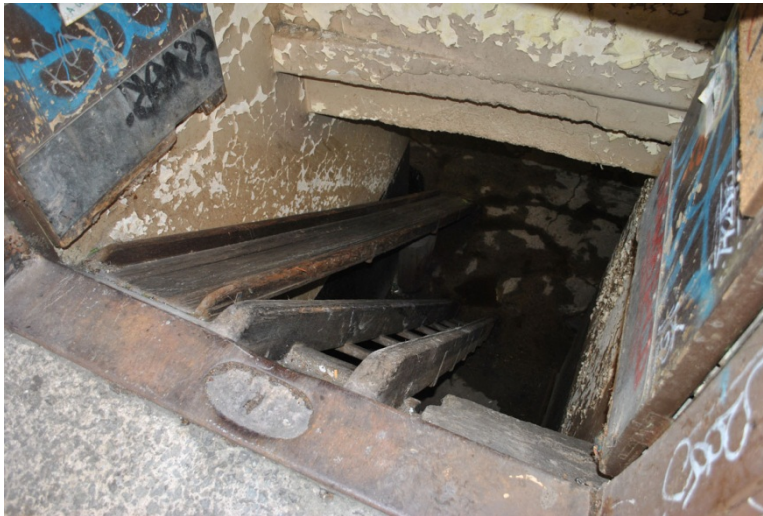
Figure 79. The robustly constructed timber keystone and case chute to the cellar has survived intact.

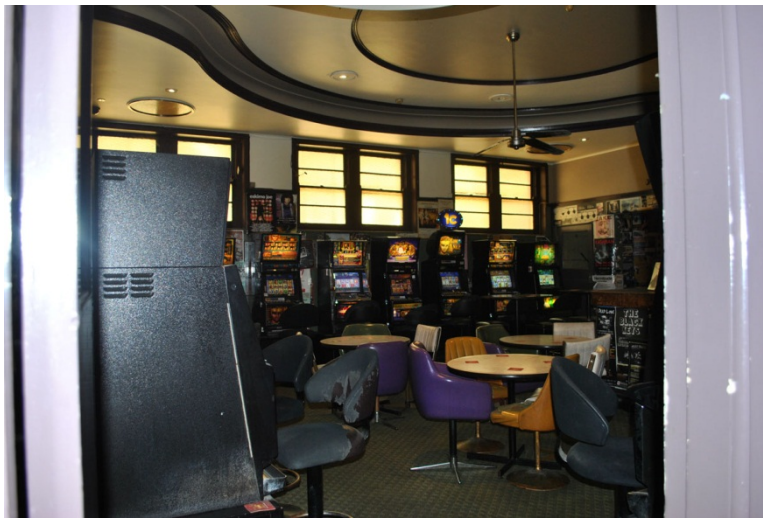
Figure 81. The original Saloon Bar has been converted to a gaming room, although the dramatically modelled curvilinear ceiling is intact. Wall finishes may remain under later applied finishes
