## CUB SITE – INVENTORY / ASSESSMENT SHEET- NO.7

| ITEM DETAILS | | | | | | |
|---|---|--|---|--|---|---|
| Name of Item | Terrace, 38 Kensington Street | | | | | |

Extract from 2012 Conservation Management Plan  
for the Kensington Street Precinct –  
Contributory Elements and their Value

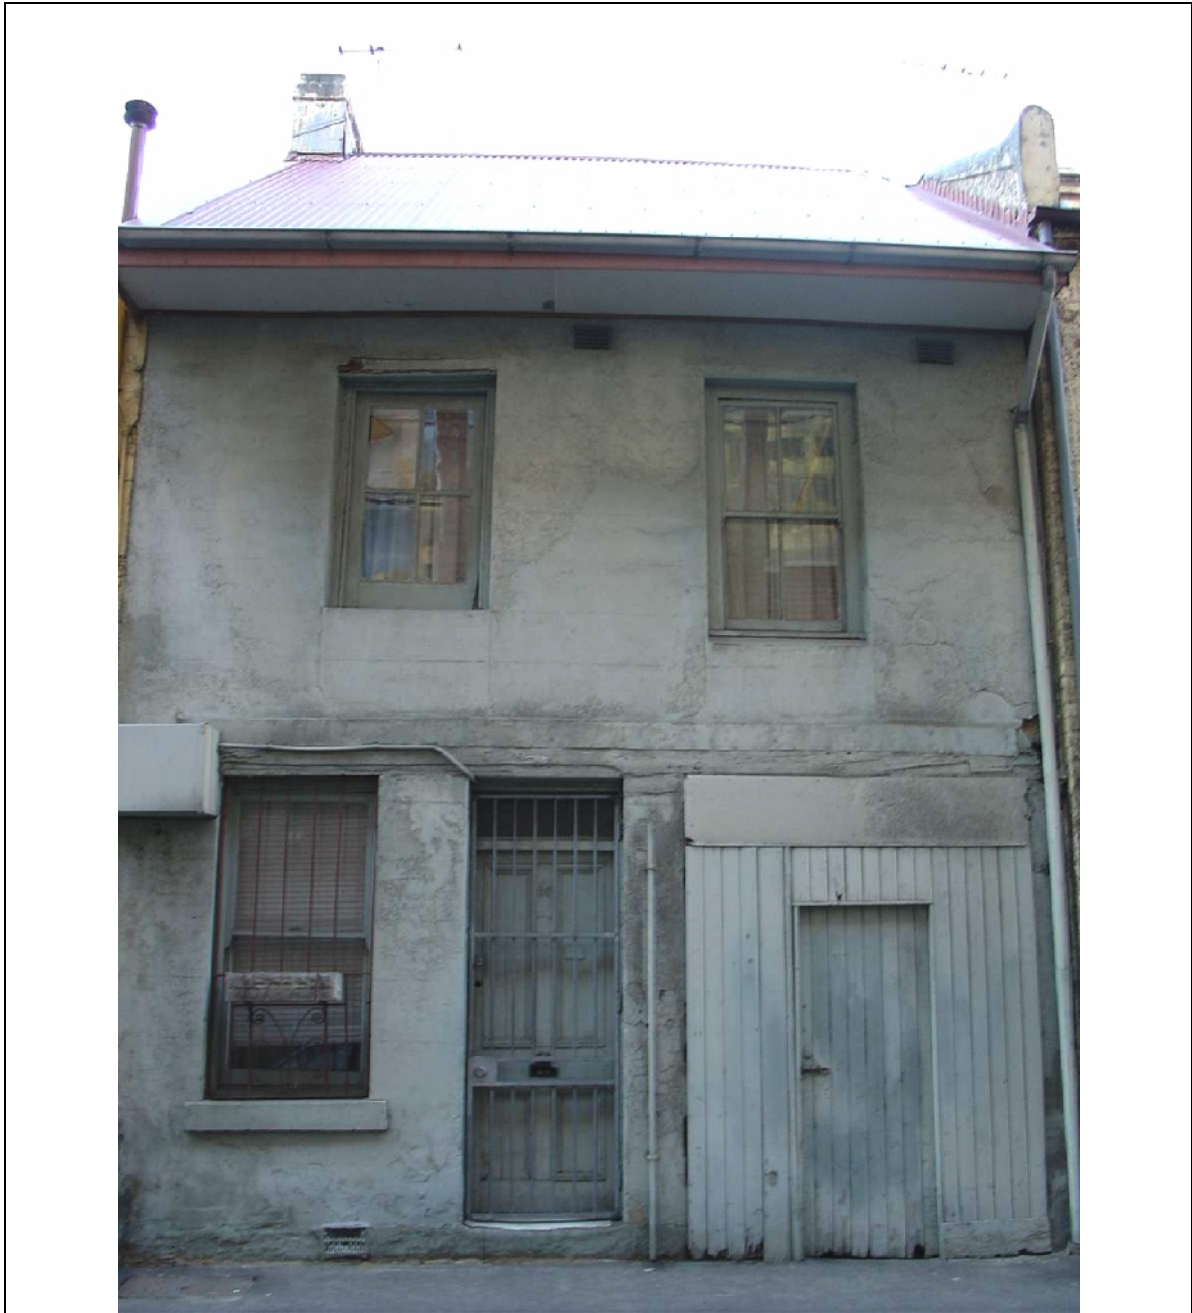
| Image caption | 38 Kensington Street, West Elevation | | | | |

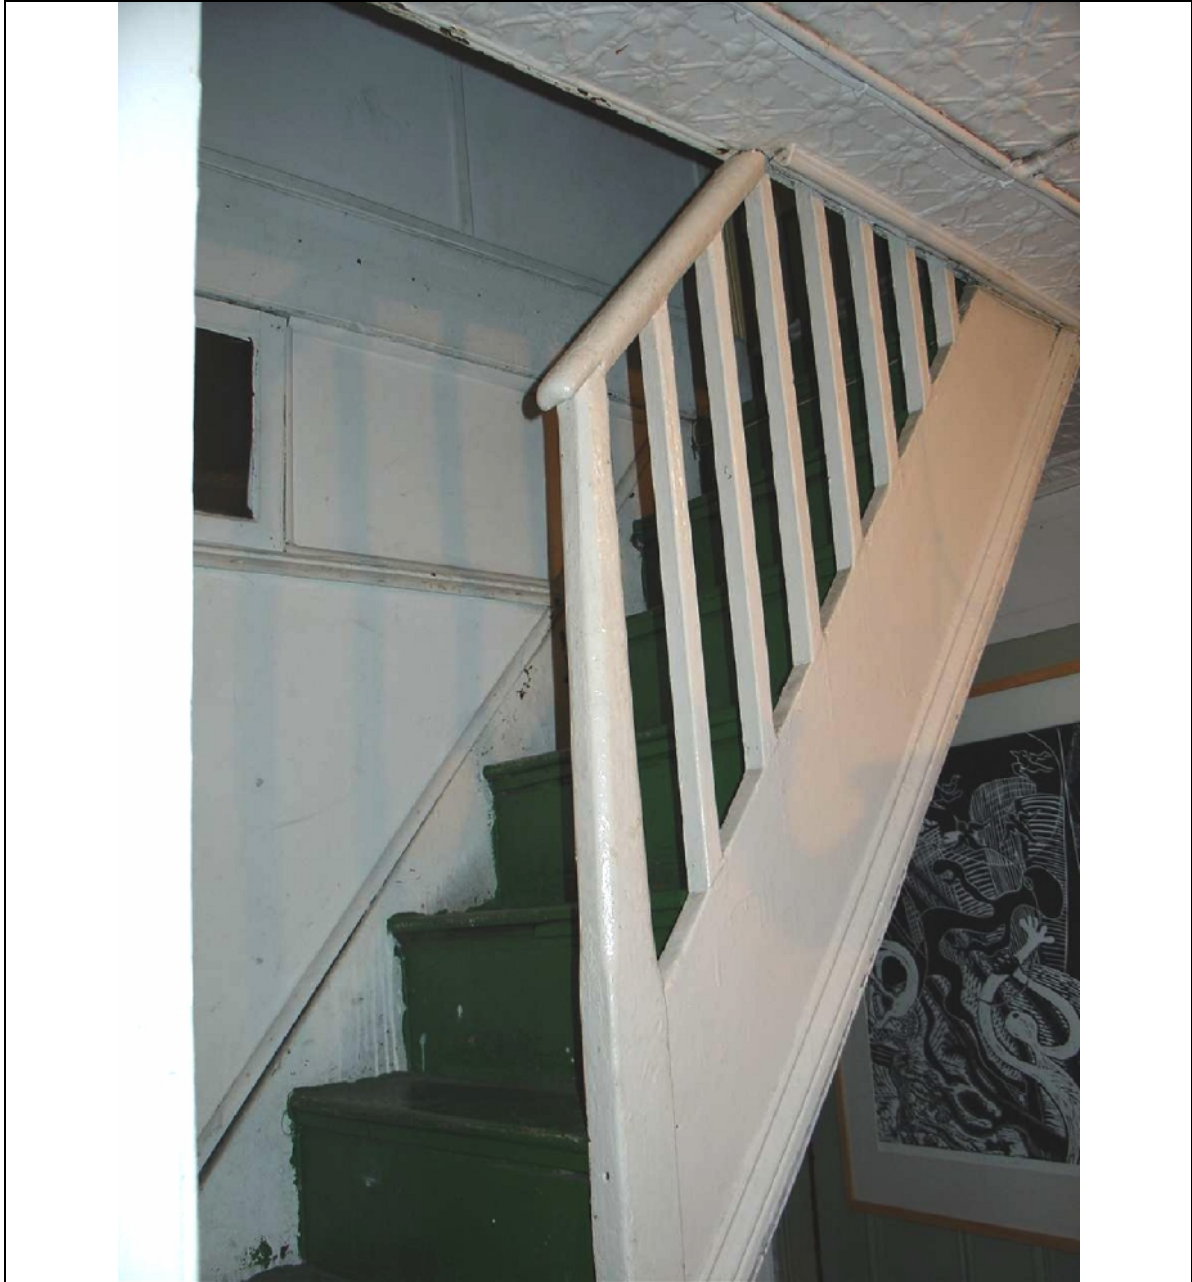
| Image caption | 38 Kensington Street, Interior, Room G2 | | | | |
