#### 4.4 FORMER GARAGE/RUM STORE AT 2-10 KENSINGTON STREET

## DESCRIPTION OF THE FABRIC OF 2-10 KENSINGTON STREET

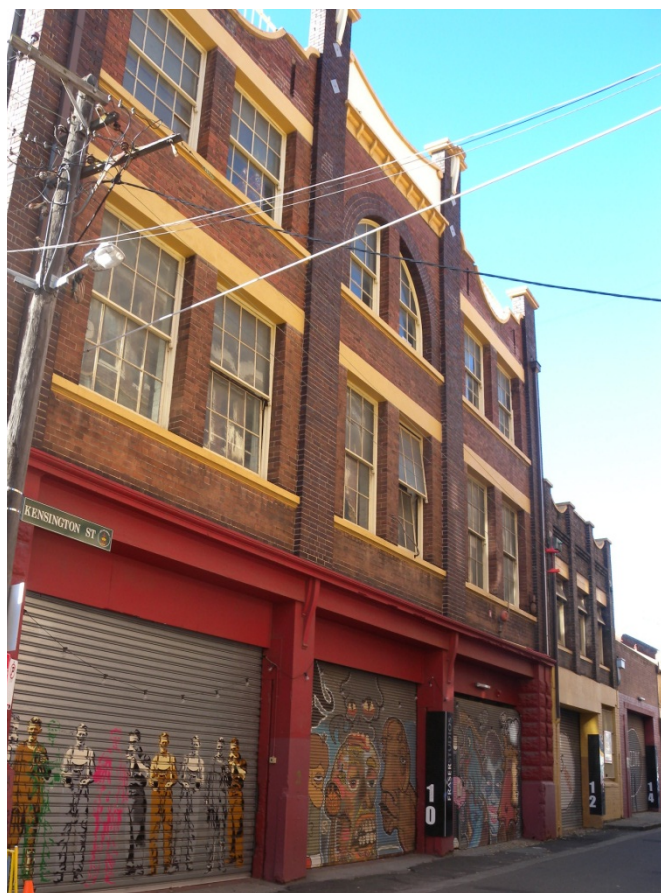
Figure 26. The Kensington St façade of the building is characterised by its simple but strongly arranged horizontal lines of dark red brick brickwork with painted concrete lintels and window sills which area divided into three vertical bays by engaged brick piers in darker (liver red) brickwork. The façade is dominated by the prominent Federation style parapet above.

Lintels are rendered and painted over large timber-framed sash windows; the central pair on the top floor forming an arched opening. The ground level is divided into bays, each with a steel roller door.

The piers were clad at ground level by cast cement panels that read as rusticated stone, although the detail is clearly evident where the panels have been cut to allow work to the downpipes (for example, at the southern end). There is no separate pedestrian doorway, with access being via a small door set into one of the roller doors. The roller doors have been painted in 'urban art' style, one referencing the brewery workers.

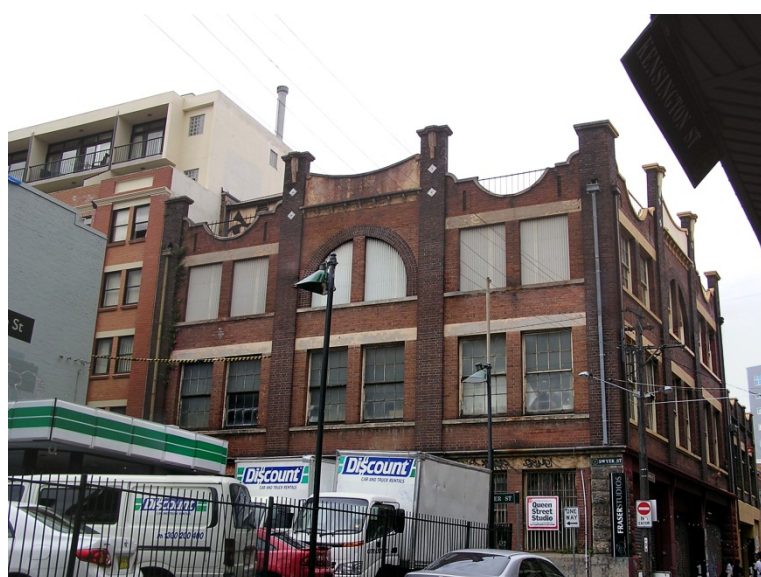
Figure 27. The parapet is formed of brick with cement capping and a cement render finish to the rear (roof side). The parapet has been braced on the roof side but is deformed in places. Inset iron grille rails to the scalloped profile of the parapet are rusting and their soundness is not known. The roof is a simple gabled structure set behind the parapet and is clad in corrugated iron sheets. Some sheets have surface rusting in places but they appear to be relatively new and generally sound: inspection of the interior of the roof space revealed few holes and no evidence of recent water ingress. Flashing has been replaced where the roof abuts the parapet – there is evidence of earlier water damage to the brickwork. The old flashing sheets are stored within the roof space.

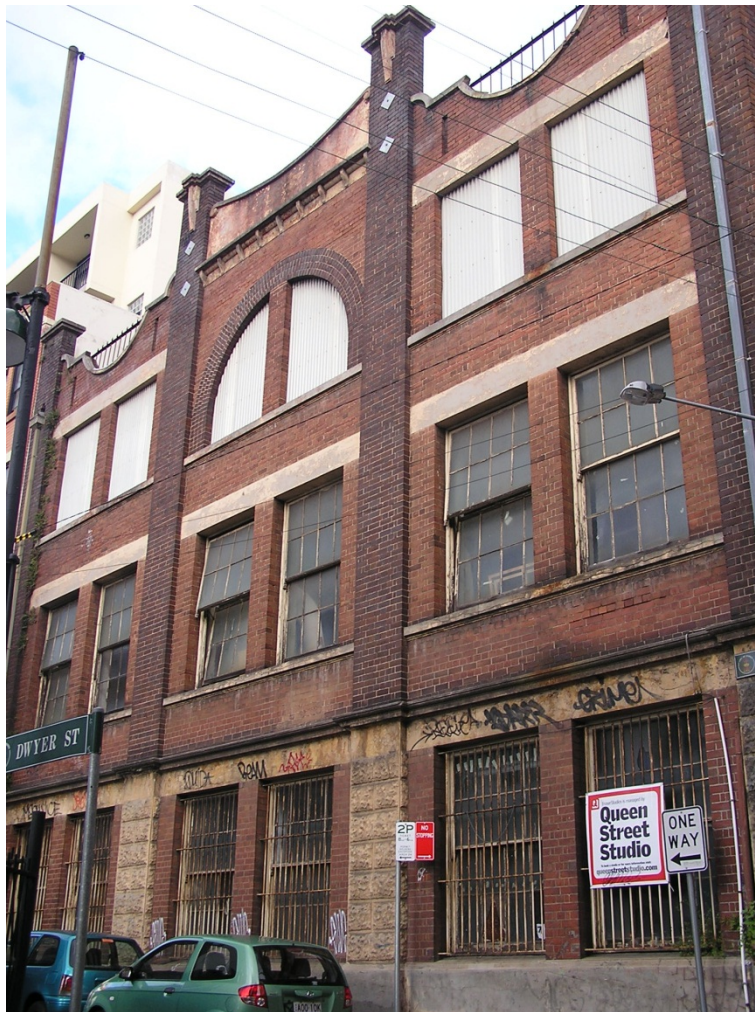
Figure 28. The Dwyer Street elevation is consistent with the form and detailing of the Kensington Street elevation. It also features three bays — allowing the building to have a strong and symmetrical street presence, particularly when viewed from the northern end of Kensington Street near Broadway.

The site falls slightly towards Kensington Street. No access is available from this elevation. The window frames to the 2<sup>nd</sup> (uppermost) floor have been removed and fiberglass/synthetic corrugated profile panels have been inserted.

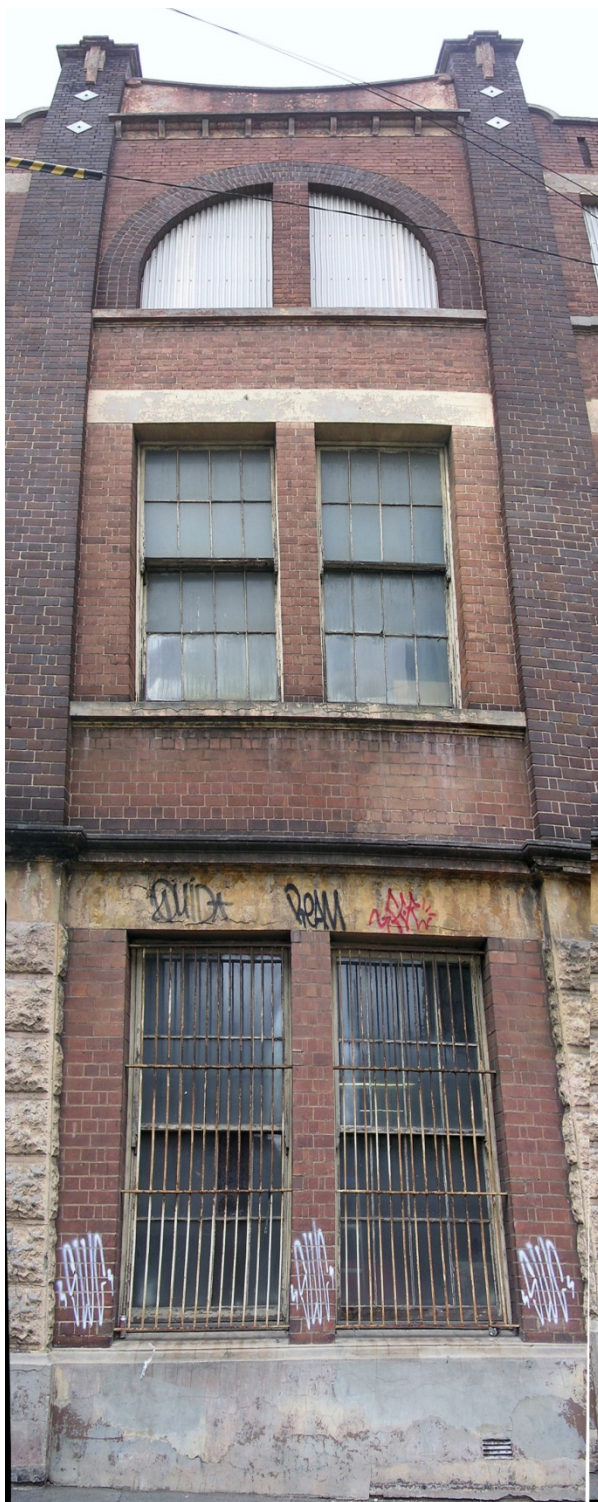
Figure 32 (above). Detail of the windows to Dwyer Street. The windows to the main elevations at both ground and first floor level are fixed at the bottom, with the upper section tilting inwards to allow ventilation. The arched windows to the uppermost level have been removed to this elevation and corrugated translucent panelling installed in the opening.

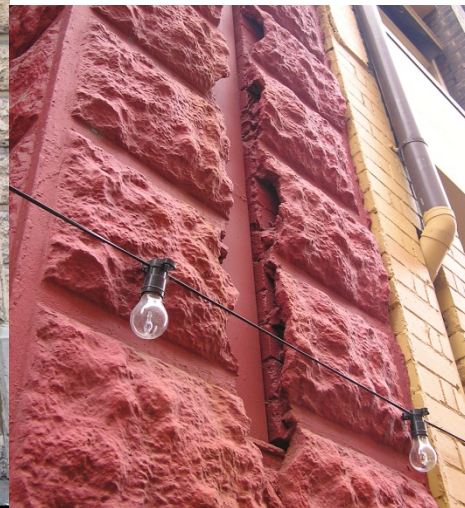
Figure 31 (below): The cast rusticated stone blocks used to finish the pillars on the lower floors can be seen where they have been cut to allow a downpipe to be inserted.

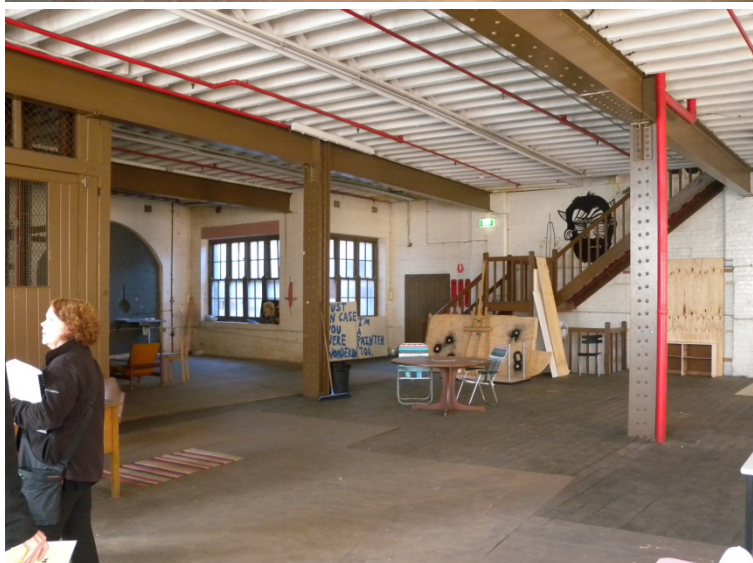
Figure 35. Level 1 – Similar to the ground level, – same structural configuration including riveted beams and columns. Floor-ceiling heights are less than the other levels. Some cracking to wall at top of the light well due to water ingress. Ceilings throughout are open to the undersides of the timber joists and floorboards of floor above with herringbone bracing..
