## FABRIC OF THE TERRACES AT 16-16A KENSINGTON STREET

## MAJOR BUILDING MAINTENANCE AND REPAIR REQUIREMENTS FOR 16-16A KENSINGTON STREET

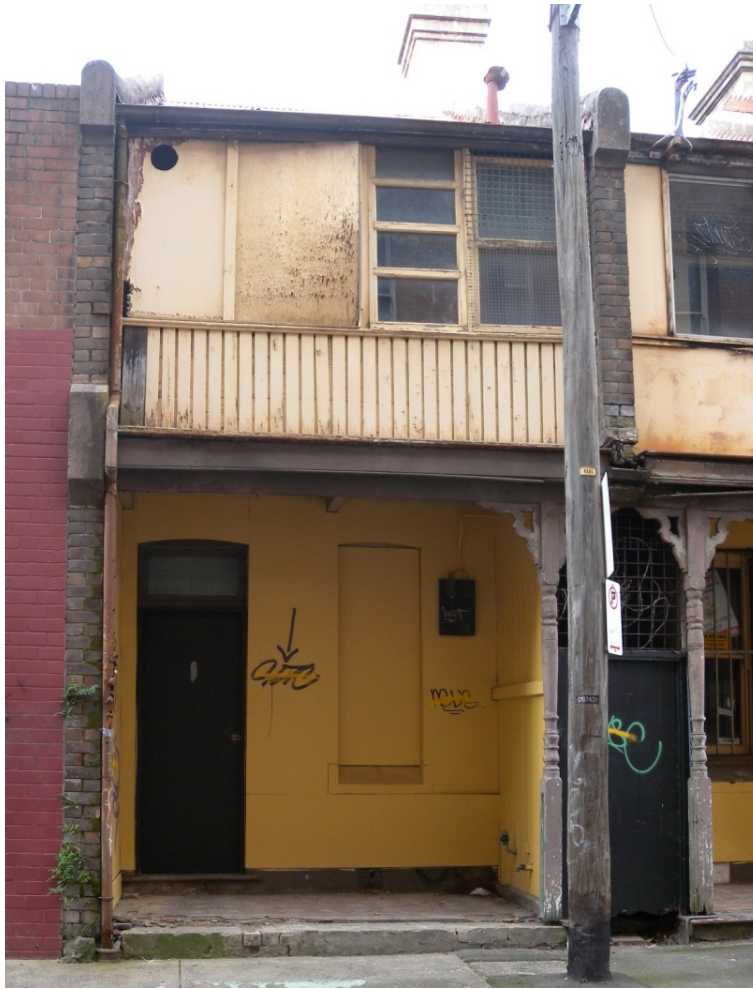
Figure 64. Façade (16)

The terrace facades originally had tuck-pointed brickwork. The facade brickwork has been covered by fibrecement panels at ground floor level and has been painted at first floor level. The original face brickwork is evident to the party wall above the roof.

The ground floor façade of each terrace features a front door with fanlight and a single narrow timber-framed double hung window with an arched soldier course and rendered window sills. No. 16A has an original timber paneled front door, No. 16 has a more recent front door.

The upper level balconies are enclosed to both terraces, however historical photographs show timber balustrading. Evidence of earlier railing remains at No. 16. Sloping timber tongue and grooved boarding forms the balcony floors.

The terraces have gabled galvanised steel roofs in generally poor condition, divided by a brick party wall with a central chimney. The balcony roofs are contiguous with the main roof.

| Element | Comment |
|---|---|
| | Existing cladding to the ground floor may be removed to reveal the original brick facade. Evidence suggests that the original facade was tuck-pointed brickwork and this should be repaired/reinstated if possible. |

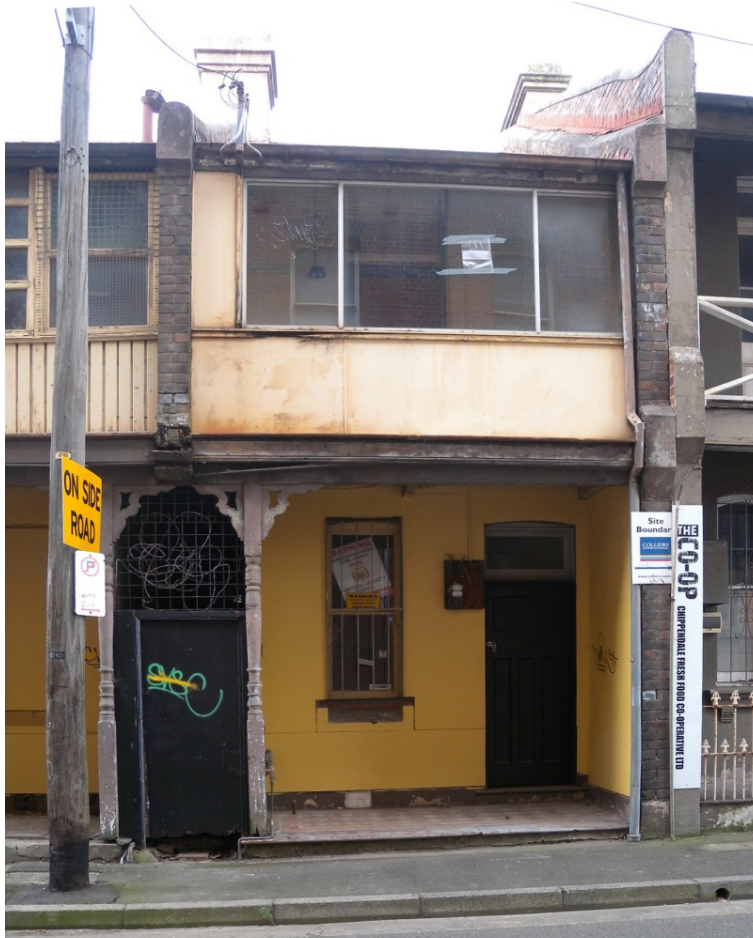
Figure 65. At the first floor level, behind the balcony enclosures, each terrace features a central doorway opening which originally housed a pair of glazed timber French doors (now missing to both), with fanlights above. Both terraces retain the fanlights. The balcony to 16 was used as a bathroom, with evidence of plumbing and venting extant and a solid infill to the street.

| Element | Comment |
|---|---|
| Verandas | The existing verandah enclosures may be retained to protect the fabric of the main wall; or that they be removed and the original veranda form reinstated. Photographic evidence reveals that the vertical timber elements to number 16 are original, as is the railing, and they should be used as the model for any reconstruction work. Deteriorated veranda floorboards to the upper level should be replaced.<br>Tessellated tiles to the ground level verandah have survived in situ, although are worn. They should be inspected by a suitably experienced tiler before any management decisions are made about this aspect of the building. |

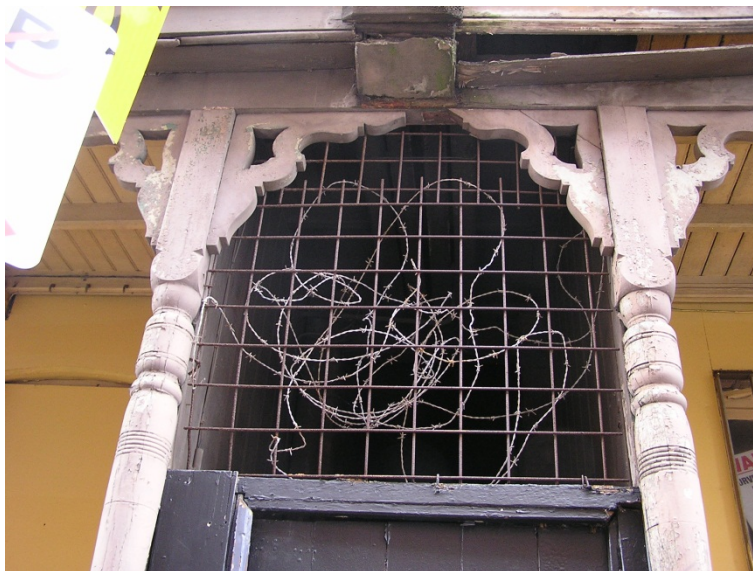
Figure 66. The terraces have a central nightsoil lane, which is flanked by turned timber posts and decorative timber brackets.

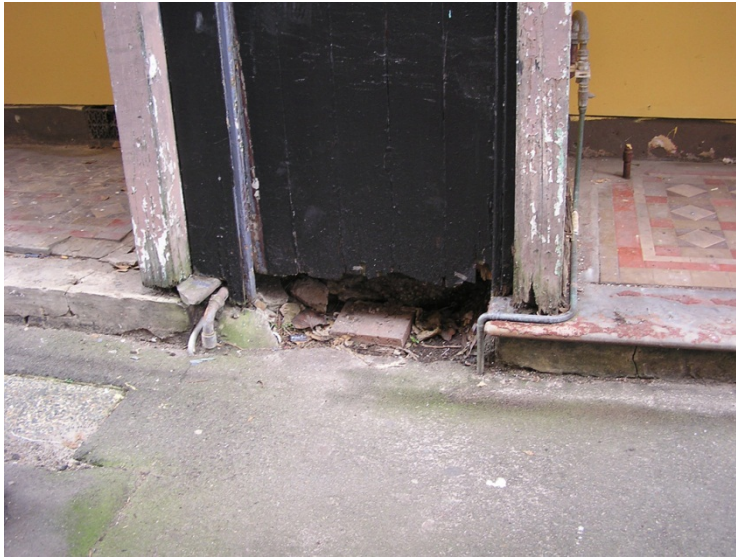
Figure 67. The fabric is original, but showing signs of deterioration.

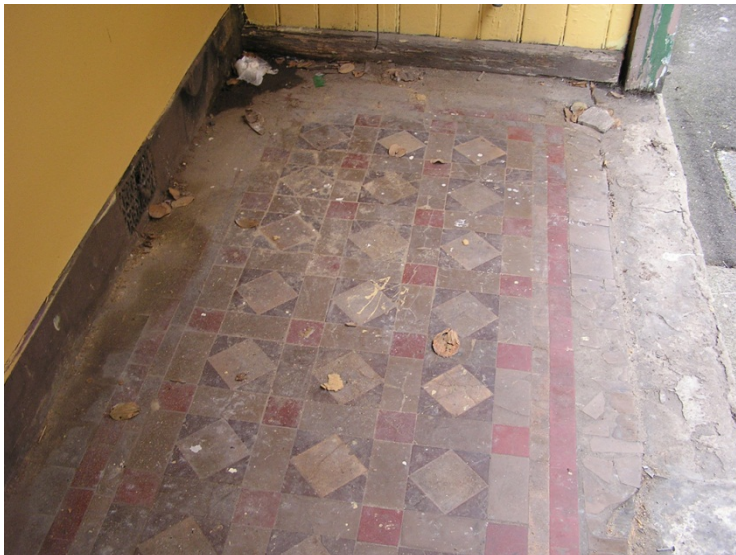
Figure 68. Verandah and balcony detailing

Front verandah floors are tessellated tiled with bull-nosed slate edging (slate edging missing to No. 16). The original cast iron fence and gates to each terrace (shown in 2001-2005 photographs at No. 16) are missing.

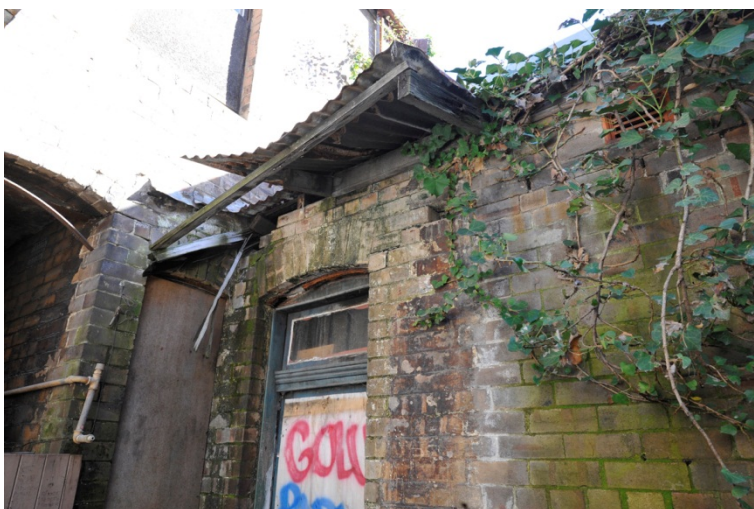
Figure 69. Detail of deterioration of the roof iron and brickwork to the skillion wings to the rear of the main building.

Each terrace retains a rear wing of a single room and a stair and door. These areas are in very poor condition with severe brickwork failure, removal of most finishes, loss of joinery and the removal of the rear wall of 16A.

Each rear wing features a brick chimney. These are in fair condition apart from damage to the rear chimney of no 16 where it adjoins the warehouse building.

The two wings are possibly recoverable but will require substantial work, including the removal of most existing fabric.

| Element | Comment |
|---|---|
| Walls | Brick walls to ground floor facades have been covered by lightweight sheets (Masonite/fibro); walls to rear wings have been painted; brickwork is otherwise original. Brickwork to rear wings is in poor condition.<br>Water ingress is affecting integrity of brickwork bonds to rear wings. The cause of the damage should be confirmed and repaired to prevent further deterioration; and damaged fabric repaired using matching materials and techniques. |

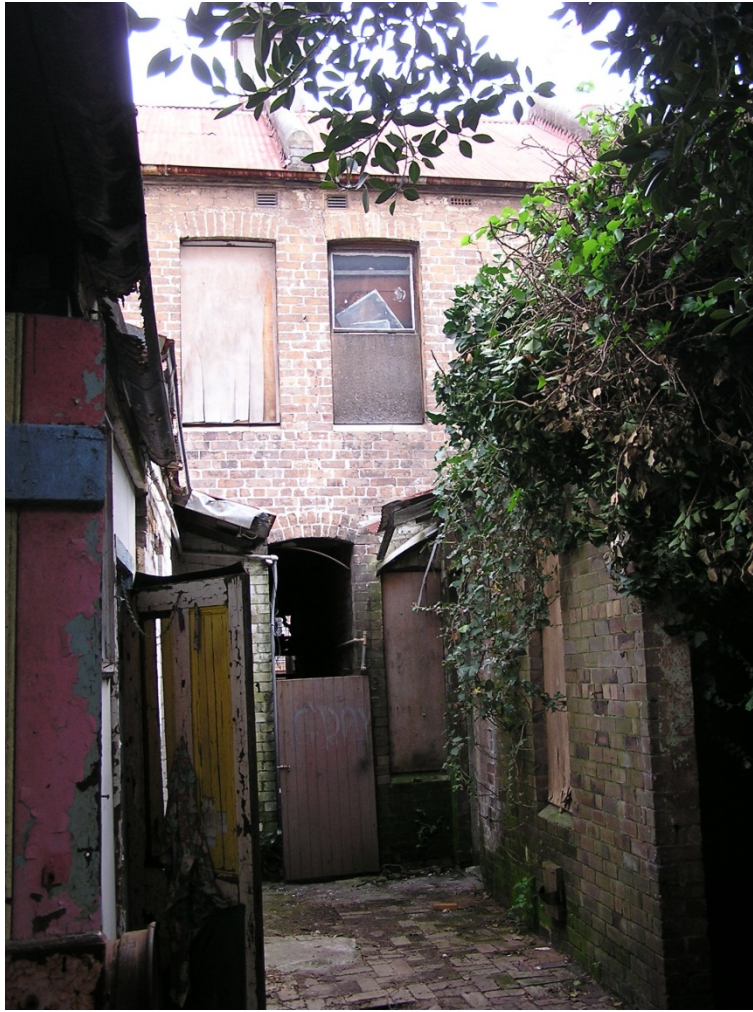
Figure 70. Walls are built of common brickwork, including to walls of the nightsoil passageway. The brickwork to the skillin-roofed wings has been painted to No.16A.

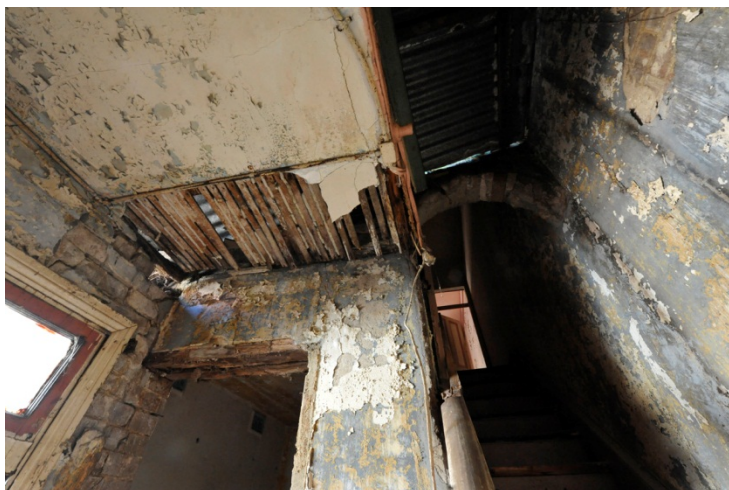
Figure 71. Roofs are corrugated steel. Roof flashings have failed and allowed water into the buildings causing a range of structural issues and failing interior and exterior finishes. (16)

The terraces are substantially intact with little evidence of layering other than the infilled verandahs and minor alteration to the original form of the rear wing extension. Significant damage to the fabric has been caused by water damage due to failure of roof sheeting and/or through a general lack of maintenance of the buildings over the years.

| Element | Comment |
|---|---|
| Roofs | Form is intact. Iron sheeting has deteriorated and needs to be replaced with matching materials. Periodic replacement of roof sheeting will be required in the future. |

- Replacement of roof cladding, flashings and rainwater goods is a priority.
- The building should be maintained in a secure form to prevent unwanted access and vandalism.

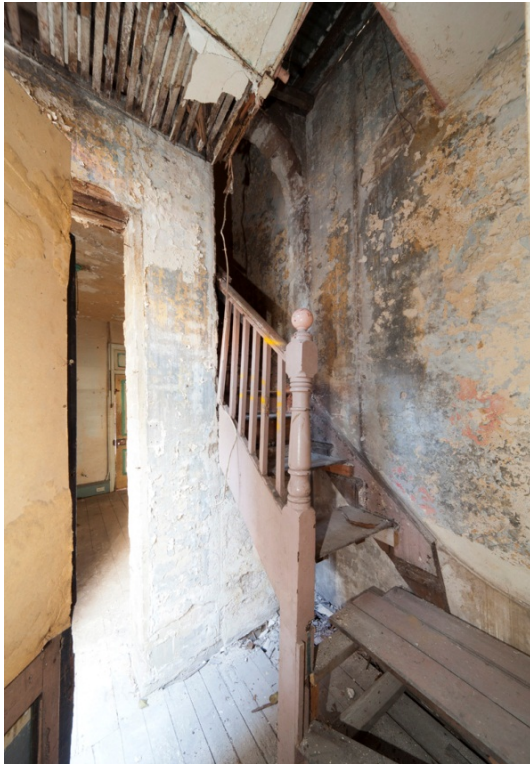
Figure 72. The stair to 16 is in very poor condition (Photo: Nat Hughes)

| Element | Comment |
|---|---|
| Staircases | The staircase to 16 Kensington Street is in poor condition and should be repaired using the adjacent intact stair of 16 A Kensington Street as a model. |

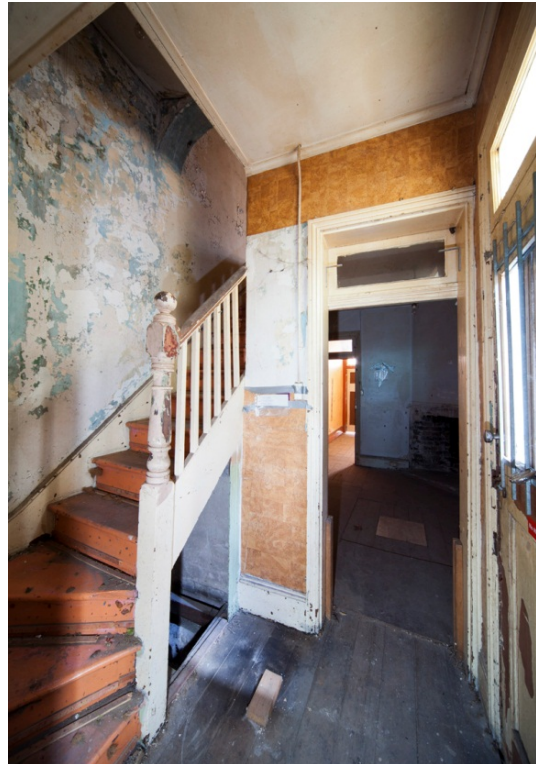
Figure 73. The stair to 16A remains trafficable (Photo: Nat Hughes)

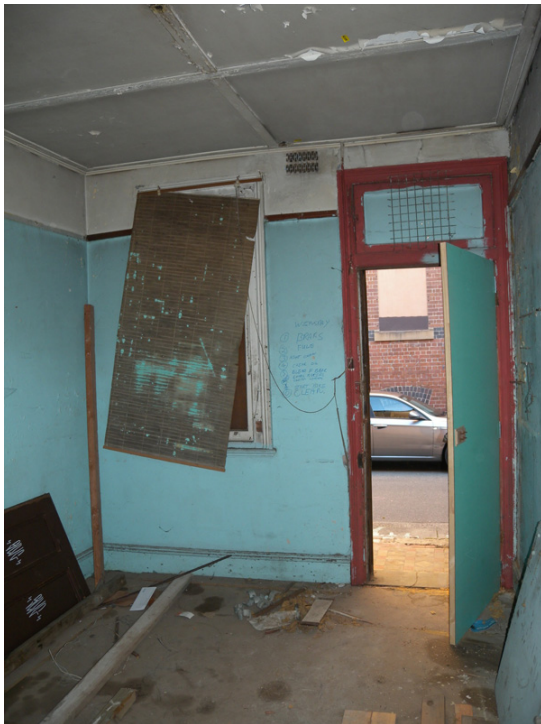
Figure 74. Main room to No. 16. The rooms are small, and although the spaces are intact, much of the fabric is in poor condition.

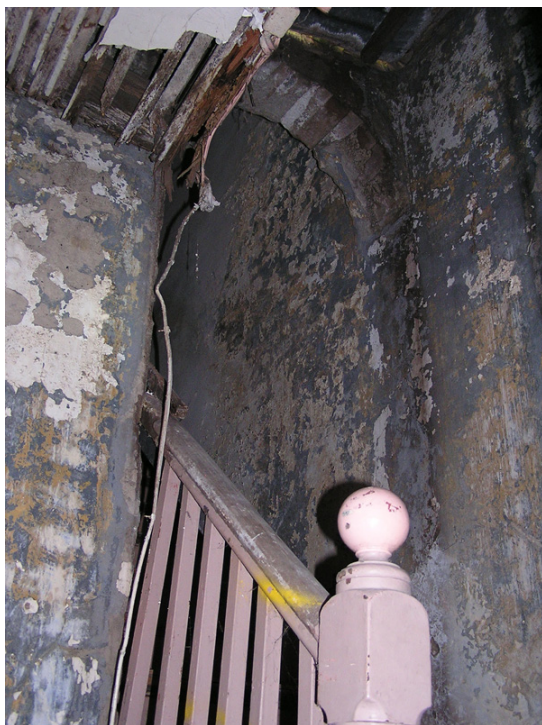
Figure 76. Stair to No.16 showing poor condition.

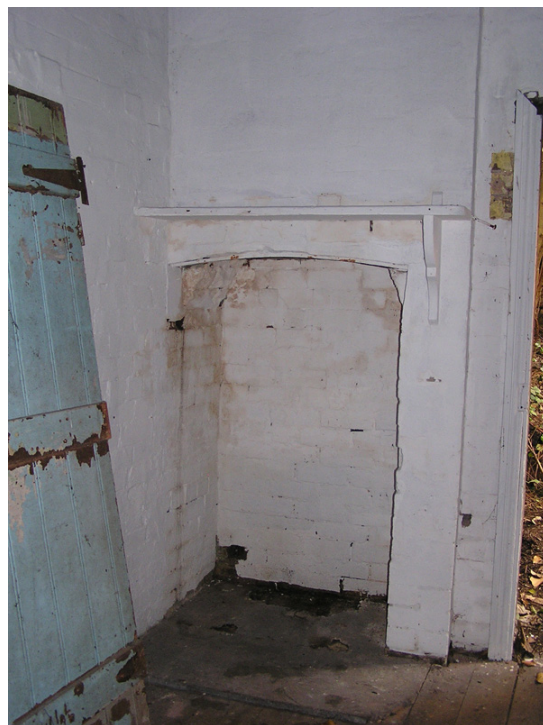
Figure 77. The original kitchen hearth and ledged back door are in the rear room. No contemporary services are evident.

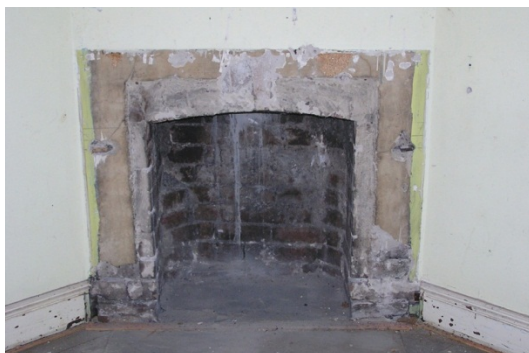
Figure 78. Internally, the terraces are reasonably intact although in poor condition: all extant joinery is original except the front doors. Ceilings are either damaged or not original, mantelpieces are either missing or not original. Much of the original joinery such as skirtings are intact.

| Element | Comment |
|---|---|
| Ceilings | Many of the internal ceilings, particularly to 16 Kensington Street, have collapsed or show significant deterioration. These need to be repaired with like materials. Other ceilings should be inspected for soundness and repaired or replaced as necessary. |

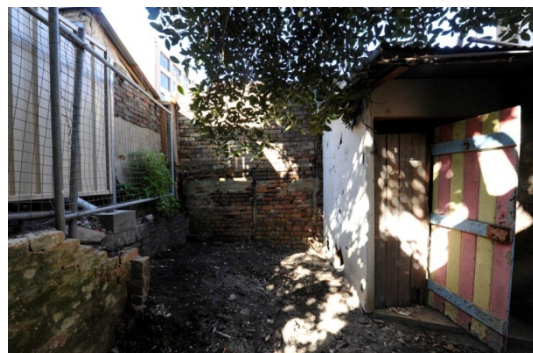
Figure 79. The rear yard was also found to be in very poor condition. It retains remnants of the early separate WC's, recently collapsed due to the actions of the developer of the adjacent site, elements of early side walls that are now incorporated into other construction, small areas of remnant pavements, several large trees and a de-stabilised rear property wall with some new retaining wall construction related to adjacent properties.
