#### 4.8 TERRACE AT 18-20 KENSINGTON STREET (C1890)

### FABRIC OF THE TERRACE AT 18-20 KENSINGTON STREET

## MAJOR BUILDING MAINTENANCE AND REPAIR REQUIREMENTS FOR 18-20 KENSINGTON STREET

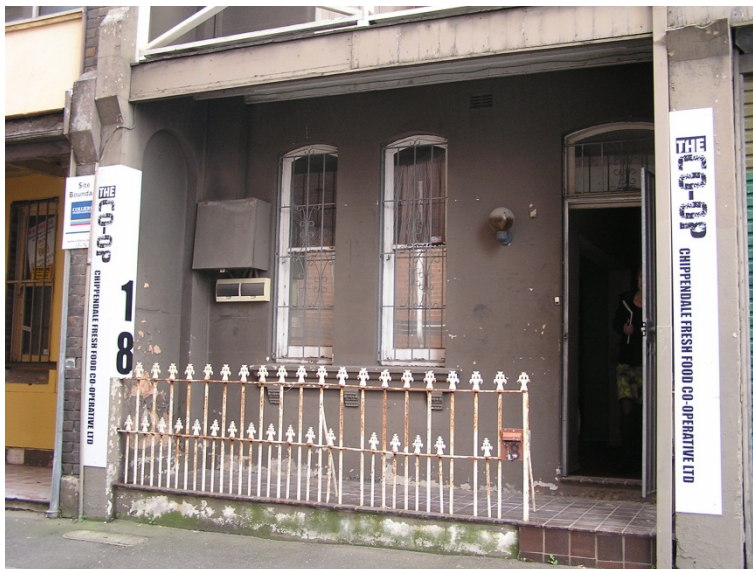
Figure 81. Detail showing veranda area. The cast iron palisade fence is original, although the tips of the decorative heads have been trimmed..

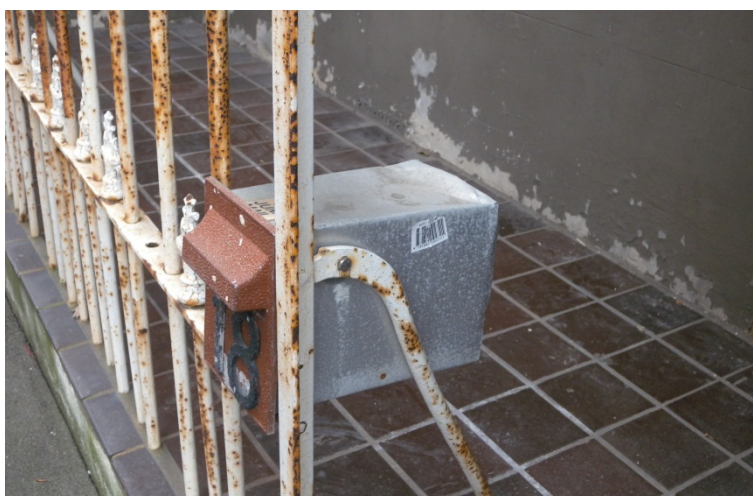
Figure 82. The floor to the veranda has been covered by glazed ceramic tiles. This has led to damage to the fabric of the walls due to the impermeable nature of the tiles.

The table below provides a summary of the condition and level of integrity for the major elements of the fabric of 18-20 Kensington Street. The property is in fair condition, with the cement rendering having been responsible for much of the damage that has occurred due to the impermeable nature of this finish.

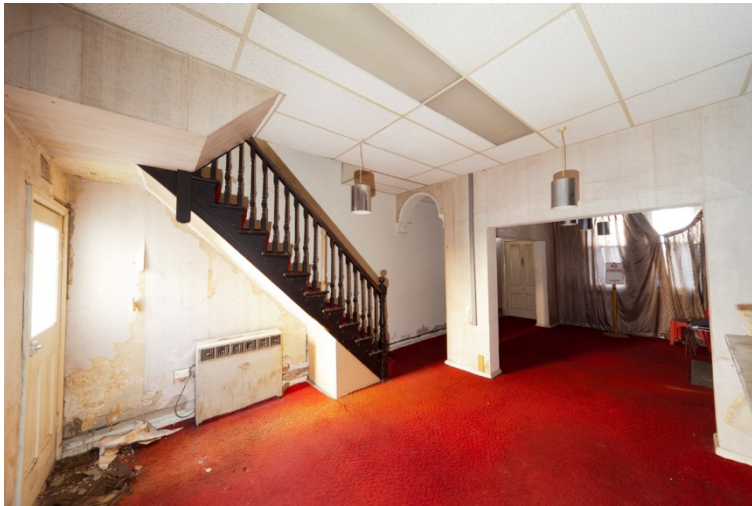
Figure 83. The interior spaces have undergone significant alteration to provide office-style accommodation. The lower level has been altered by removal of the wall dividing the main room and the hall. Circa 1970s acoustic panel ceilings have been installed throughout the terrace. Architraves to internal doors and skirting boards are modern, floors are carpeted, and walls are generally wallpapered. There is evidence of original plaster ceilings above the acoustic panel ceilings. Internal doors are modern hollow-core doors. The interior also features circa 1970s shelving and light fittings. (Photo: Nat Hughes)

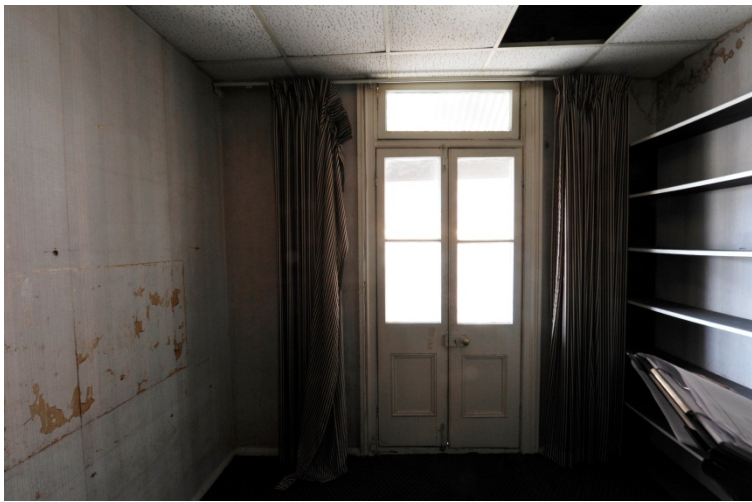
Figure 84. The fabric of the upper level has been similarly altered to provide late 20th century office space, although the arrangement of rooms is more consistent with the original. The fabric is showing signs of significant neglect and poor quality building work in the past.

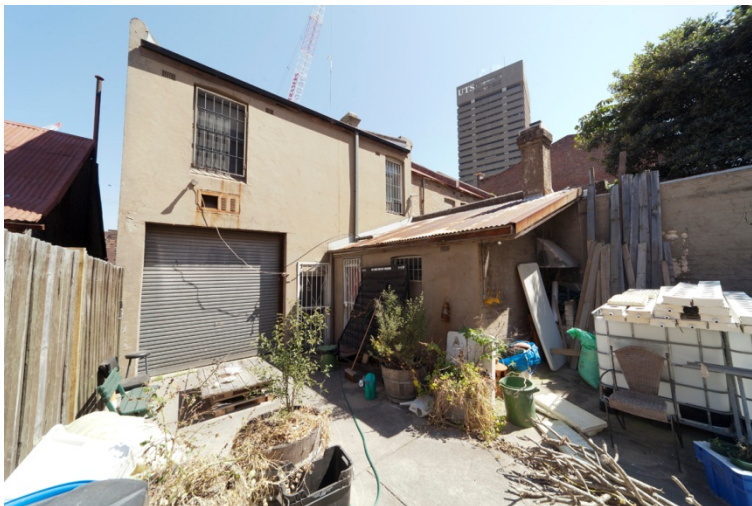
Figure 85. The rear elevation has been cement rendered. Its elevation is simple, with two windows to the upper level and a small skillion roofed extension wing. Two skylights have been inserted in the main roof pitch. Evidence of recent modification includes the opening created to install an air-conditioning unit at some time in the past.

The drive-through carport is enclosed by a steel roller shutter to this elevation as well.

Beyond the rear wing, the rear yard (which originally contained separate outbuildings, now demolished) is devoid of vegetation. (Photo: Nat Hughes)

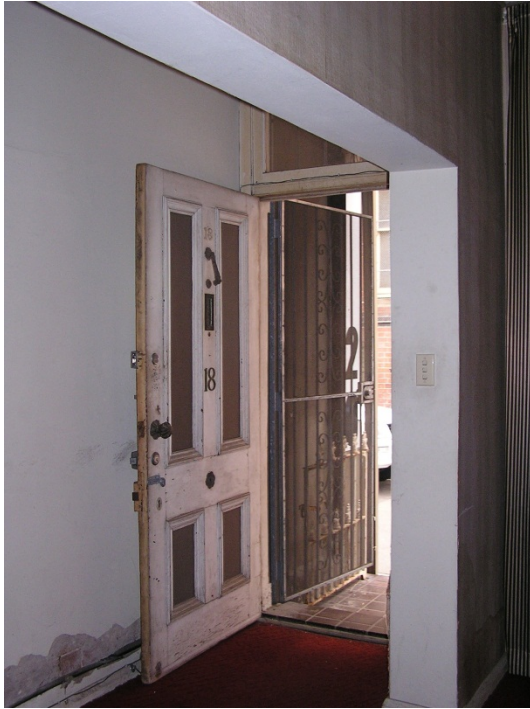
Figure 86. (Left) Looking toward the front door showing one of the larger openings that have been cut into the internal walls

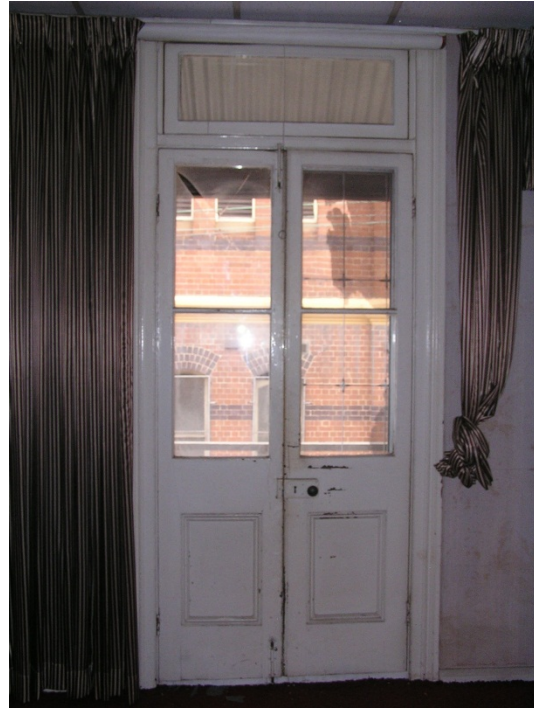
Figure 87. (Right) Looking to the veranda doors on the upper level. These doors are substantially intact, with original joinery including French doors to balcony and front door with original hardware.

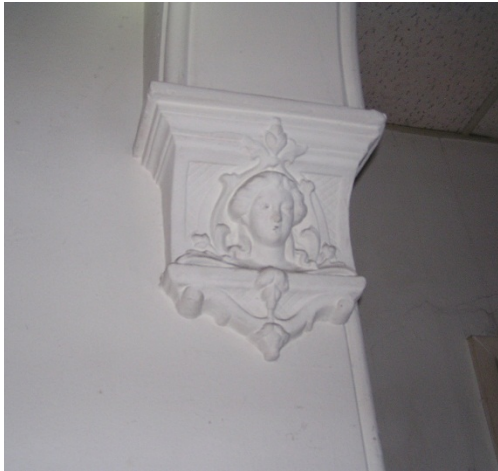
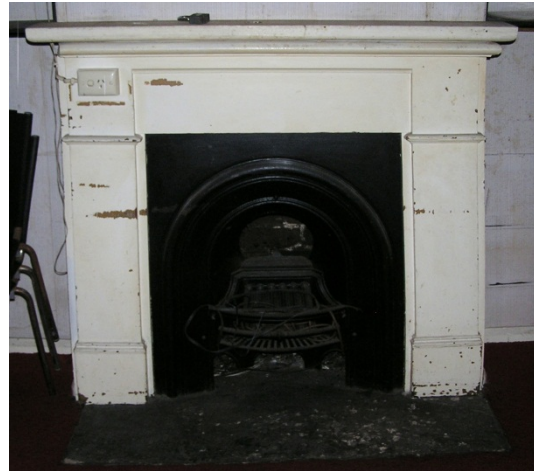
Figure 88. Notwithstanding the major intervention to much of the significant internal fabric of this property, some original elements, including plaster detailing to the hallway arches on the upper level and the simple hearths and mantelpieces, reflecting the modest means of the first owner.

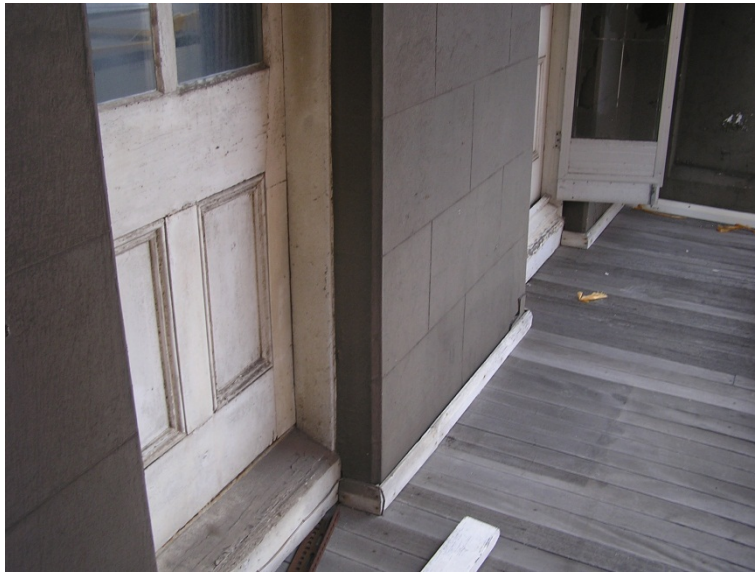
Figure 89. The floor to the verandah on the upper level is hardwood and is in very good condition, suggesting that it may have been replaced, or that the verandah was infilled for at least part of the time since its construction.

| Element | Comment |
|---|---|
| Verandas | The veranda should not be enclosed. The existing roller shutter does not need to be removed. Deteriorated veranda floorboards, particularly to the upper level, should be replaced. |

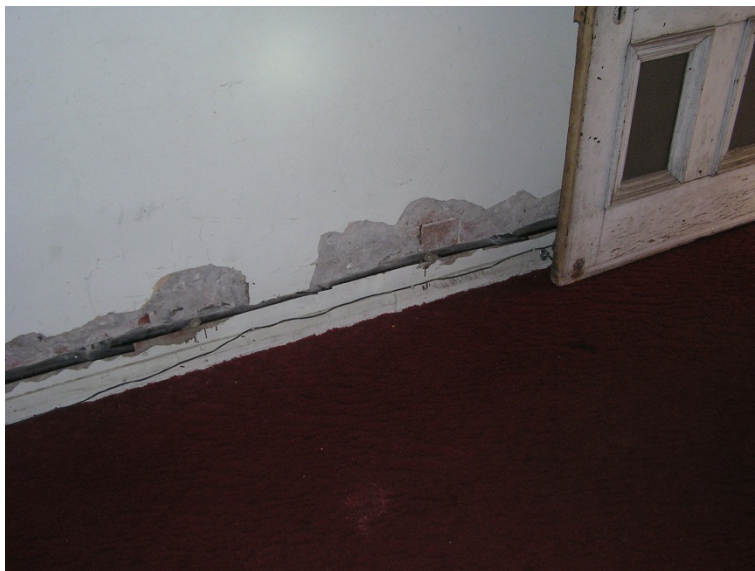
Figure 90. More recent damp proof course was inserted very crudely with significant damage to the original fabric (prior to the current ownership of the site).
