## REVIEW OF HERITAGE SIGNIFICANCE OF 22-28 KENSINGTON STREET

## CONTRIBUTORY FABRIC: 22-28 KENSINGTON STREET

## MAJOR BUILDING MAINTENANCE AND REPAIR REQUIREMENTS FOR 22-28 KENSINGTON STREET

#### 4.10 TERRACE AT 30-32 KENSINGTON STREET (C.1847)

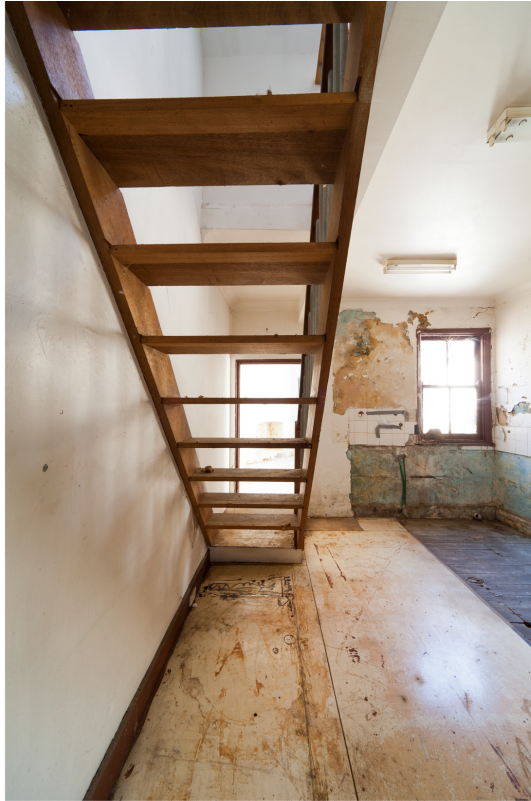
Figure 113. No.26: The ladder-like stair has been replaced by a wider and easier to negotiate stair.  
(Photo Nat Hughes)

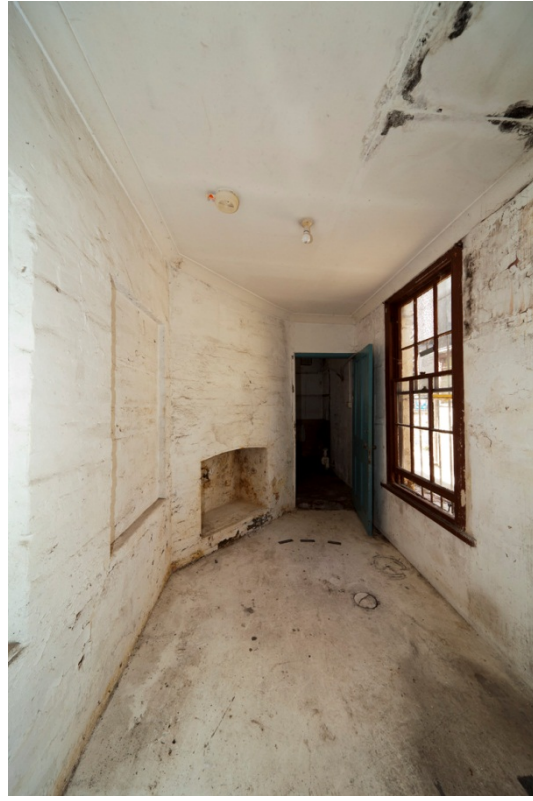
Figure 114. No.26 The original kitchen space has been stripped but its fabric is intact. Note water damage to ceiling panels.  
(Photo Nat Hughes)

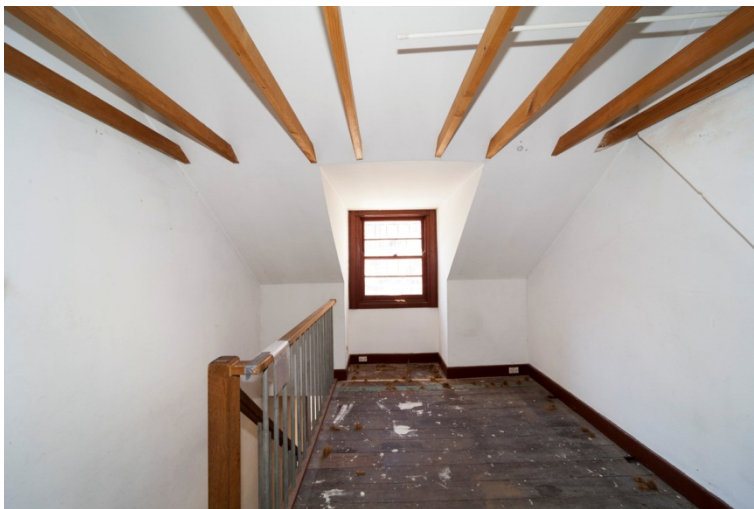
Figure 115. No.26 the attic space has also been refurbished with the ceiling beams retained as a feature. The new window is wider than the original, leading to impact on the rhythmical qualities of the roofscape of the group.  
(Photo Nat Hughes)

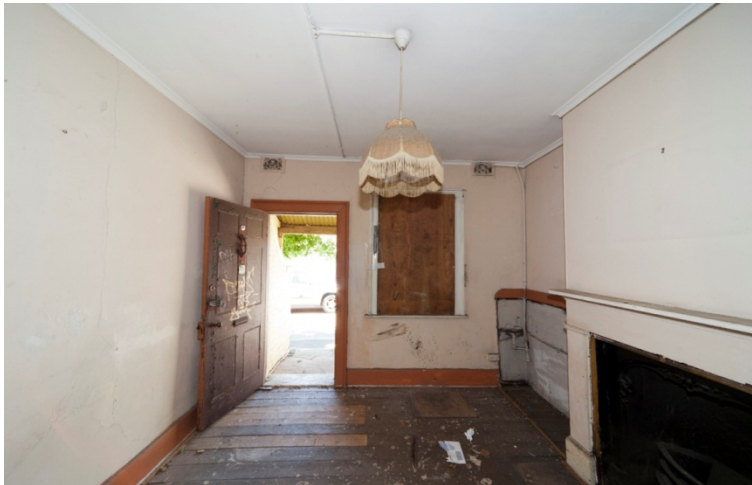
Figure 117. No.28: main room. Note  
electrical conduit to protect wiring and  
the simple and original mantle over the  
fireplace.  
(Photo Nat Hughes)

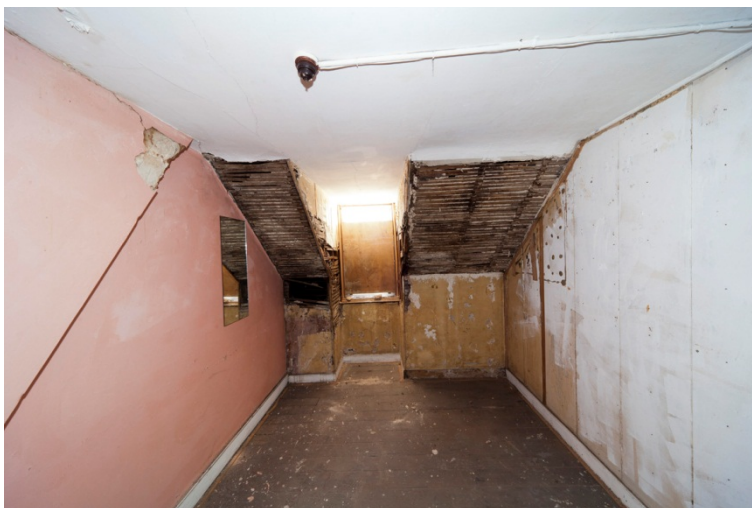
Figure 118. No.28: Attic room showing  
its original configuration. The plaster  
to the underside of the main roof plane  
has been removed/deteriorated.  
(Photo Nat Hughes)

| Element | Comment |
|---|---|
| Ceilings | Many of the internal lath and plaster ceilings have collapsed or show significant deterioration. These need to be repaired with like materials. All ceilings should be inspected for soundness and repaired or replaced as necessary. |

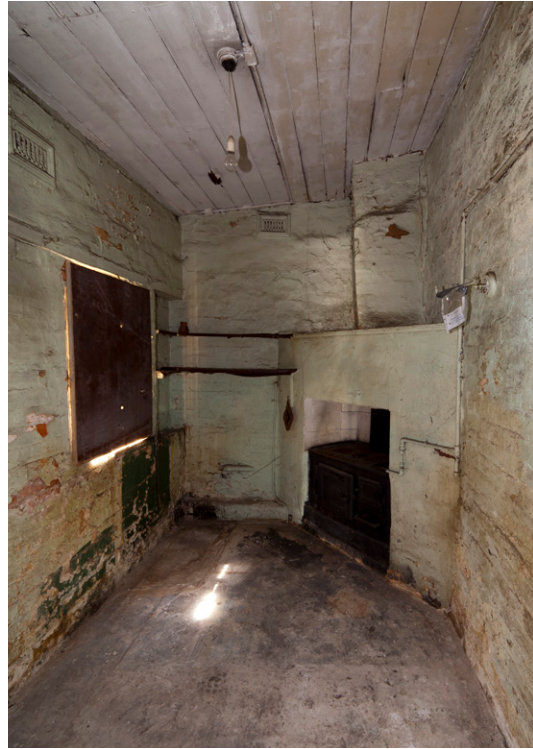
Figure 120. No.28: The original cooking range has also survived in the fireplace. Wall finishes are peeling, but the underlying layers of paint can be readily read and interpreted. (Photo Nat Hughes)

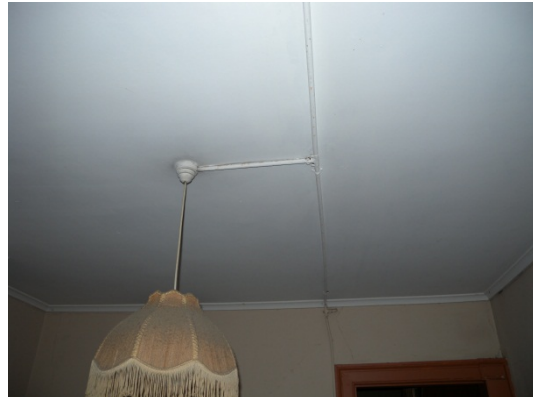
Figure 124. No.28:  
The electric wiring is laid in exposed conduits.

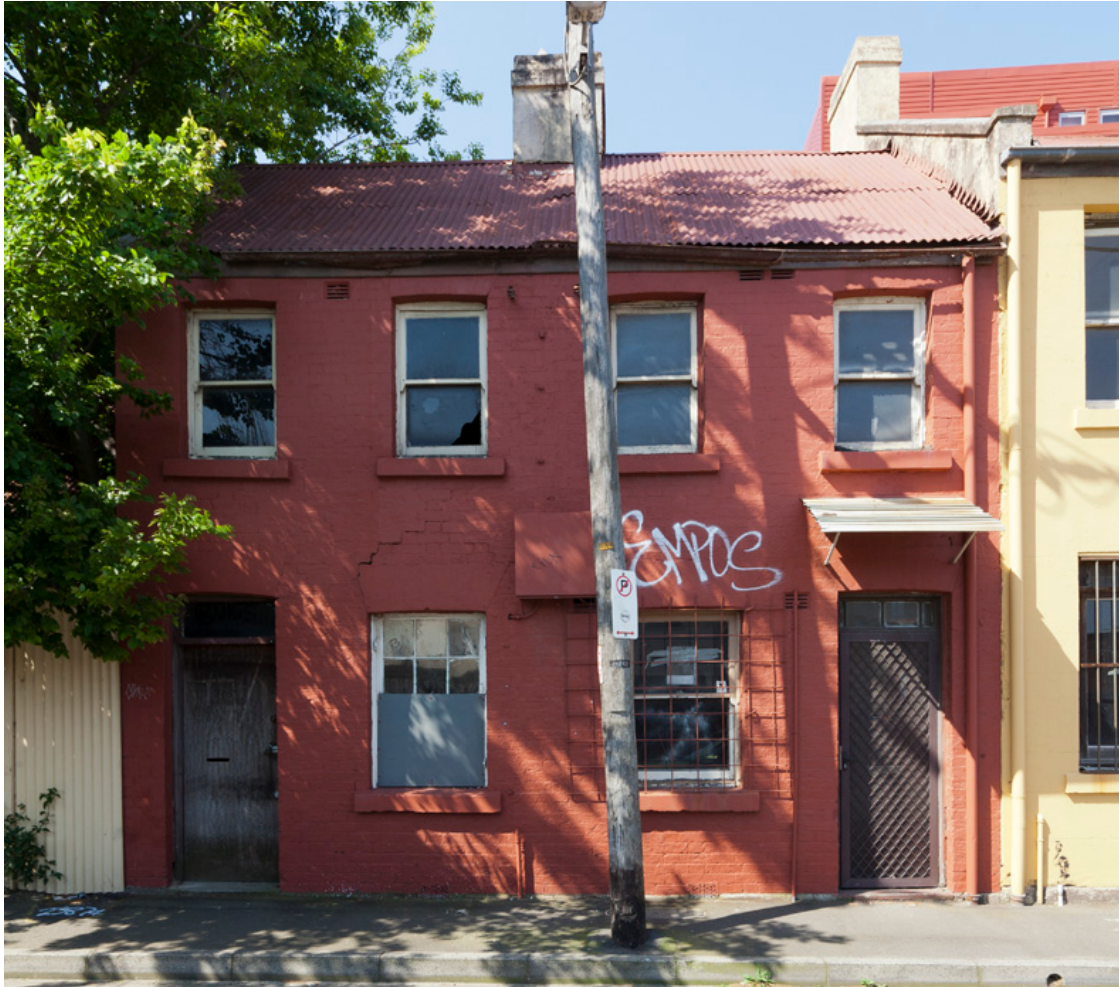
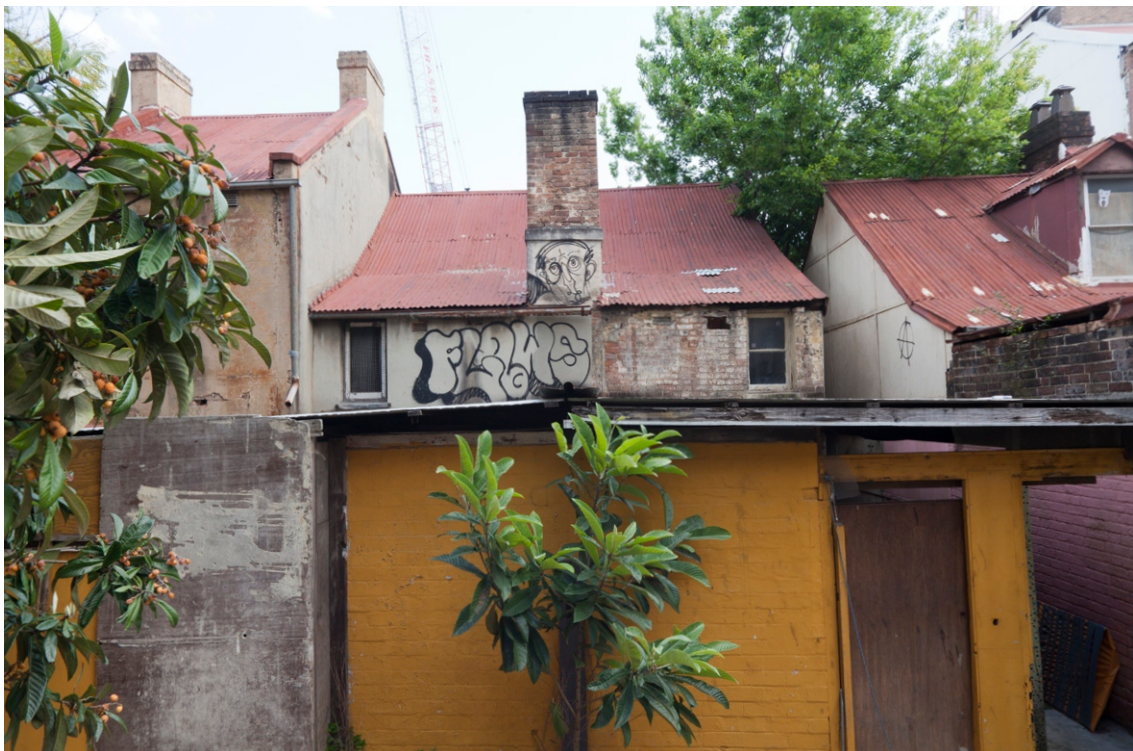
Each ground floor façade features a modern front door with an early multi-paned fanlight above and a single timber framed double hung window. No. 30 retains a Victorian Georgian style timber-framed double-hung window with 6 panes to each sash but the front window to No. 32 is later. There is evidence for timber shutters on the original ground floor window to No. 30. The first floor façade to each terrace features later timber-framed double hung windows. There is some cracking to brickwork above the window to 30 in particular.

The façade to No. 32 has a modern metal awning over the front door and a large electricity meter box has been installed on the façade at the juncture of the two terraces.
