## REVIEW OF THE HERITAGE SIGNIFICANCE OF 30-32 KENSINGTON STREET

## CONTRIBUTORY FABRIC: 30-32 KENSINGTON STREET

## MAJOR BUILDING MAINTENANCE AND REPAIR REQUIREMENTS FOR 30-32 KENSINGTON STREET

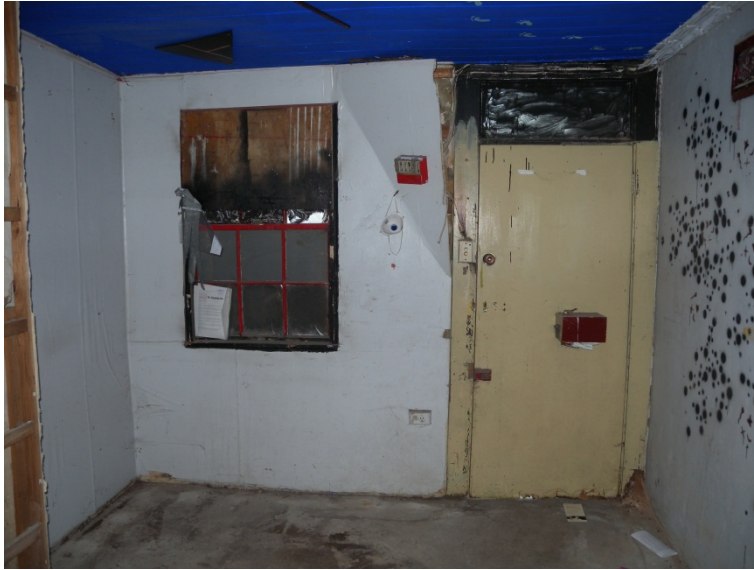
Figure 125. 30 Kensington Street.  
Rear ground floor room. Note the early window .

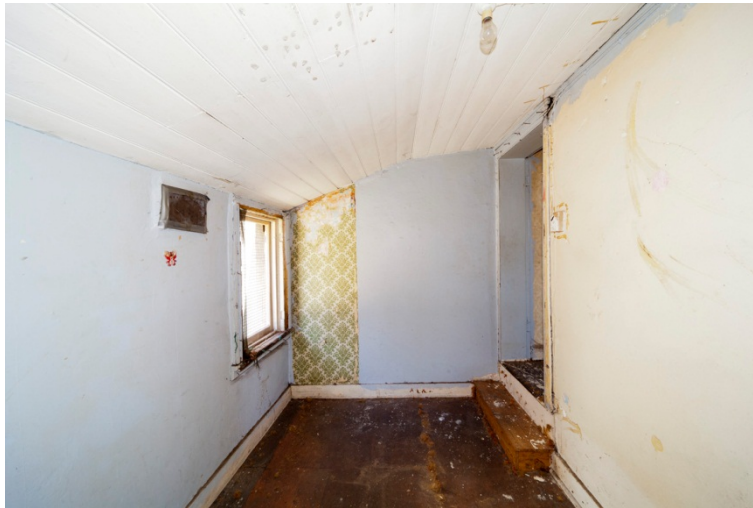
Figure 135. 32 Kensington Street .  
The upper level of this terrace in particular is substantially intact.  
(photo: Nat Hughes)

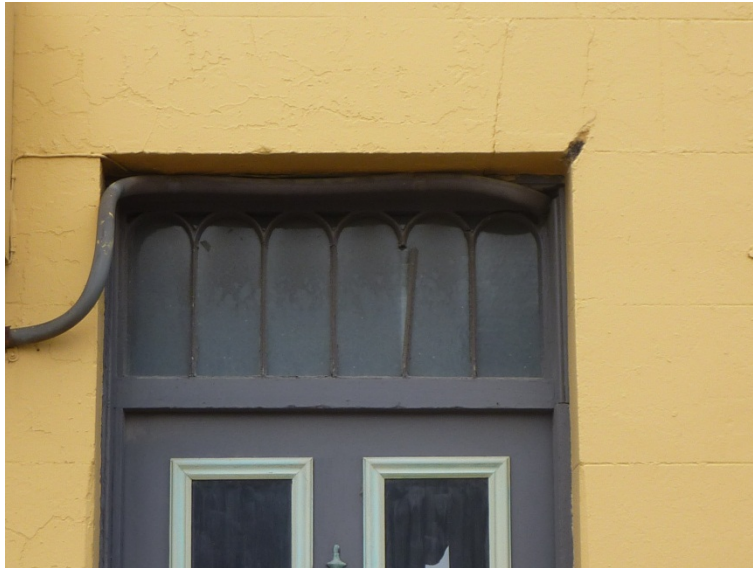
Figure 137. 34 Kensington Street  
Delicate arched detailing has been applied to the fanlight glazing.

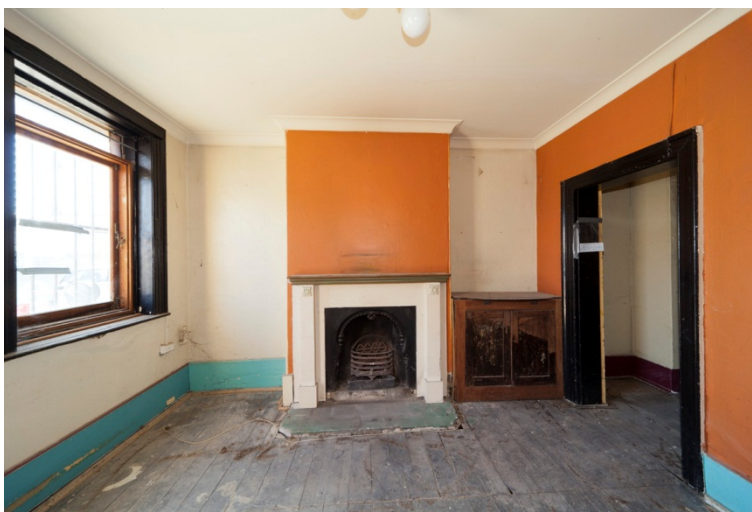
Figure 140. 34 Kensington Street  
Main front room. The small cupboard  
near the fireplace is an original  
element, with the same found in the  
matching half at 36 Kensington Street.  
(Photo: Nat Hughes)

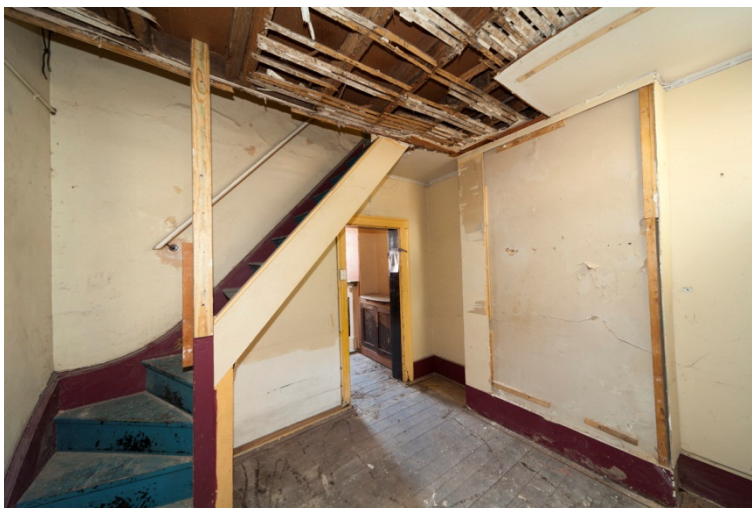
Figure 141. 34 Kensington Street  
Back (dining) room. This room is in  
more original condition, with significant  
damage to the lath and plaster ceilings  
and other elements.  
(Photo: Nat Hughes)

| Element | Comment |
|---|---|
| Ceilings | Many of the internal lath and plaster ceilings have collapsed or show significant deterioration. These need to be repaired with like materials. All ceilings should be inspected for soundness and repaired or replaced as |
