## REVIEW OF HERITAGE SIGNIFICANCE OF 34-36 KENSINGTON STREET

### CONTRIBUTORY FABRIC: 34-36 KENSINGTON STREET

## MAJOR BUILDING MAINTENANCE AND REPAIR REQUIREMENTS FOR 34-36 KENSINGTON STREET

#### 4.12 TERRACE AT 38 KENSINGTON STREET (C.1856-1860)

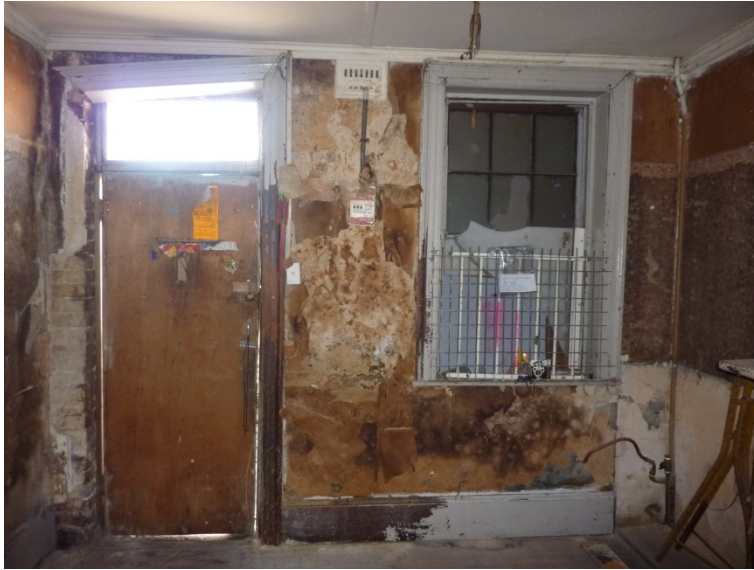
Figure 145. 36 Kensington Street.  
The street wall shows evidence of significant deterioration, although elements such as the original sash window joinery, have survived.  
(Photo: Nat Hughes)

| Element | Comment |
|---|---|
| Walls | Exterior brickwork is largely intact, particularly to the street elevation and the main walls of the rear. Water ingress is affecting integrity of brickwork to the Kensington Street façade in particular. The cause of the damage should be confirmed and repaired to prevent further deterioration; and damaged fabric repaired using matching materials and techniques. Interior walls should not be removed to create larger spaces. The intimacy of building scale should be preserved. Any repairs or alterations should be made using lime mortar. No cement or impervious materials should be used on any element of the fabric.<br>Evidence at the upper level of early cantilevered verandah with access doors (now infilled). |

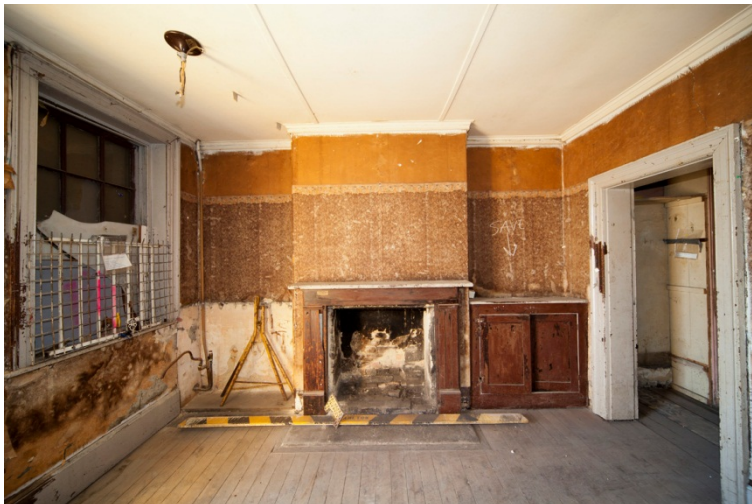
Figure 146. 36 Kensington Street  
This terrace has retained its early 20<sup>th</sup> Century decoration with patterned wallpaper to picture rail height finished by a decorative border, and then a toned pattern above. The original mantle and an early side cupboard have also survived. The ceilings have been replaced.  
(Photo: Nat Hughes)

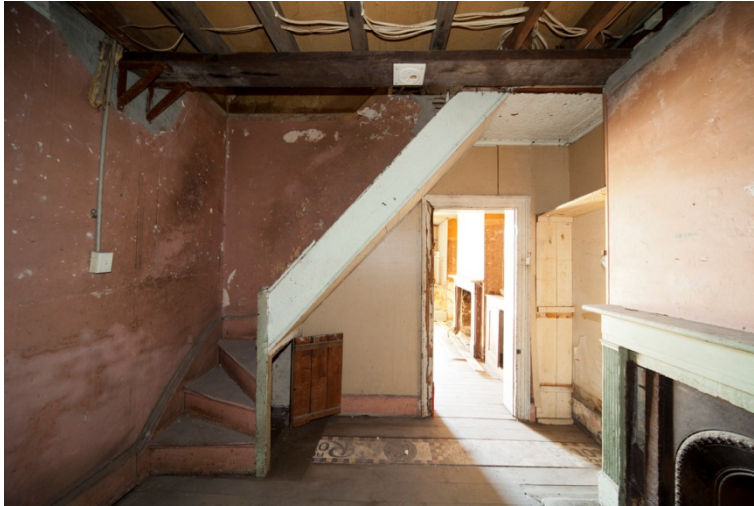
Figure 148. 36 Kensington Street  
The stair to the bedroom floor is accessed from this room. Joinery to this back room is simpler, although elements such as the fire grate and timber mantle have survived in both rooms. The ceiling and cornices have also been removed from this room.  
(Photo: Nat Hughes)

| Element | Comment |
|---|---|
| Ceilings | Many of the internal lath and plaster ceilings have collapsed or show significant deterioration. These need to be repaired with like materials. All ceilings should be inspected for soundness and repaired or replaced as necessary. |

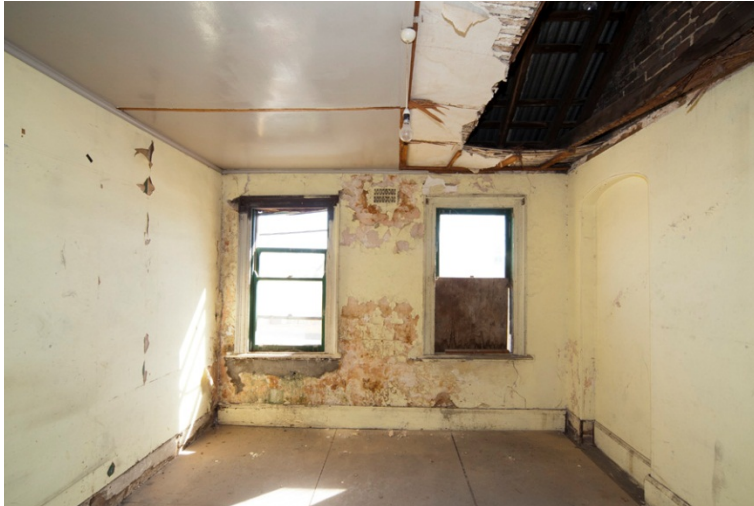
Figure 151. 36 Kensington Street  
Upstairs bedroom. Note deterioration  
to ceiling and evidence of water  
penetration to the front wall near the  
windows.

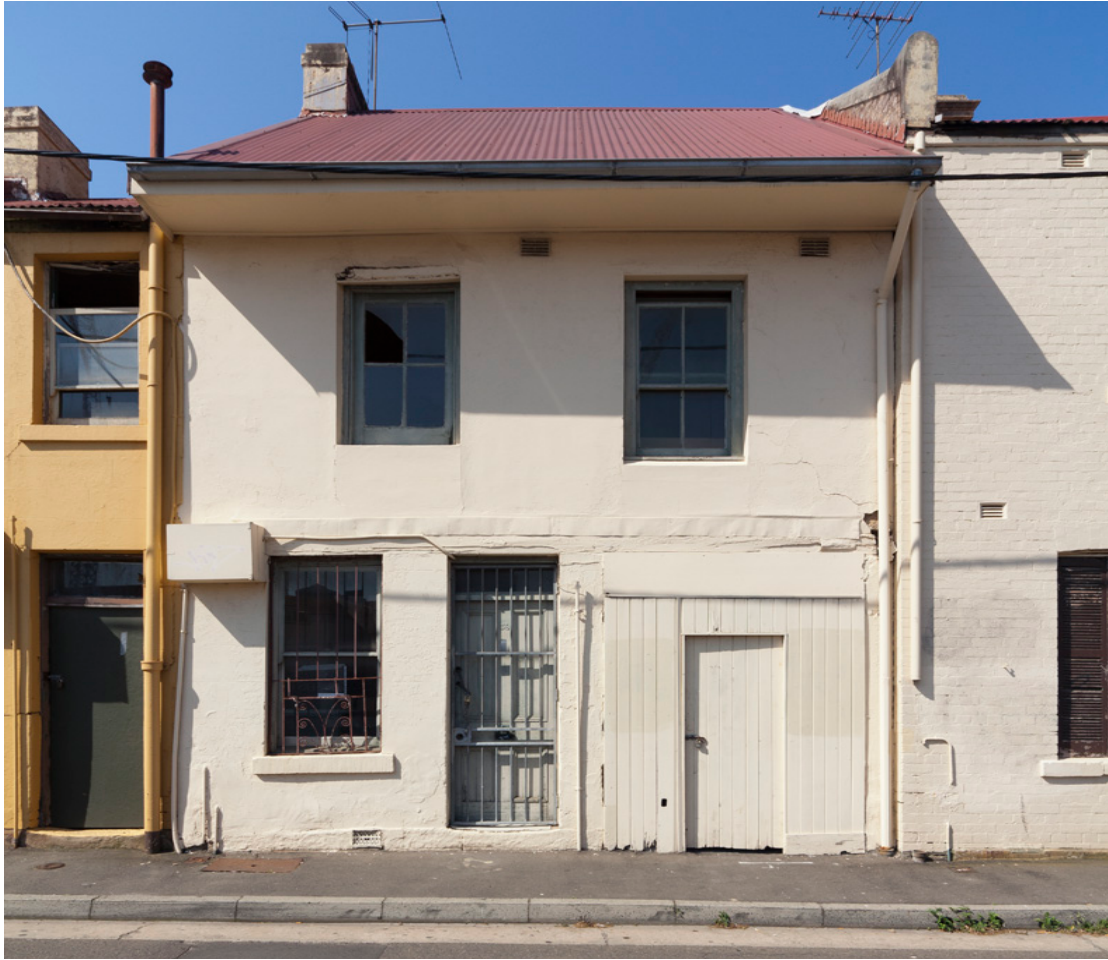
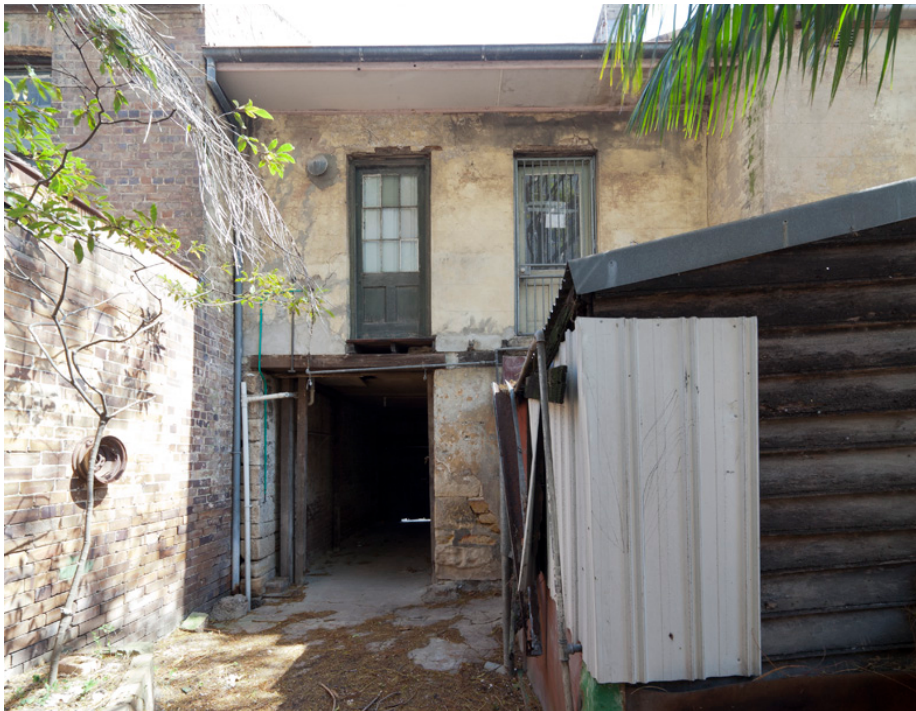
Walls have been rendered and ruled, and there is evidence of cracking above some of the windows, particularly the northern window facing Kensington Street. There is also evidence of damage to brickwork on the eastern (rear) elevation. A cantilevered verandah also existed on the rear elevation, the two doors remain in situ. The roof over this verandah also appears to have been altered. The original stone work can be seen on the rear wall where render is failing.

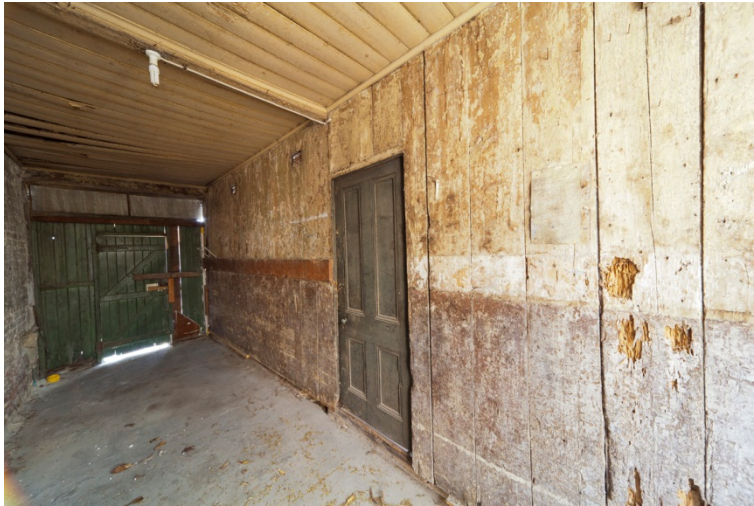
Figure 155. Carriage drive-through the building: The northern wall of the passage carriage passage retains its original wide vertical timber slabs (termite damaged). Ceiling is timber tongue and groove boarding. A timber 4-panel door provides direct access to the dwelling. (photo Nat Hughes)

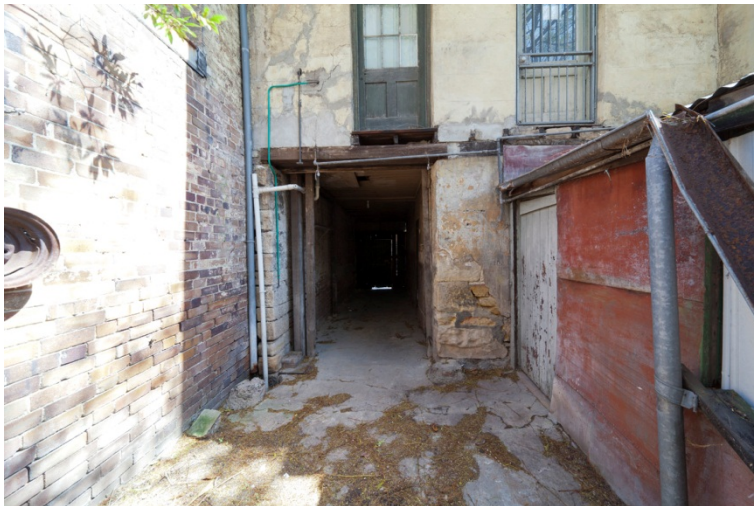
Figure 156. Rear of building showing the access to the street. No evidence of the stable described in the Sands Directory remains.

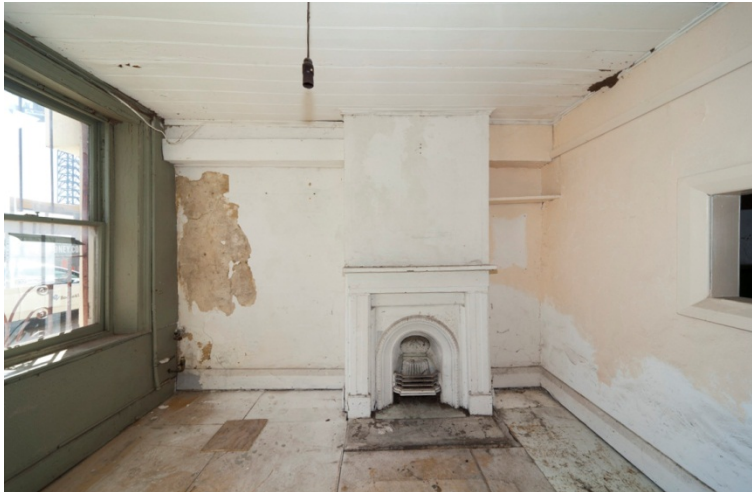
Figure 158. Ground floor: painted mid-Victorian timber mantelpiece with cast iron fireplace to front room chimney breast, timber tongue and groove board ceiling. The second room on the upper level also has a pressed-metal ceiling.

Timber tongue and groove floors, damaged in sections. Internal doors 4-panel timber Victorian period.

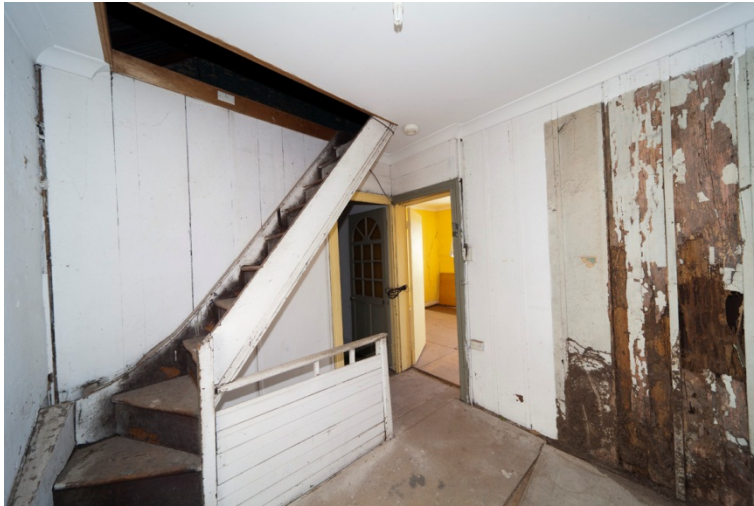
Figure 161. The stair continues from the first floor. Note the termite damage to the wide timber wall panels. (photo Nat Hughes)

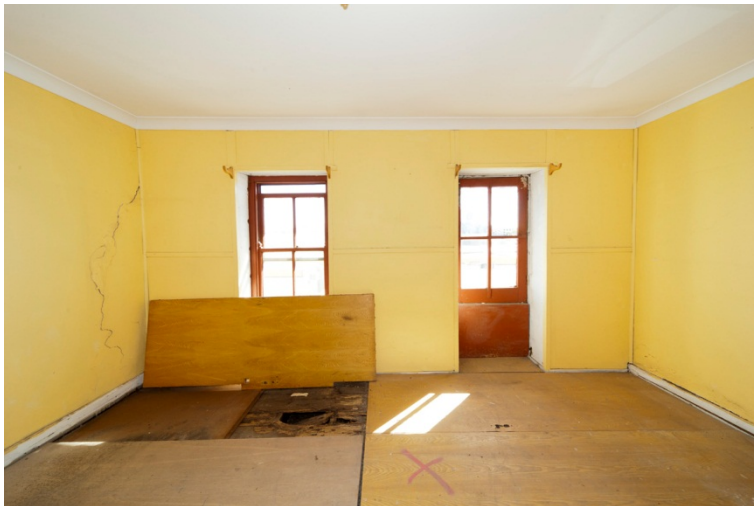
Figure 162. Main upper level room. Note the full-length opening to the window on the right, suggesting that it was formerly a door to a verandah. The window on the left has evidence of an earlier window seat in the bay.

Note also the significant damage to the floors caused by termites and the cracks to the southern wall of the building. Most other internal walls on this level have been re-built from fibro sheeting.

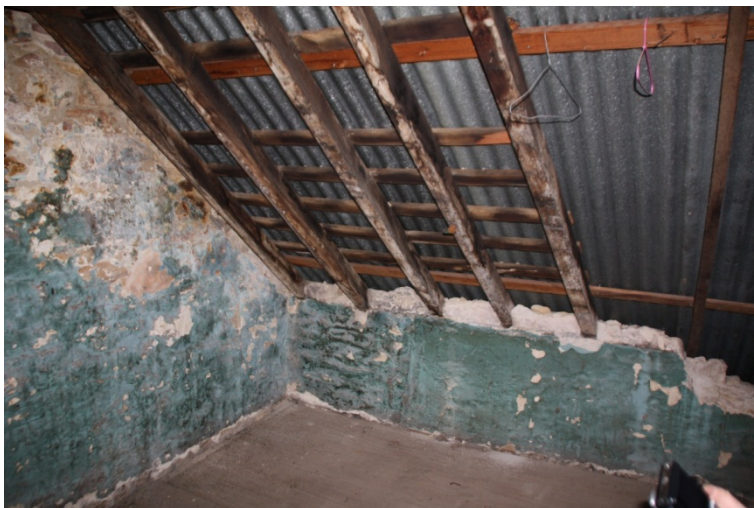
Figure 163. The roof framing has been partially replaced but evidence of the earlier dormer windows can still be seen in the open area to the right of this image.
