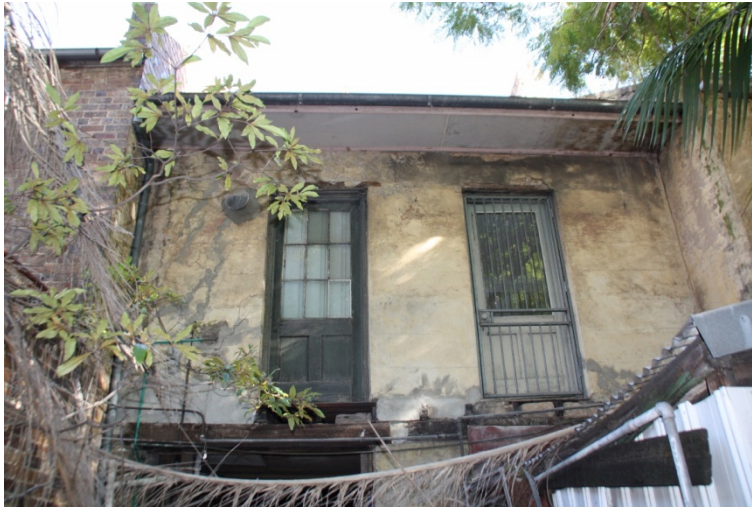
Figure 164. Detail of the upper level rear elevation. Note cut-off joists suggesting that the doors opened onto a rear balcony.

| Element | Comment |
|---|---|
| Verandas | The earlier verandahs have been removed, revealing joist holes and cut timbers where once attached. These need to be treated to ensure that they do not provide entry points for further insect invasion or rot. |

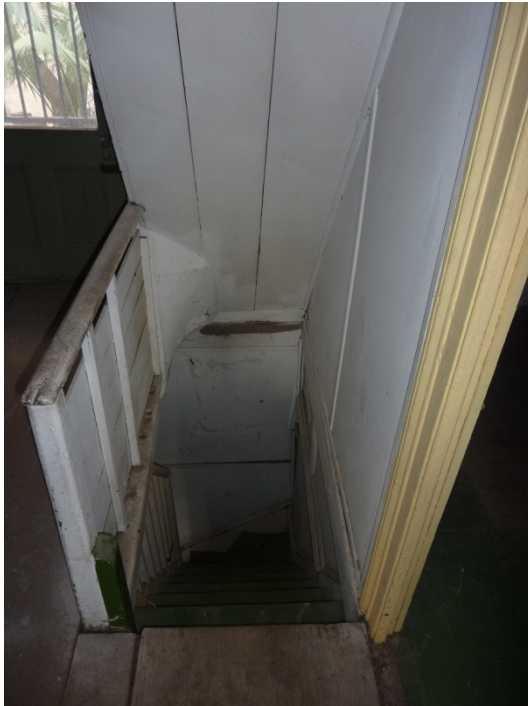
Figure 165. Looking from level 1 to the ground floor. The stairs are pitched steeply.

| Element | Comment |
|---|---|
| Staircases | The staircases are narrow with winders, and their structural condition was not tested. They are likely to also have suffered termite damage. The stairs will need to be made safe. |

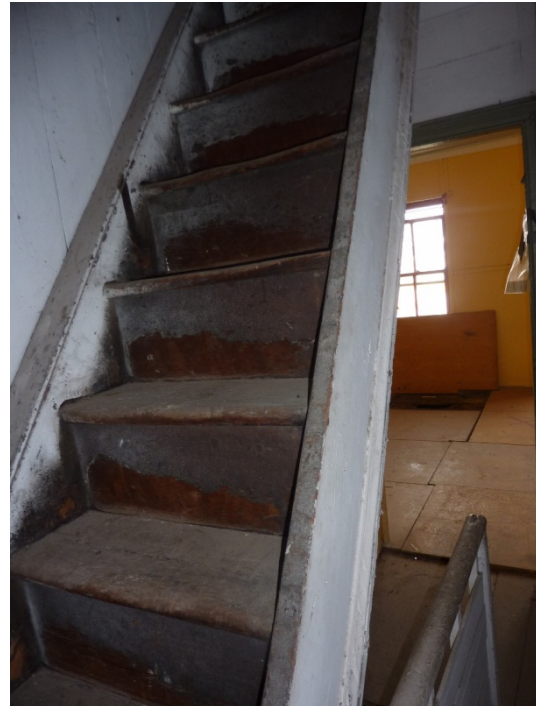
Figure 166. The stairs from the upper level to the former attic room are similarly pitched and do not have a handrail.

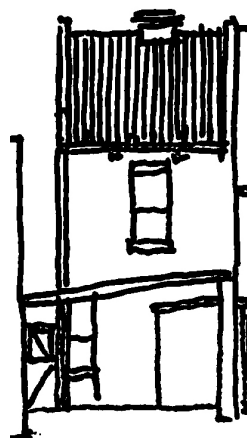
40 Kensington Street- rear (eastern) elevation

The rear walls are painted common brick. Some structural cracking is evident under the windows at ground level. The rear wing extension is partially clad in asbestos cement sheeting. The back door is a typical mid-late Victorian ledged and braced timber door.

| Element | Comment |
|---|---|
| Walls | Exterior brickwork is largely intact, particularly to the street elevation and the main walls of the rear. More detailed inspection is required and if damage is found it should be repaired using matching materials and techniques. Painted brickwork may be re-painted if required. The wall should not be rendered. |

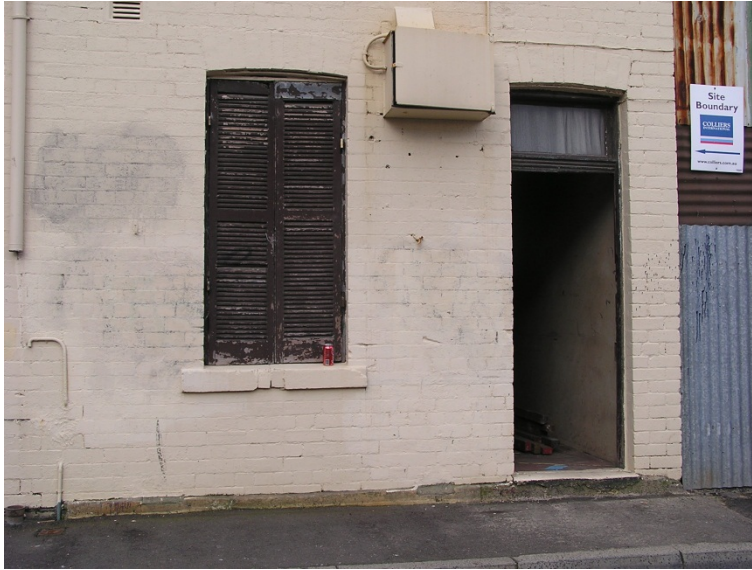
Figure 167. Detail of shutter to window at ground level.

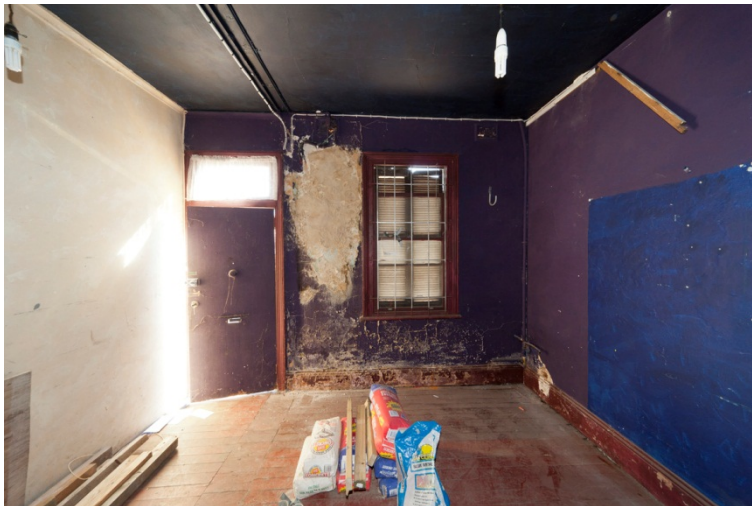
Figure 168. Looking to the front door. Note exposed electrical conduits. Most joinery is original.

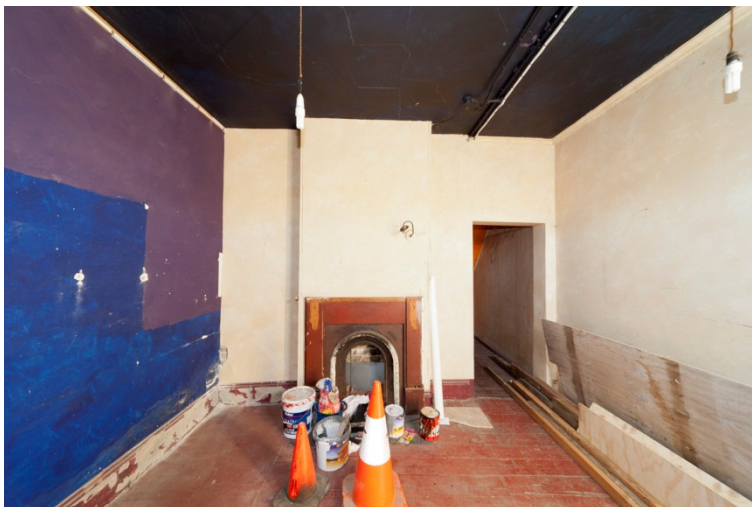
Figure 169. The fireplace is located on the internal wall and rises to the chimney on the ridgeline.

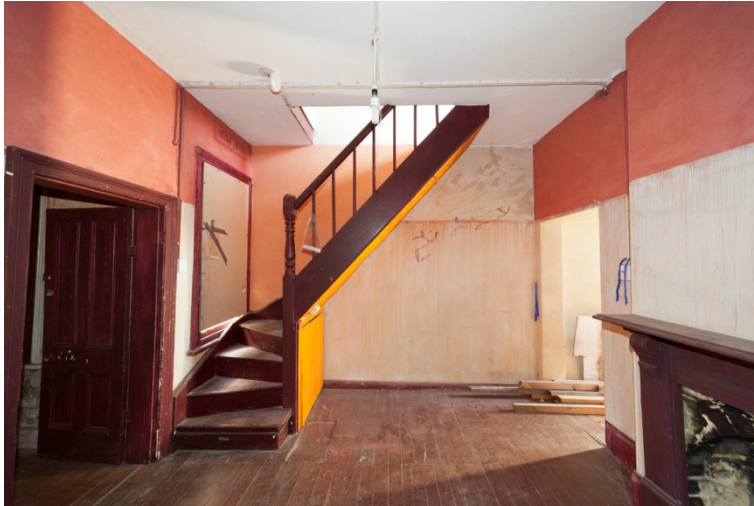
Figure 170. The rear room on the ground floor shares the central chimney. The winding stair is original.

| Element | Comment |
|---|---|
| Staircases | The staircase appears to be sound, but should be inspected regularly and repaired where necessary. |

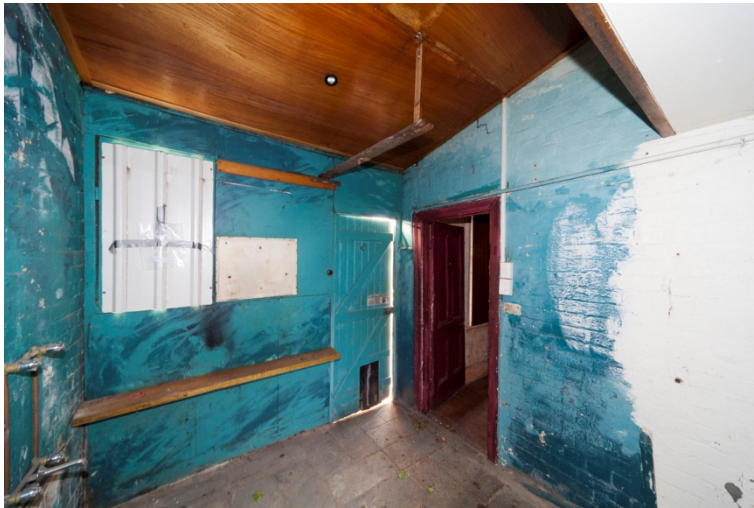
Figure 171. The former service room is under the skillion roofed wing. It has been partially re-lined, but the majority of fabric is original.

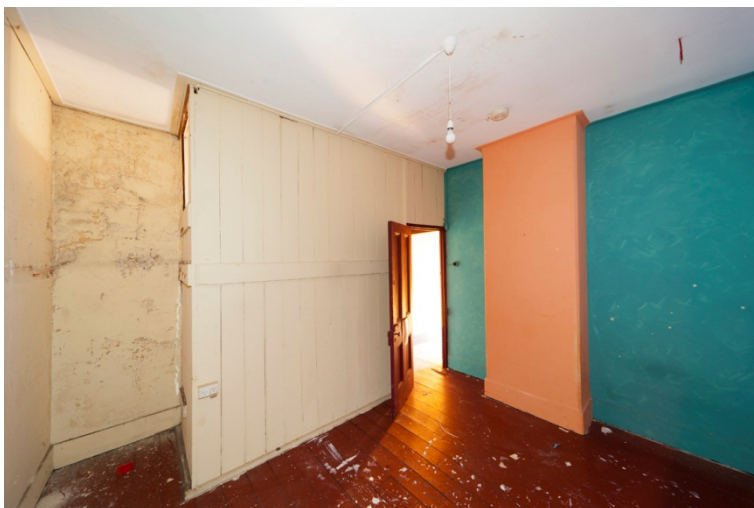
Figure 172. The rooms to the upper level have retained original timber dividing walls enclosing the stair. The alcove on the left is illuminated by borrowed light from a small window above the stair.

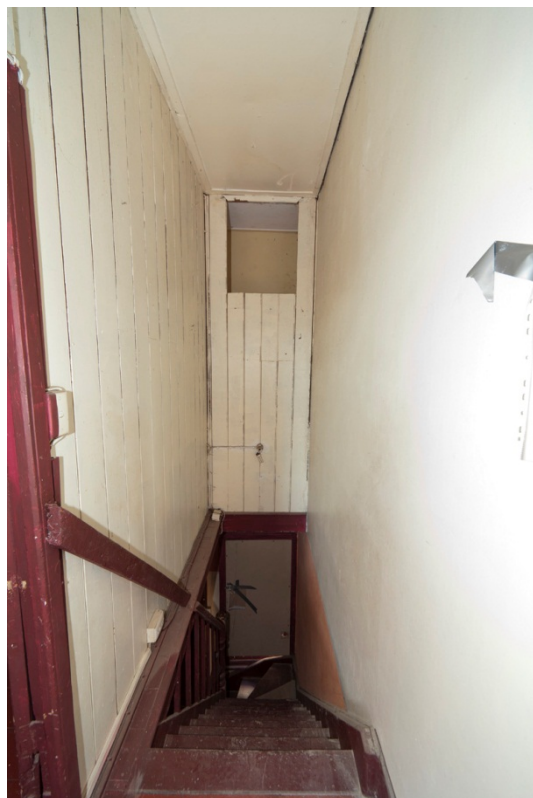
Figure 173. Detail of the stair showing the small opening to admit borrowed light to the alcove behind the stair

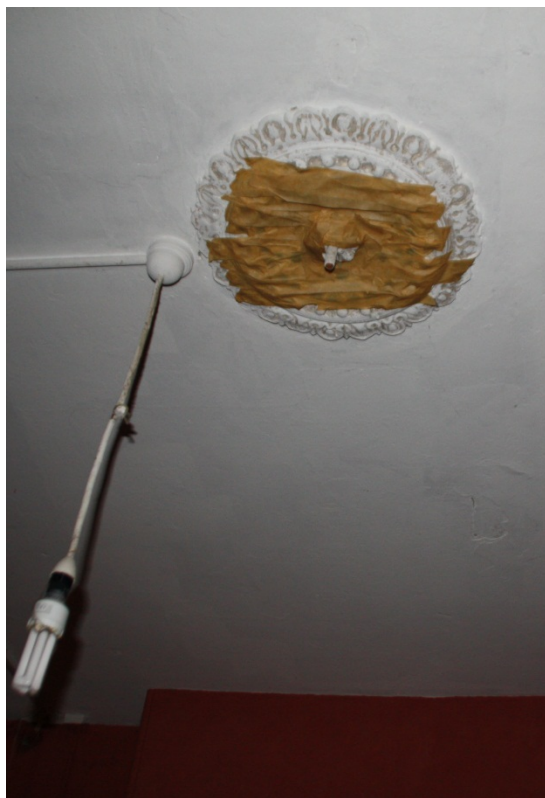
Figure 174. The original central gas fitting has survived in the centre of the ceiling, with adjacent electrical wiring and contemporary low-energy fitting.

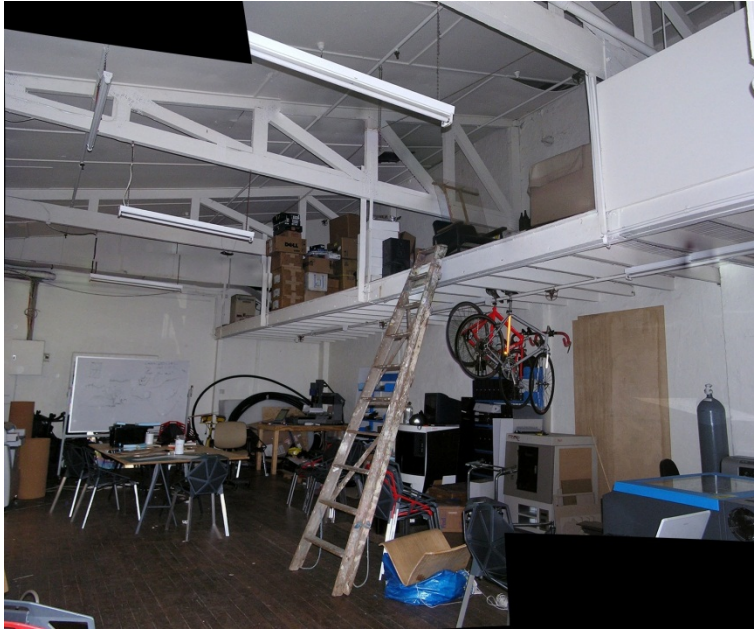
Figure 177. Main office area. The floors are seasoned Ironbark boards. The remainder of the fabric is nondescript in quality and heritage value.

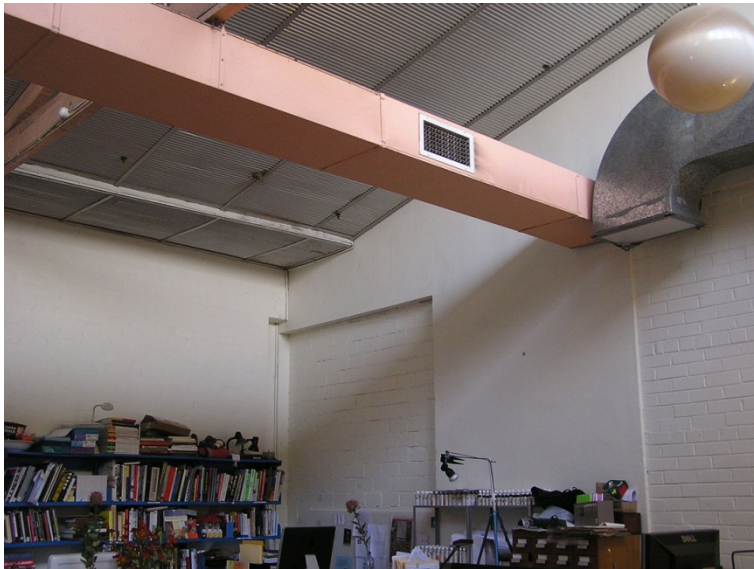
Figure 178. The northern area is of late, and even more basic construction, with rendered walls broken by brick-lined bays with a ripple-iron ceiling.

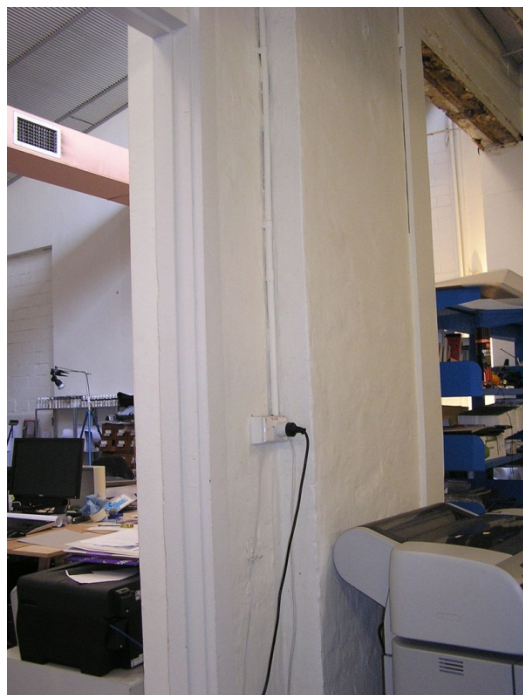
Figure 179. Detail of the wall dividing the northern and southern sections of the building. The wall was originally the external wall of the earlier form of the factory and has been extended through the window and door openings in each structural bay.

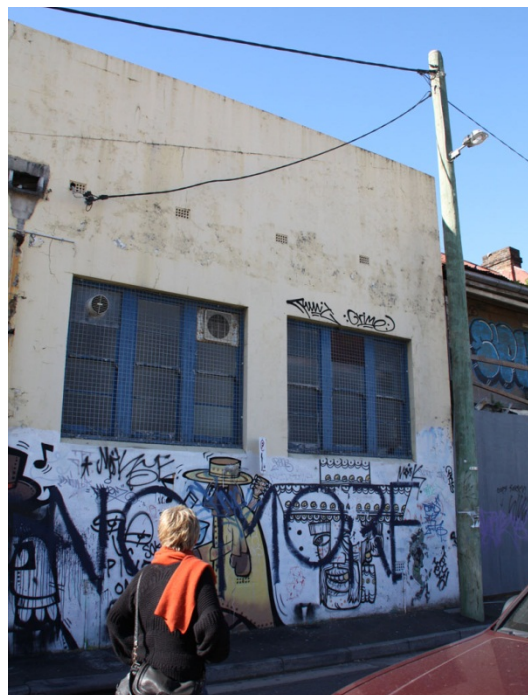
Figure 180. Detail of the earlier, southern part of the building. Its date of construction is not known with certainty, but the evidence of the fabric suggests the early 20<sup>th</sup> Century to the InterWar period.
