#### 4.15 TERRACE AT 46-48 KENSINGTON STREET (C.1858)

### FABRIC OF THE TERRACES AT 46-48 KENSINGTON STREET

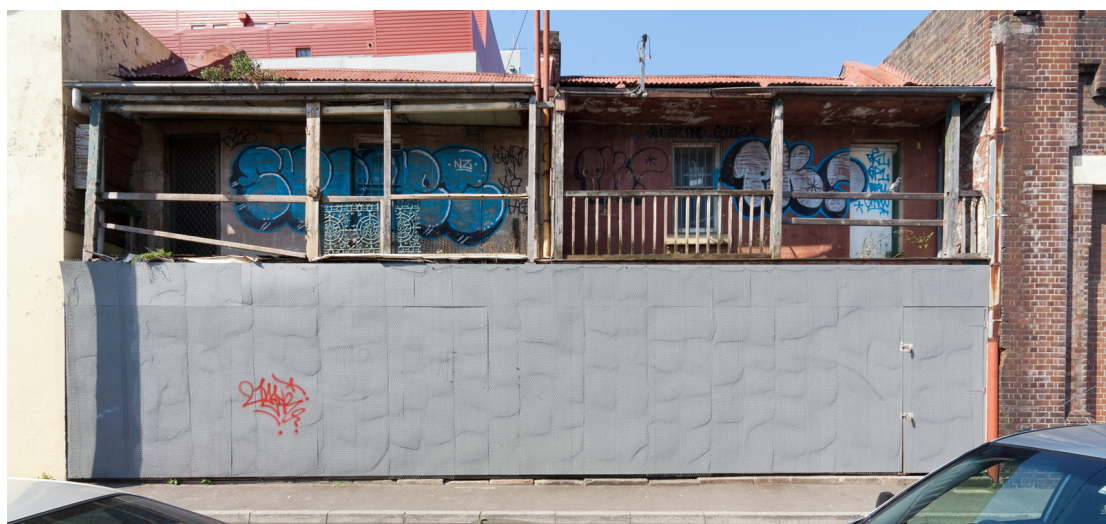
Figure 181. Following extensive vandalism to the exterior of the terrace, the façade is now protected by a solid hoarding. (Photo: Nat Hughes)

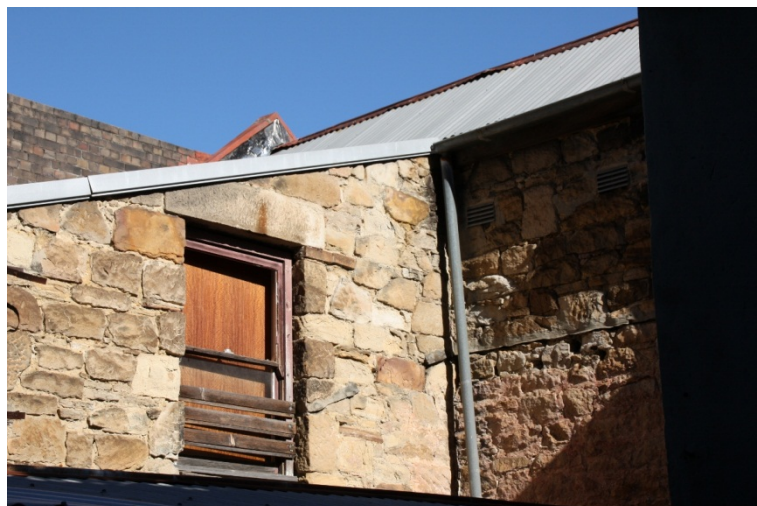
Figure 182. The stonework to the rear of the terraces is random-coursed.

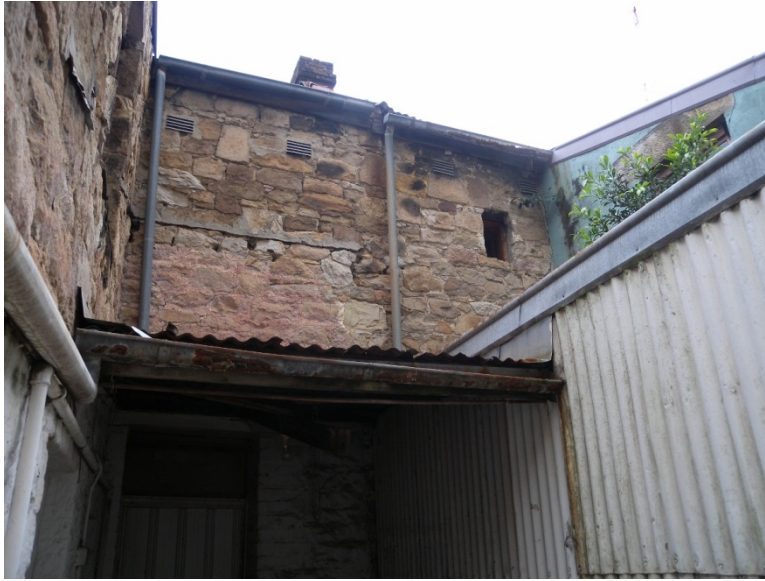
Figure 183. Detail of the central part of the rear wall between the two wings.

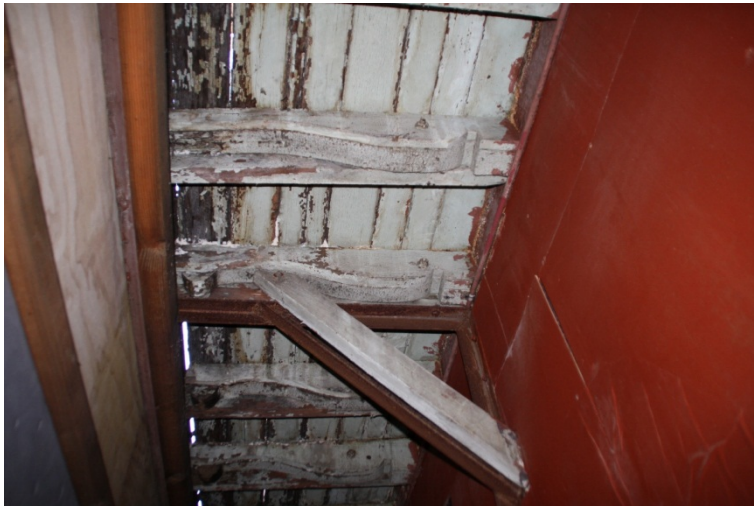
Each terrace has a suspended balcony supported by ogee-profile timber supports (extensions of the upper level joists) that have been reinforced more recently by paired timbers and angled steel brackets. The timber railed balcony detailing is evident in both the 1916 and 2000 photos of the property and is original.

Figure 184. Detail of underside of balcony brackets.

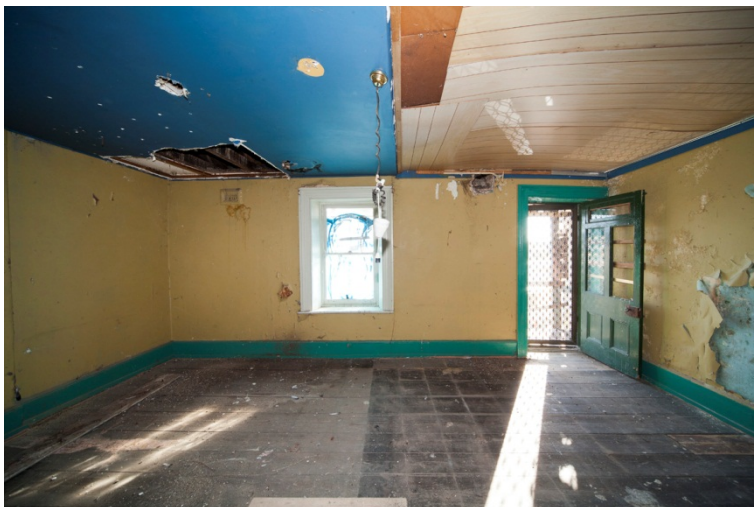
The double hung timber sash windows are set into deep lined recesses (the thickness determined by the sandstone block wall). Rot and termite damage is evident in places. Internal floors are in poor condition with areas patched with hardboard. There is also evidence of serious water ingress to the upper rooms of no.48.

Figure 185. 46 Kensington Street. First floor main front room. Note original joinery and evidence of damage to ceilings being covered by lightweight boarding. (photo Nat Hughes)

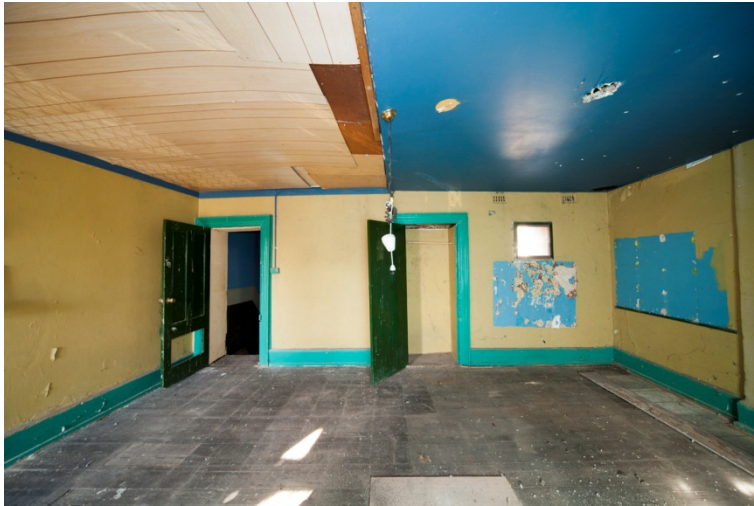
Figure 186. 46 Kensington Street.  
First floor looking to the rear  
rooms.  
(photo Nat Hughes)

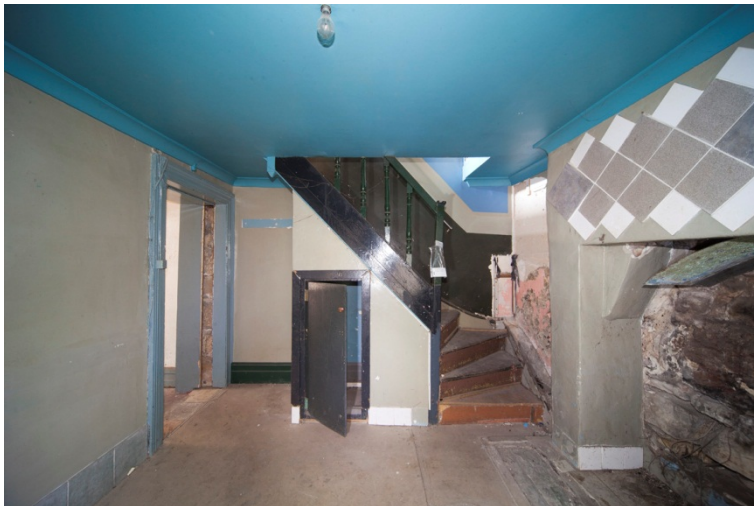
Figure 187. 46 Kensington Street.  
The middle room to this dwelling  
has been redecorated in a late  
20thC large glazed ceramic tile.  
Much of the original joinery has  
however been retained.  
(photo Nat Hughes)

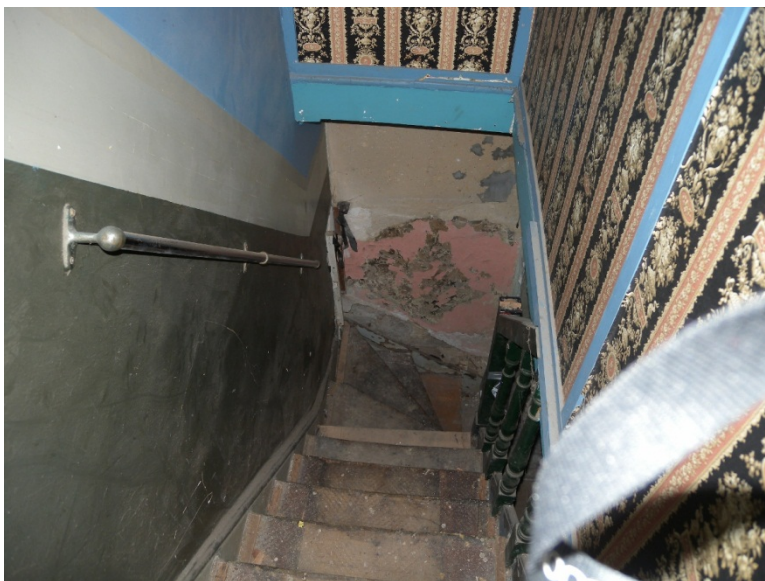
Figure 188. 46 Kensington Street.  
Detail of stair. Like all of the  
original terraces in the Kensington  
Street Precinct the stair is narrow  
and steep with winders. A steel  
handrail has been added.  
(photo Nat Hughes)
