Report on  
Hazardous Building Materials (HBM) Survey

Lot 100 DP1261496, Maitland Street, Muswellbrook,  
NSW

Prepared for  
Pacific Brook Christian School Ltd

Project 91601.01  
August 2020

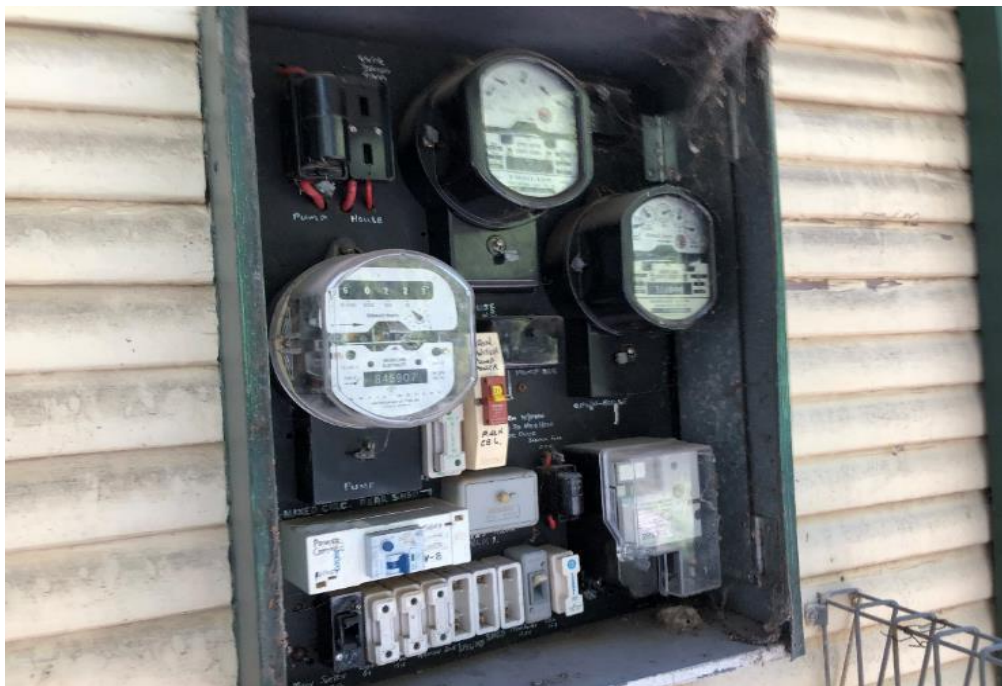
Photograph 2: Residential Dwelling, external south wall, electrical backing board, zelemite, asbestos (assumed).

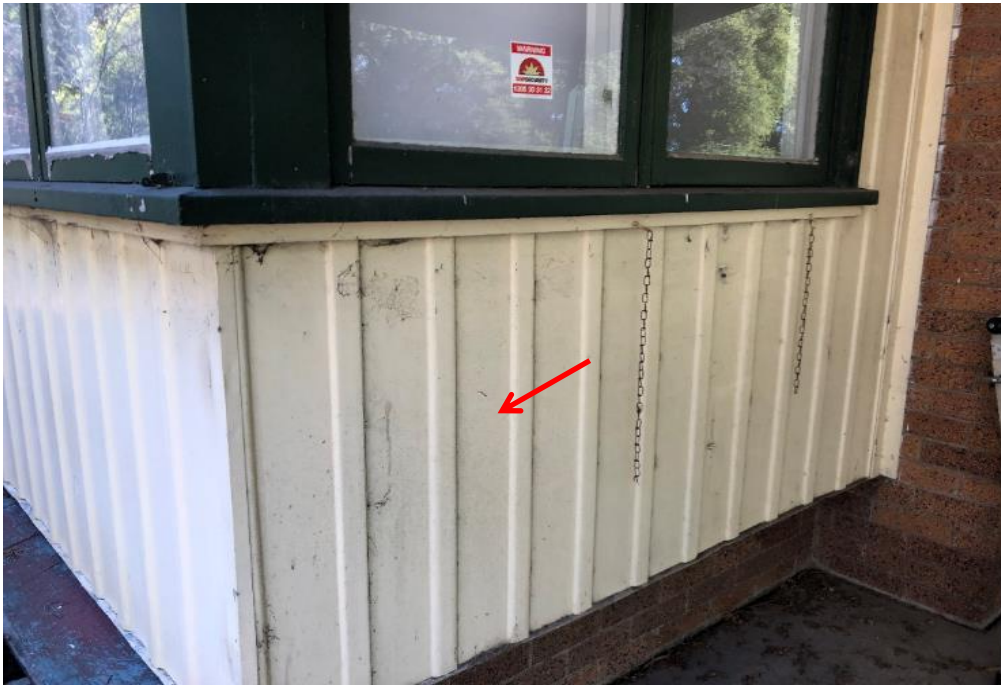
Photograph 3: Residential Dwelling, external , walls, fibre cement sheet, asbestos detected by analysis.

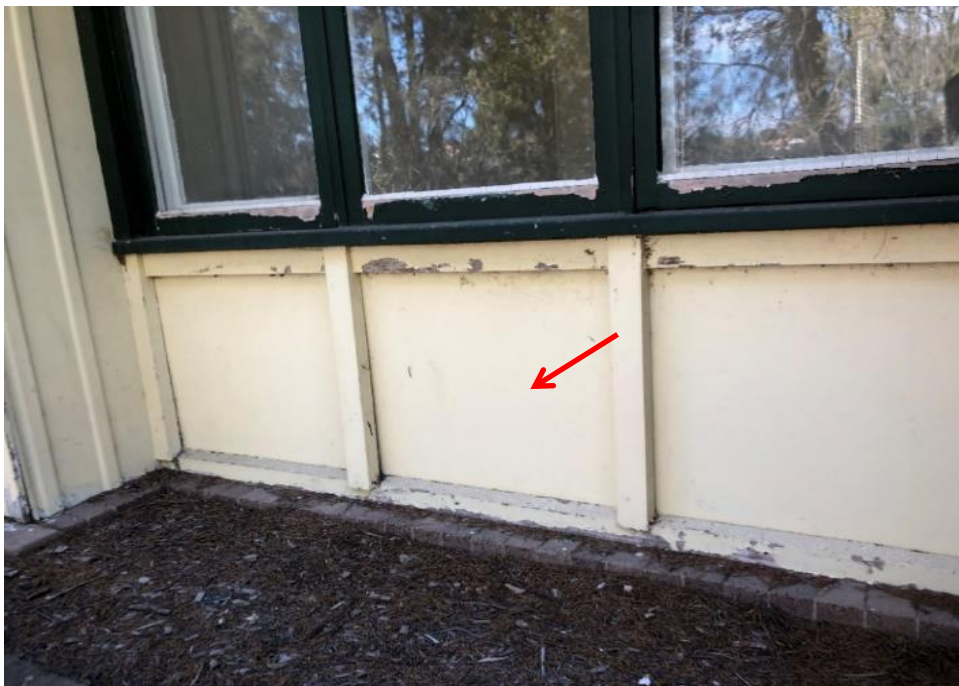
Photograph 4: Residential Dwelling, external, infill panel below windows, fibre cement sheet, asbestos detected by analysis.

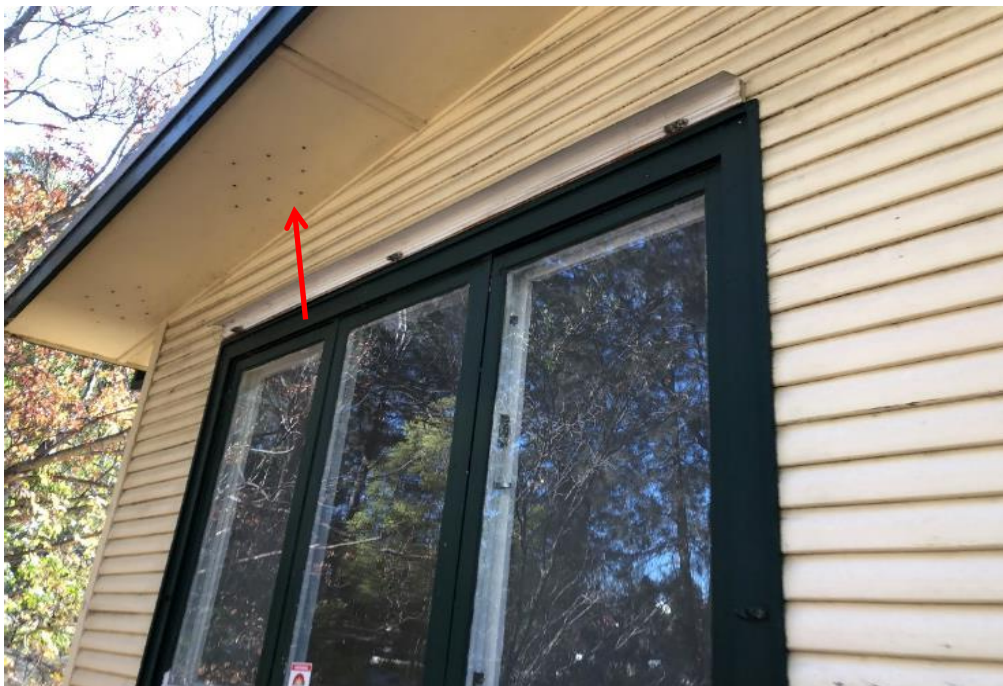
Photograph 5: Residential Dwelling, external, eaves, fibre cement sheet, asbestos detected by analysis.

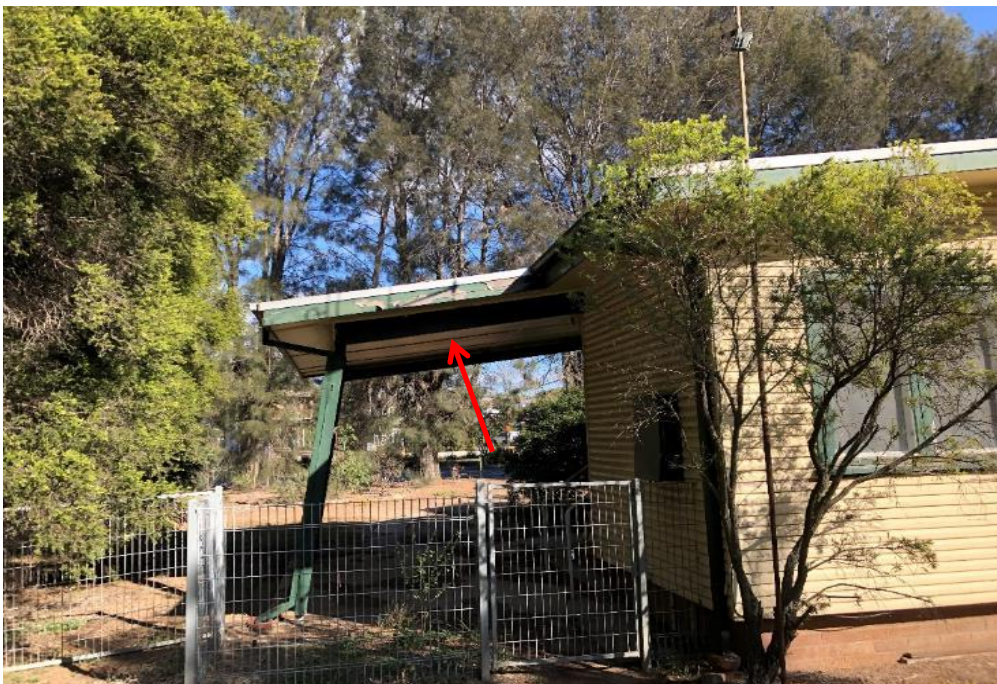
Photograph 6: Residential Dwelling, external, carport soffit, fibre cement sheet, asbestos detected by analysis.

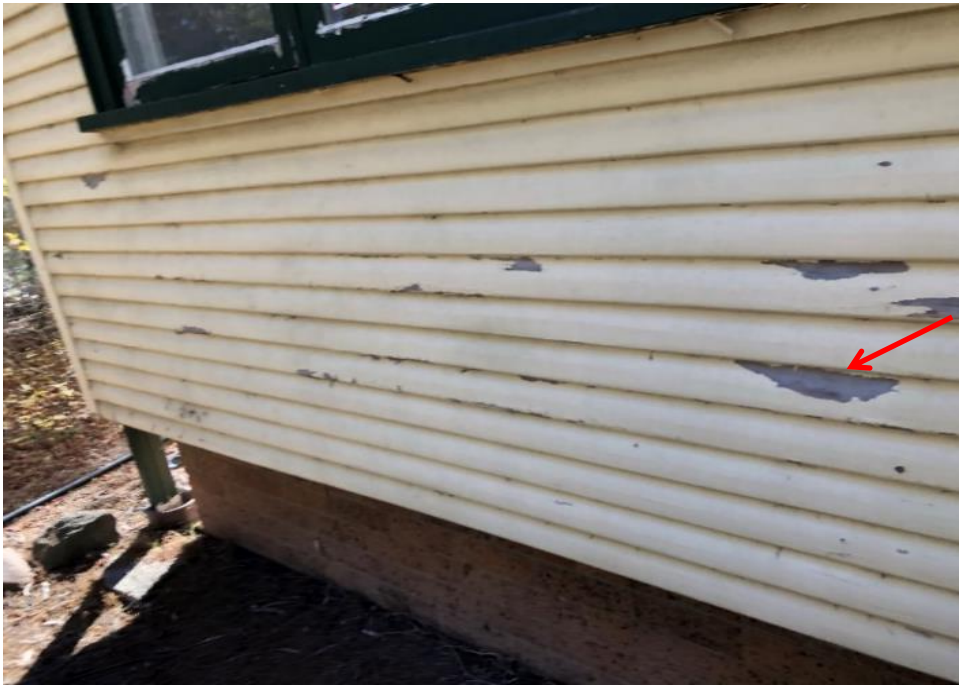
Photograph 7: Residential Dwelling, external , walls, beige paint, lead paint (assumed).

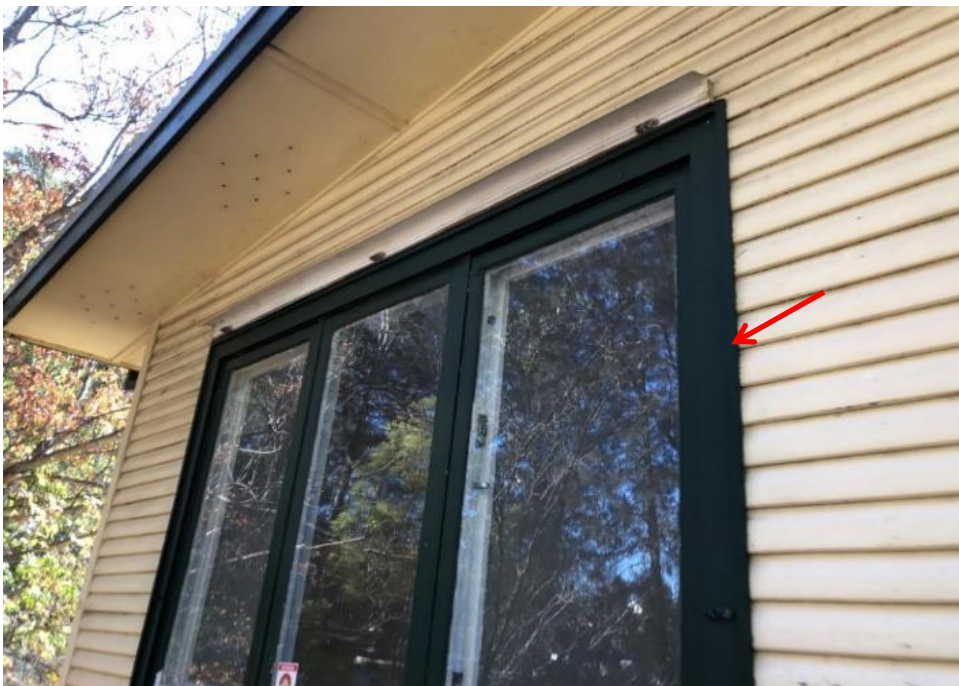
Photograph 8: Residential Dwelling, external , windows, green paint, lead paint (>0.1% lead w/w).

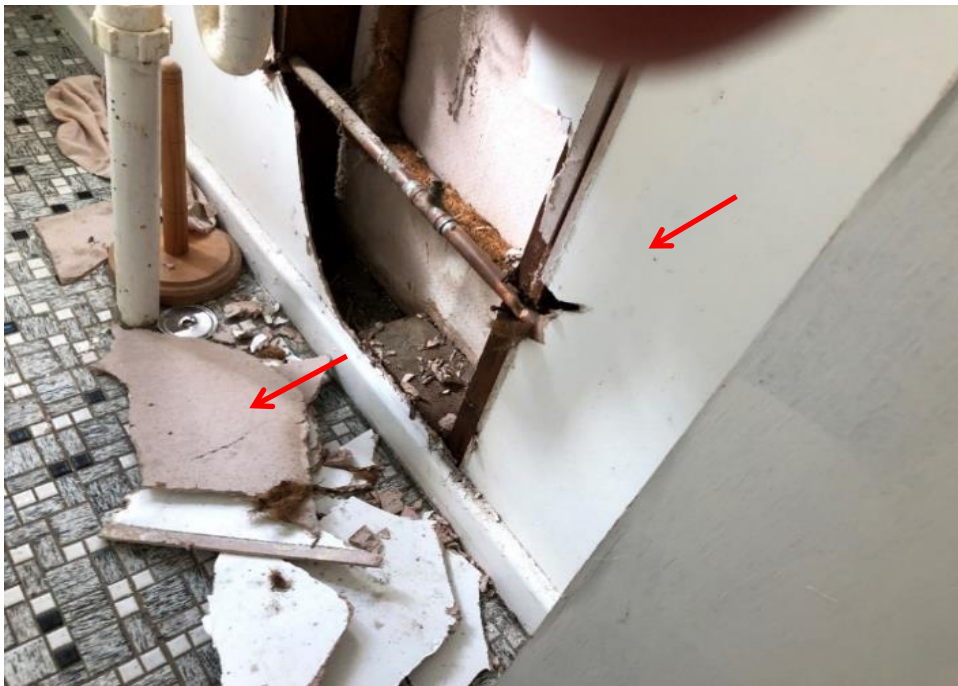
Photograph 10: Residential Dwelling, internal , walls to bathroom, fibre cement sheet, asbestos detected by analysis.

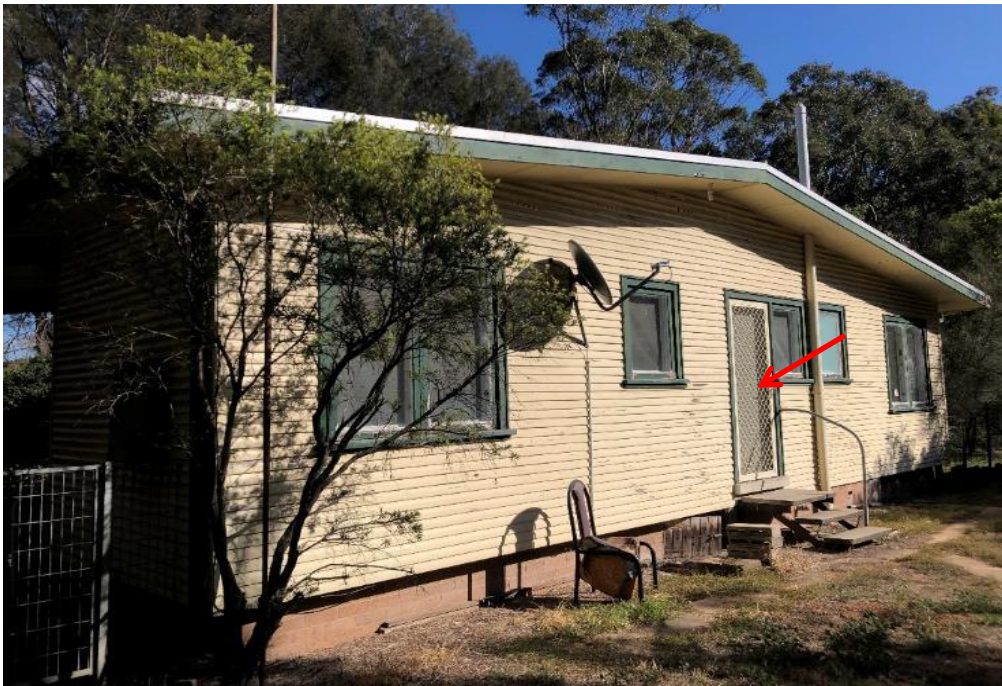
Photograph 13: Residential Dwelling, internal , laundry door, beige paint, lead paint (>0.1% lead w/w).

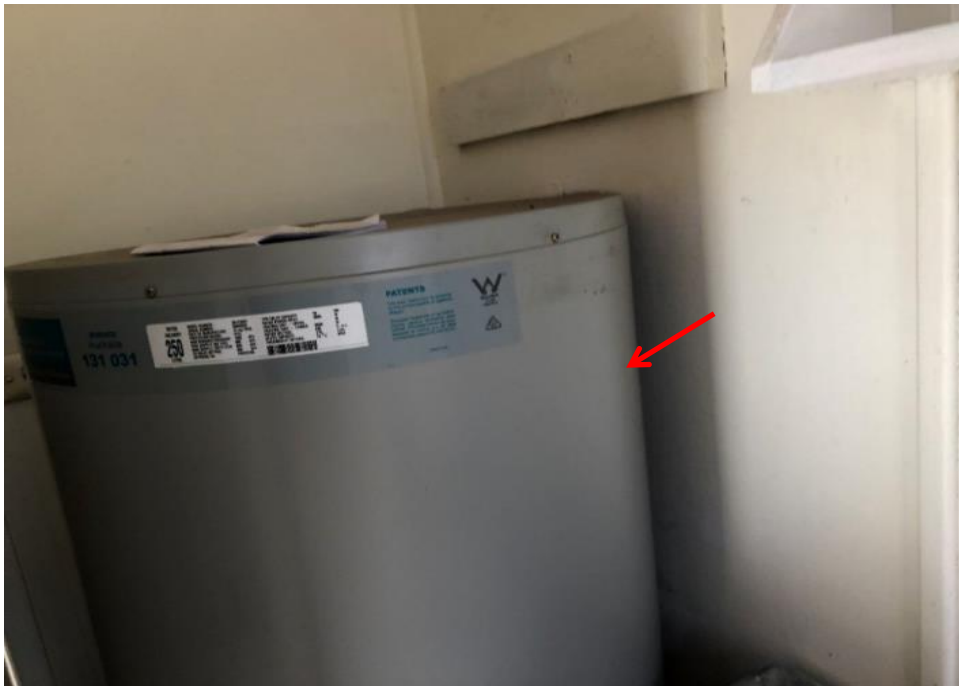
Photograph 15: Residential Dwelling, external , north east wall, hot water unit, SMF (assumed).

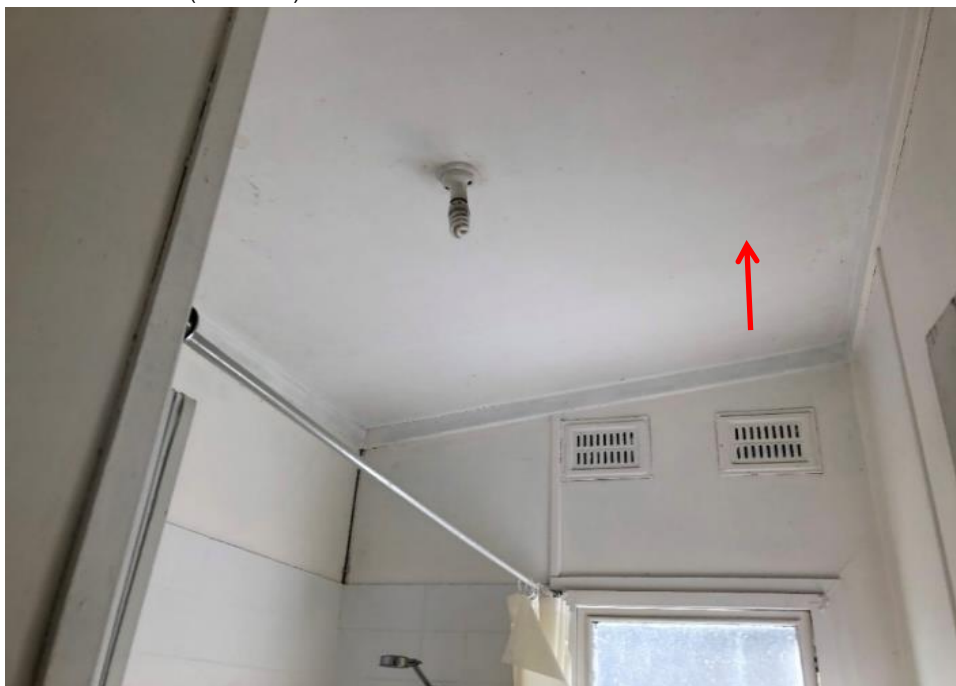
Photograph 16: Residential Dwelling, internal , ceiling cavity, insulation material, SMF (assumed).

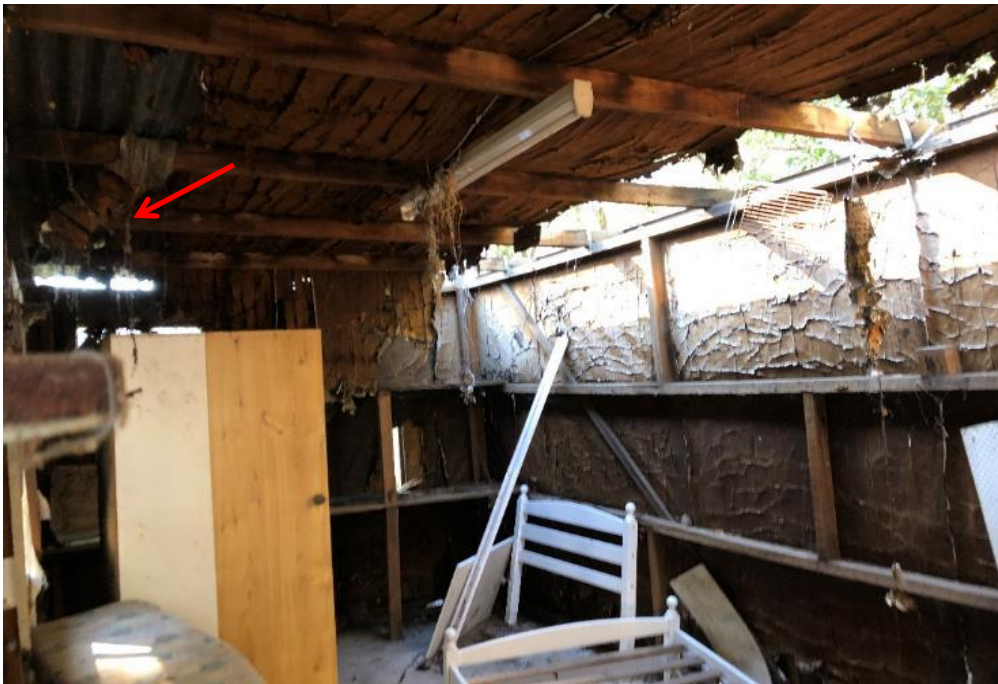
Photograph 18: Rear Shed, roof, insulation blanket, insulation, SMF (assumed).

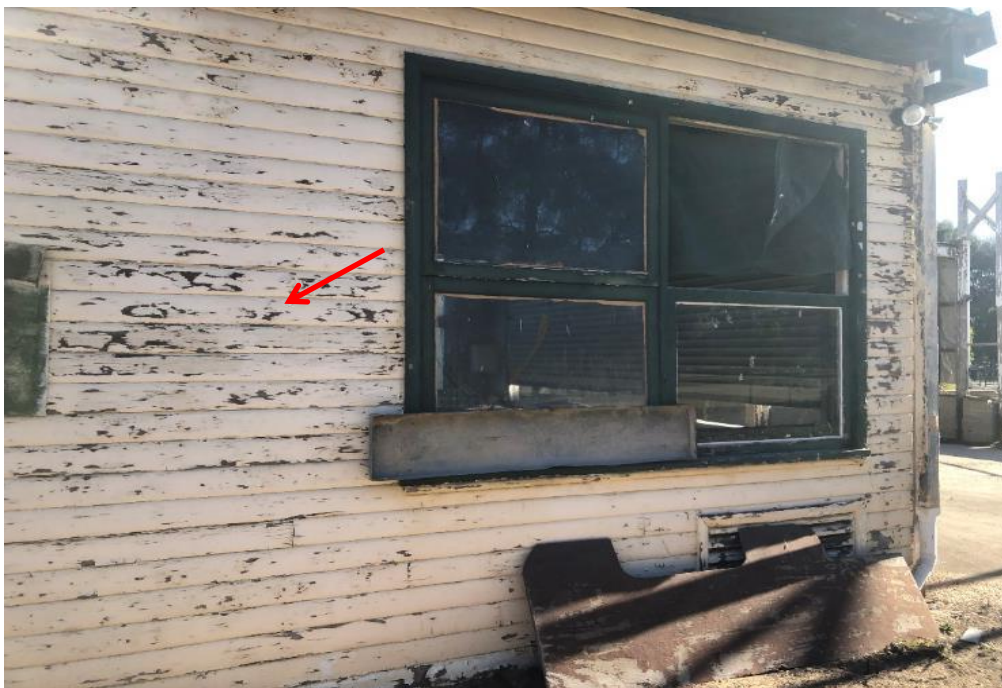
Photograph 22: Potting shed, external , walls, cream paint, lead paint (>0.1% lead w/w).

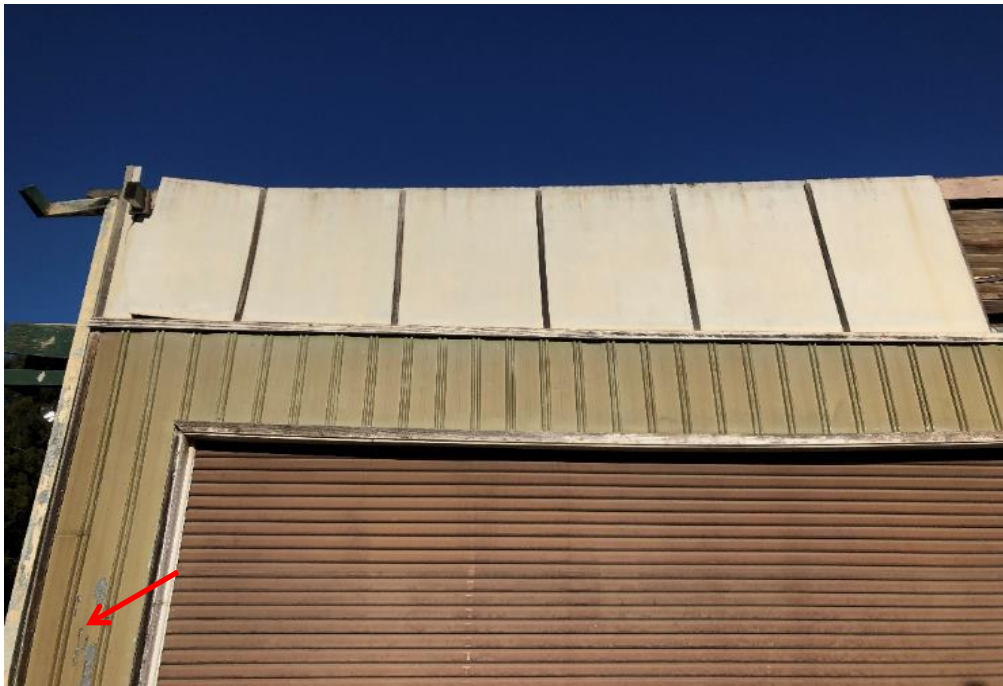
Photograph 23: Potting shed, external , corrugated sheet metal, green paint, lead paint (>0.1% lead w/w).

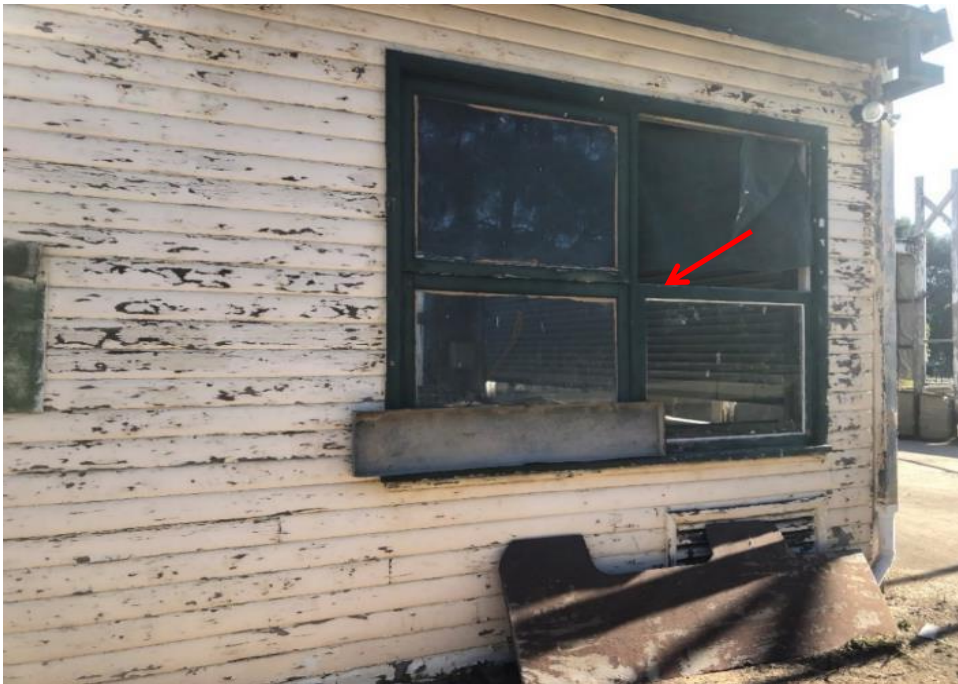
Photograph 26: Potting shed, external , windows, green paint, lead paint (>0.1% lead w/w).

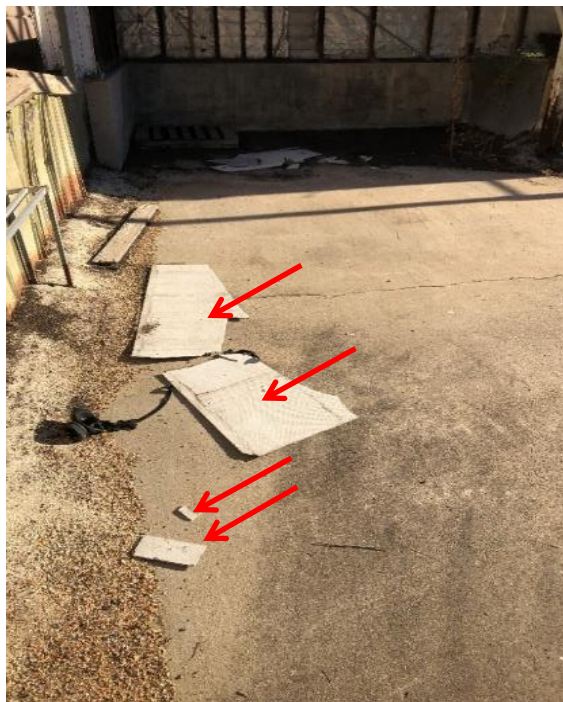
Photograph 28: Potting shed, external , ground surface, fibre cement sheet debris, asbestos detected by analysis.

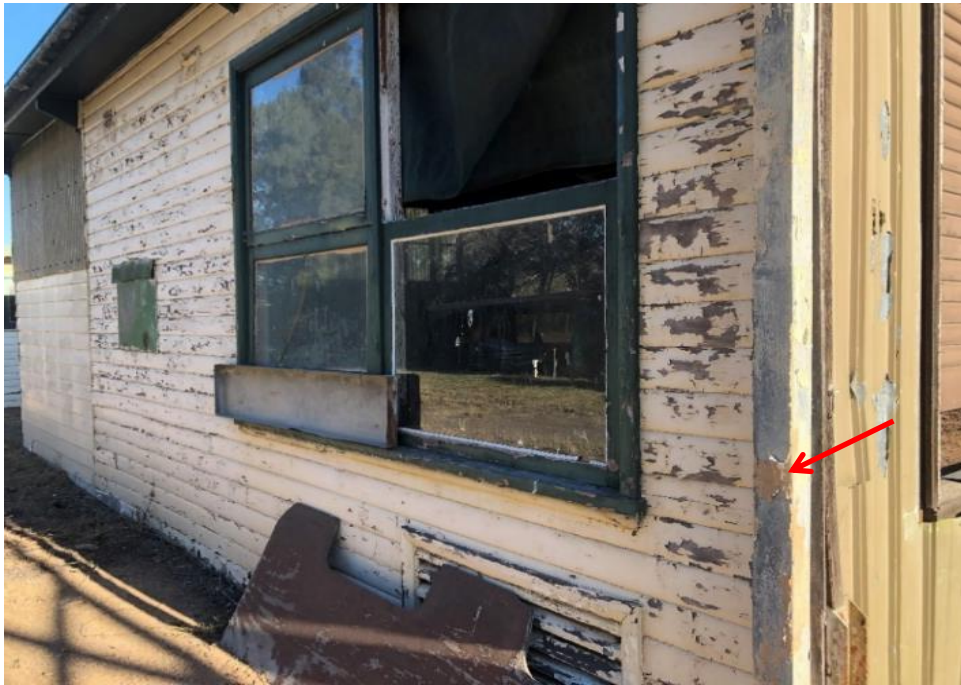
Photograph 29: Potting shed, external , downpipes, brown paint, lead paint (>0.1% lead w/w).

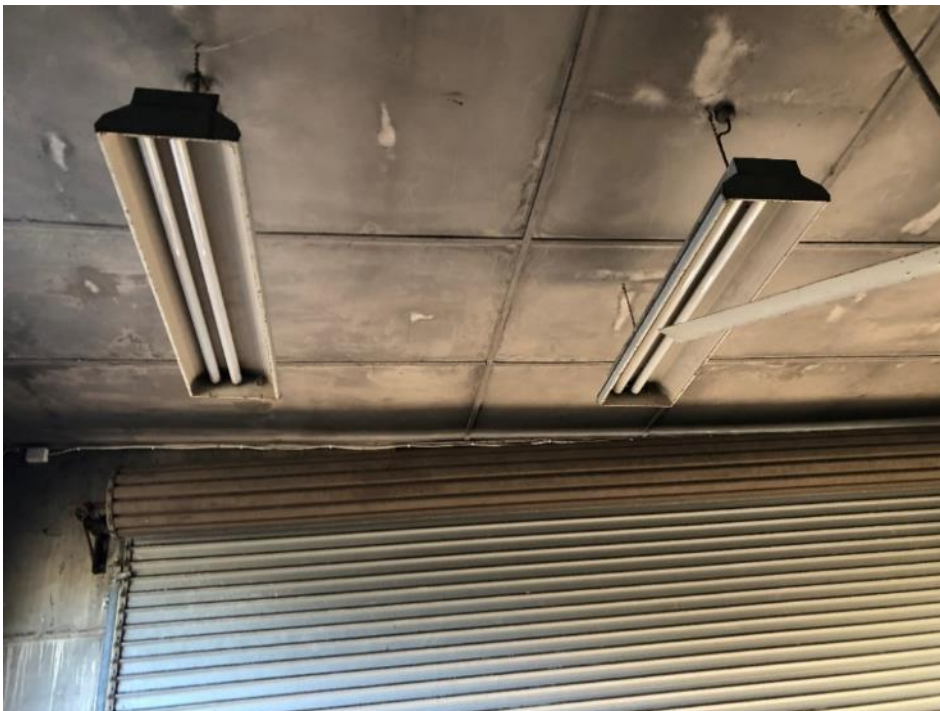
Photograph 30: Potting shed, internal , light fittings, capacitors, insulating oil, PCB (assumed).

Any PCB containing capacitors that exhibit leakage should be removed and replaced by a suitably qualified and experienced contractor as soon as possible. Access to areas containing leaking capacitors should be suitably restricted.

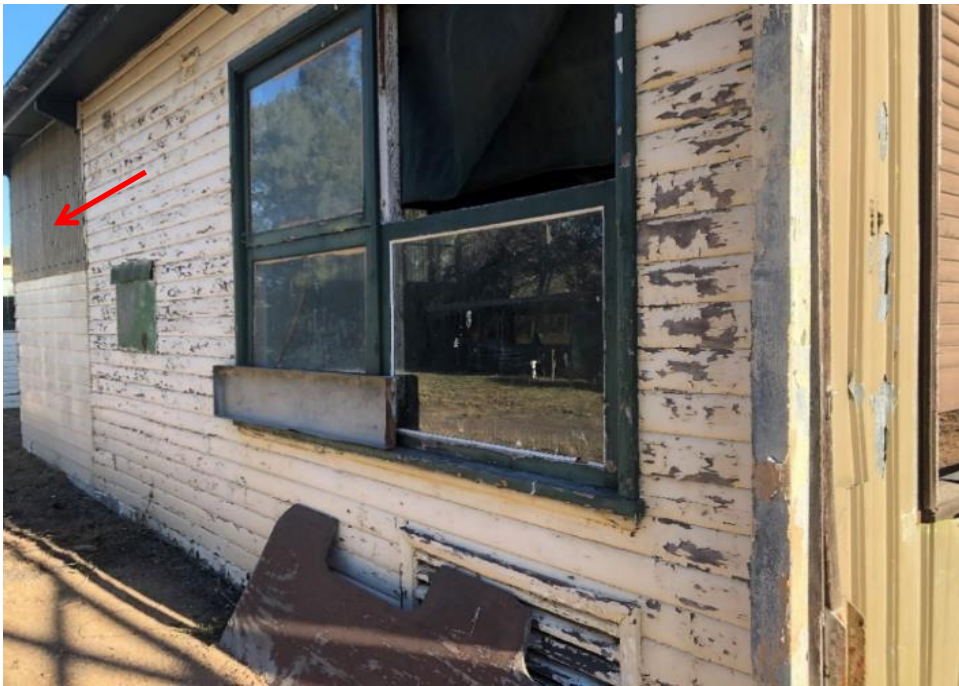
Photograph 31: Potting shed, external , walls, corrugated sheeting, SMF (assumed).

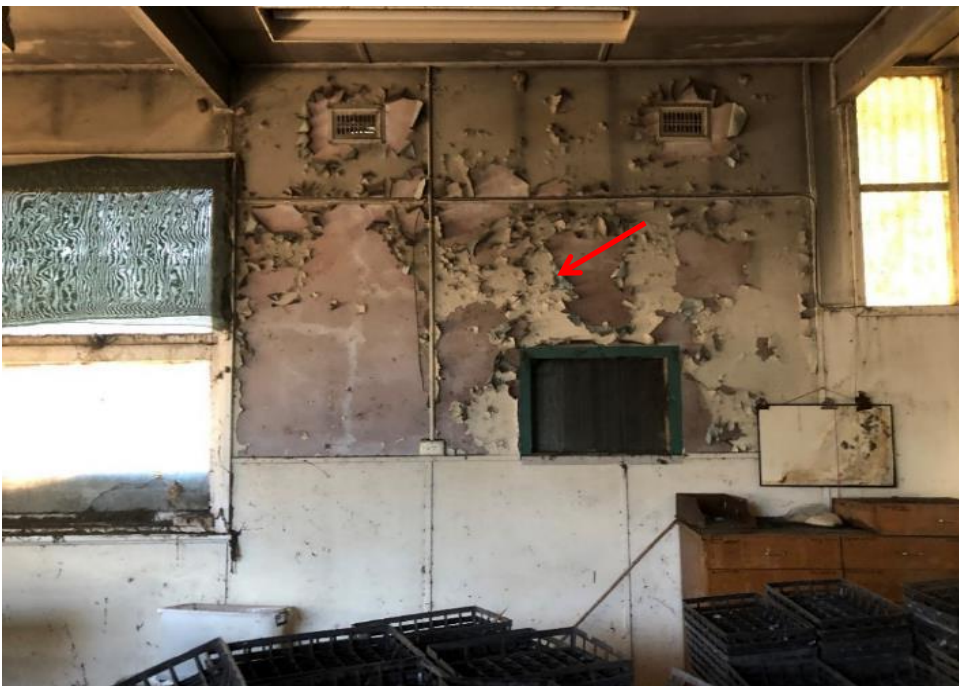
Photograph 32: Potting shed, internal , walls, beige paint, lead paint (>0.1% lead w/w).

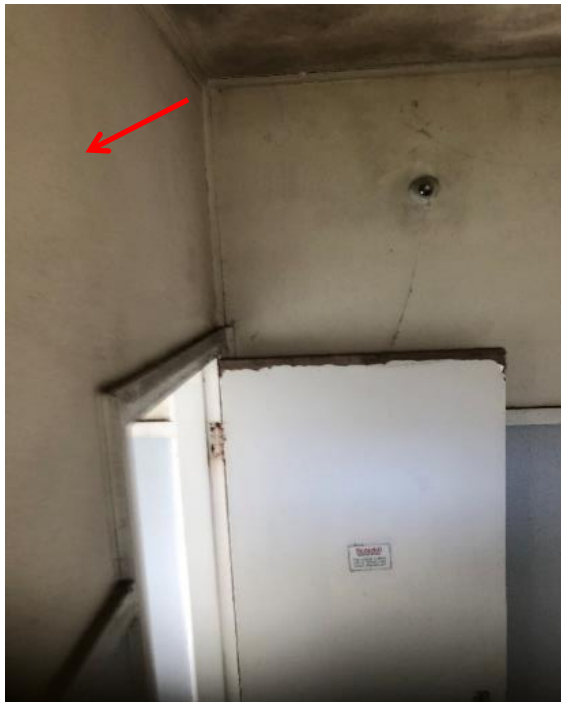
Photograph 40: Front Office, internal, walls to bathroom, fibre cement sheet, asbestos detected by analysis.

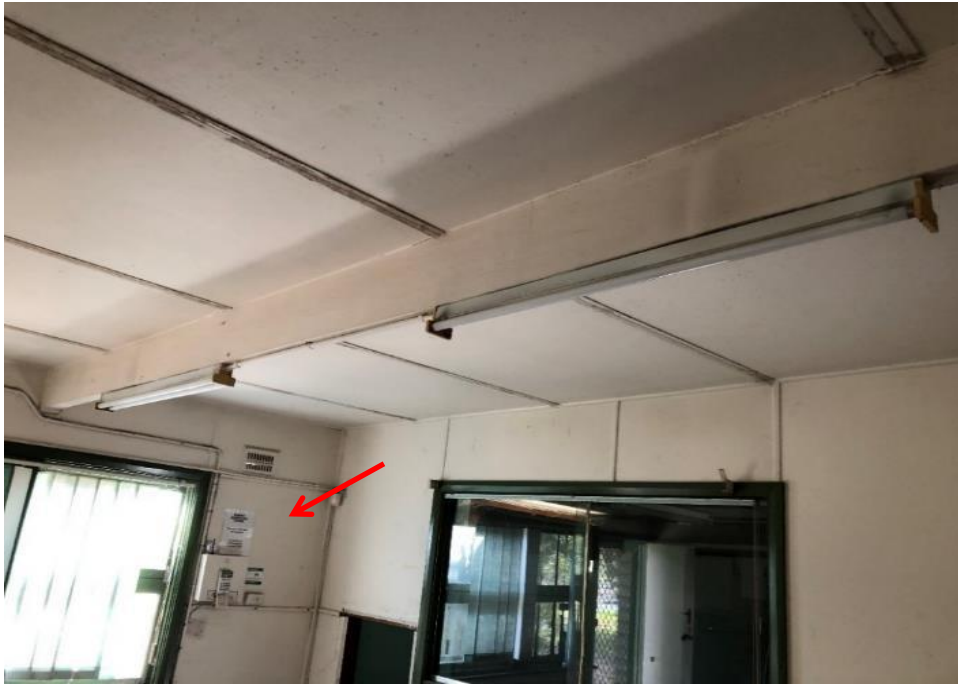
Photograph 41: Front Office, internal , wall cavities, insulation material, SMF (assumed).

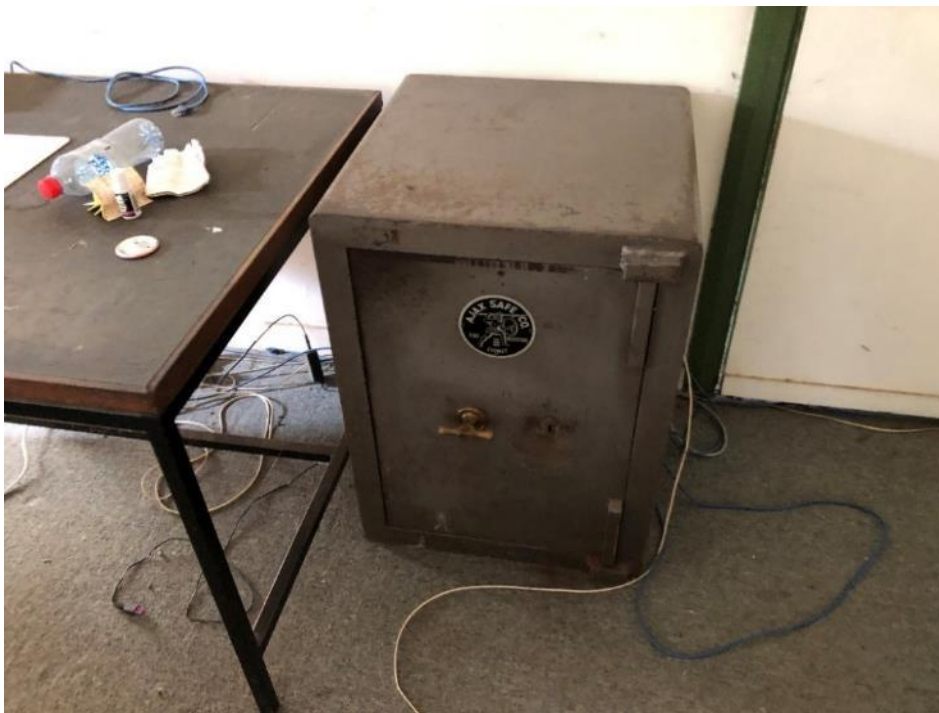
Photograph 42: Front Office, internal , "Ajax" brand safe, internal insulation, asbestos (assumed).

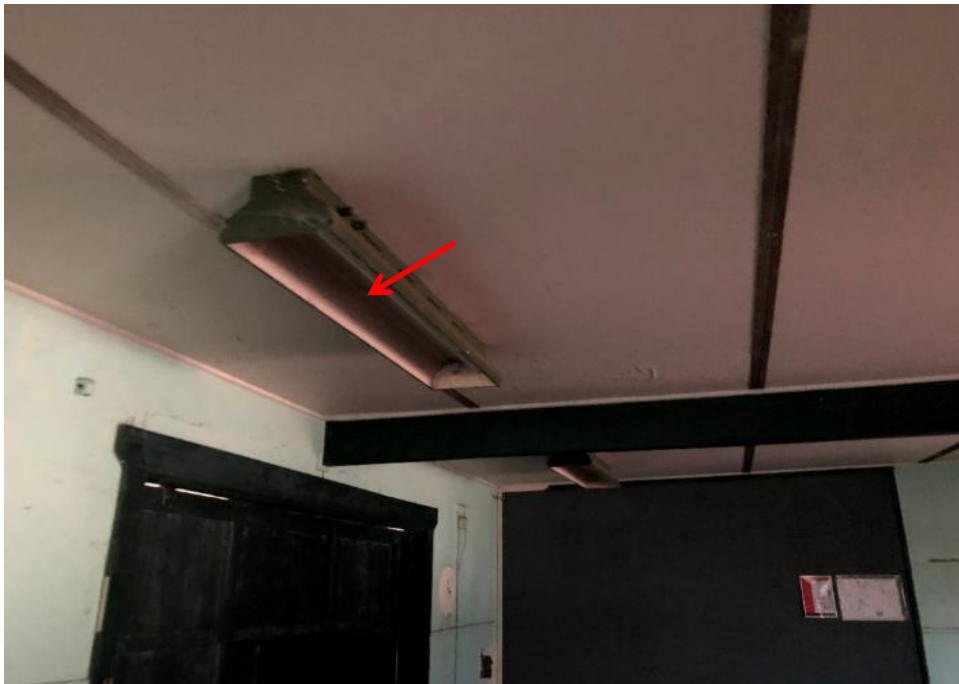
Photograph 43: Front Office, internal , fluorescent light fittings, capacitors, insulating oil, PCB (assumed).

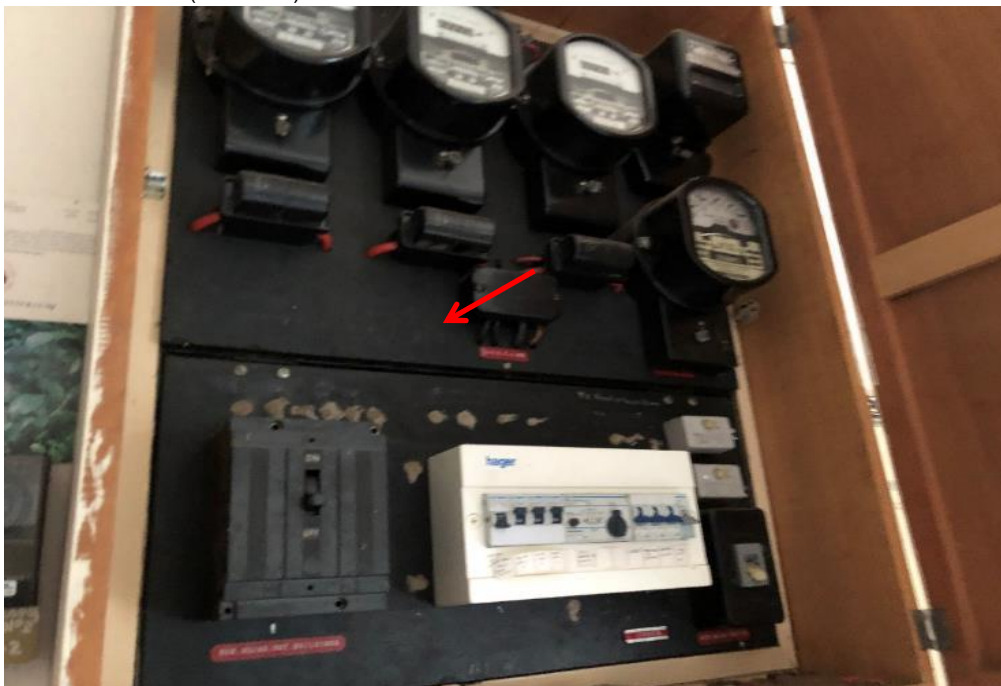
Photograph 44: Front Office, internal , electrical panel, electrical backing board, asbestos (assumed).

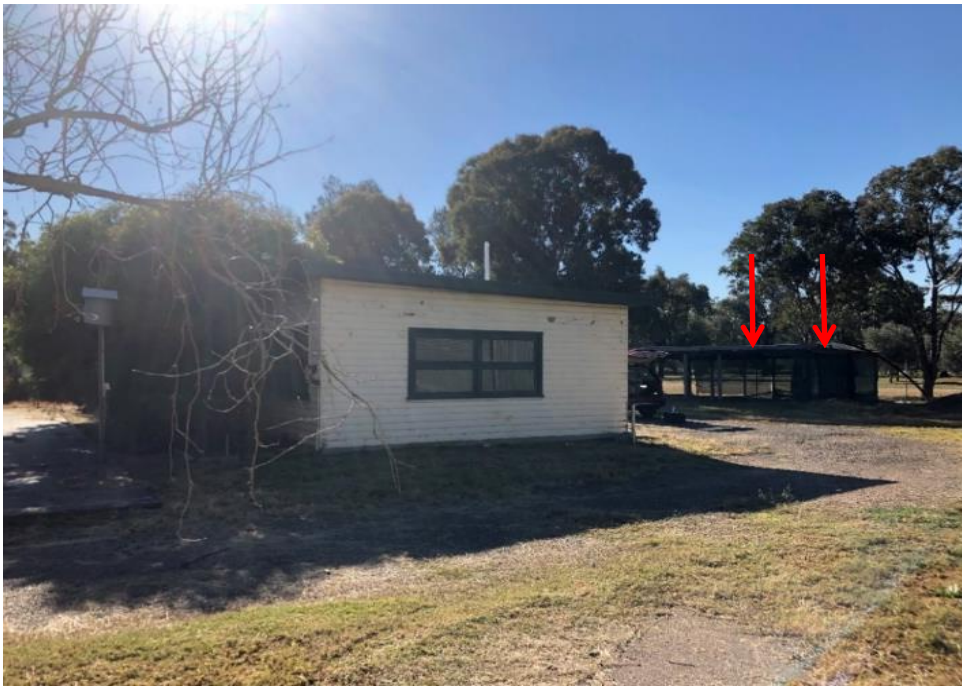
Photograph 49: Shade cloth greenhouse, external, roof, corrugated sheeting, SMF (assumed).

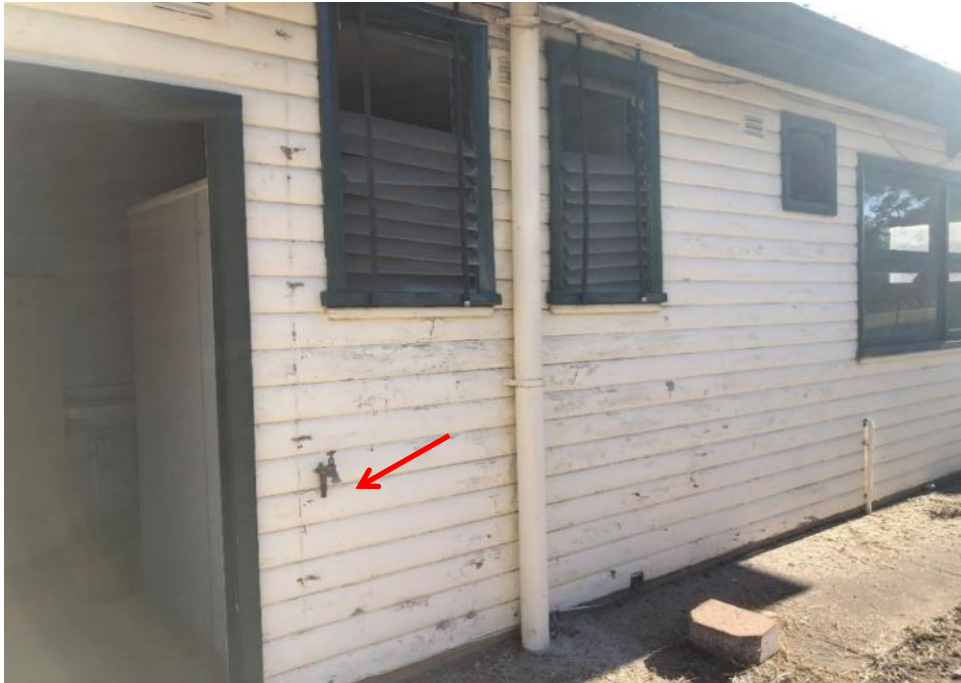
Photograph 51: Rear Office, external, walls, beige paint, lead paint (>0.1% lead w/w).

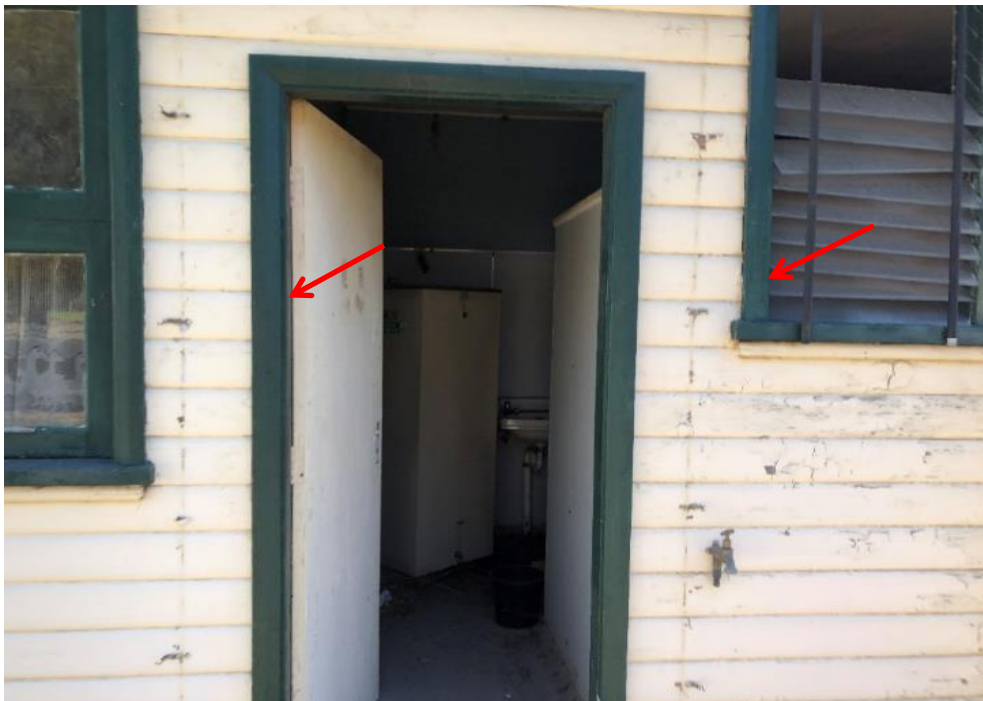
Photograph 52: Rear Office, external, windows, green paint, lead paint (>0.1% lead w/w).

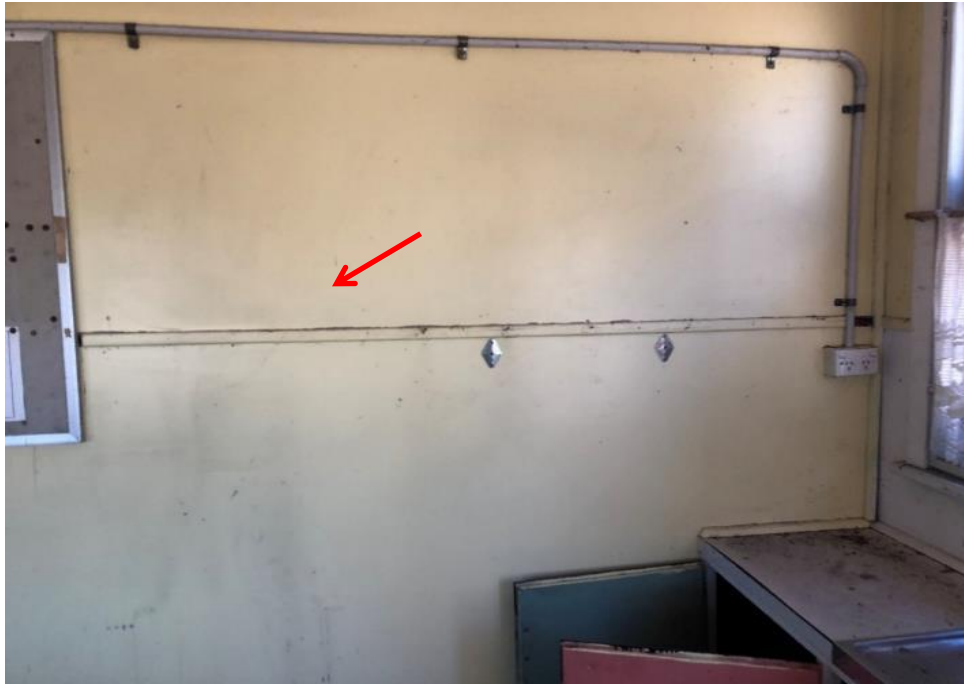
Photograph 55: Rear Office, internal , walls, yellow paint, lead paint (>0.1% lead w/w).

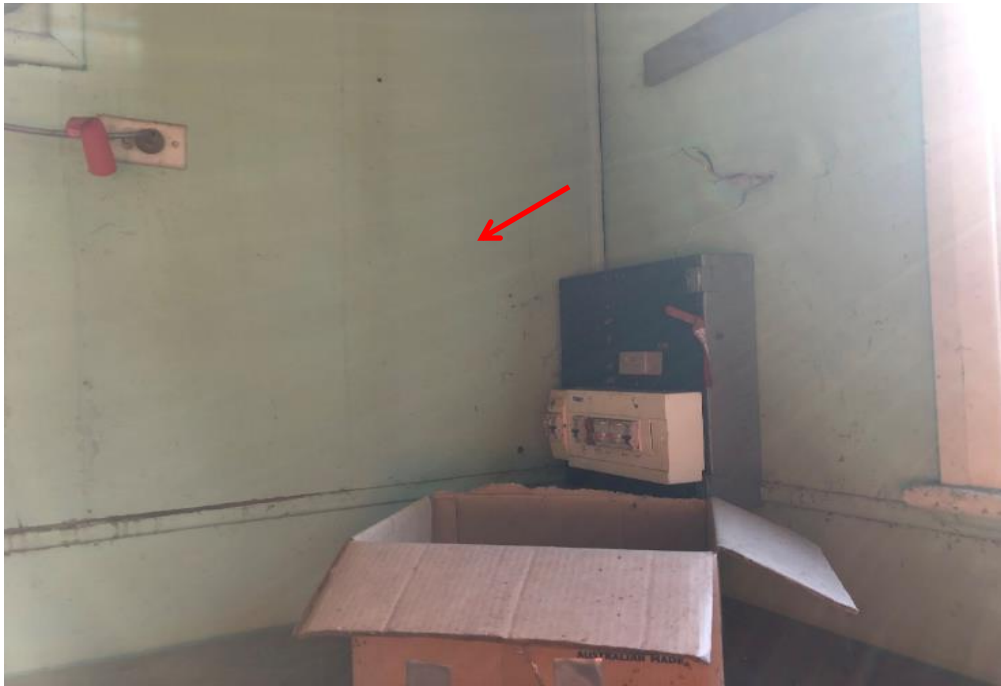
Photograph 57: Rear Office, internal , walls, fibre cement sheet, asbestos detected by analysis.

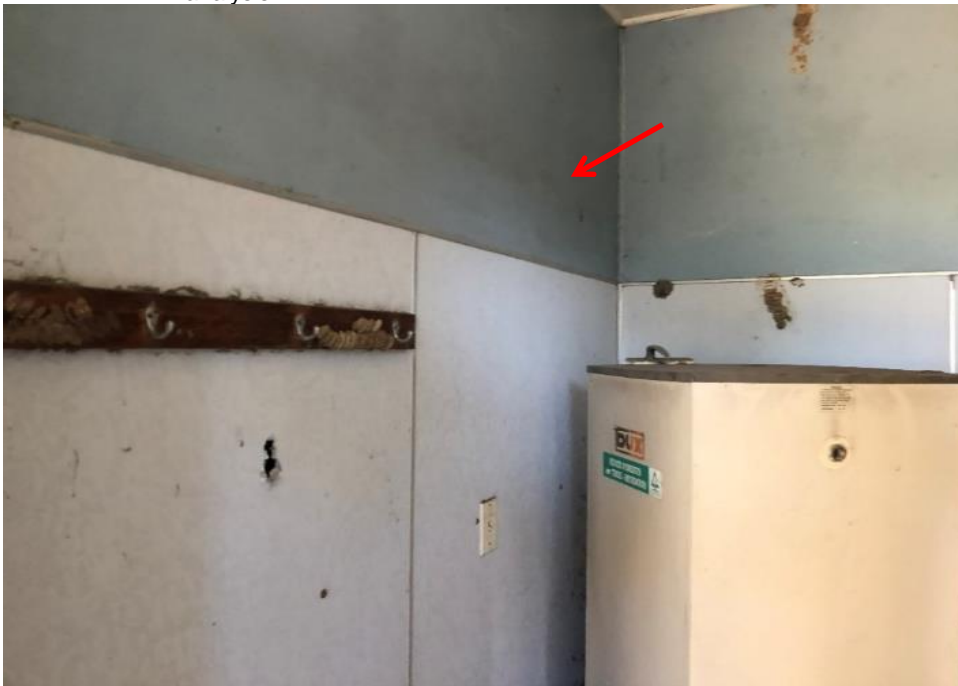
Photograph 58: Rear Office, internal , wet room, upper walls, fibre cement sheet, asbestos detected by analysis.

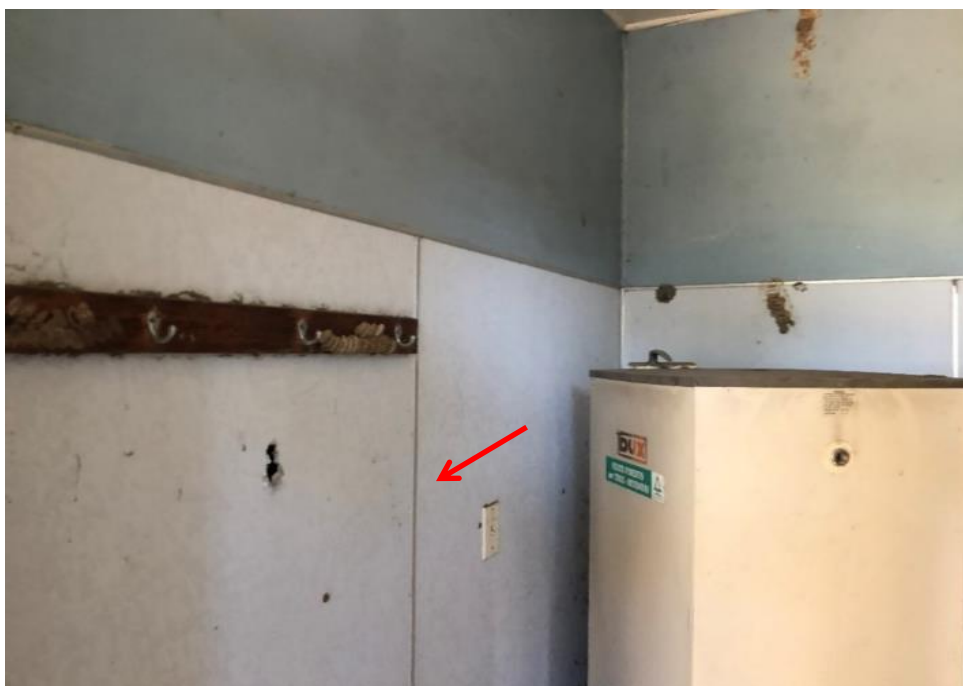
Photograph 59: Rear Office, internal , wet room, walls, lower half (marbled finish), fibre cement sheet, asbestos detected by analysis.

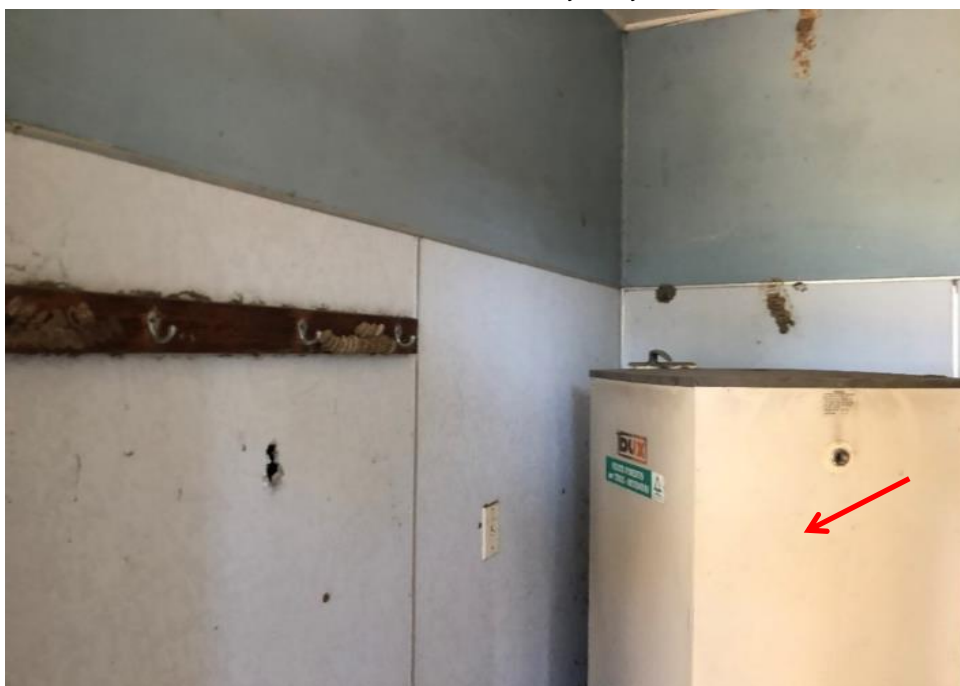
Photograph 60: Rear Office, internal, hot water unit, internal insulation, SMF (assumed).

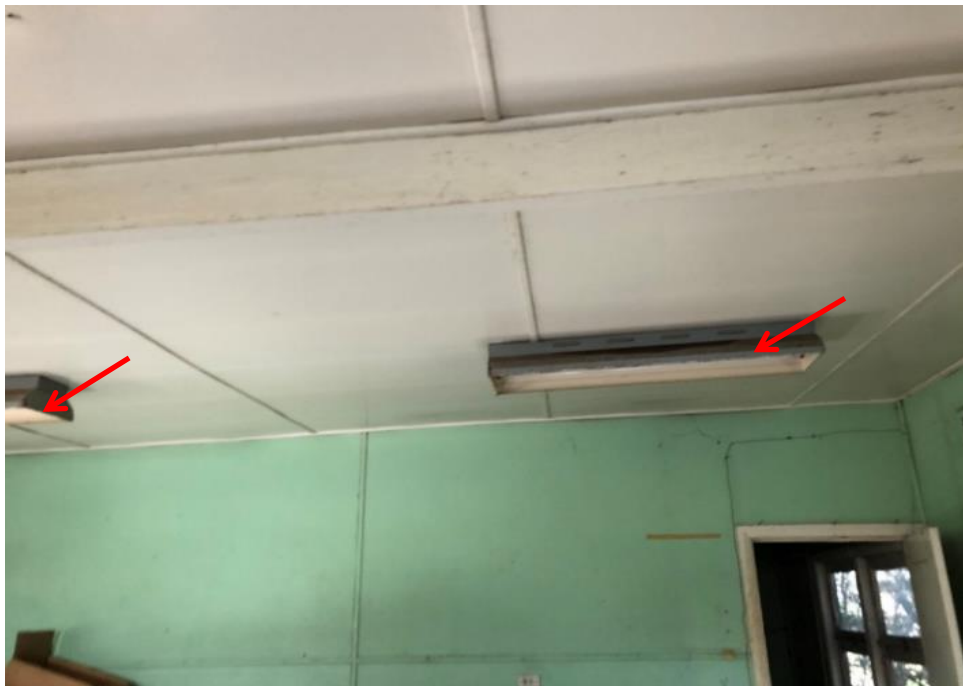
Photograph 61: Rear Office, internal , light fittings, capacitors, insulating oil, PCB (assumed).
