Report on  
Hazardous Building Materials (HBM) Survey

Lot 100 DP1261496, Maitland Street, Muswellbrook,  
NSW

Prepared for  
Pacific Brook Christian School Ltd

Project 91601.01  
August 2020

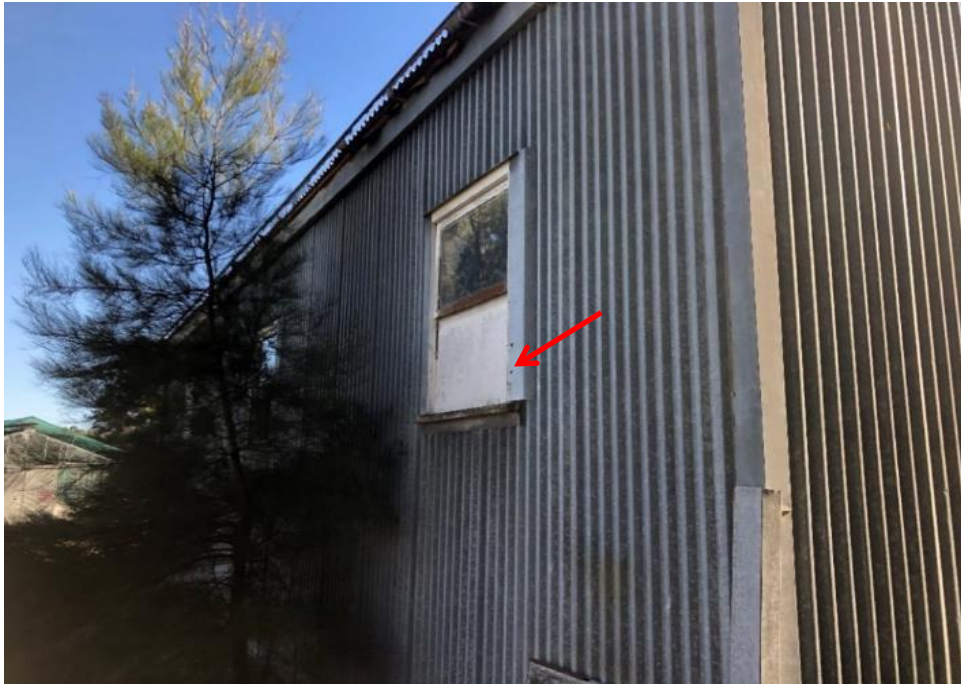
Photograph 63: HAZCHEM shed, external, windows, white paint, lead paint (>0.1% lead w/w).

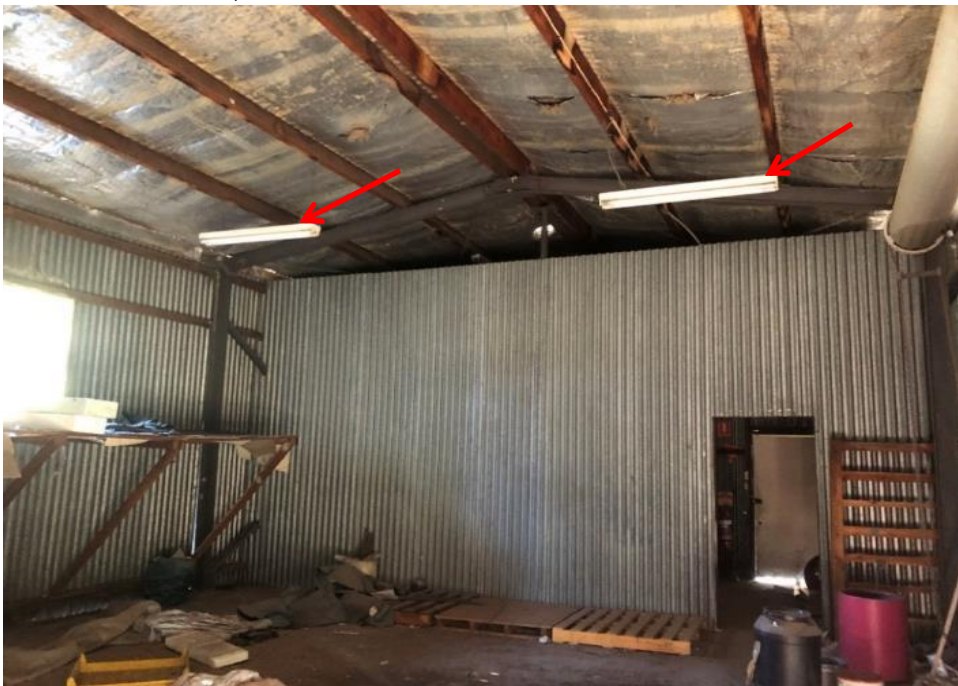
Photograph 64: HAZCHEM shed, internal , light fittings, capacitors, insulating oil, PCB (assumed).

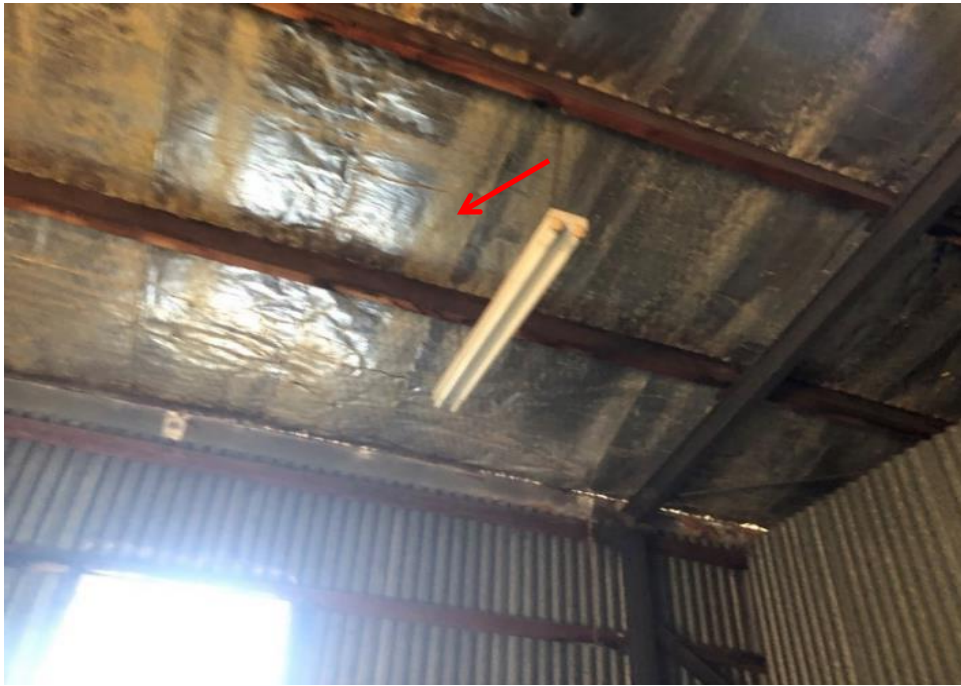
Photograph 65: HAZCHEM shed, internal , roof, insulation material, SMF identified visually.
