# **Preliminary Site Investigation for Contamination**

**Proposed Marulan Quarry at No. 16501  
Hume Highway, Marulan, NSW**

Global Quarries Australia Pty Ltd

23 December 2025

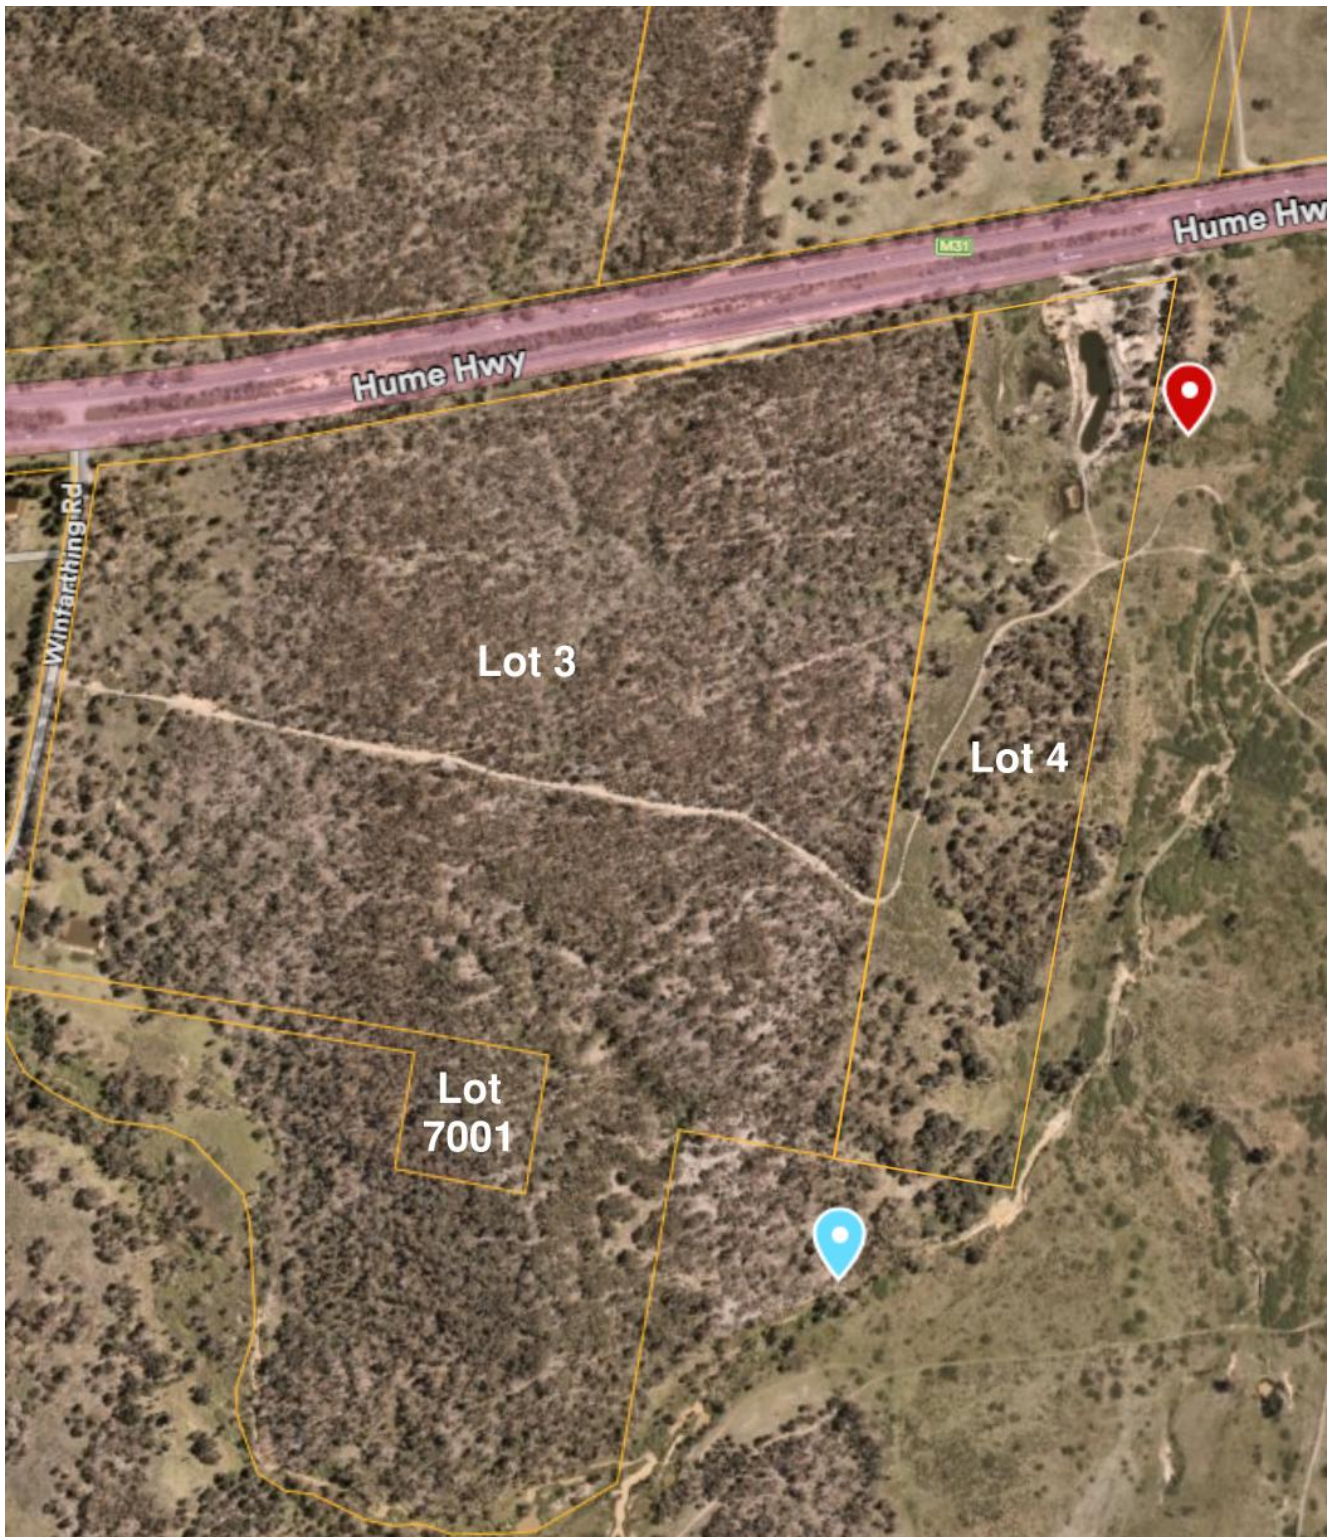
**Figure 3.1** Location of foam within Narambulla Creek indicated by the blue marker and iron precipitation indicated by the red marker (Nearmap image 1/3/2025)

During the August 2024 sampling event, foam was observed within Narambulla Creek at coordinates -34.750824, 149.904646 (refer to Photo 1 and Photo 2 below). During the February 2022 monitoring event, iron precipitation was observed at coordinates -34.743569, 149.908124 (refer to Photo 3 and Photo 4 below). The location of the foam and iron precipitation is indicated by the blue and red markers in Figure 3.1, respectively and are located off-site and down-gradient of the site. Foam and iron precipitation was only observed once in the four site visits that have been undertaken since 2022 suggesting the occurrence may be transient coinciding with high rainfall events (refer to Section 4). Foam and iron precipitation can occur naturally (e.g. bacteriological activity, change in pH due to natural oxidation of soil or rock, etc.).

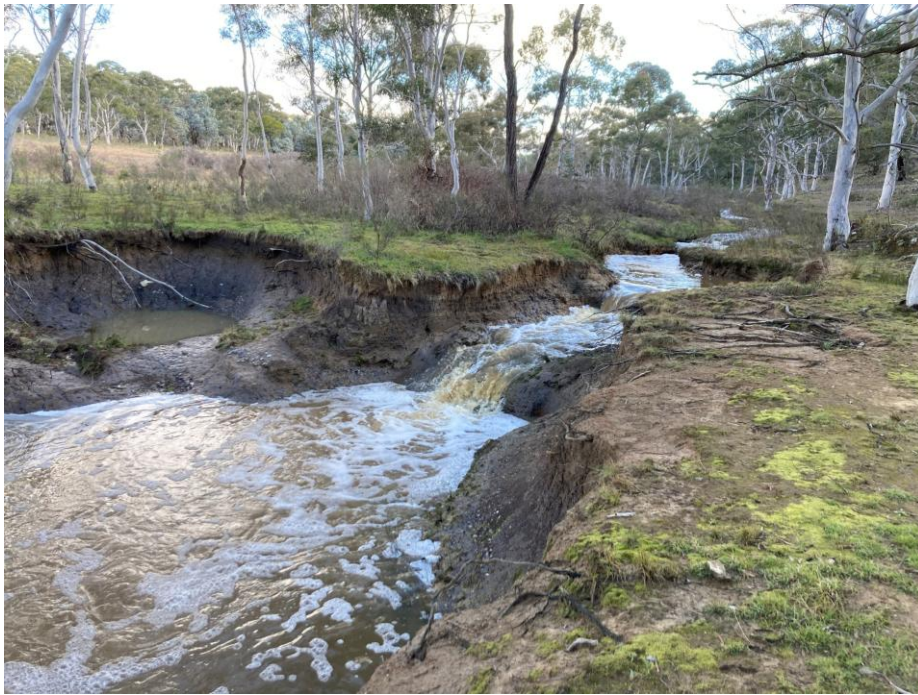
Photo 1: View looking upstream at Narambulla Creek. Note foam on the water within upstream sections of the creek (15/8/2024)

Foam and iron precipitation were observed during the August 2024 and February 2022 monitoring rounds, respectively. The foam was observed within Narambulla Creek whilst the iron precipitation occurred in area of pooled water approximately 65 m south-east of the borrow pit area on Lot 4 (off-site). The source of the foam and cause of the iron precipitation are unknown. Foam and iron precipitation can occur naturally (e.g. bacteriological activity, change in pH due to natural oxidation of soil or rock, etc.). Foam and iron precipitation was only observed once in the four site visits that have been undertaken since 2022 suggesting the occurrence may be transient coinciding with high rainfall events. Although groundwater and surface water were analysed, this did not include pesticides, herbicides and PFAS. Remaining water quality parameters including petroleum hydrocarbons, nutrients, and heavy metals (except for cadmium, copper and zinc) did not exceed DGVs (ANZG, 2018). Historical activities have not identified an on-site source for cadmium, copper or zinc, suggesting the higher concentration reported in surface water and / or groundwater may be associated with natural sources (i.e. local geology).

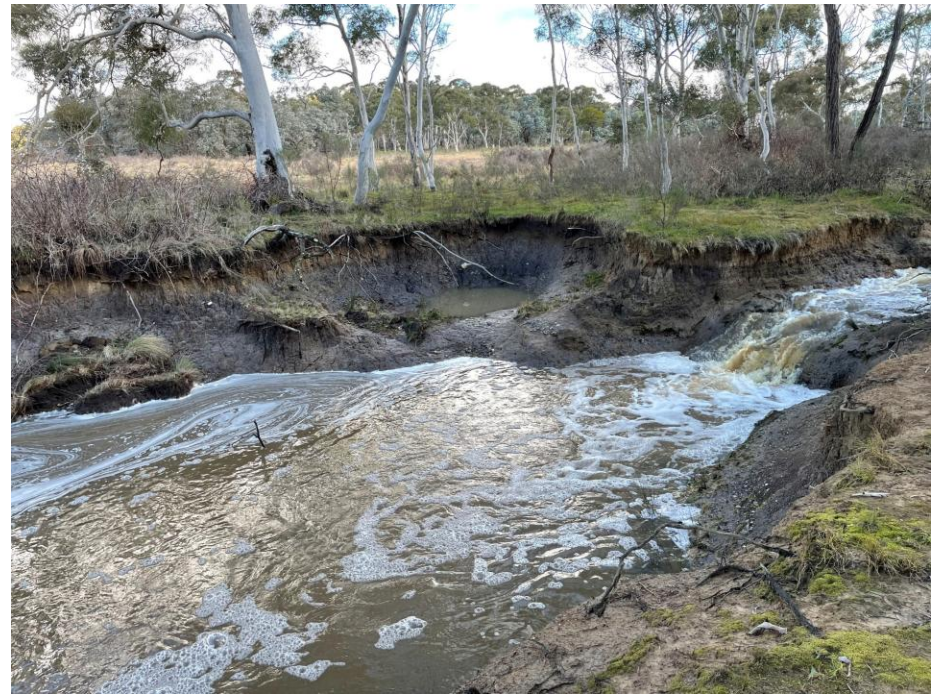
Photo 2: Close up view of the foam within Narambulla Creek (15/8/2024)

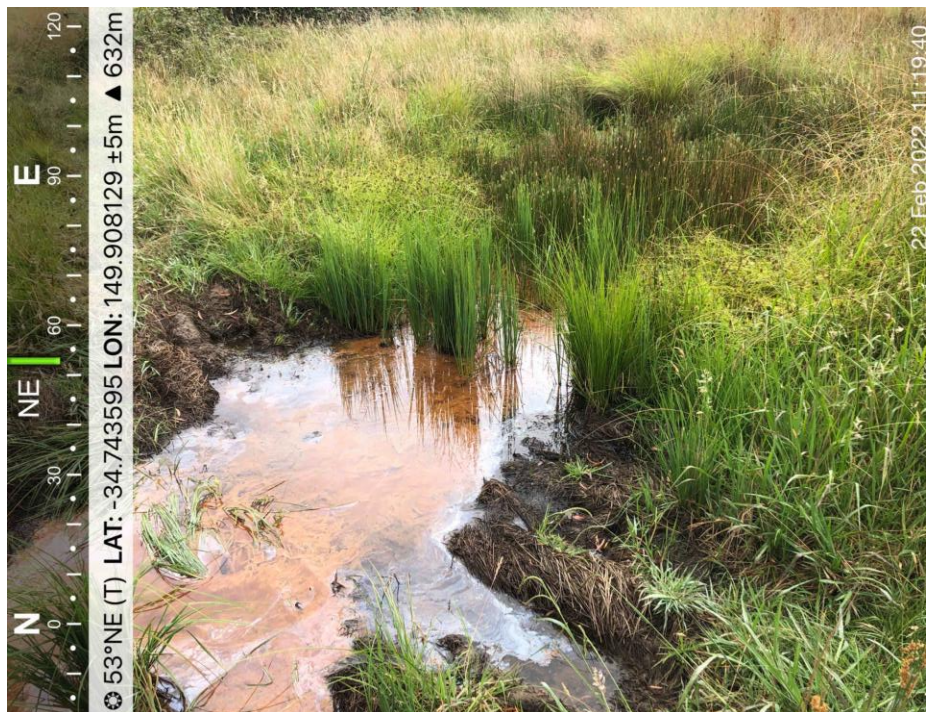
Photo 3: View looking north at iron precipitation in pooled water located approximately 65 m south-east of the borrow pit area (22/2/2022)

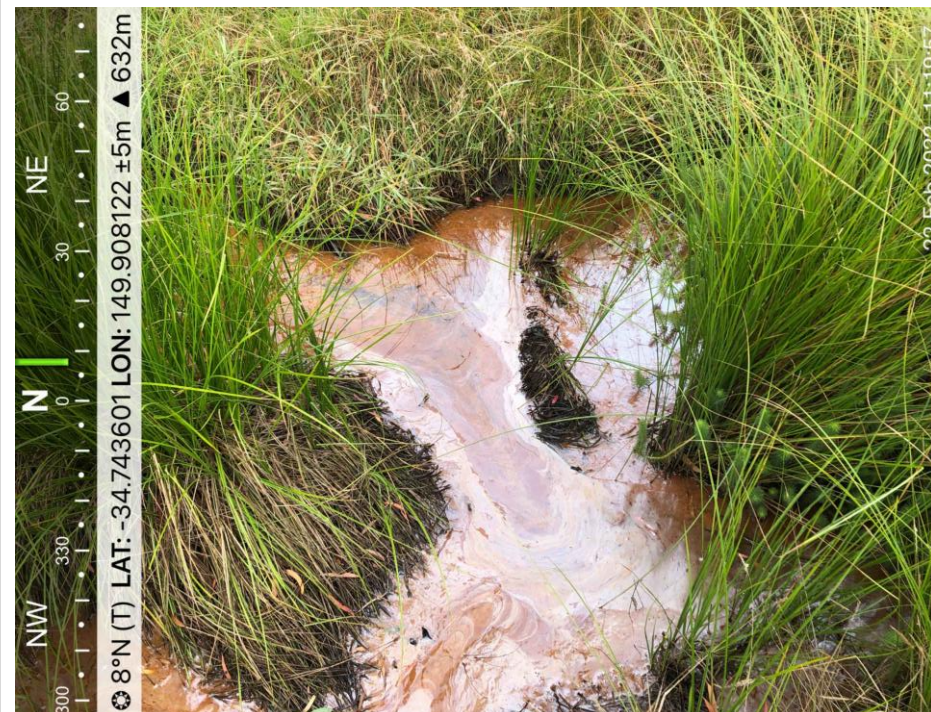
Photo 4: Close up view of iron precipitation in pooled water located approximately 65 m south-east of the borrow pit area (22/2/2022)

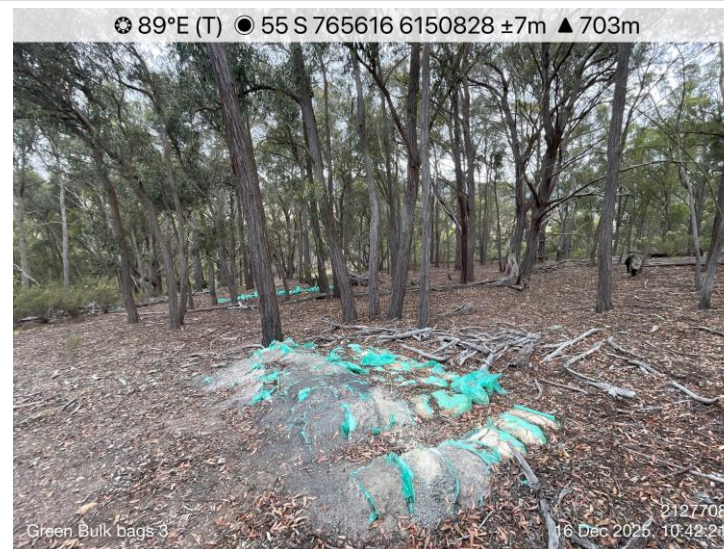
In the southern part of Lot 3 approximately 70 to 120 green bulk bags were observed stockpiled at various locations. The stockpile areas were between 50 and 250 m of the trigonometrical station on Lot 7001 (Photo 8). The bulk bags were labelled with the letters 'GCRC' and had depths ranging from one to over 100 (assuming metres) written on them. The bulk bags appear to be associated with site investigations (possibly geological exploration). Two boreholes / piezometers, cased with PVC pipe, were located in the vicinity of these bulk bags (Photo 9). The piezometers were open (i.e. not capped) and each measured depths greater than 30 m. No groundwater was encountered within 30 m of the ground surface.

Photo 8: Green bulk bags with soil/rock samples. The plastic has degraded, and the bags are open (16/12/2025)

Site history information and site observations have not identified any significant placement of fill. Fill comprising rocks, likely from the site, has been used around the base of the trig station. Soil and rock samples from exploratory drilling undertaken at the site (i.e. reworked natural materials) have been stockpiled at various locations within the southern half of Lot 3. The plastic bags containing the samples have degraded and present an aesthetic impact.

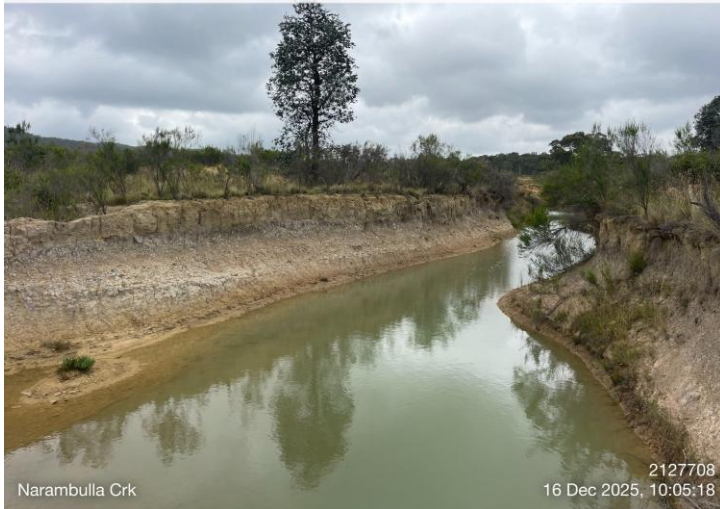
Creek flats were present around Narambulla Creek, largely occupied by grass, blackberry bushes and sparse trees (Photo 10). Narambulla Creek and its tributaries were not flowing at the time of the site visit. The water was ponded within discontinuous segments of the watercourse. Narambulla Creek appeared slightly cloudy with low turbidity and had an aqua blue tinge (Photo 11). Further upstream, the surface water was pale brown, more cloudy with moderate to high turbidity (Photo 12). No odours, sheen, iron precipitation or foam were noted in the watercourse. The creek was deeply incised into the surrounding land and highly eroded (Photo 13), with the banks approximately 2 m high in some areas.

Photo 13: View looking south at steep and highly eroded creek banks of Narambulla Creek (16/12/2025)

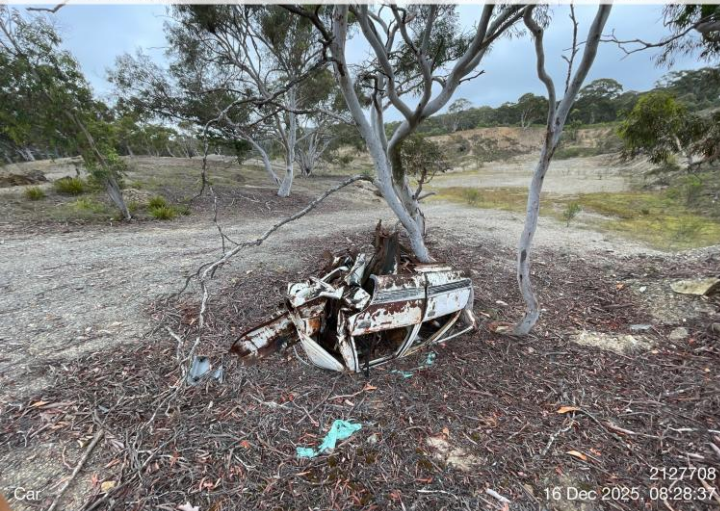
Photo 15: Old vehicle body located near access road to borrow pit (16/12/2025)

- Borrow pit area (Lot 4): remnants of a car (i.e. passenger cab only), rusted and mangled.
- Road verge and median strip: litter (i.e. food wrappers, drink bottles, etc.), hard and soft plastics, Styrofoam, a tyre, and a small pile of asphalt near the northern access gate (Lot 4).

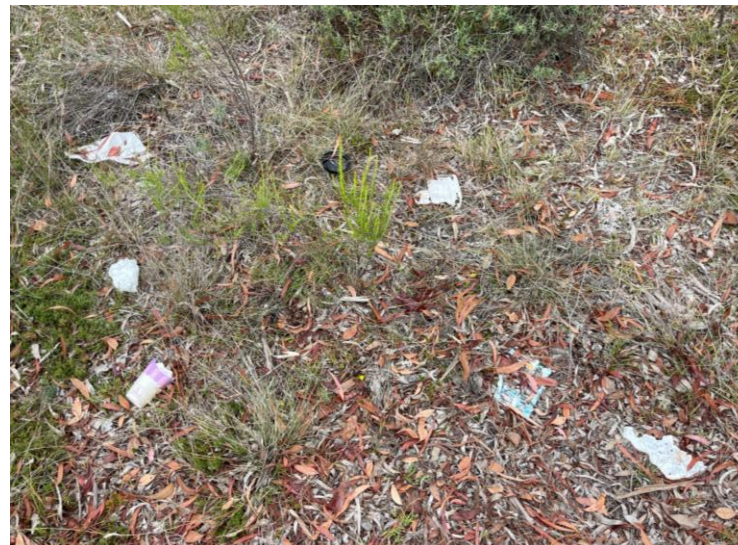
The northern site boundary occurs adjacent to the Hume Highway for approximately 2.2 km (Photo 19). Rubbish was frequently observed scattered along the road shoulder and median strip, and included fast food containers and wrappers, Styrofoam, soft and hard plastics and a tyre (Photo 20). A small pile of bitumen with tyre tread and plastics was dumped near the access gate to site on the northern boundary (Lot 4) (Photo 21). No other fly tipping was observed along the Hume Highway at the time of the site visit.

Photo 20: Example of the general rubbish found scattered in proximity to the Hume Highway – on road shoulder (16/12/2025)

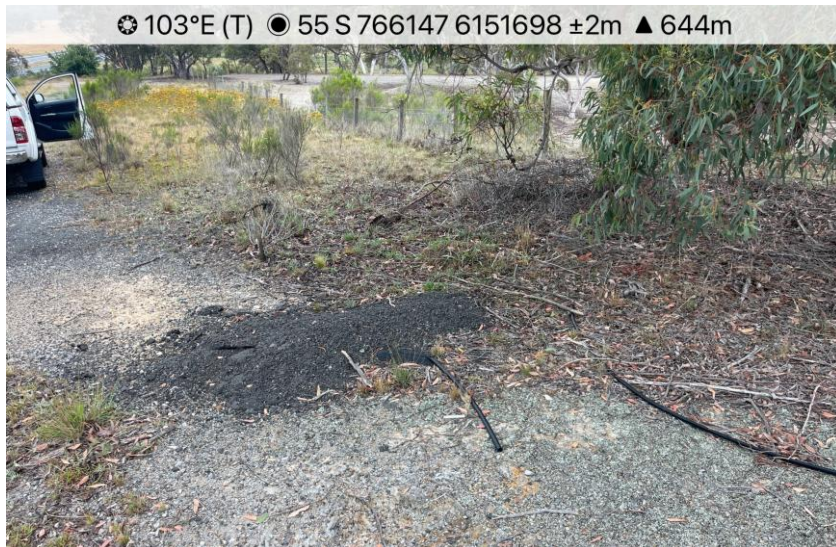
Photo 21: Bitumen with tyre tread and plastic on Hume Highway road shoulder near Lot 4 access gate (16/12/2025)

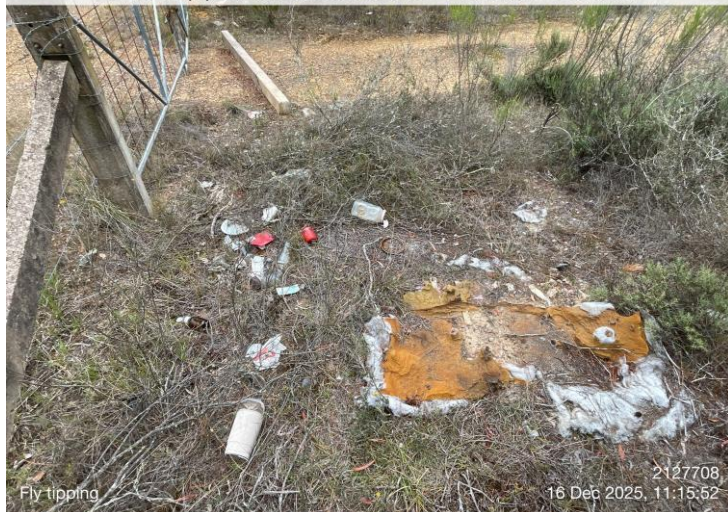
Photo 27: Fly tipping evident over fence into property, near northern access gate from Winfarthing Road (16/12/2025)

- Winfarthing Road:
  - Fly tipping 1 (on-site): Degraded mattress, bottles and jars, ceramics. Located on-site adjacent to the Lot 3 access gate on Winfarthing Road.
  - Fly tipping 2 (off-site): Cardboard boxes and sandwich toaster press were located within the road shoulder approximately 150 m south of the second access gate on Winfarthing Road. The tipping appears relatively recent. Disused wire was entwined in the site fence near fly tipping 2.
  - Fly tipping 3 (on-site): four pieces of rusted scrap metal, resembling corrugated iron sheeting and 44 gallon drum located approximately 75 m south of the Hume Highway on Lot 3.

There was no evidence of contamination such as oil staining or asbestos containing material (ACM) associated with these instances of fly tipping.

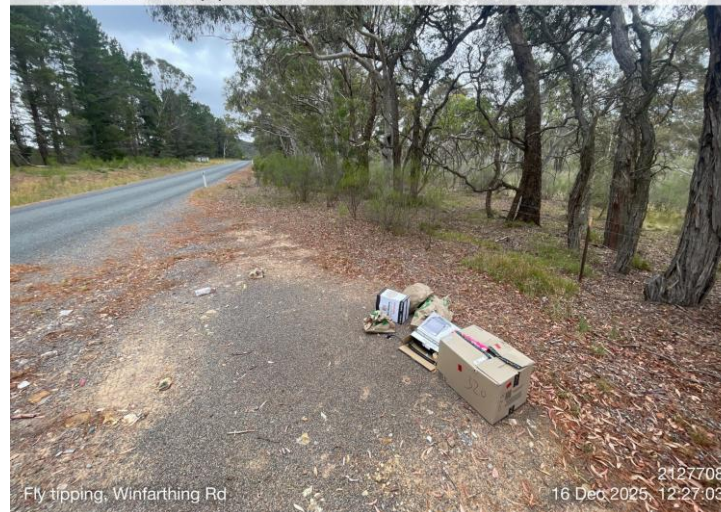
Photo 28: Fly tipping evident on road shoulder of Winfarthing Road (16/12/2025)

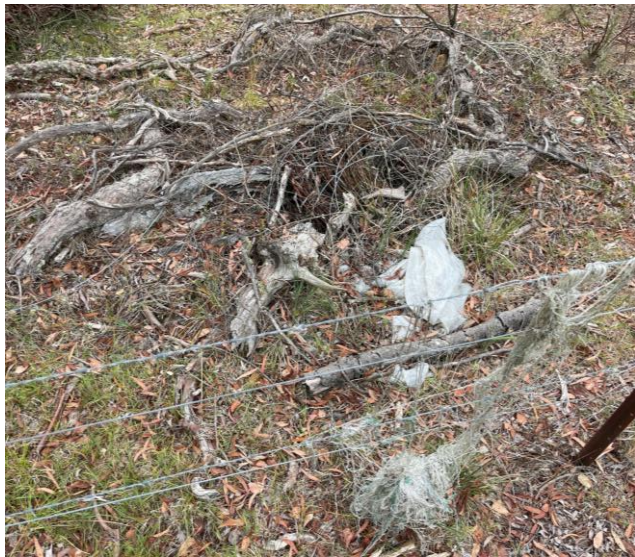
Photo 29: Pile of wire located just inside boundary fence off Winfarthing Road (16/12/2025)
